DO15 RC Indoor Phase VI Test Daily Notes

Date: June 21, 2019

Cycle count: 1630

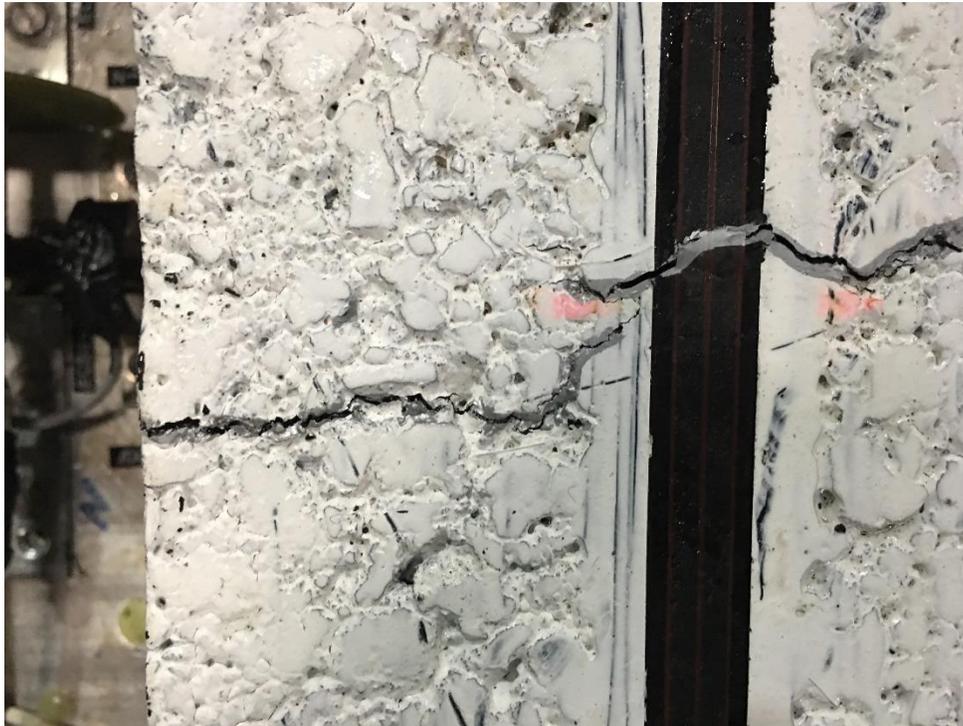
Fig 3 Surface crack on North Section reached outer edge

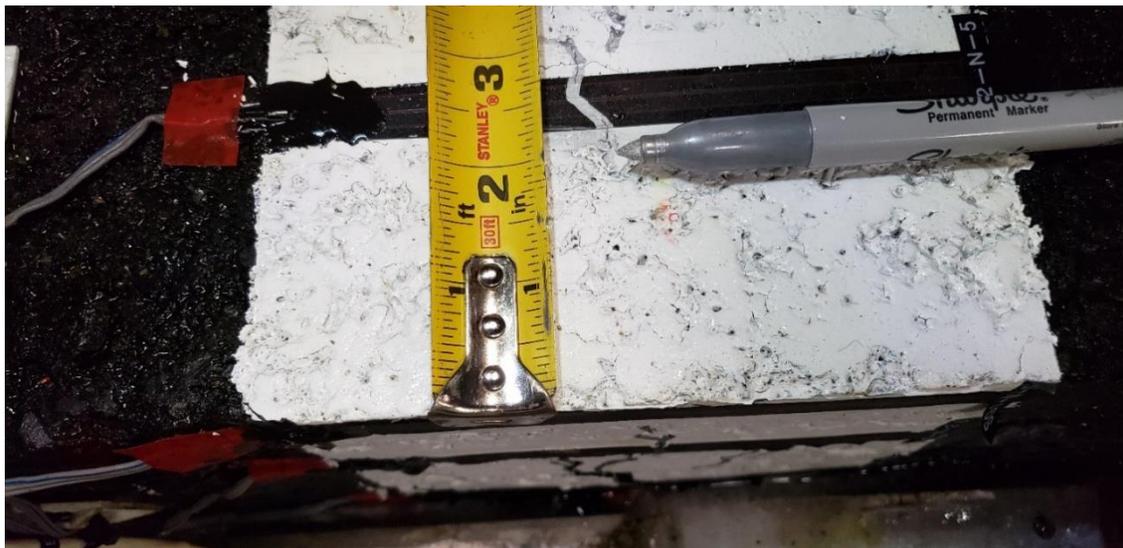
Fig 4 North section surface crack 2 inch from the inner vertical edge

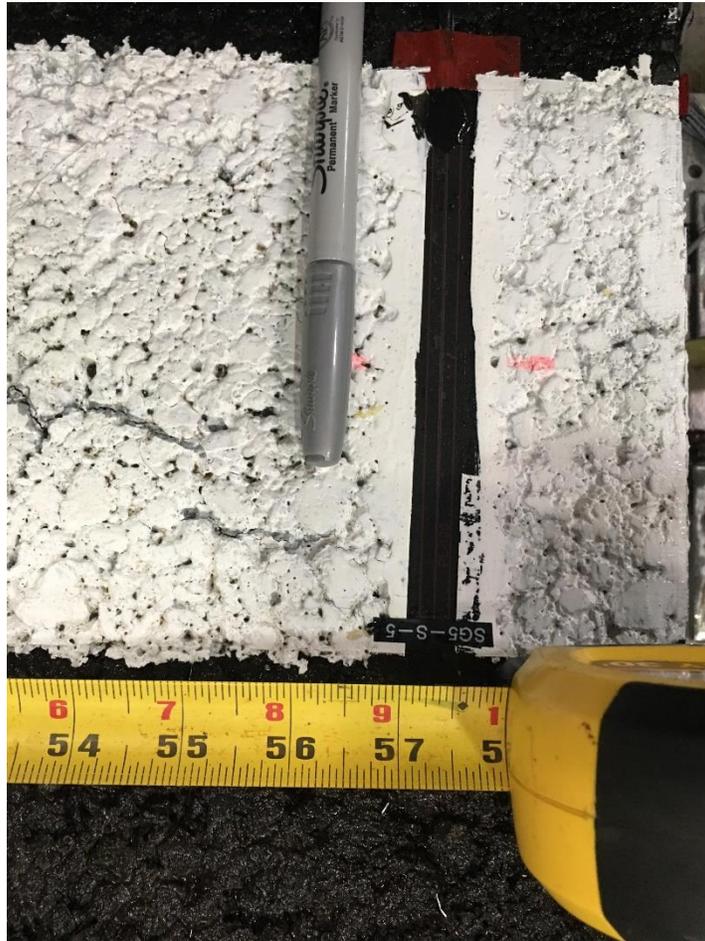
Fig 8 South section surface crack 3.5 inches from the outer vertical edge
