DO15 RC Indoor Phase VI Test Daily Notes

Date: July 26, 2019

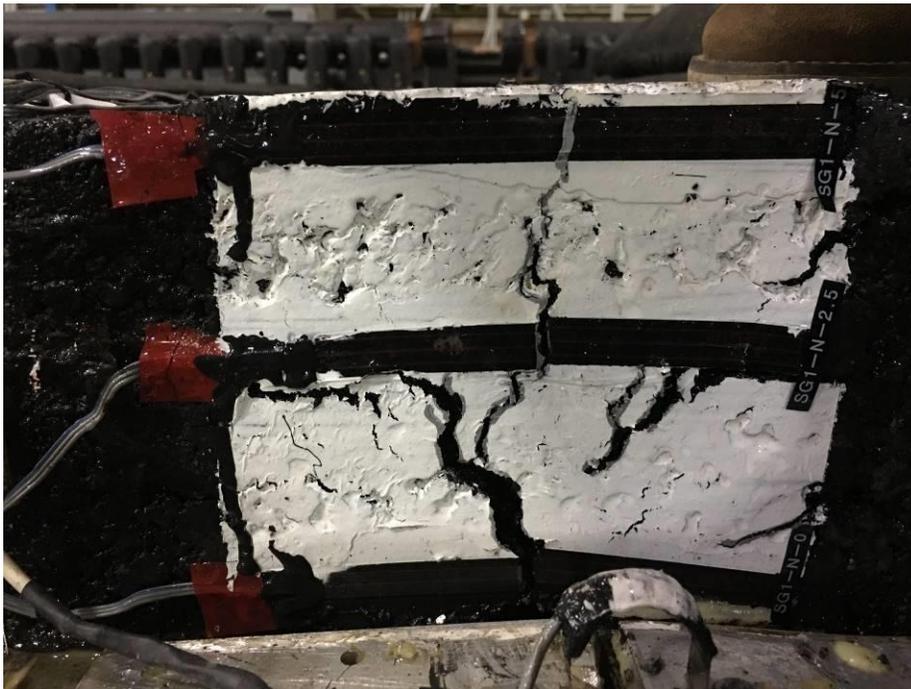
- Completed cracked, no further change.
- Bottom up crack at inner vertical edge (Fig 1). Bottom up crack at outer vertical edge (Fig 2).
- Surface crack connected to the bottom-up crack of the outer edge (Fig 3), and the inner vertical edge (Fig 4).

Fig 1 Bottom-up crack at north section inner vertical edge reached top surface

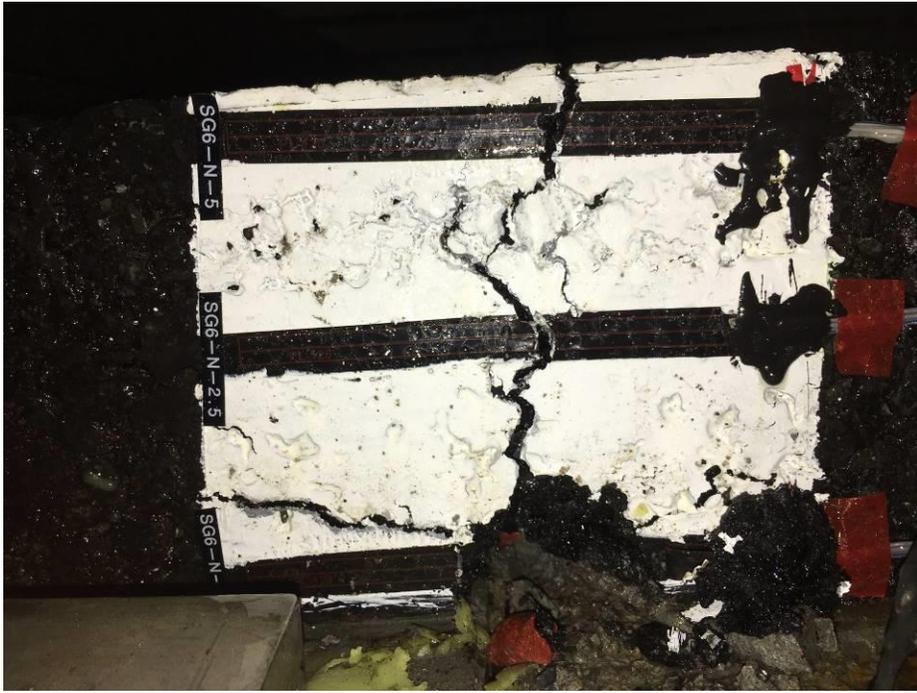
Fig 2 Bottom-up crack at north section outer edge reached top surface

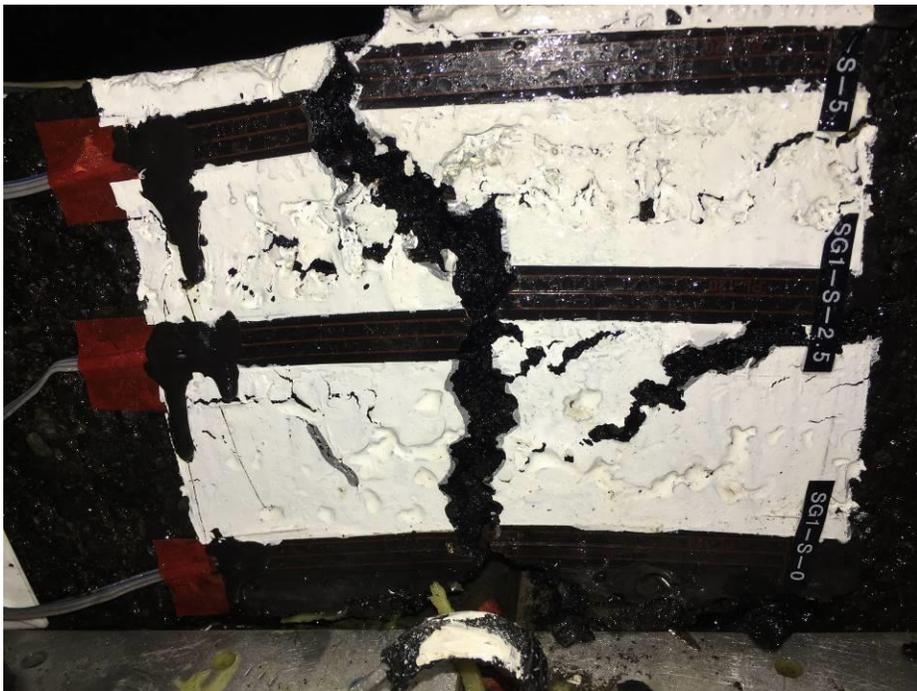
- No change from last observation.
- Bottom up crack at inner vertical edge (Fig5). Bottom up crack at outer vertical edge propagate approximately 0.5 inch resulting SG6-S-2.5 read open (Fig 6).
- Surface crack reached the inner vertical edge (Fig 7), approximately 3.5 inches from the outer vertical edge, no change (Fig 8)

Fig 5 Bottom-up crack at inner vertical edge of south section reached top surface
