DO15 RC Indoor Phase VI Test Daily Notes

Date: June 19, 2019

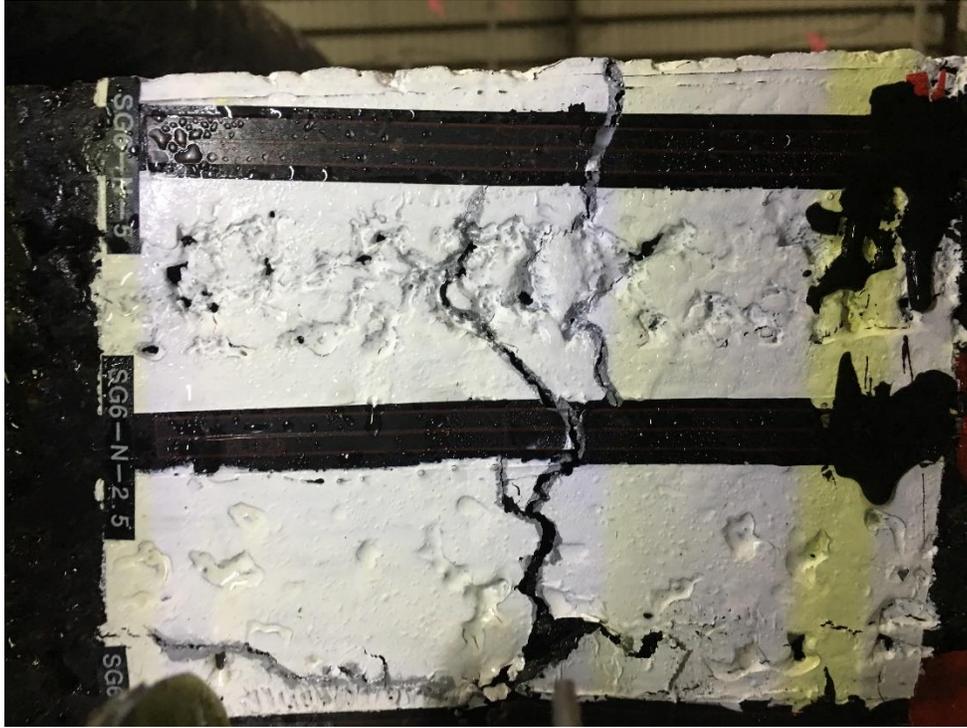
Fig 2 Bottom-up crack north outer edge reached top surface

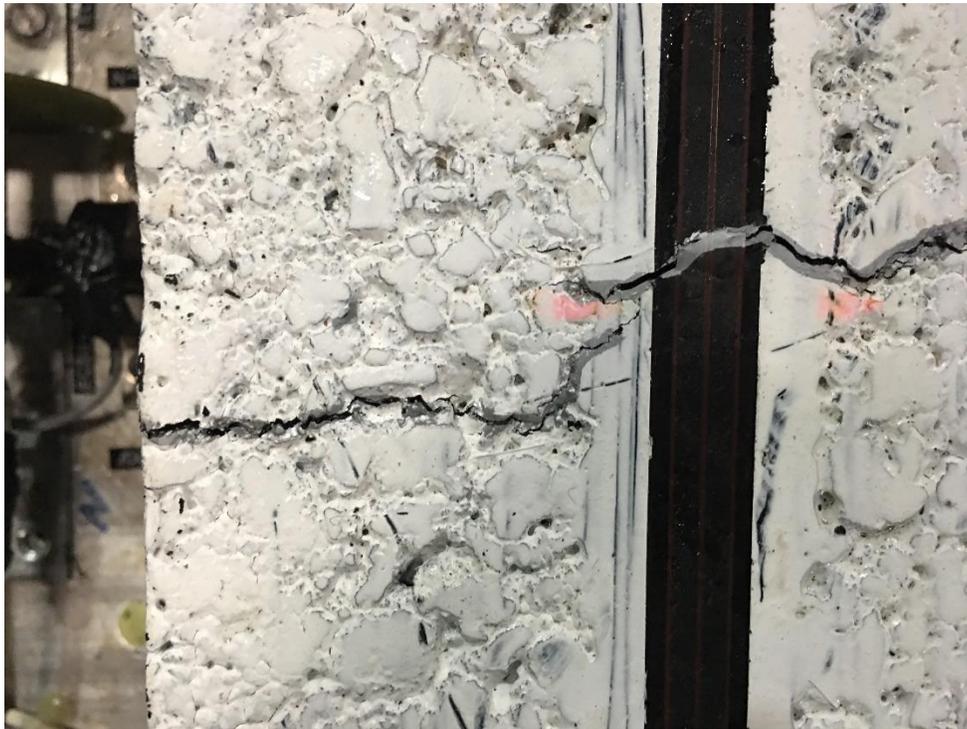
Fig 3 Surface crack on North Section reached outer edge

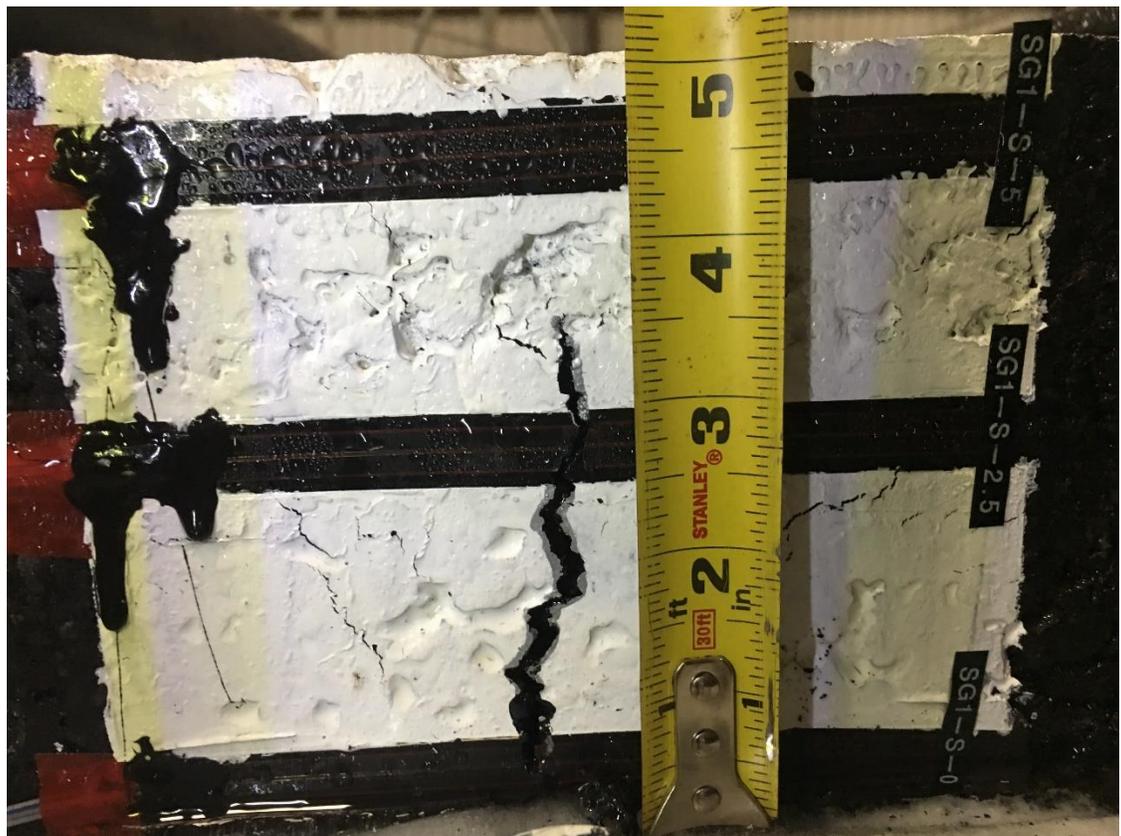
Fig 4 Bottom-up crack at SG1-S-0 3.75 inch long

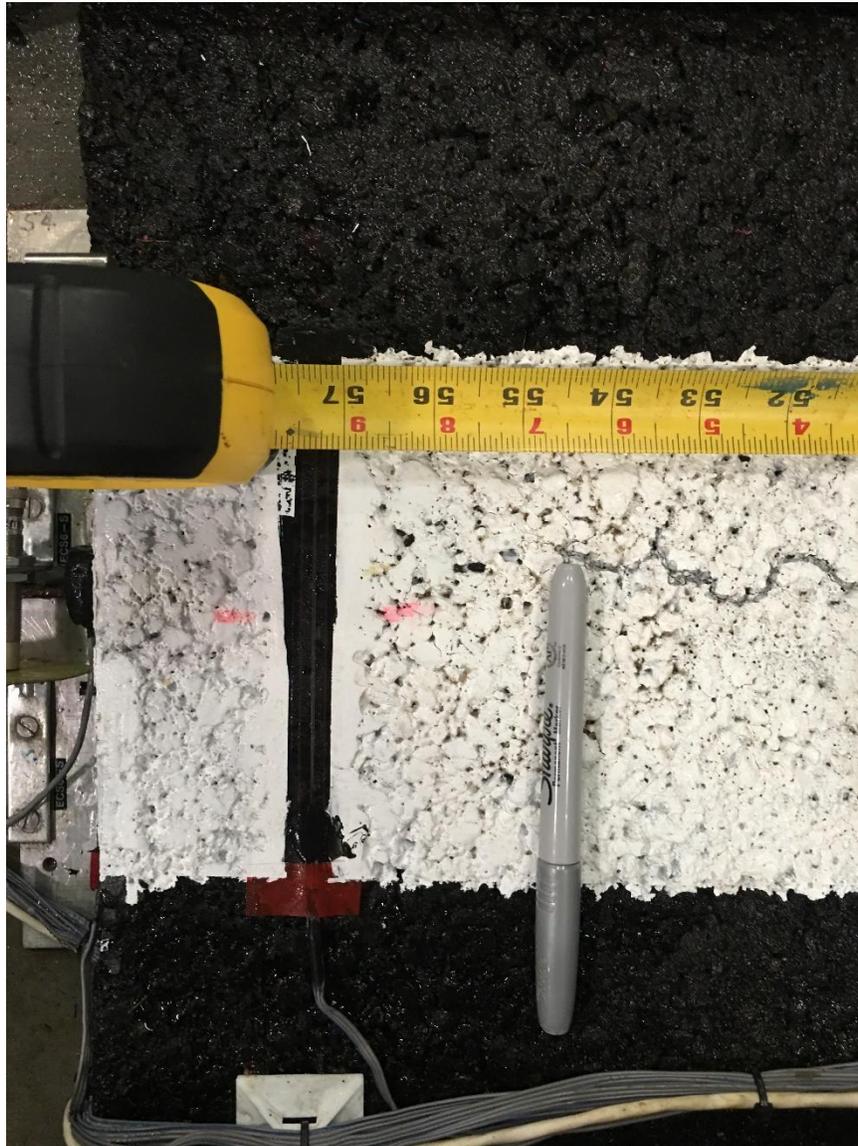
Fig 7 South section surface crack 5.5 inches from the outer vertical edge
