DO15 RC Indoor Phase VI Test Daily Notes

Date: June 27, 2019

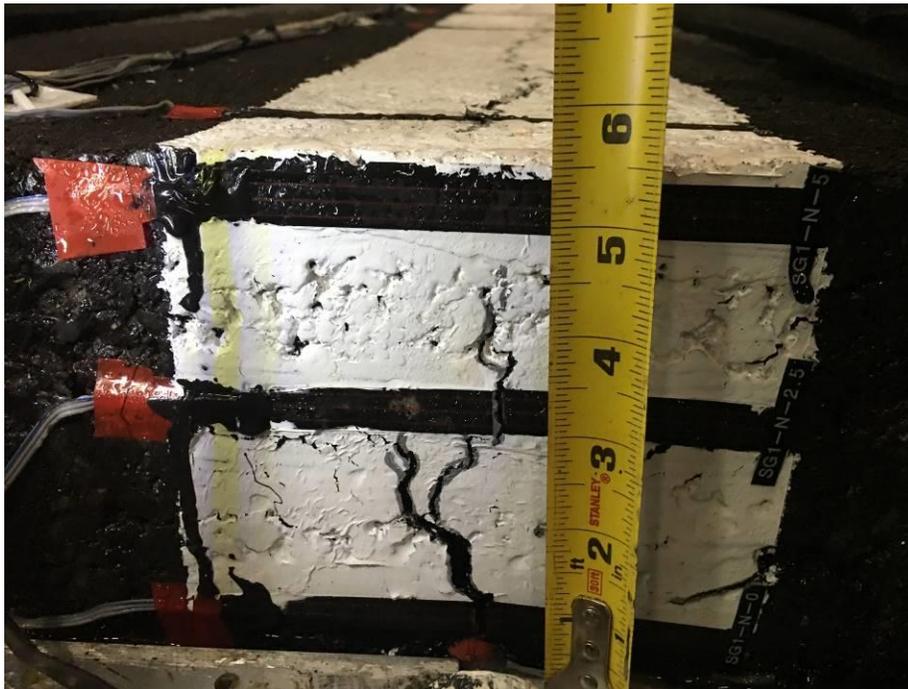
Fig 1 Bottom-up crack at SG1-N-0 and SG1-N-2.5 4.5 inch long

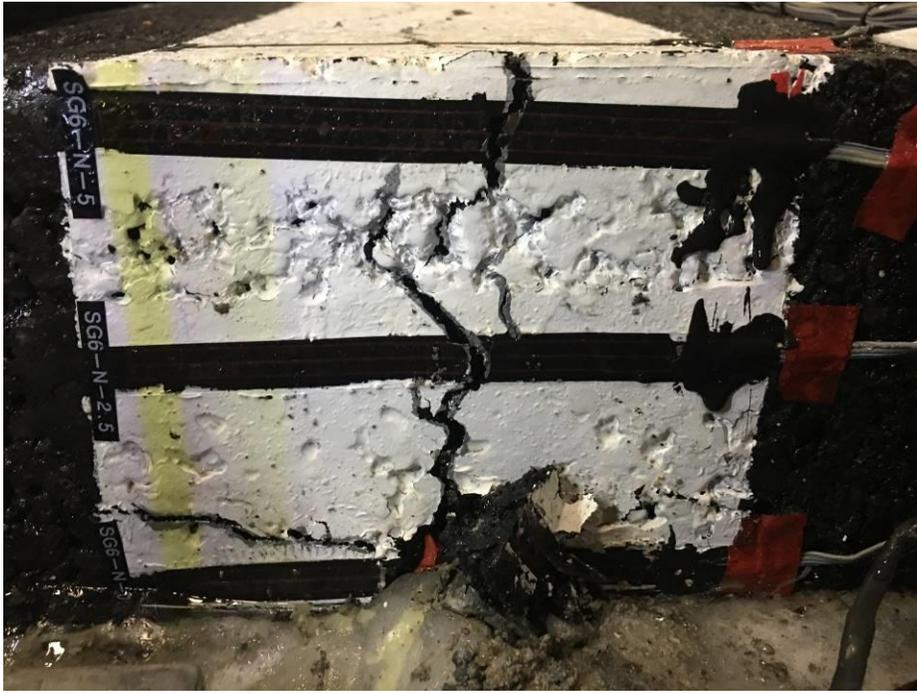
Fig 2 Bottom-up crack north outer edge reached top surface

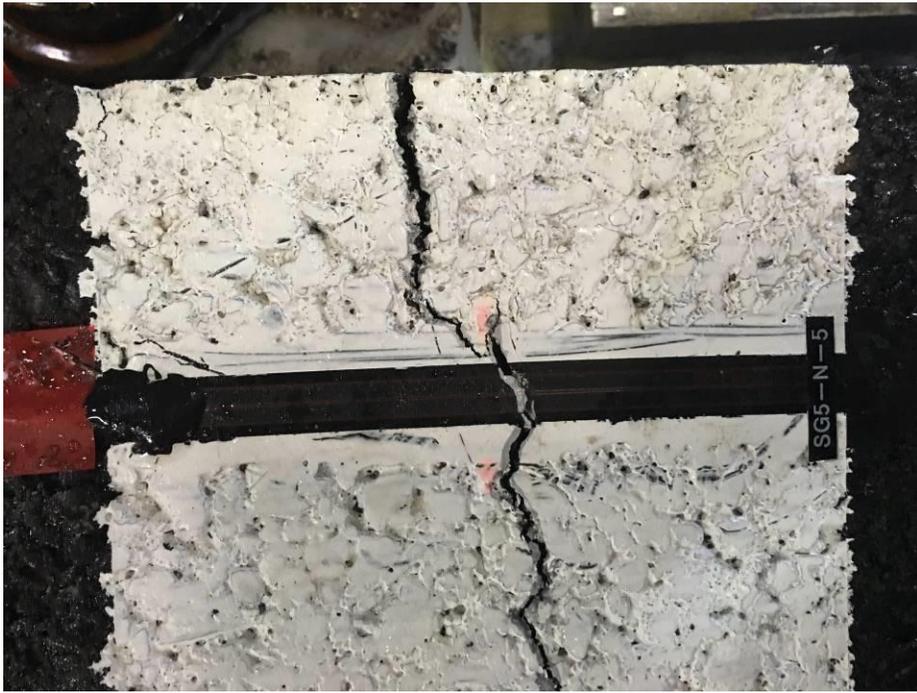
Fig 3 Surface crack on North Section reached outer edge

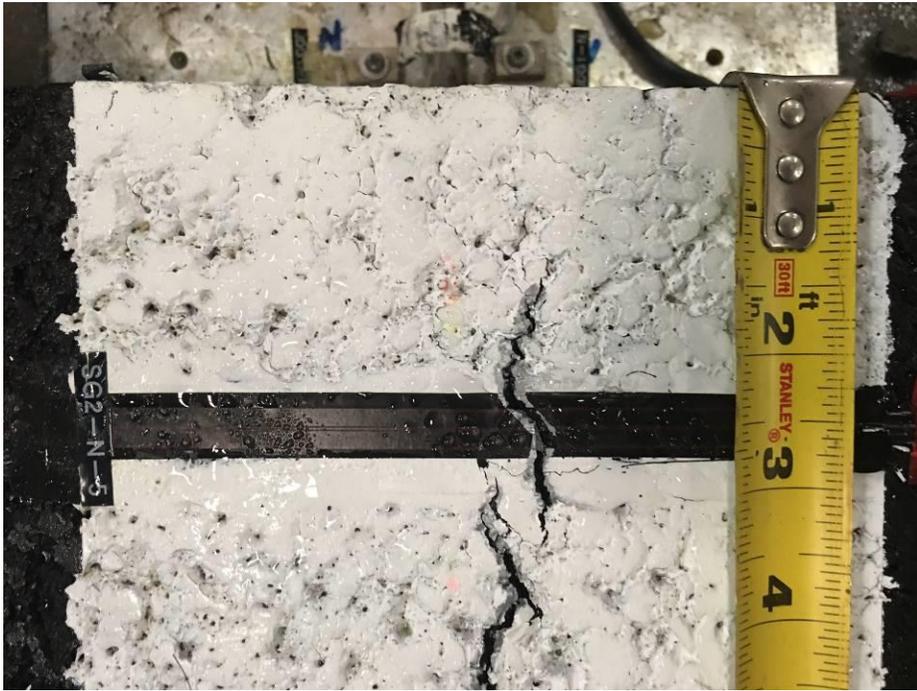
Fig 4 North section surface crack 1.5 inch from the inner vertical edge

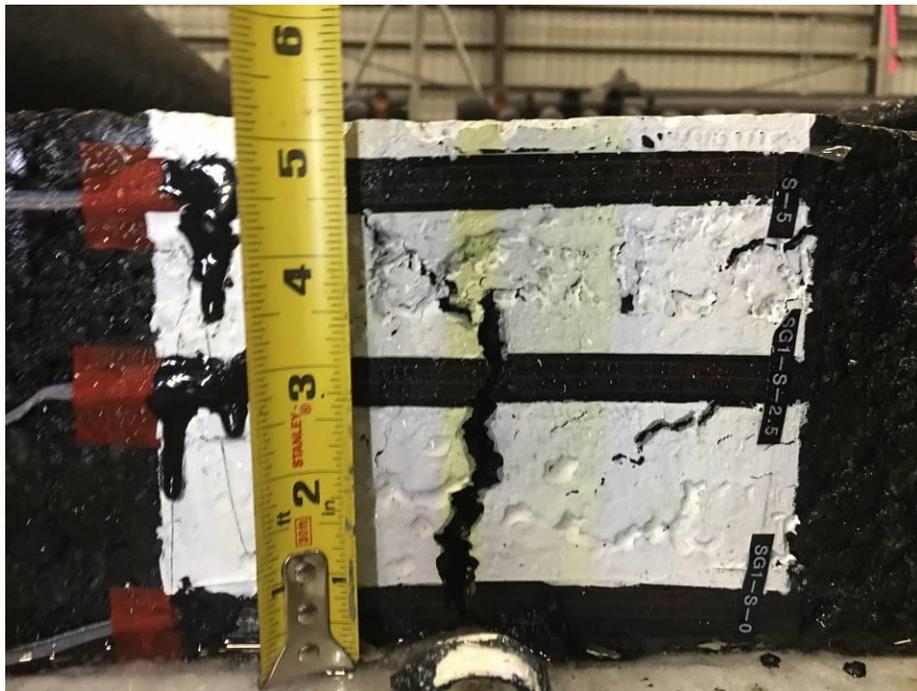
Fig 5 Bottom-up crack at SG1-S-0 4.5 inch long

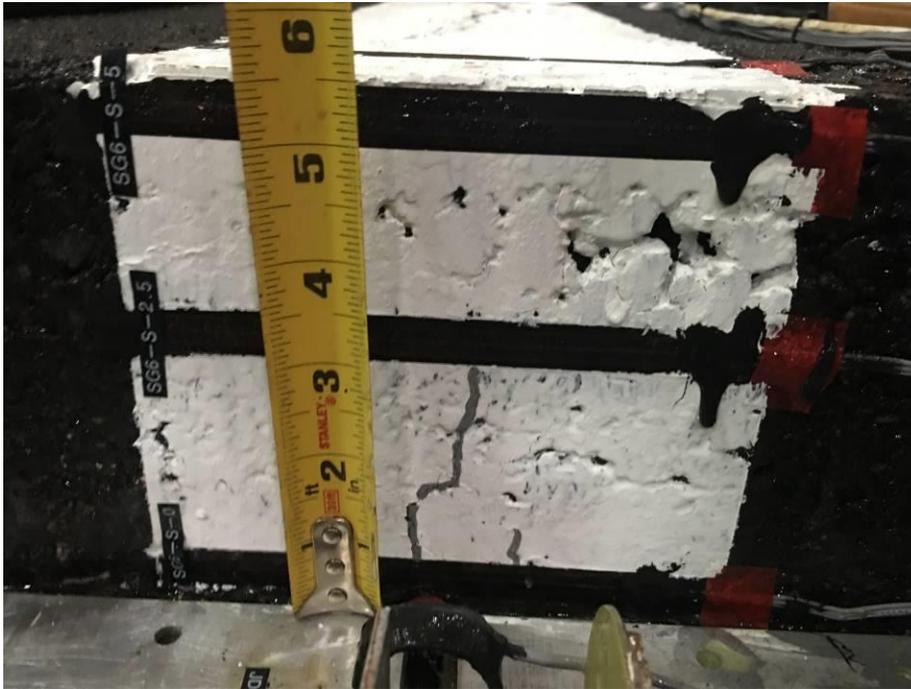
Fig 6 Bottom-up crack at SG6-S-0 3 inch long

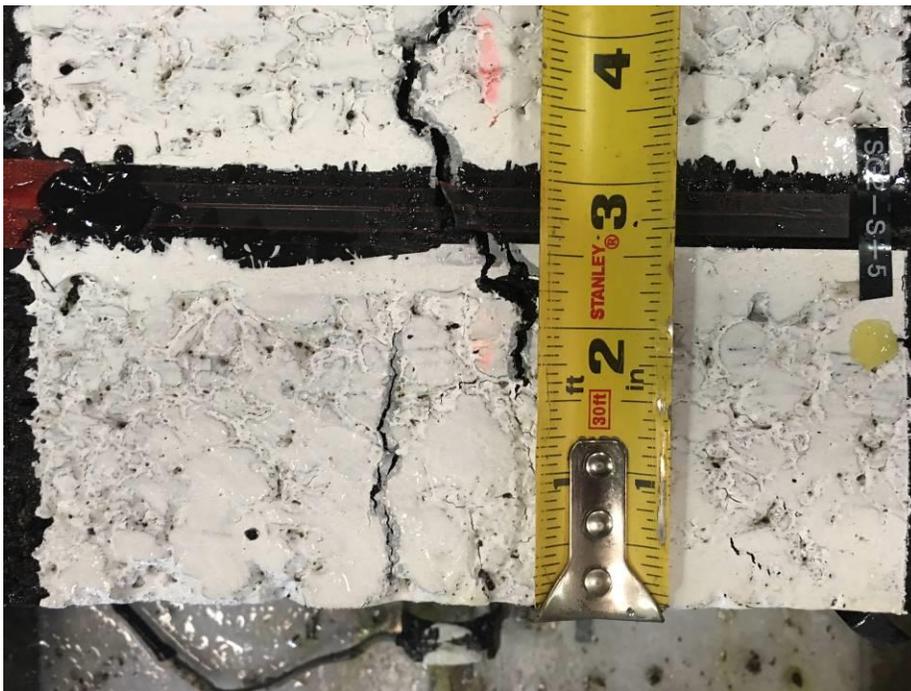
Fig 7 South section surface crack reached the inner vertical edge

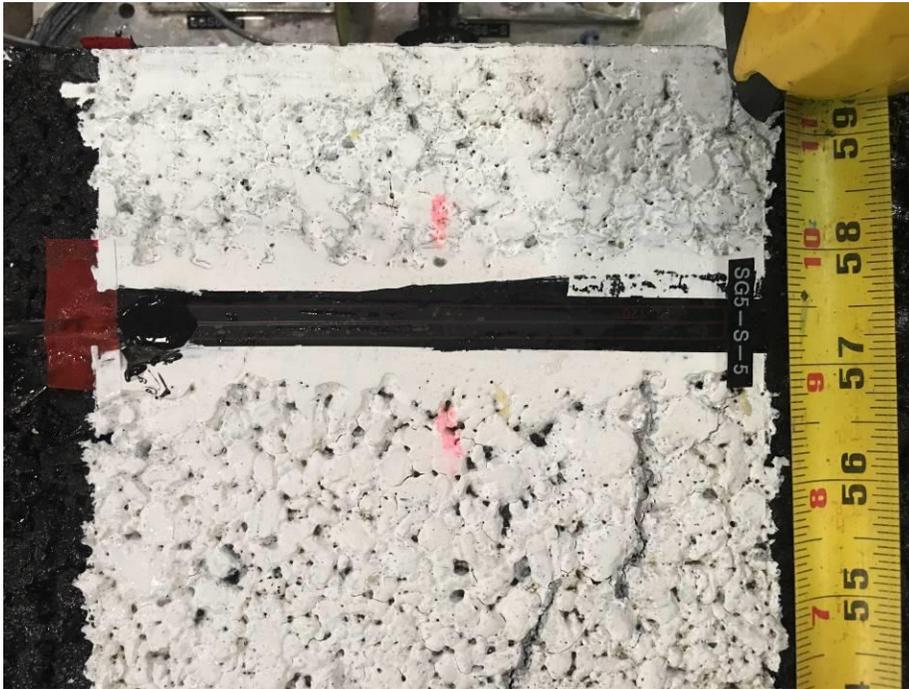
Fig 8 South section surface crack 3 inches from the outer vertical edge

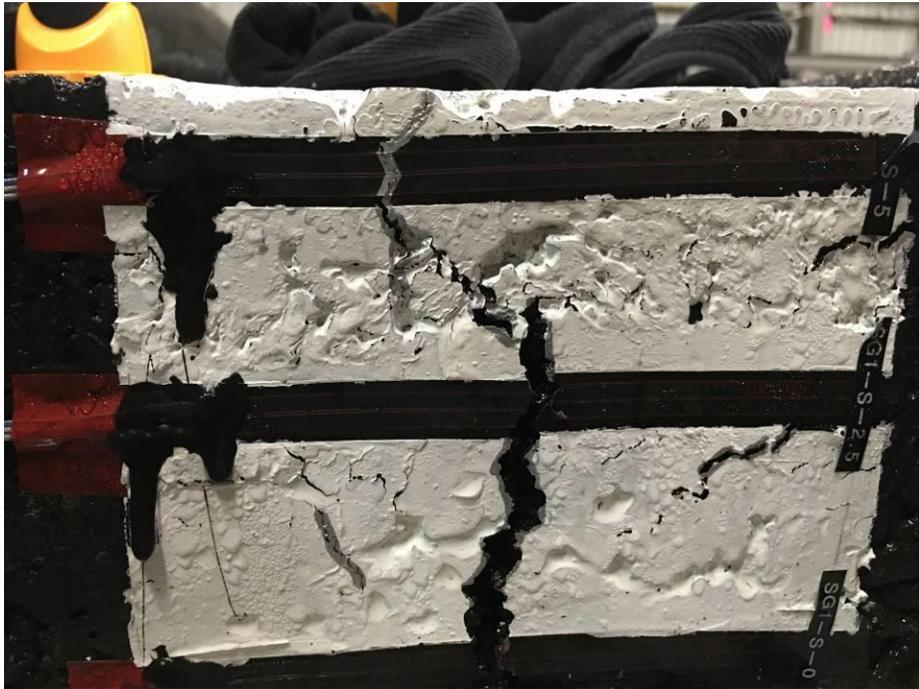
- The bottom-up crack through SG1-S-0, SG1-S-2.5 and SG1-S-5 reached the top surface and connected to the surface crack (Fig 9, Fig 10)

Fig 9 Bottom-up crack on south section inner edge reached the top surface

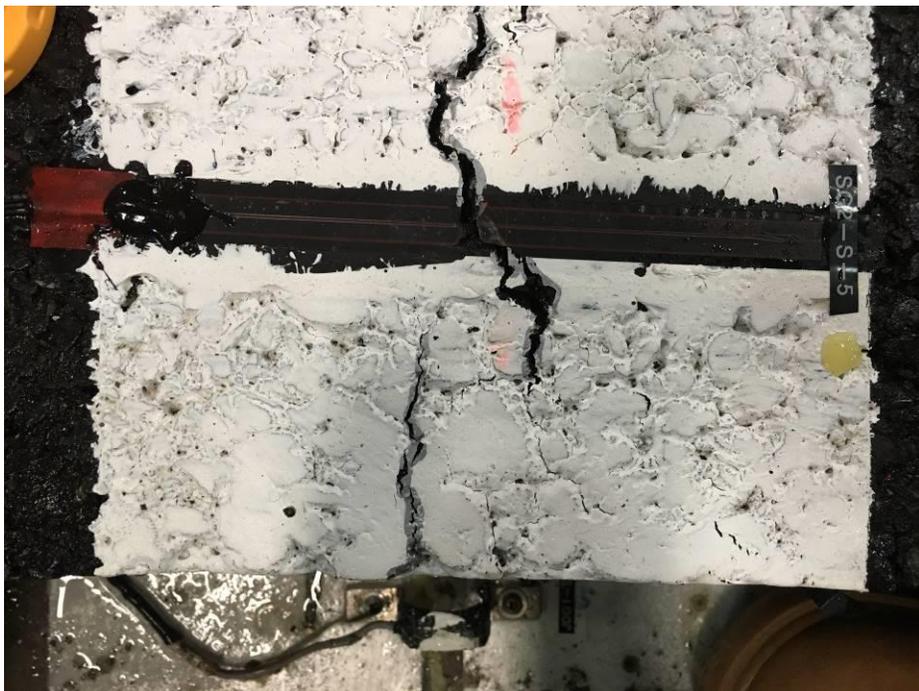
Fig 10 Surface crack on south section connected with the bottom up crack on inner edge
