DO15 RC Indoor Phase VI Test Daily Notes

Date: June 13, 2019

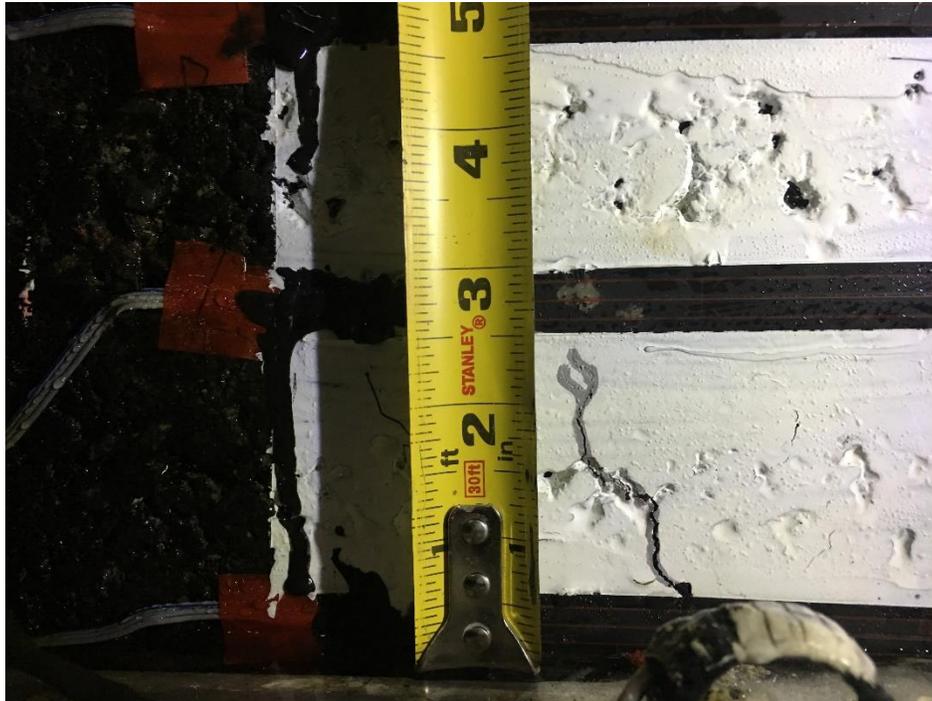
Fig 1 Bottom-up crack at SG1-N-0 2.5 inch long

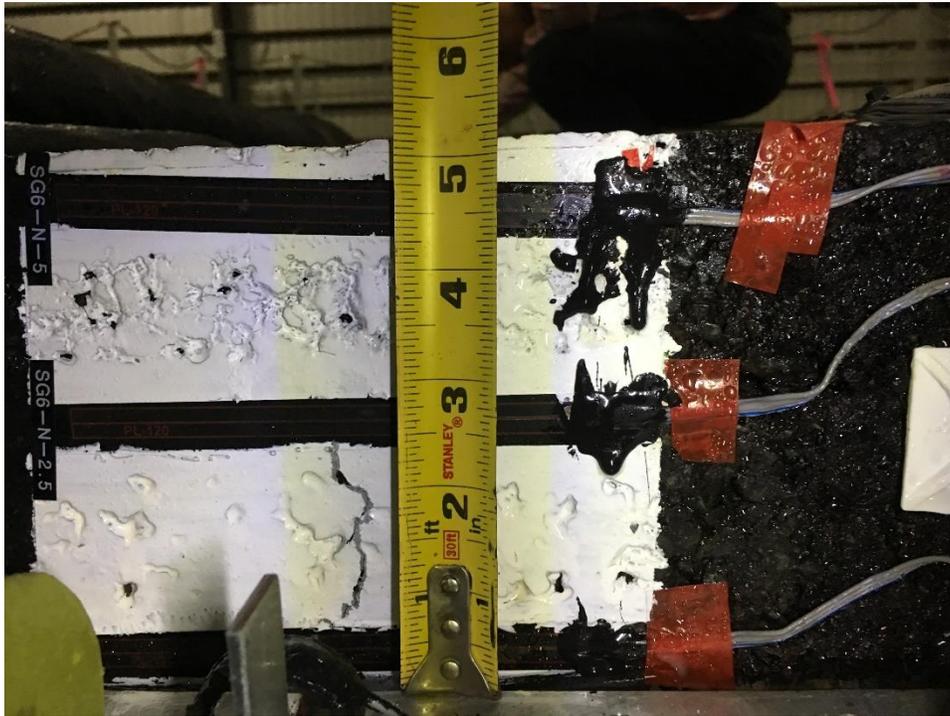
Fig 2 Bottom-up crack at SG6-N-0 2.5 inch long

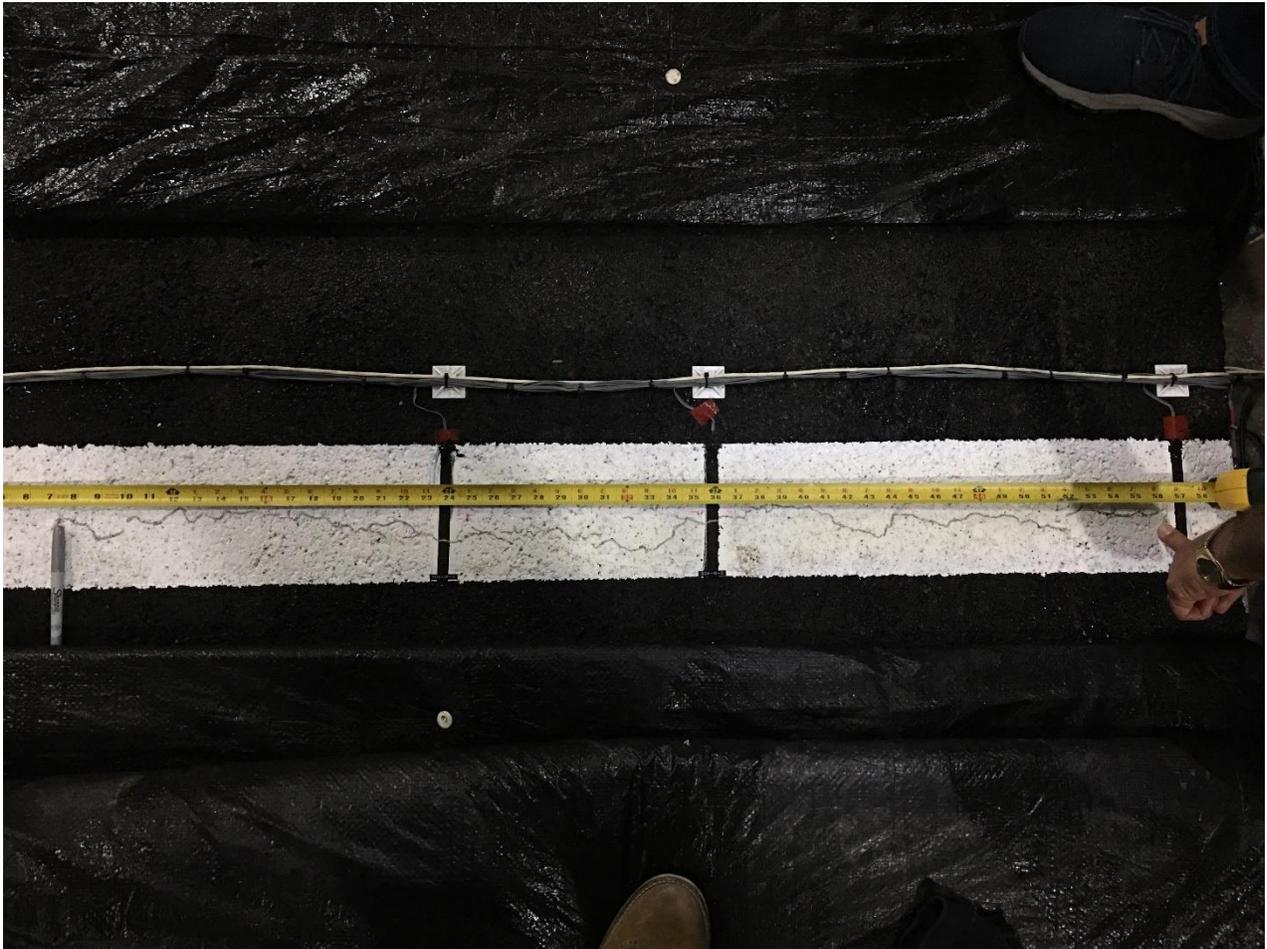
Fig 3 Surface crack on North Section approximately 7 to 56.5 inch

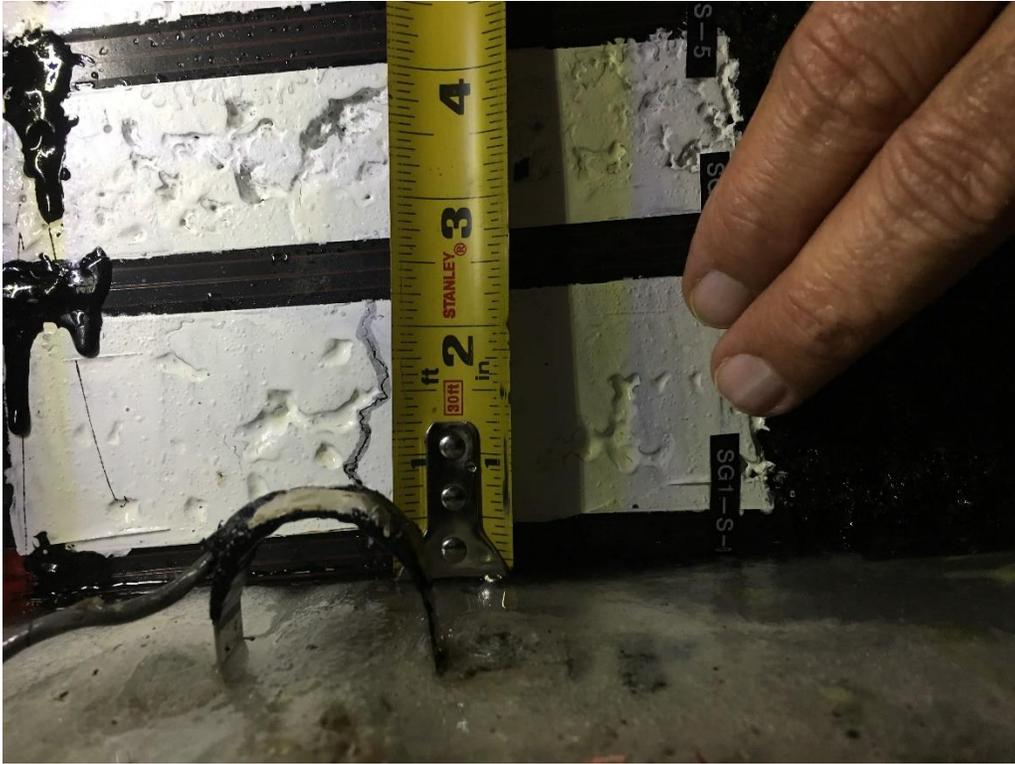
Fig 4 Bottom-up crack at SG1-S-0 2.5 inch long

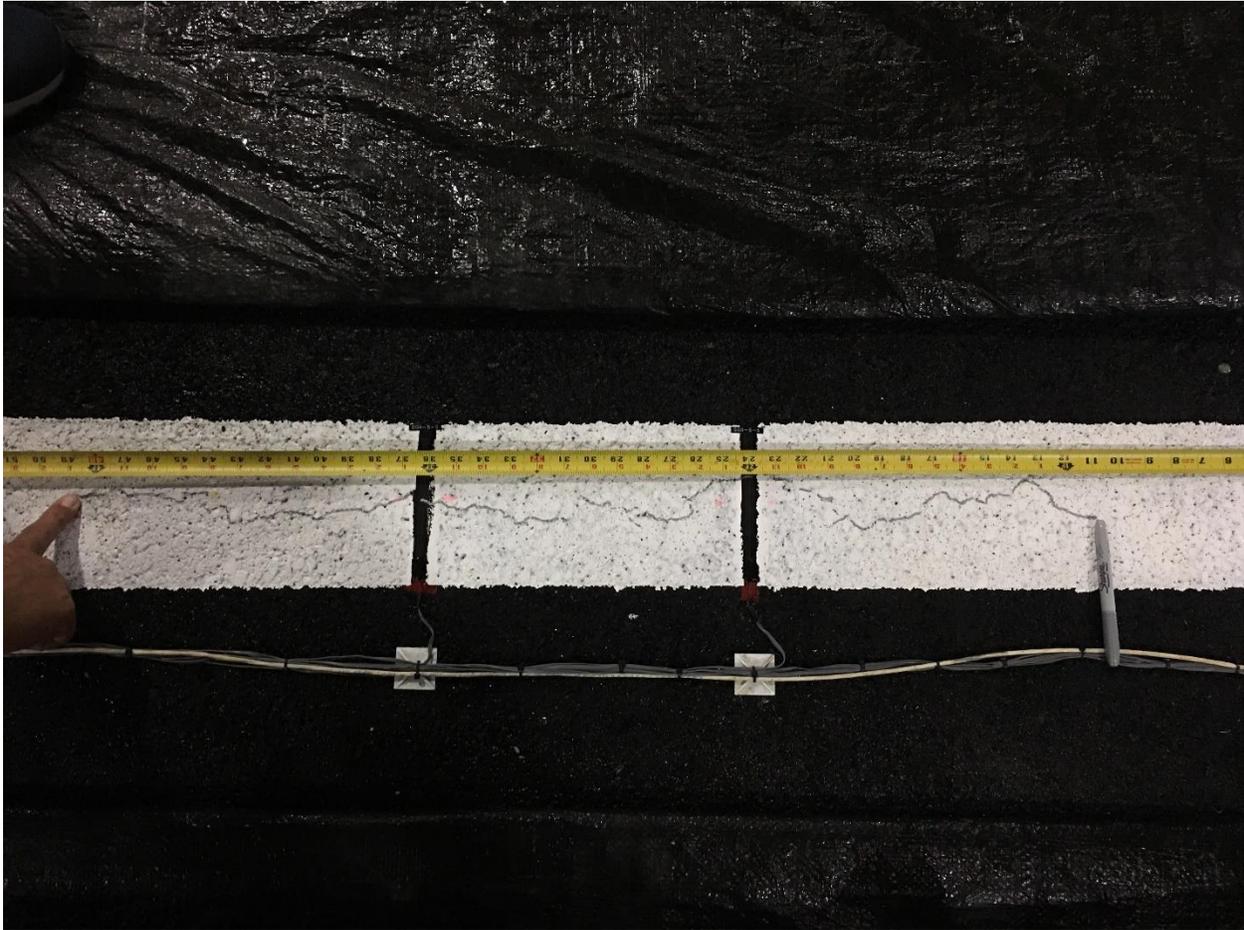
Fig 5 Surface crack on south section between 11'' and 48.5''
