DO15 RC Indoor Phase VI Test Daily Notes

Date: July 30, 2019

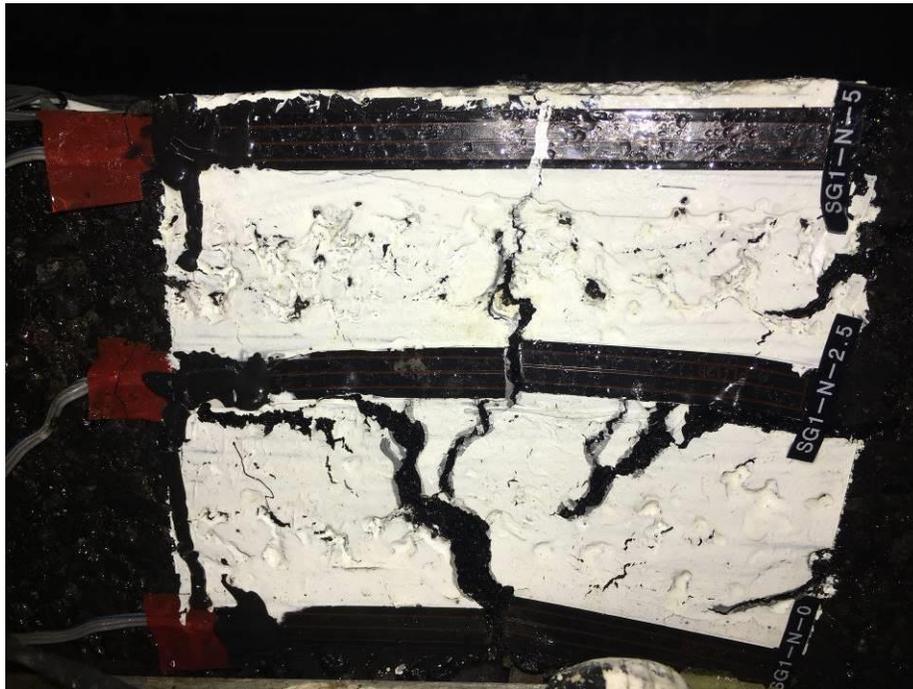
Fig 1 Bottom-up crack at north section inner vertical edge reached top surface

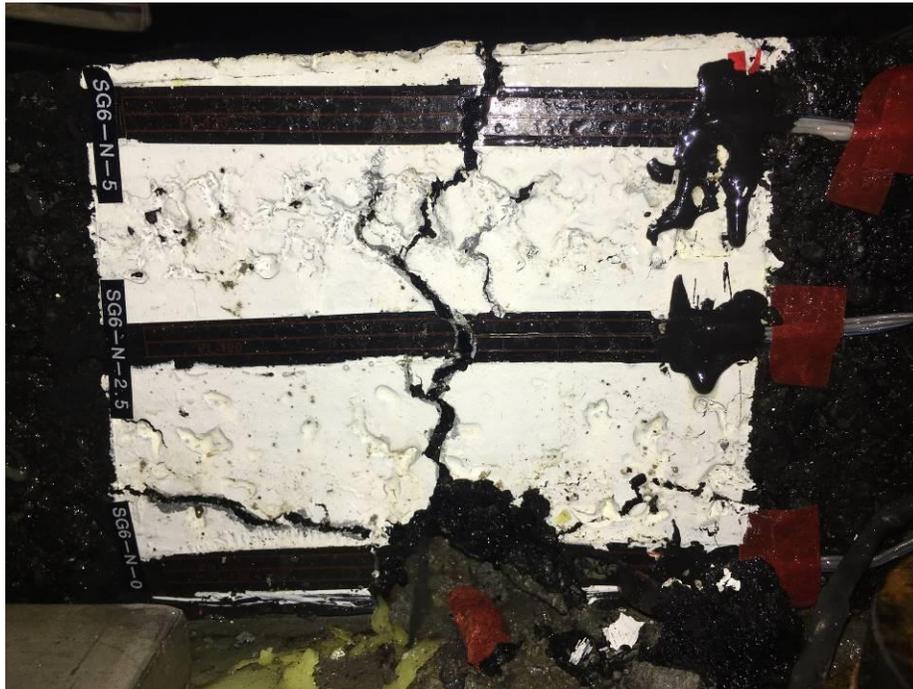
Fig 2 Bottom-up crack at north section outer edge reached top surface

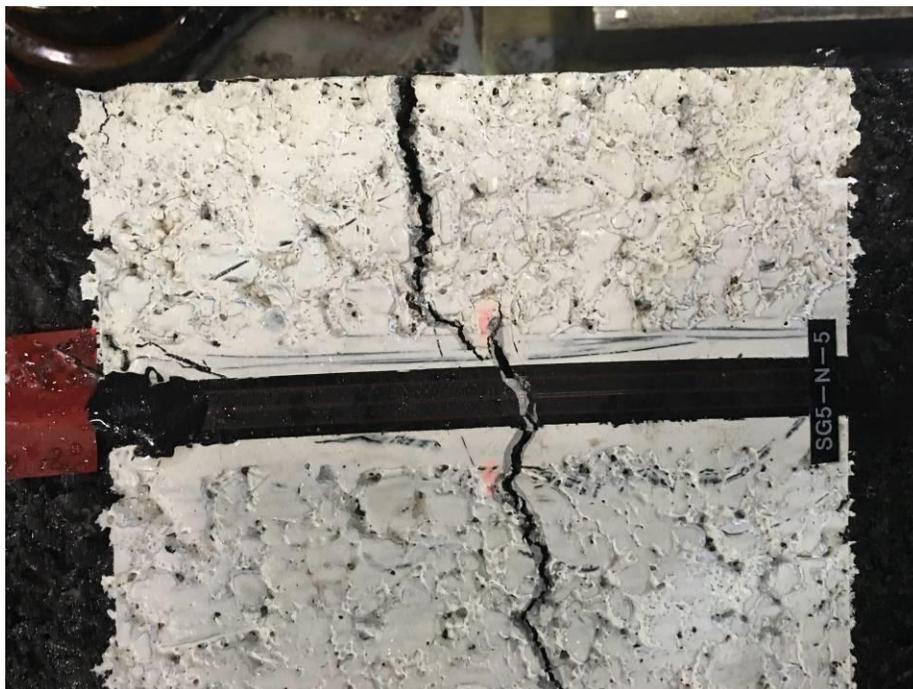
Fig 3 Surface crack on North Section reached outer edge
