## DO15 RC Indoor Phase VI Test Daily Notes

*Date: July 09, 2019*

*Cycle count: 3293*

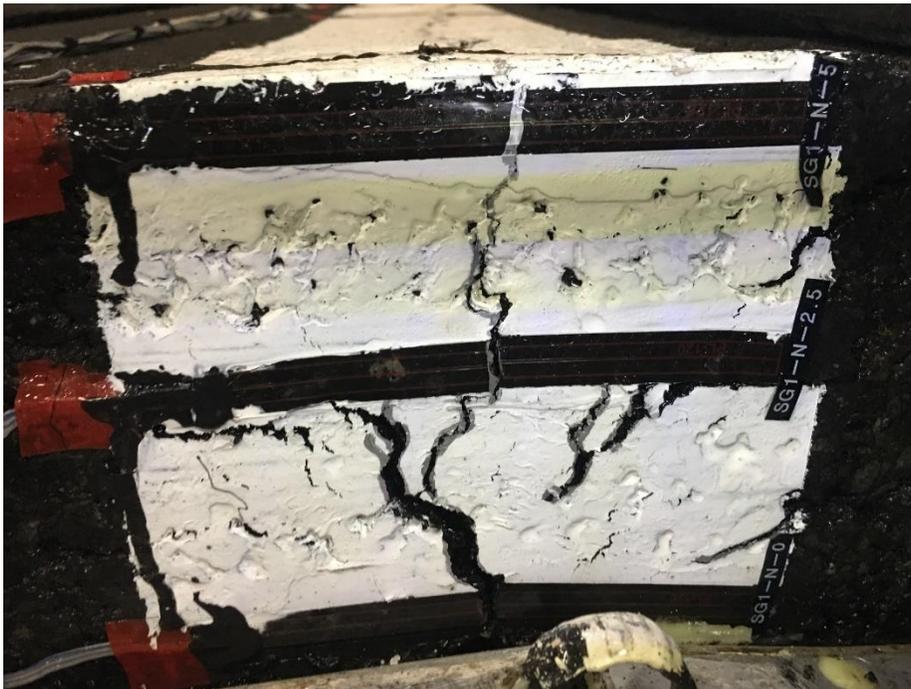
Fig 1 Bottom-up crack at north section inner vertical edge reached top surface

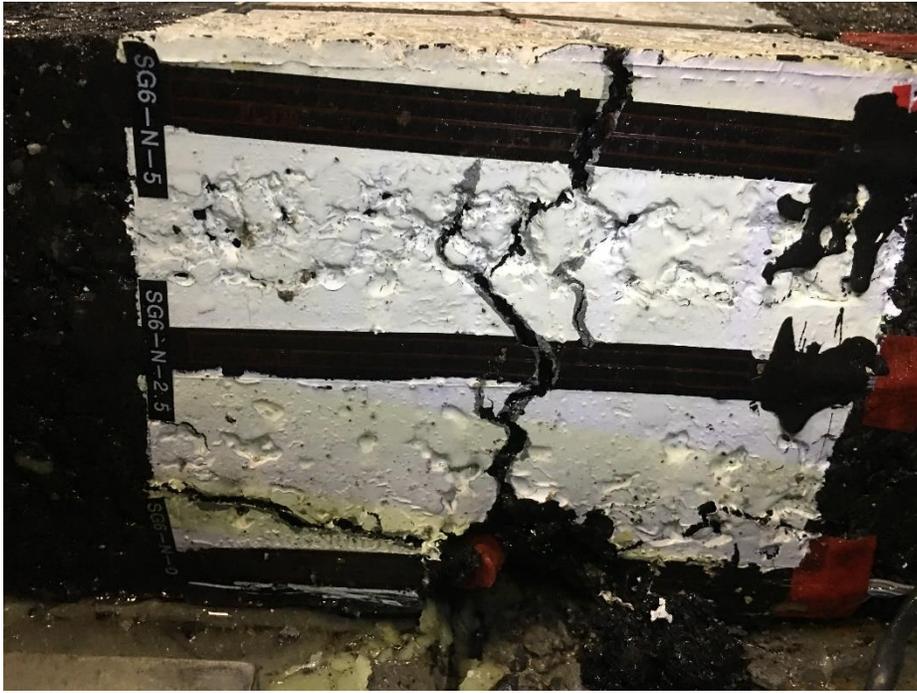
Fig 2 Bottom-up crack at north section outer edge reached top surface

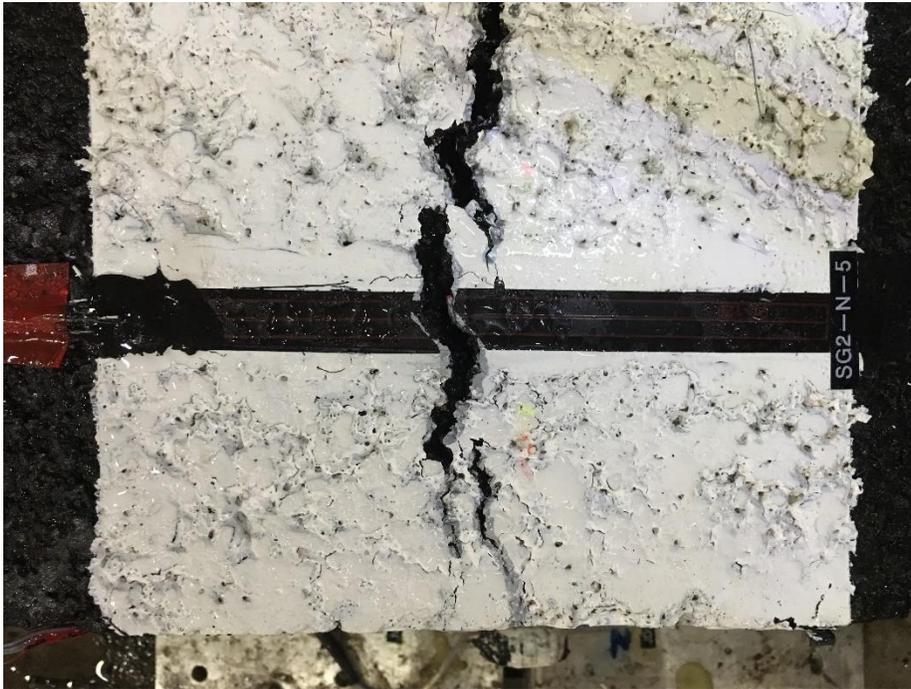
Fig 4 North section surface crack reached inner vertical edge

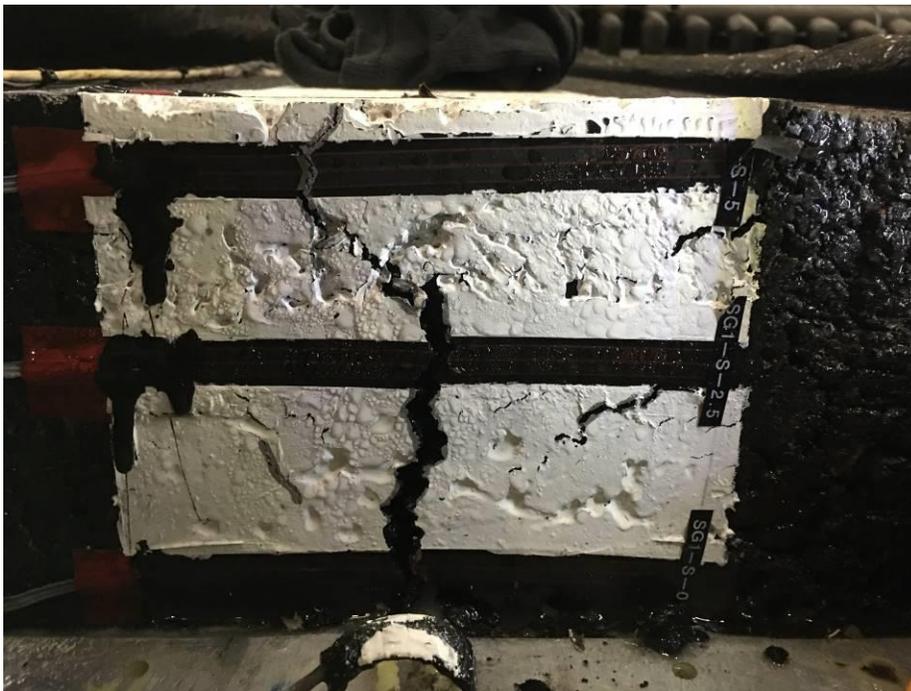
Fig 5 Bottom-up crack at inner vertical edge of south section reached top surface

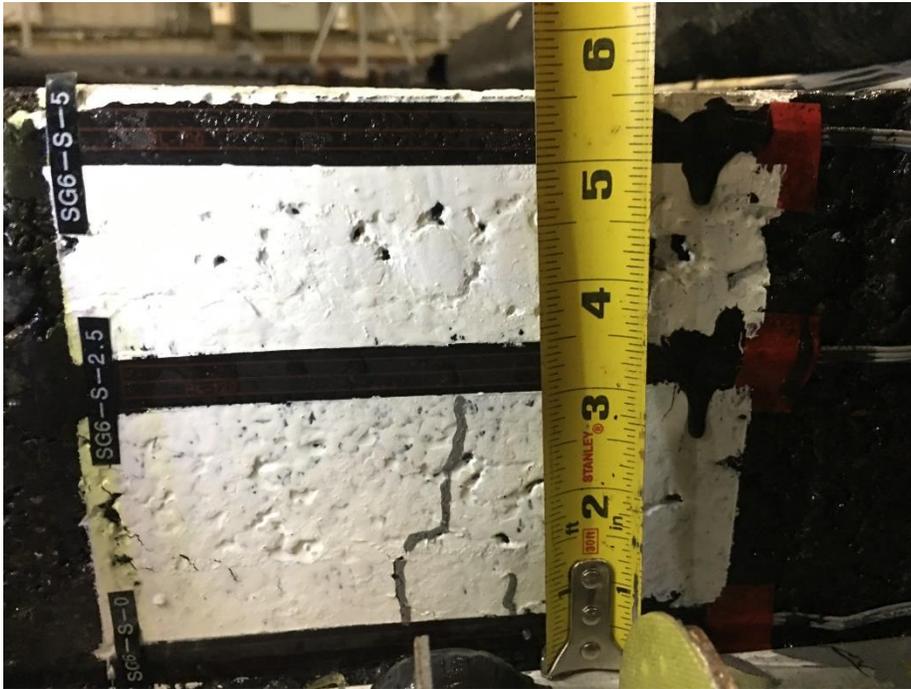
Fig 6 Bottom-up crack at SG6-S-0 3 inch long

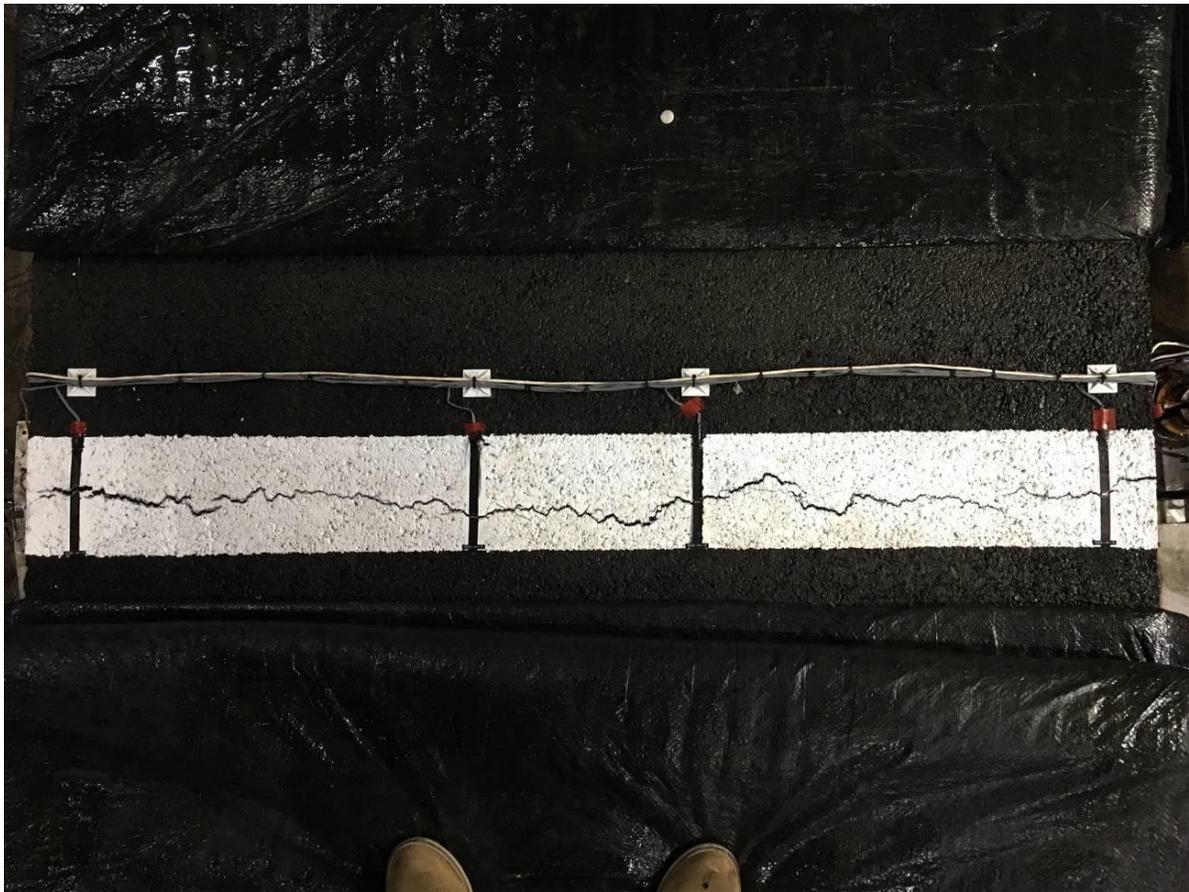
Fig 9 Surface crack on the north section
