## DO15 RC Indoor Phase VI Test Daily Notes

*Date: July 08, 2019*

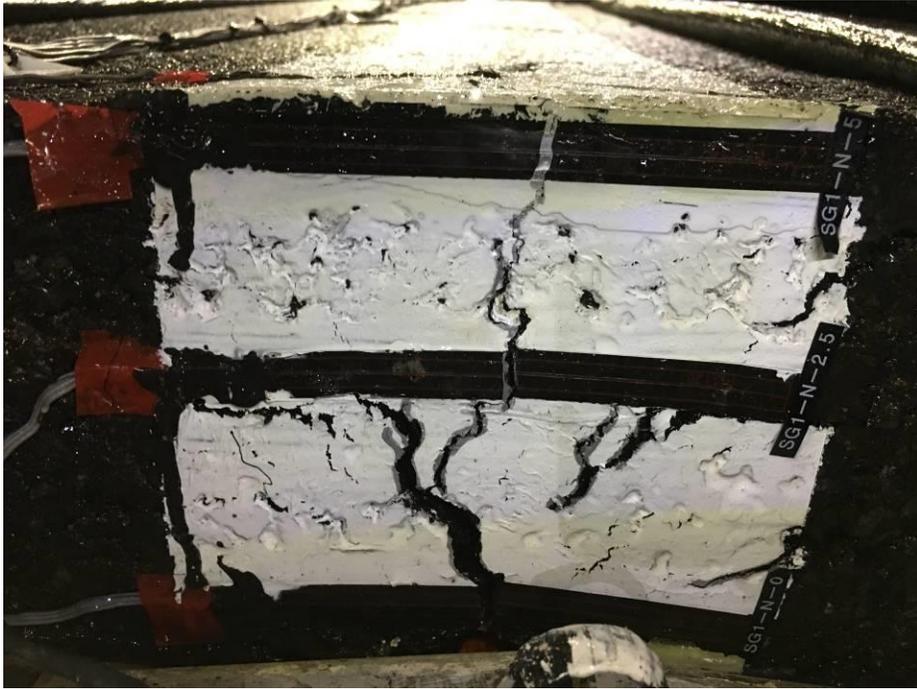
- 1 crack through SG1-N-0, SG1-N-2.5 and SG1-N-5 reached the top surface (Fig 1).
- 1 crack through SG6-N-0, SG6-N-2.5 and SG6-N-5 reached the top surface (Fig 2).
- Surface crack connected to the bottom-up crack of the outer edge (Fig 3), and the inner vertical edge (Fig 4).

Fig 1 Bottom-up crack at north section inner vertical edge reached top surface

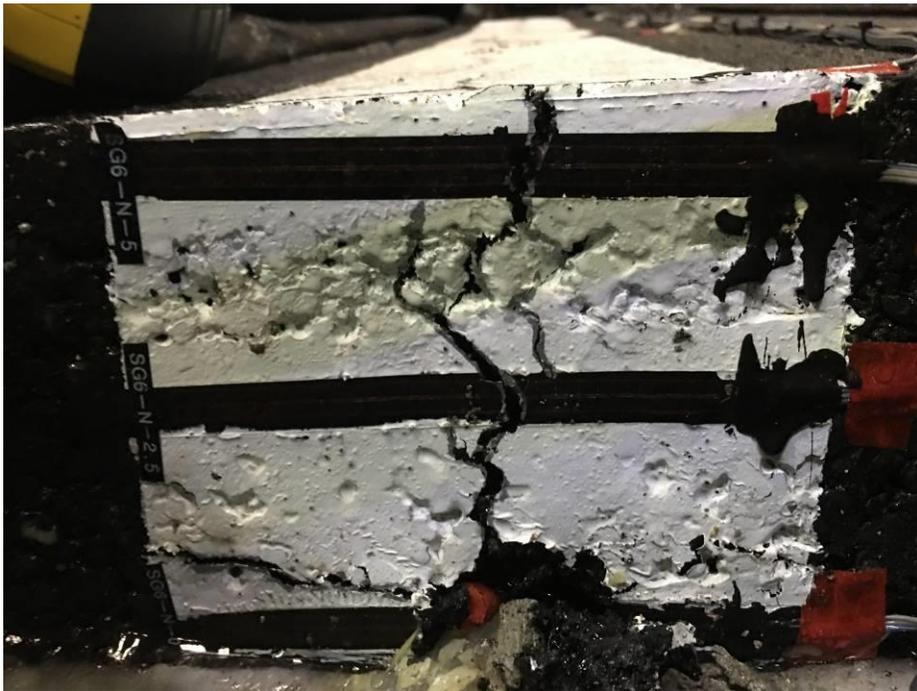
Fig 2 Bottom-up crack at north section outer edge reached top surface

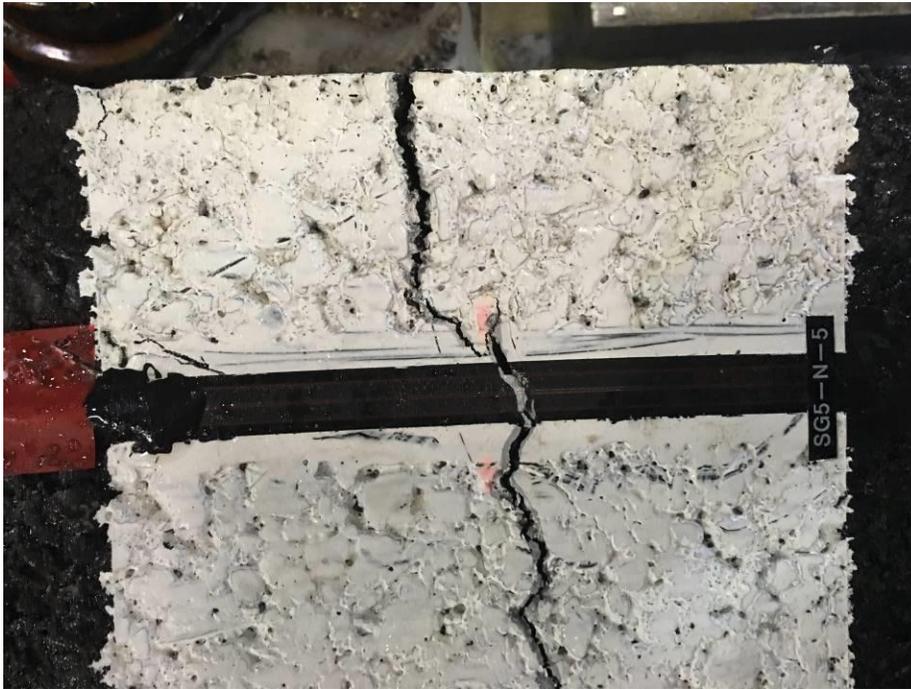
Fig 3 Surface crack on North Section reached outer edge

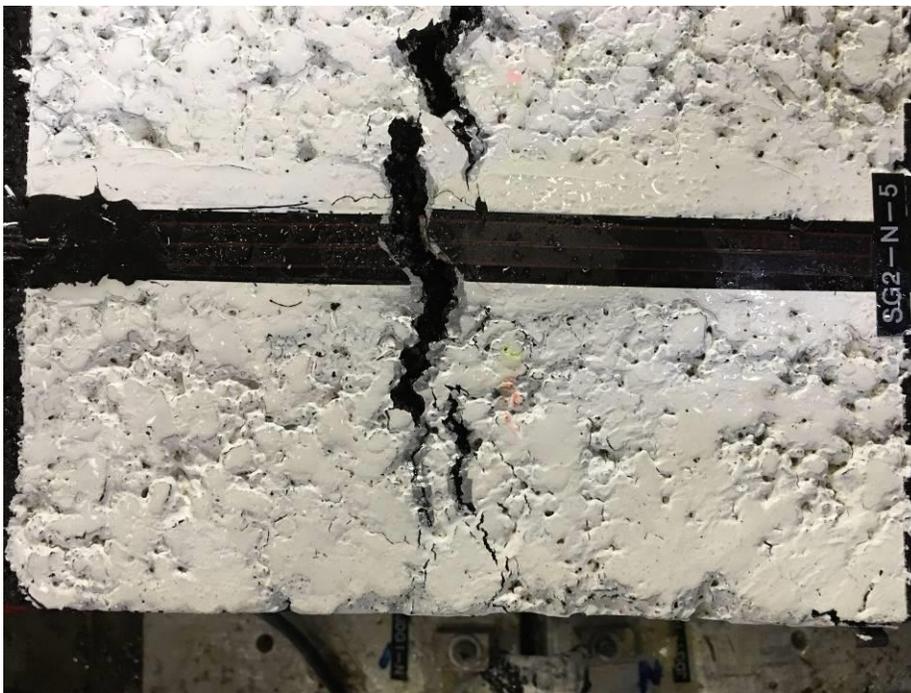
Fig 4 North section surface crack reached inner vertical edge

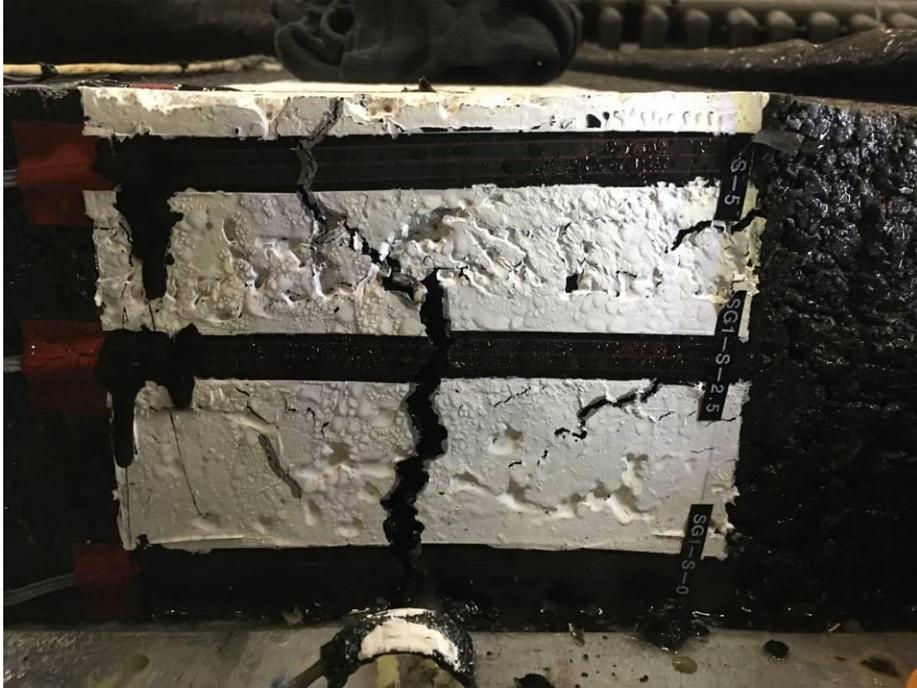
- Bottom up crack through SG1-S-0 reached top surface (Fig5).
- 1 crack through SG6-S-0, approximately 3 inches, no change (Fig 6).
- Surface crack reached the inner vertical edge (Fig 7), approximately 3 inches from the outer vertical edge, no change (Fig 8)

Fig 5 Bottom-up crack at inner vertical edge of south section reached top surface

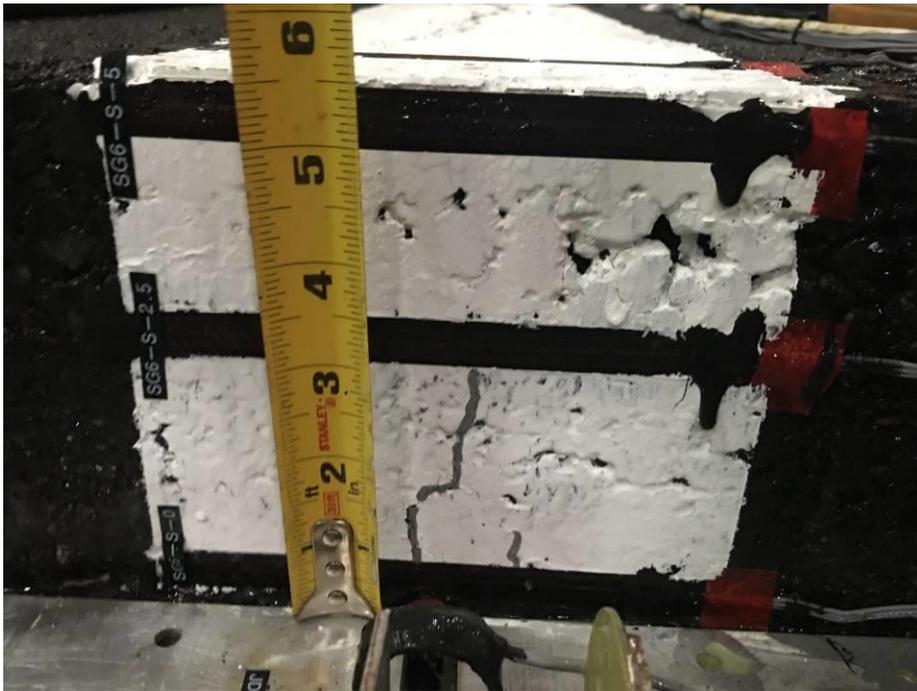
Fig 6 Bottom-up crack at SG6-S-0 3 inch long

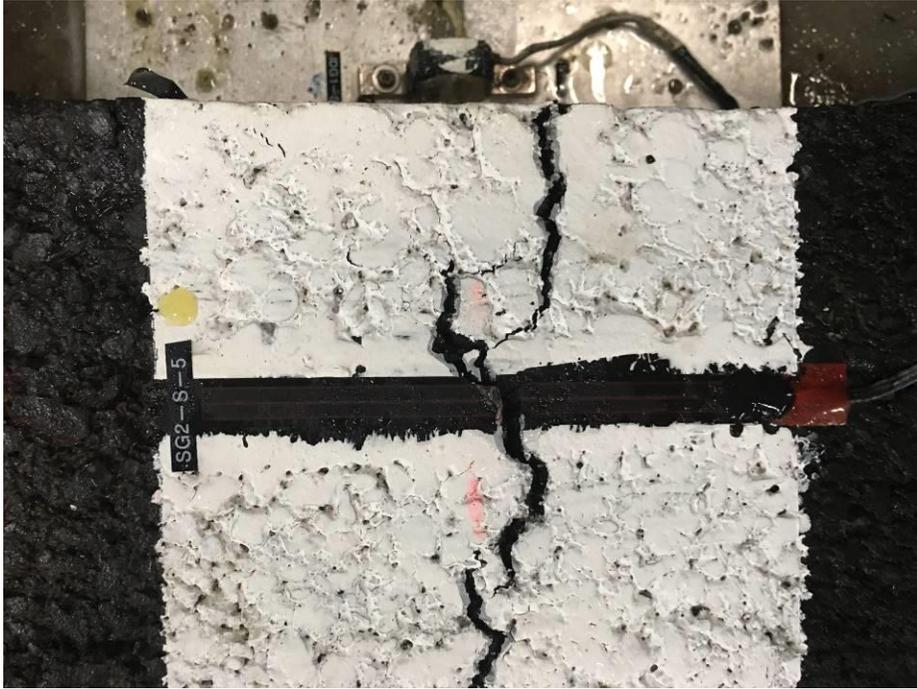
Fig 7 South section surface crack reached the inner vertical edge

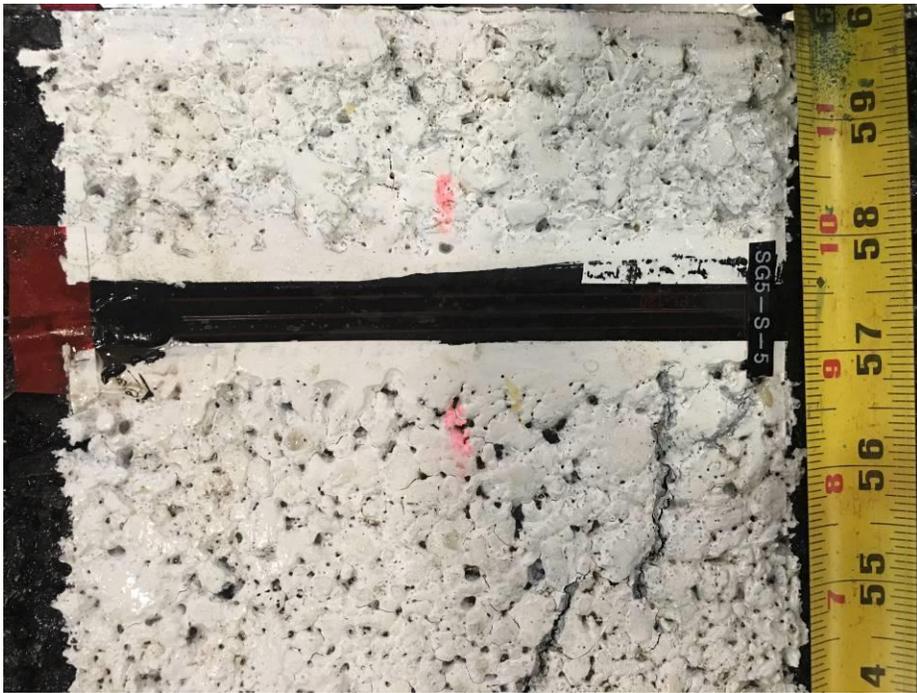
Fig 8 South section surface crack 3 inches from the outer vertical edge

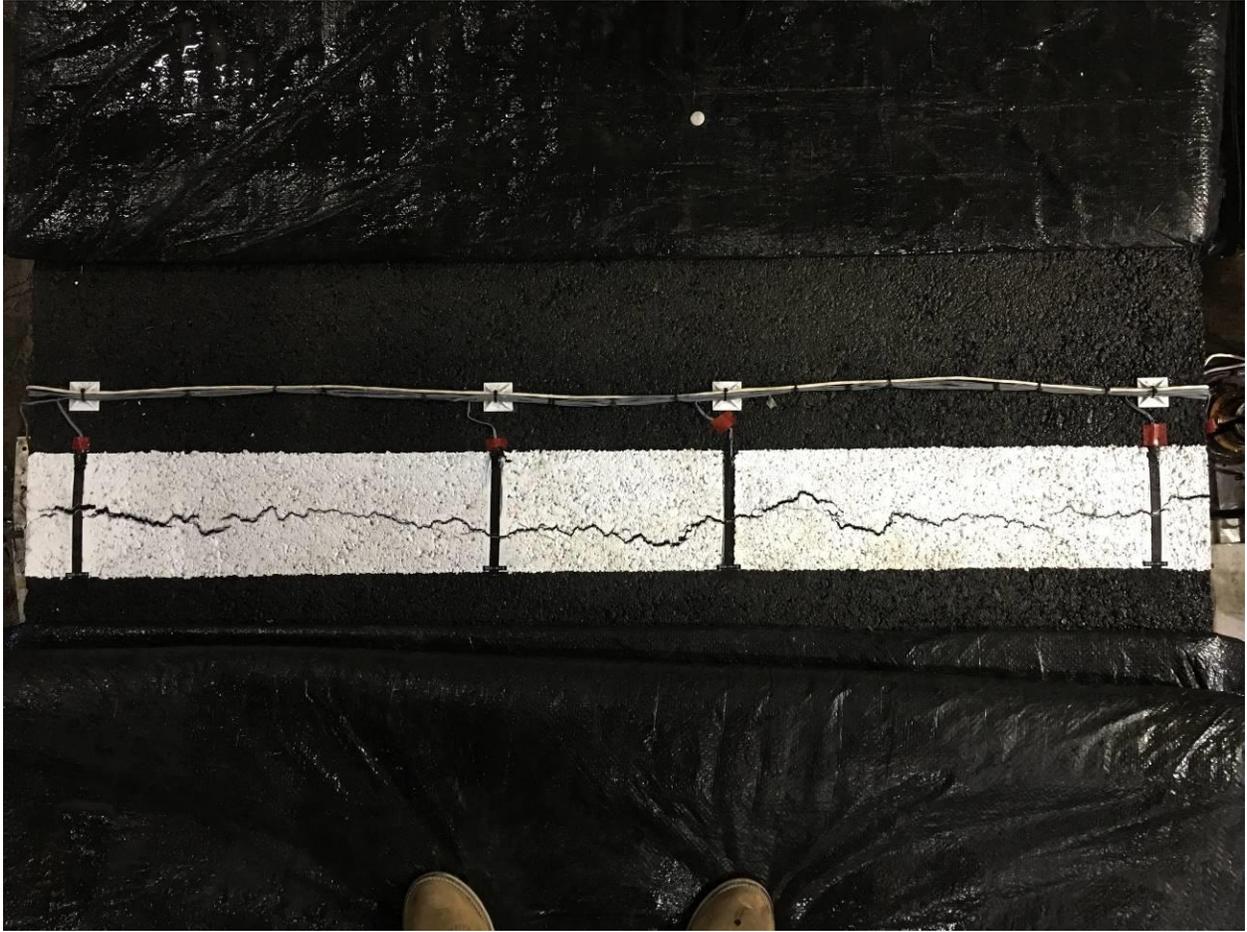
Fig 9 Surface crack on the north section
