## DO15 RC Indoor Phase VI Test Daily Notes

*Date: July 05, 2019*

*Cycle count: 3050*

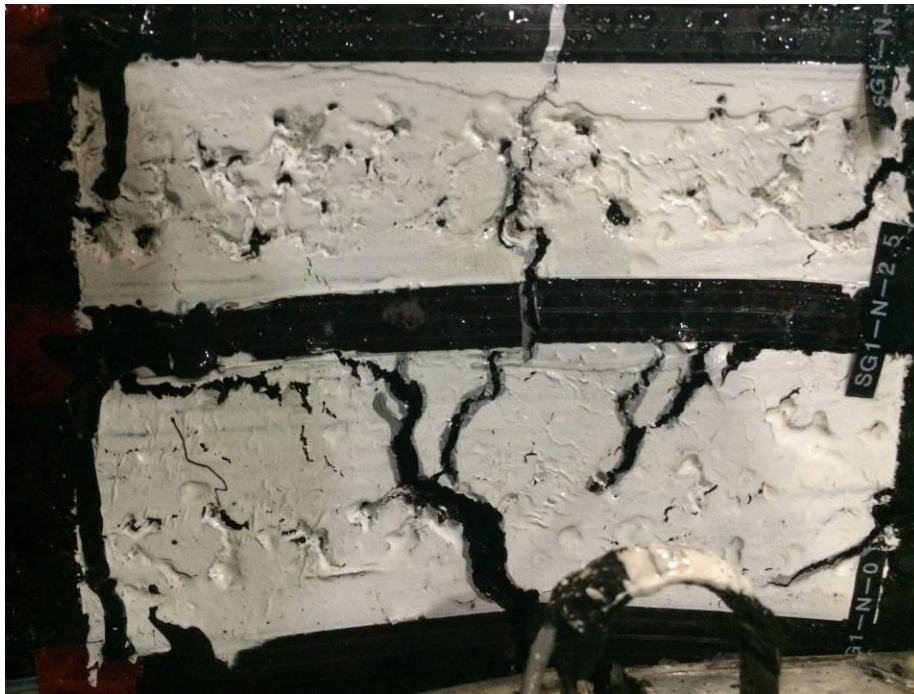
Fig 1 Bottom-up crack at north section inner vertical edge reached top surface

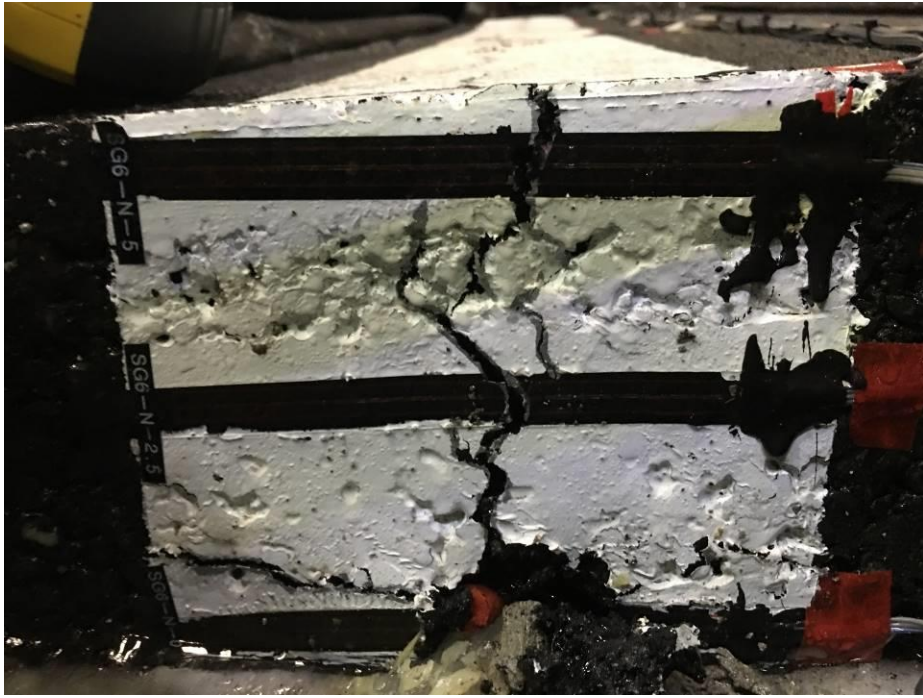
Fig 2 Bottom-up crack north outer edge reached top surface

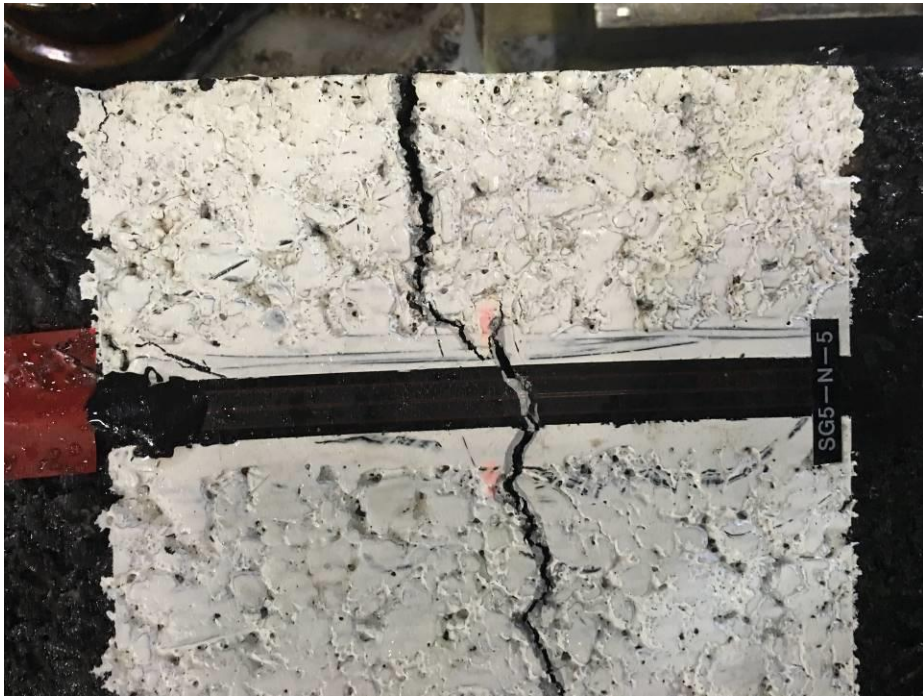
Fig 3 Surface crack on North Section reached outer edge

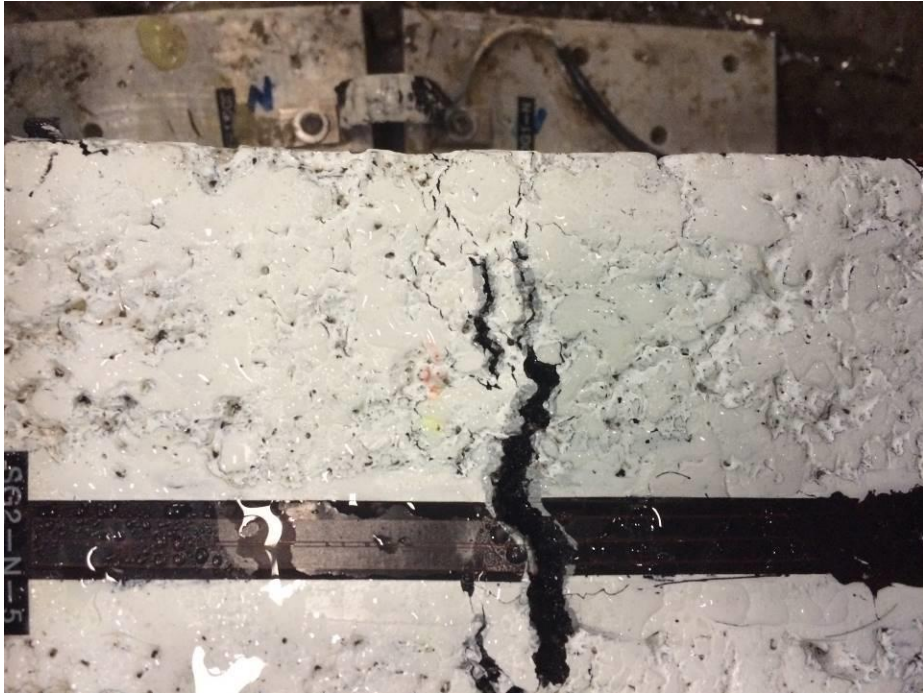
Fig 4 North section surface crack reached the inner vertical edge

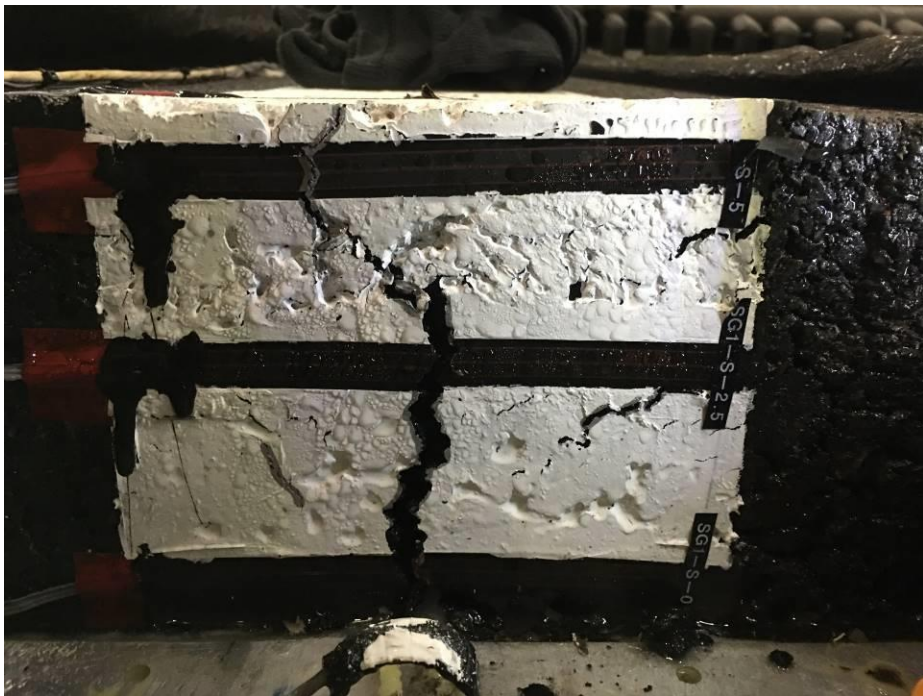
Fig 5 Bottom-up crack at inner vertical edge of south section reached top surface

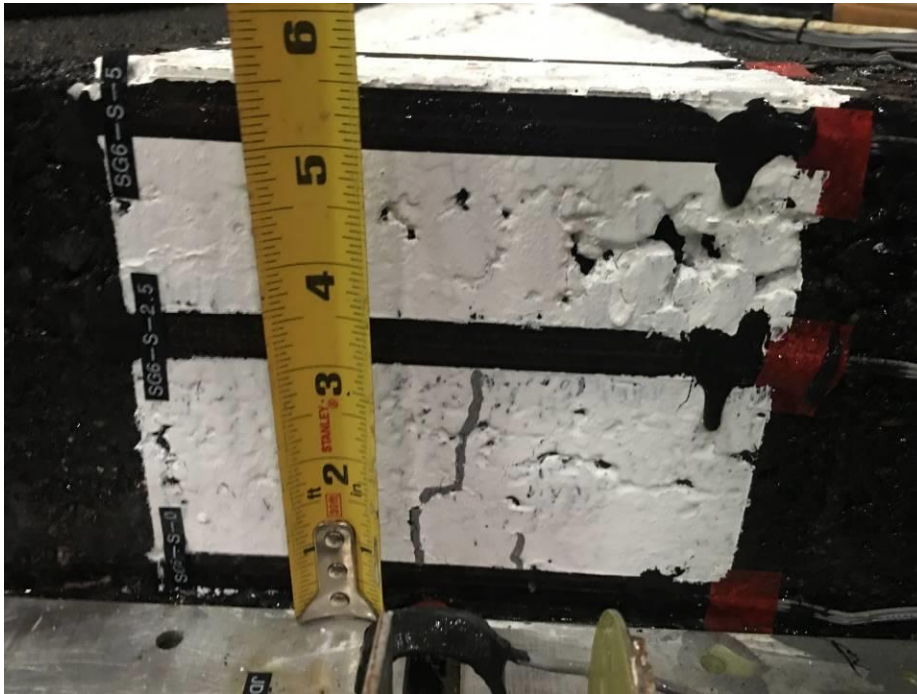
Fig 6 Bottom-up crack at SG6-S-0 3 inch long

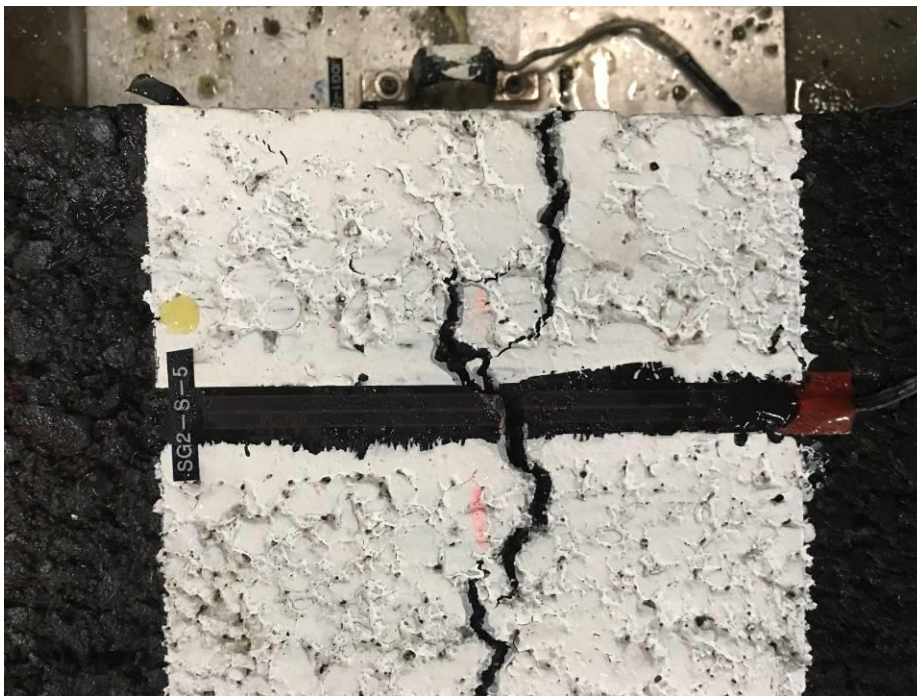
Fig 7 South section surface crack reached the inner vertical edge
