DO15 RC Indoor Phase VI Test Daily Notes

Date: June 18, 2019

Cycle count: 1284

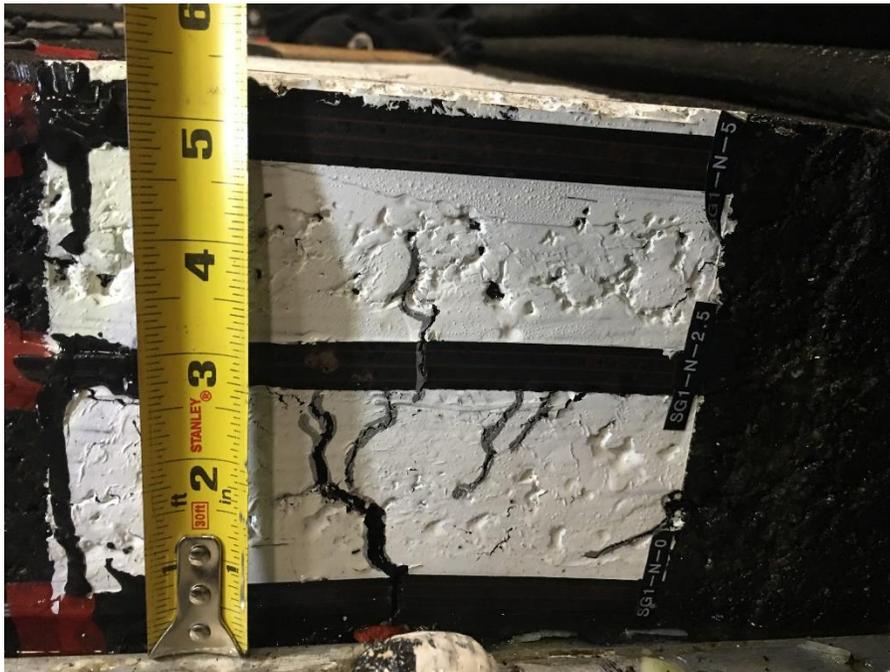
Fig 1 Bottom-up crack at SG1-N-0 and SG1-N-2.5 4.25 inch long

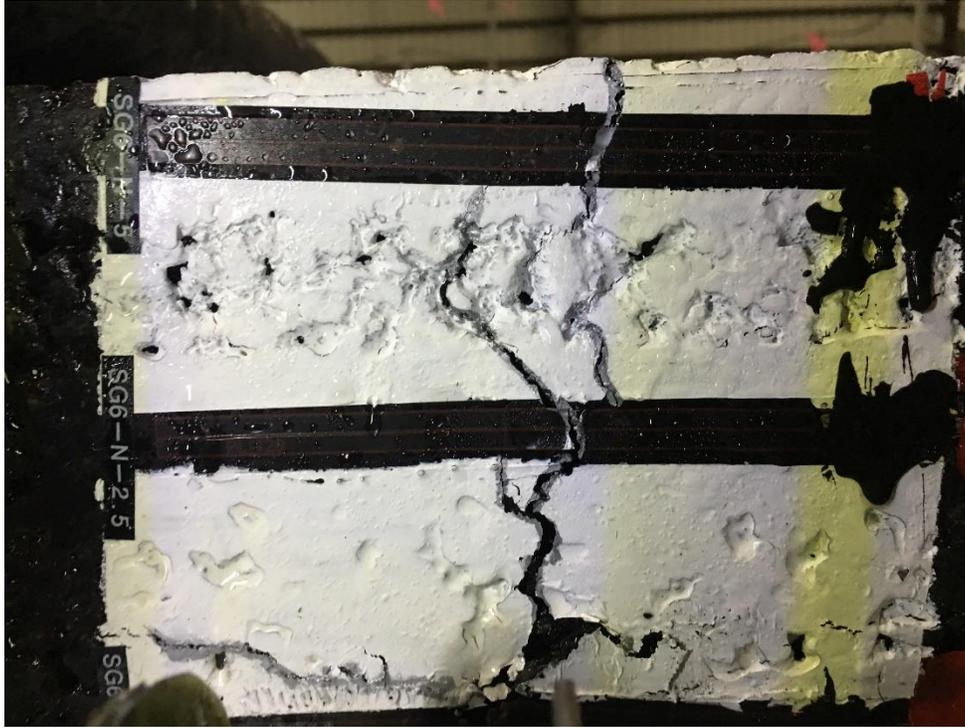
Fig 2 Bottom-up crack north outer edge reached top surface

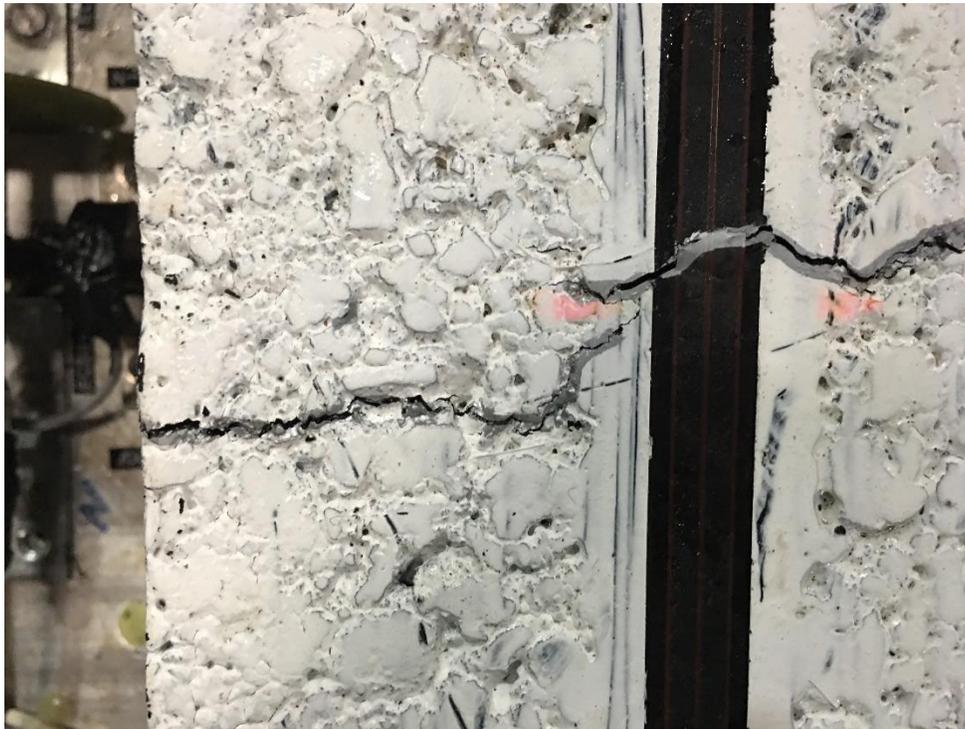
Fig 3 Surface crack on North Section reached outer edge

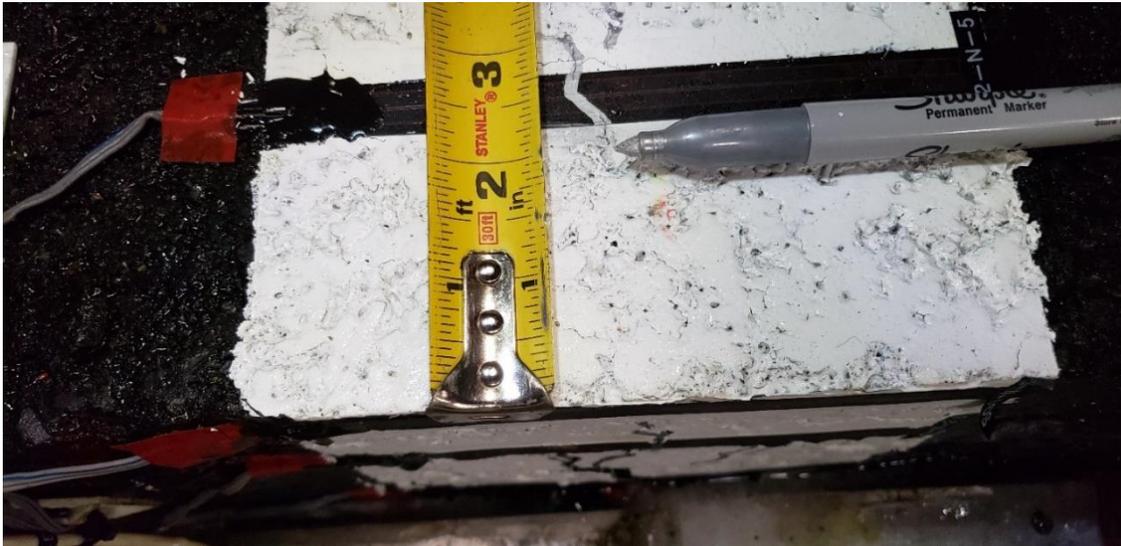
Fig 4 North section surface crack 2 inch from the inner vertical edge

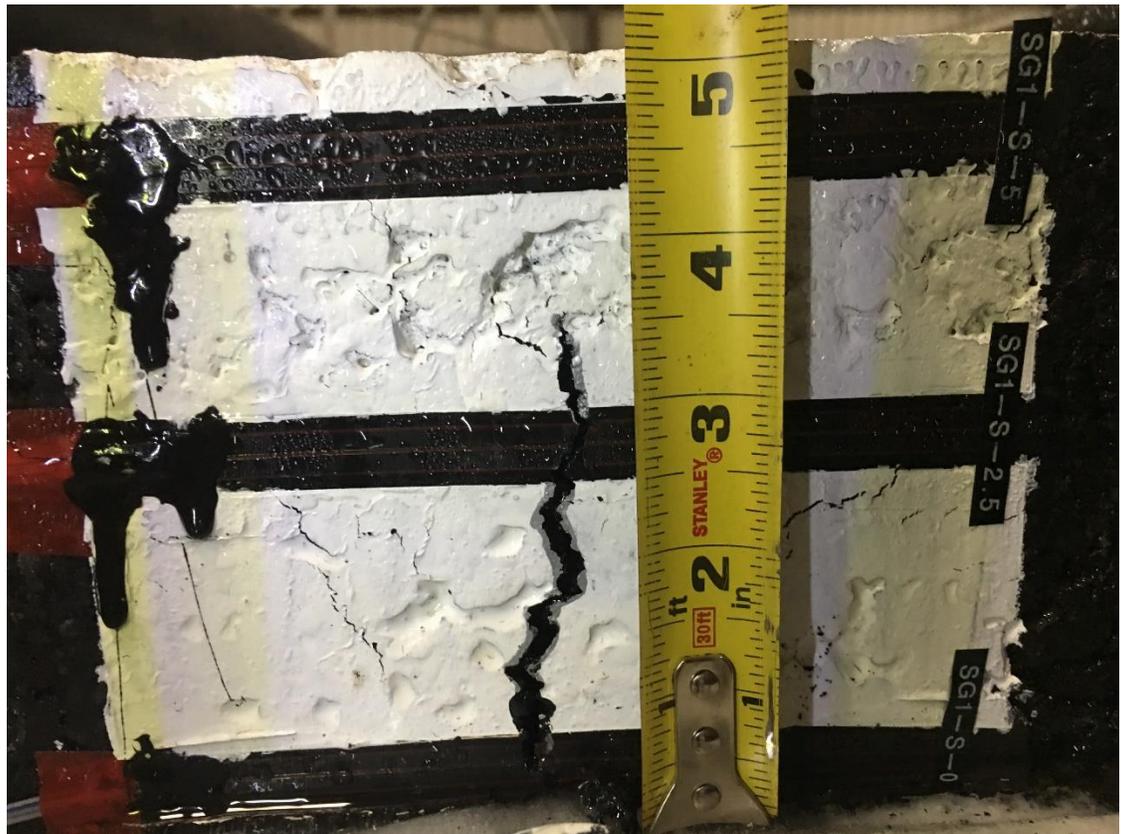
Fig 4 Bottom-up crack at SG1-S-0 3.75 inch long

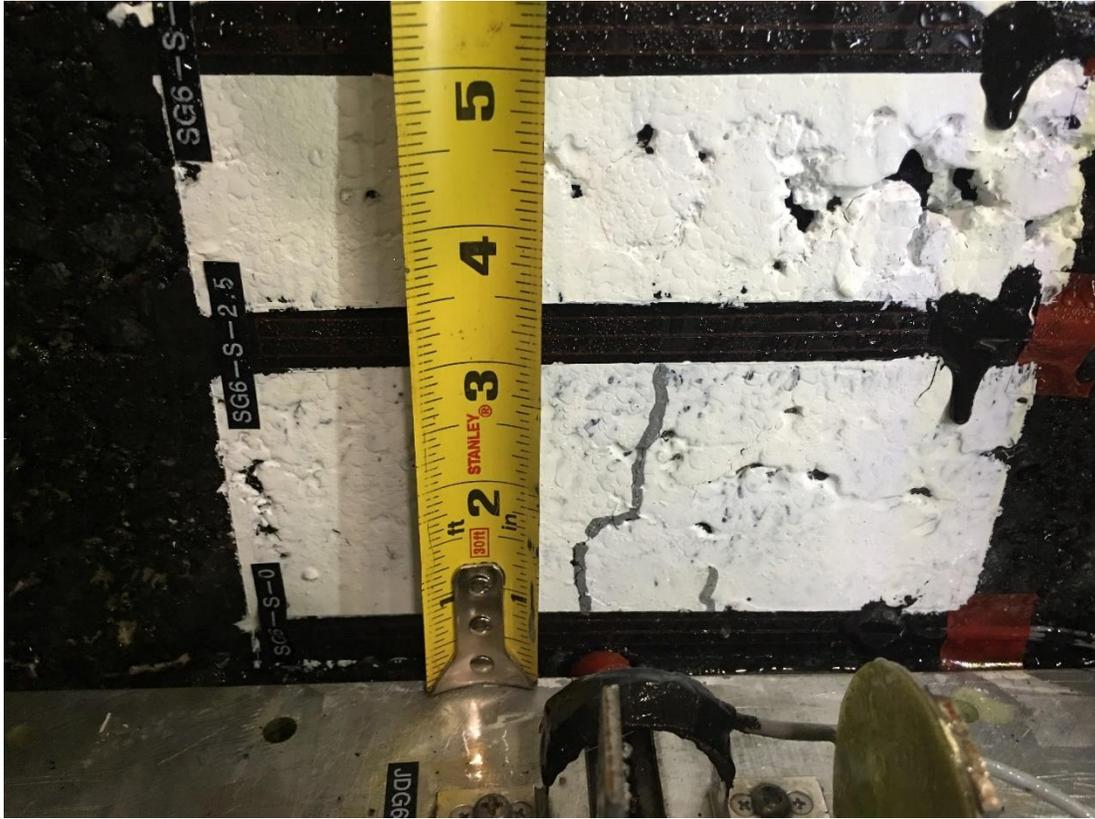
Fig 5 Bottom-up crack at SG6-S-0 3 inch long

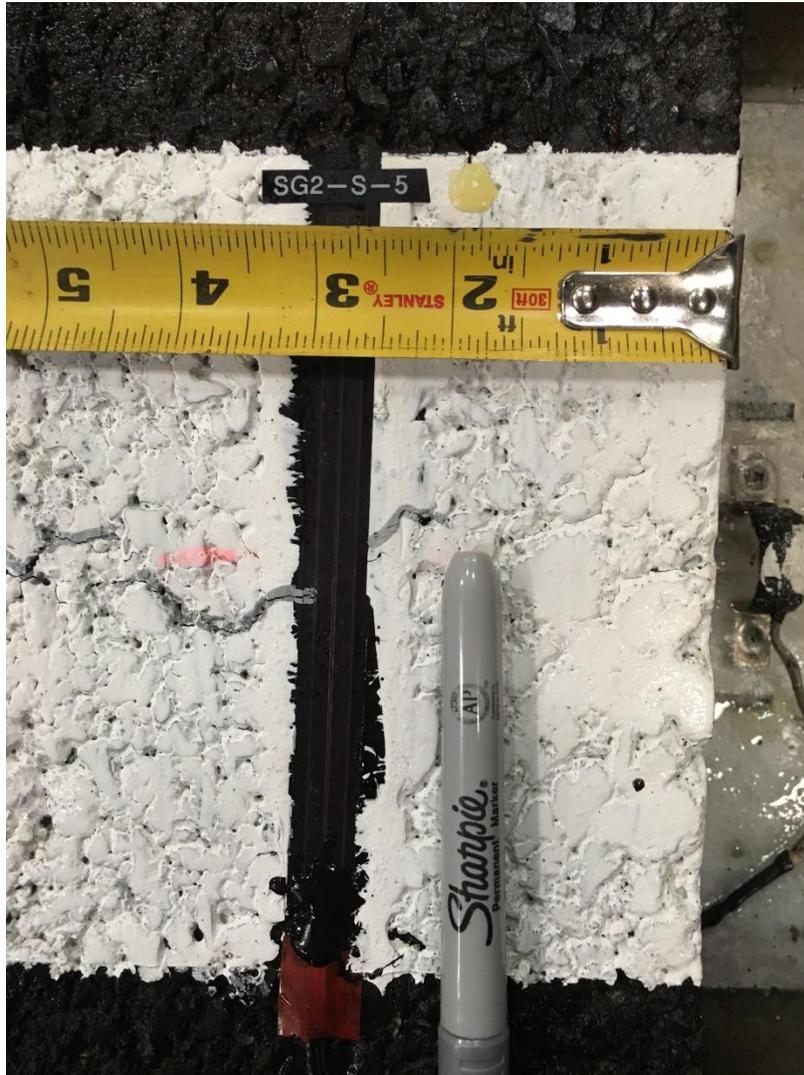
Fig 6 South section surface crack 2 inches from the inner vertical edge

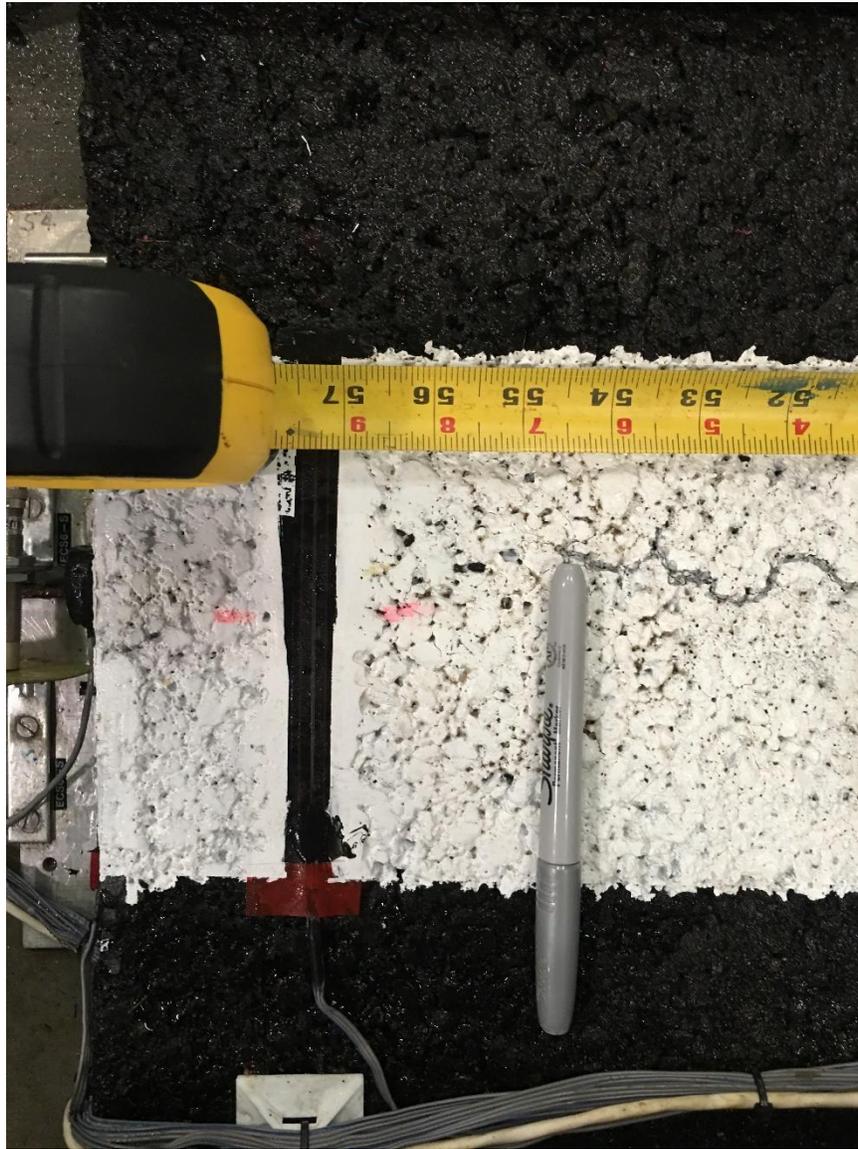
Fig 7 South section surface crack 5.5 inches from the outer vertical edge
