DO15 RC Indoor Phase VI Test Daily Notes

Date: July 01, 2019

Cycle count: 2550

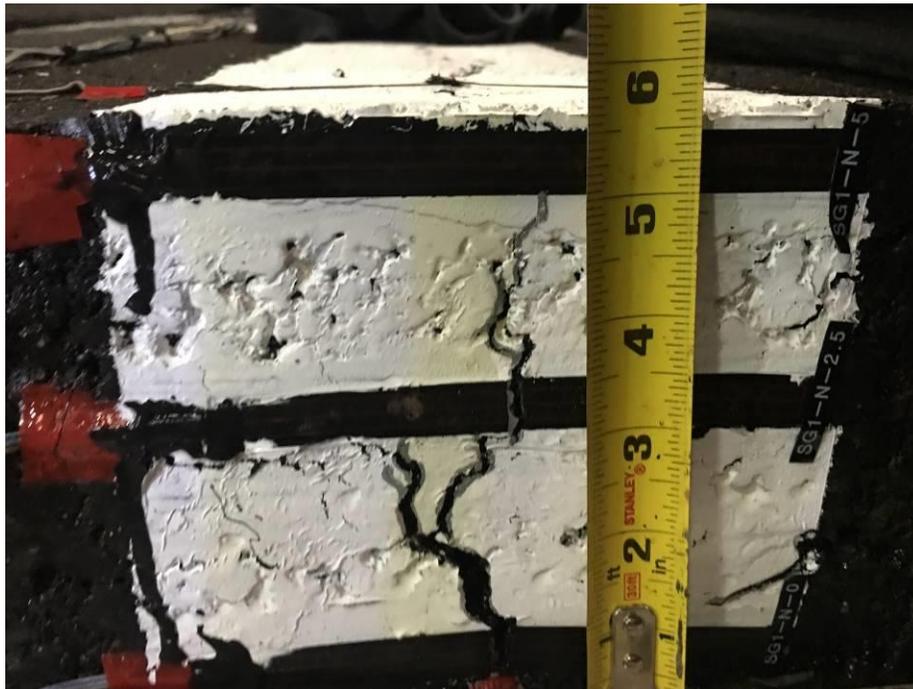
- 1 crack through SG1-N-0 and SG1-N-2.5 approximately 5 inches (Fig 1).
- 1 crack through SG6-N-0, SG6-N-2.5 and SG6-N-5 all the way to the top surface (Fig 2).
- Surface crack connected to the bottom-up crack of the outer edge (Fig 3), 0.5 inch from the inner vertical edge, no change (Fig 4).

Fig 1 Bottom-up crack at SG1-N-0 and SG1-N-2.5 5 inch long

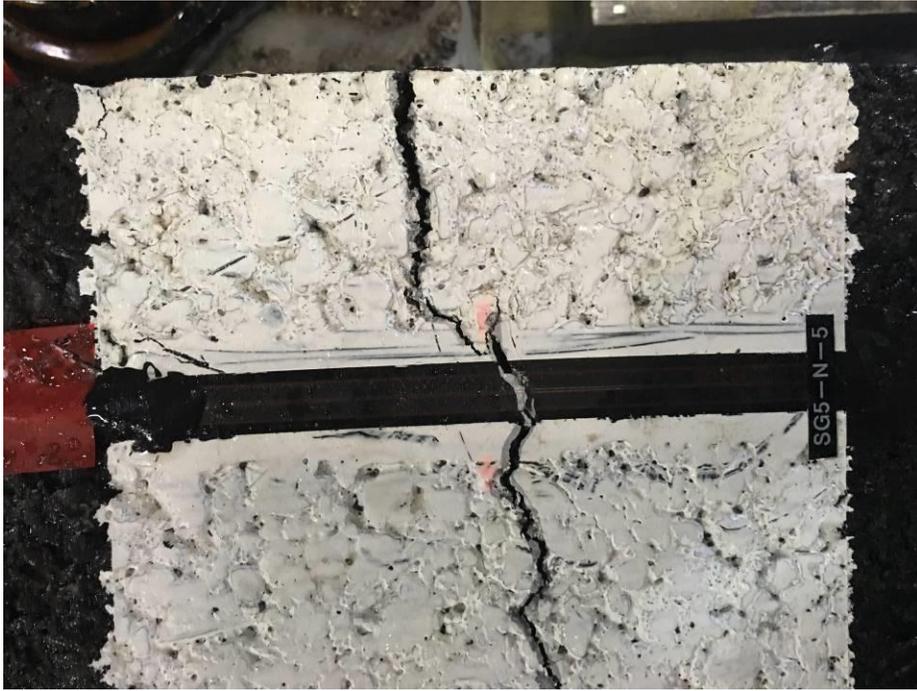
Fig 3 Surface crack on North Section reached outer edge

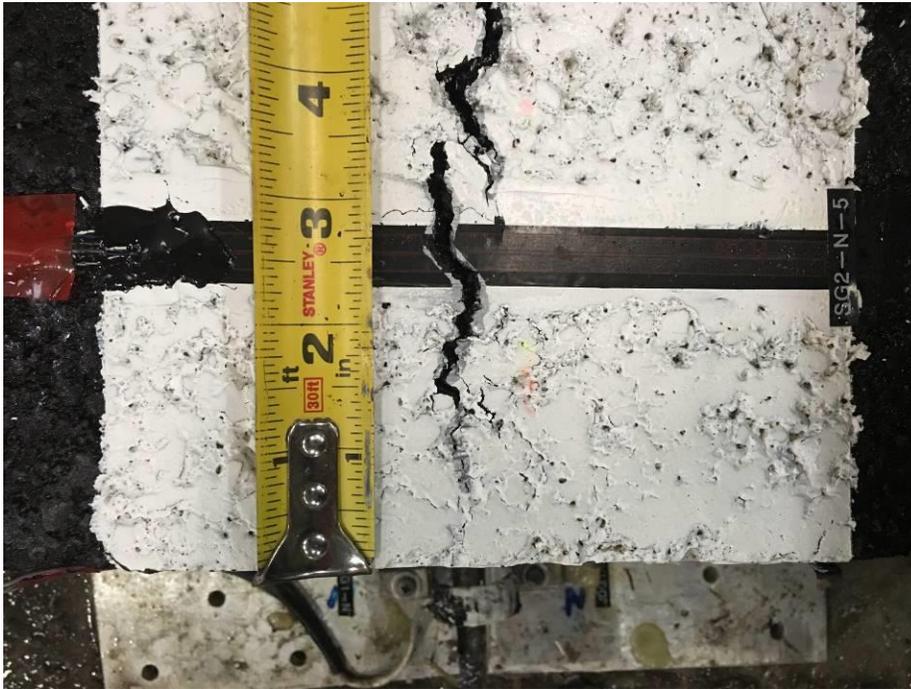
Fig 4 North section surface crack 0.5 inch from the inner vertical edge
