DO15 RC Indoor Phase VI Test Daily Notes

Date: July 18, 2019

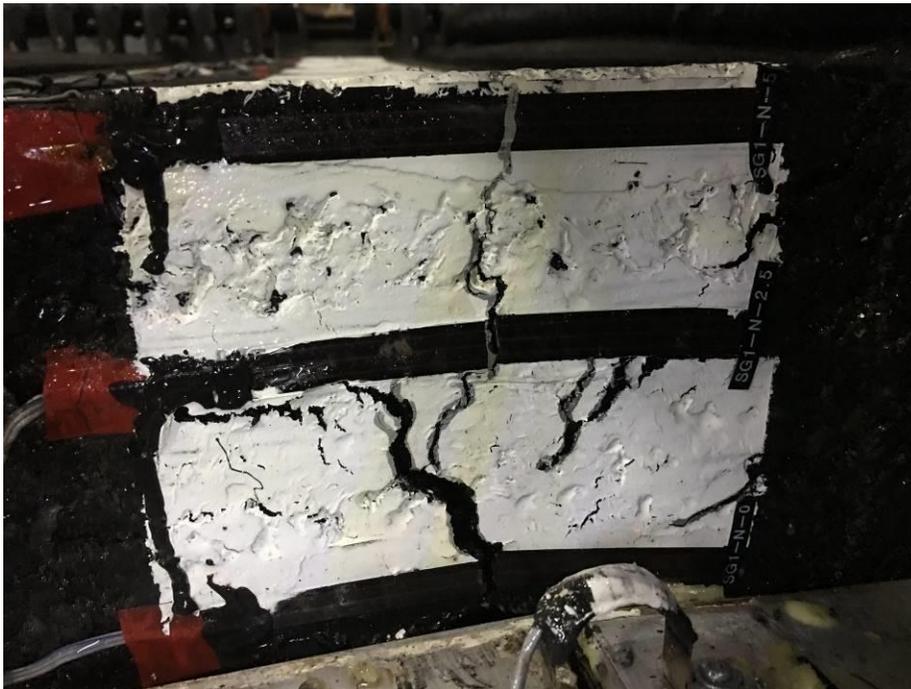
- Completed cracked, no further change.
- Bottom up crack at inner vertical edge (Fig 1). Bottom up crack at outer vertical edge (Fig 2).
- Surface crack connected to the bottom-up crack of the outer edge (Fig 3), and the inner vertical edge (Fig 4).

Fig 1 Bottom-up crack at north section inner vertical edge reached top surface

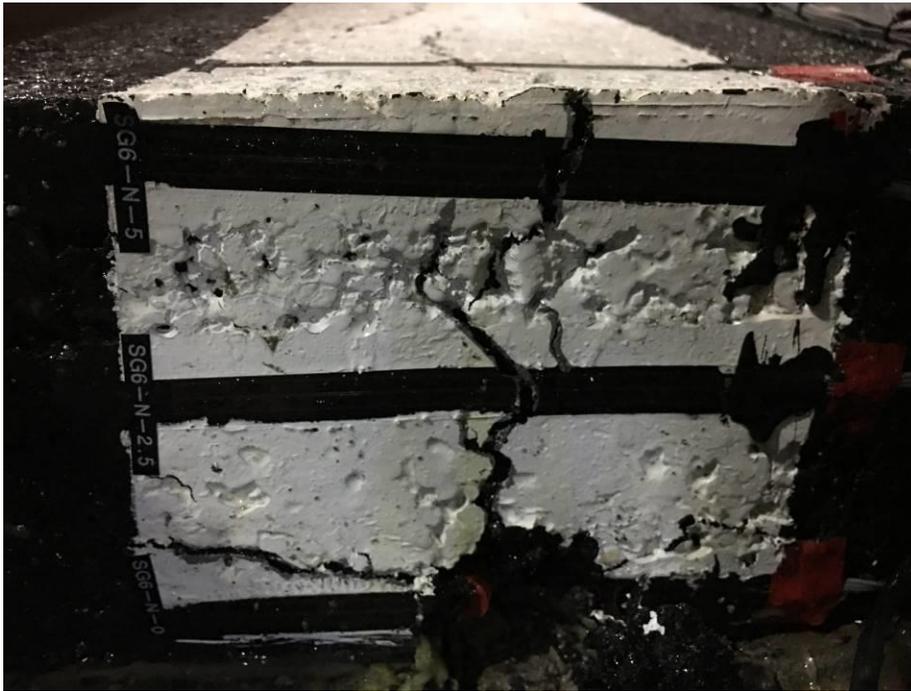
Fig 2 Bottom-up crack at north section outer edge reached top surface

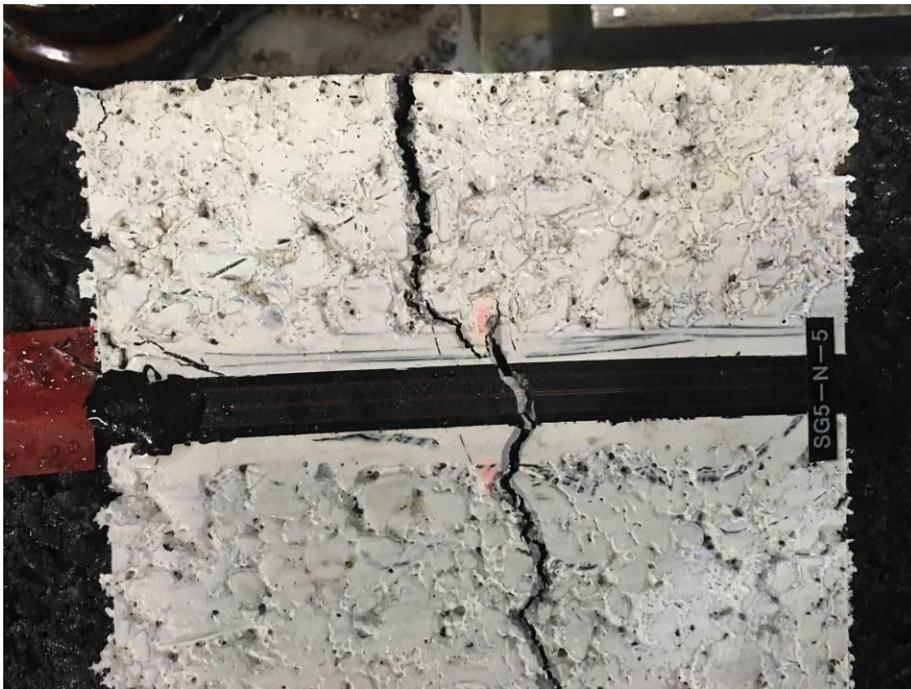
Fig 3 Surface crack on North Section reached outer edge

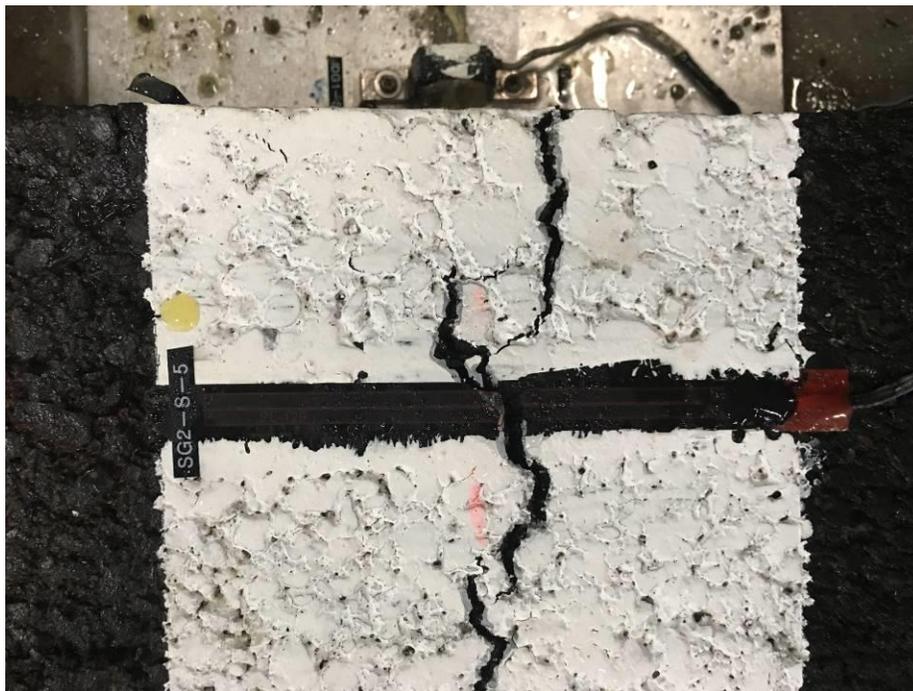
Fig 7 South section surface crack reached the inner vertical edge
