## DO15 RC Indoor Phase VI Test Daily Notes

*Date: June 25, 2019*

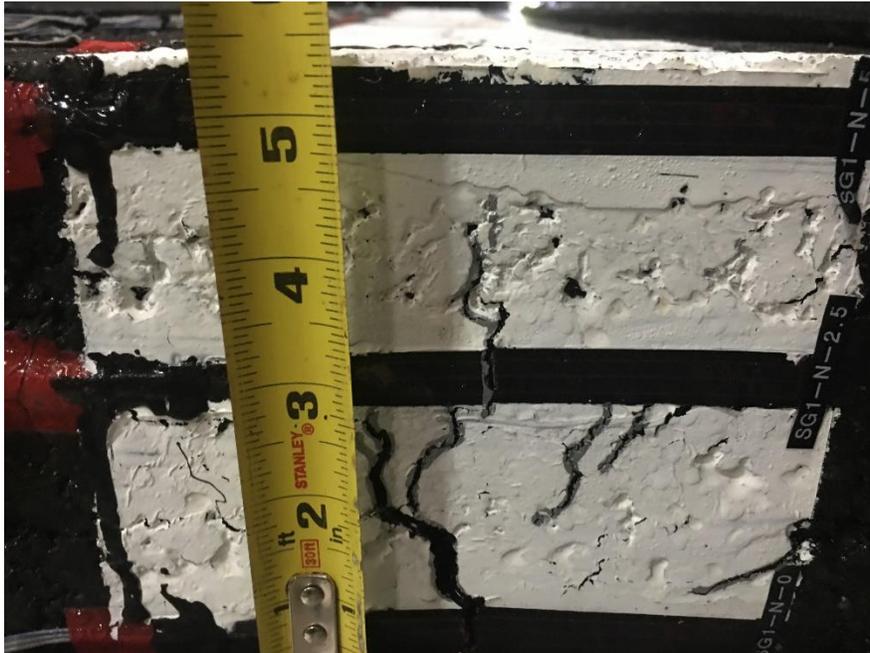
- 1 crack through SG1-N-0 and SG1-N-2.5 approximately 4.5 inches, no change (Fig 1).
- 1 crack through SG6-N-0, SG6-N-2.5 and SG6-N-5 all the way to the top surface (Fig 2).
- Surface crack connected to the bottom-up crack of the outer edge (Fig 3), 1.5 inch from the inner vertical edge, no change (Fig 4).

Fig 1 Bottom-up crack at SG1-N-0 and SG1-N-2.5 4.5 inch long

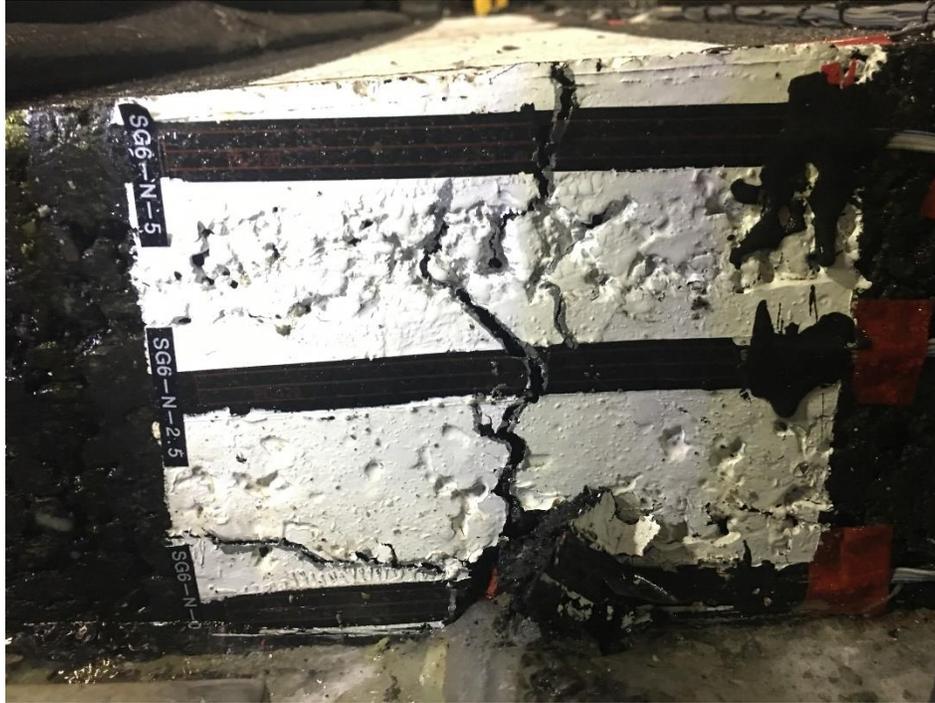
Fig 2 Bottom-up crack north outer edge reached top surface

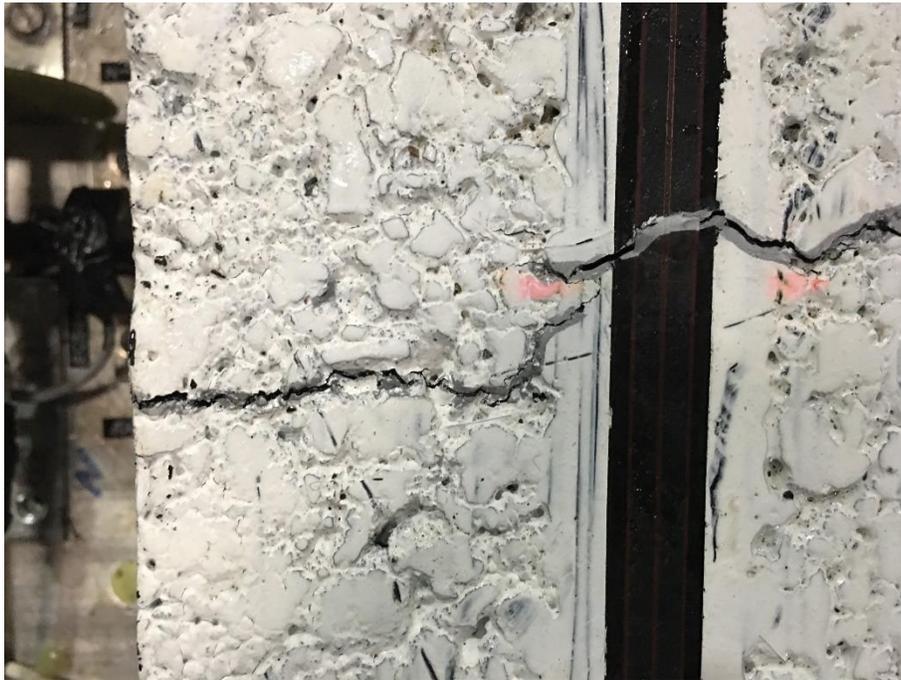
Fig 3 Surface crack on North Section reached outer edge

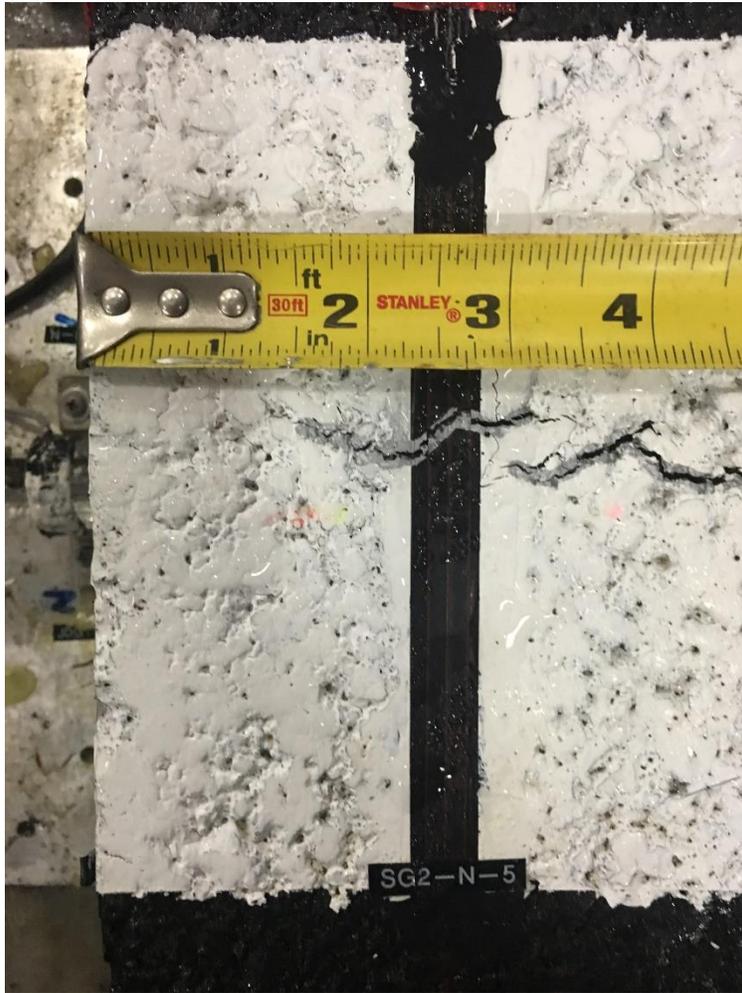
Fig 4 North section surface crack 1.5 inch from the inner vertical edge

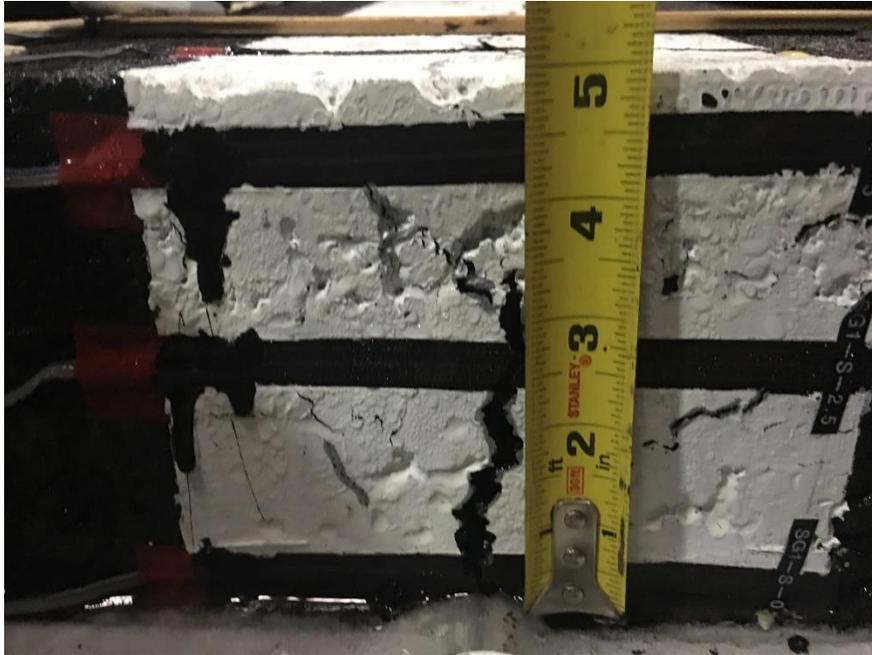
- 1 crack through SG1-S-0, approximately 4.25 inches (Fig 5).
- 1 crack through SG6-S-0, approximately 3 inches, no change (Fig 6).
- Surface crack is 1.0 inch from the inner vertical edge (Fig 7), approximately 3 inches from the outer vertical edge (Fig 8)

Fig 5 Bottom-up crack at SG1-S-0 4.25 inch long

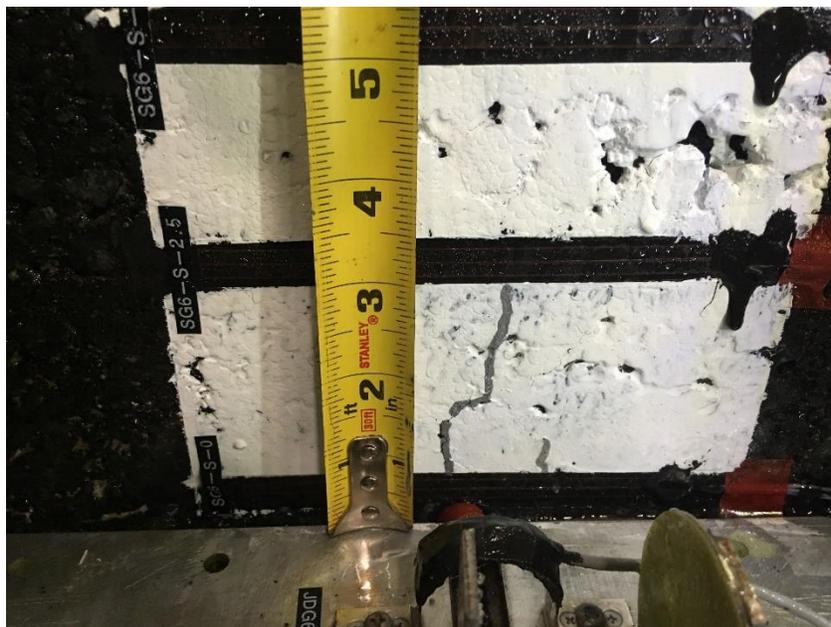
Fig 6 Bottom-up crack at SG6-S-0 3 inch long

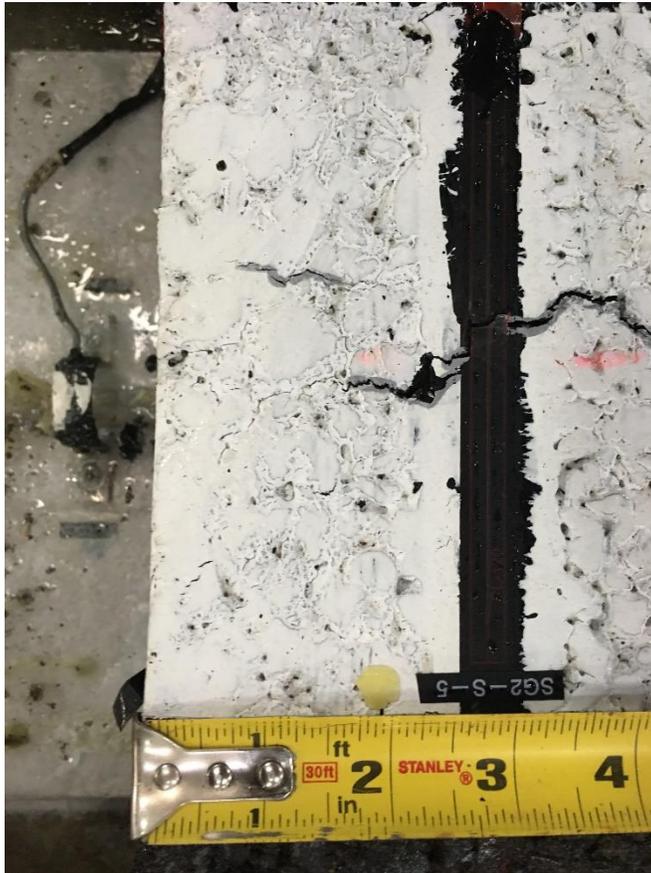
Fig 7 South section surface crack 1 inches from the inner vertical edge

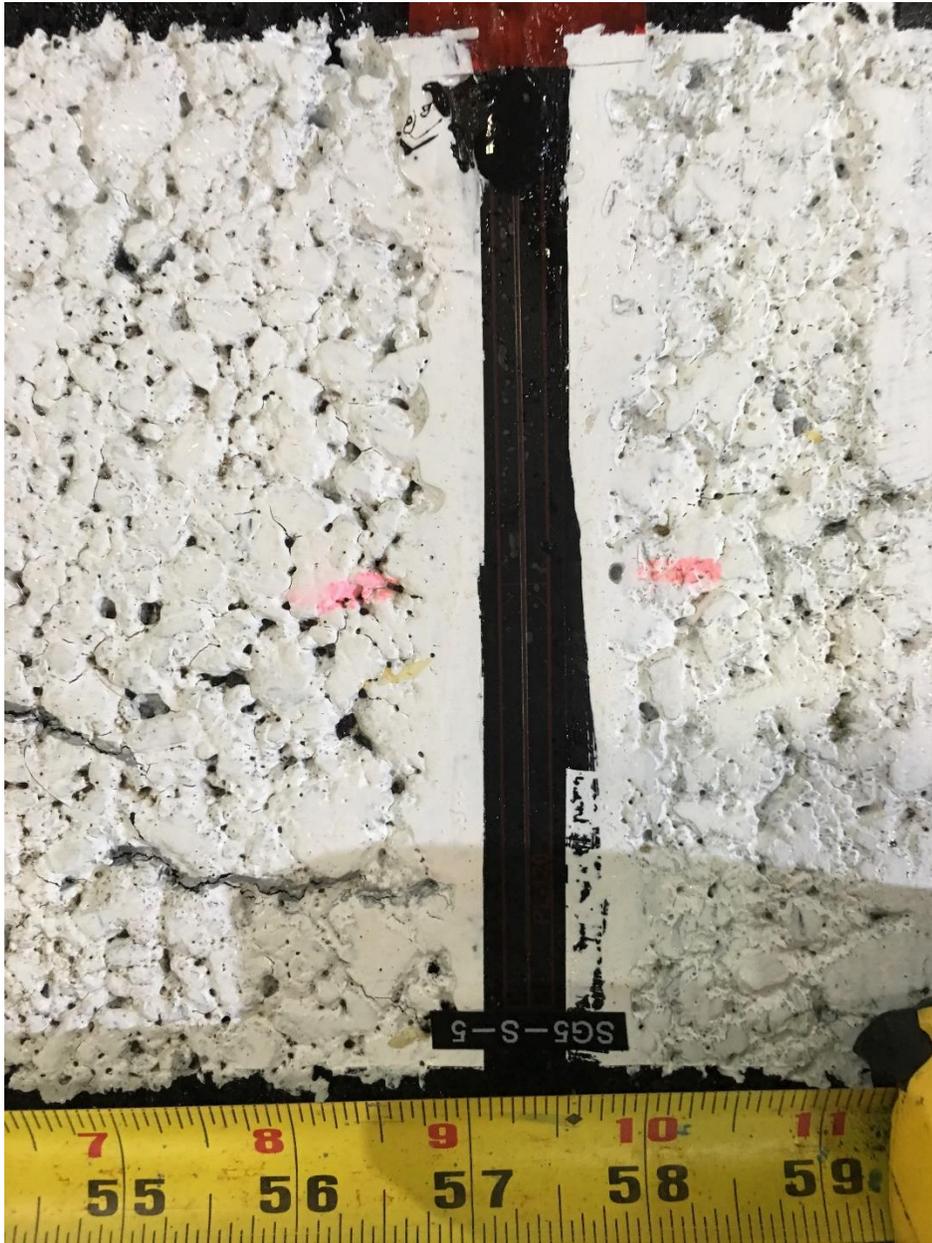
Fig 8 South section surface crack 3 inches from the outer vertical edge
