DO15 RC Indoor Phase VI Test Daily Notes

Date: July 11, 2019

Cycle count: 3531

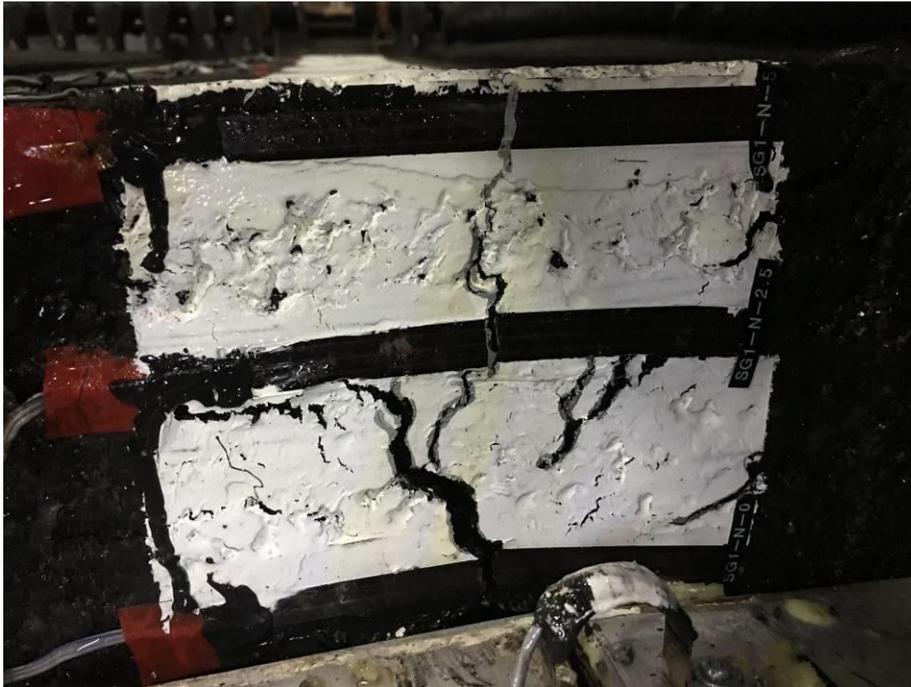
Fig 1 Bottom-up crack at north section inner vertical edge reached top surface

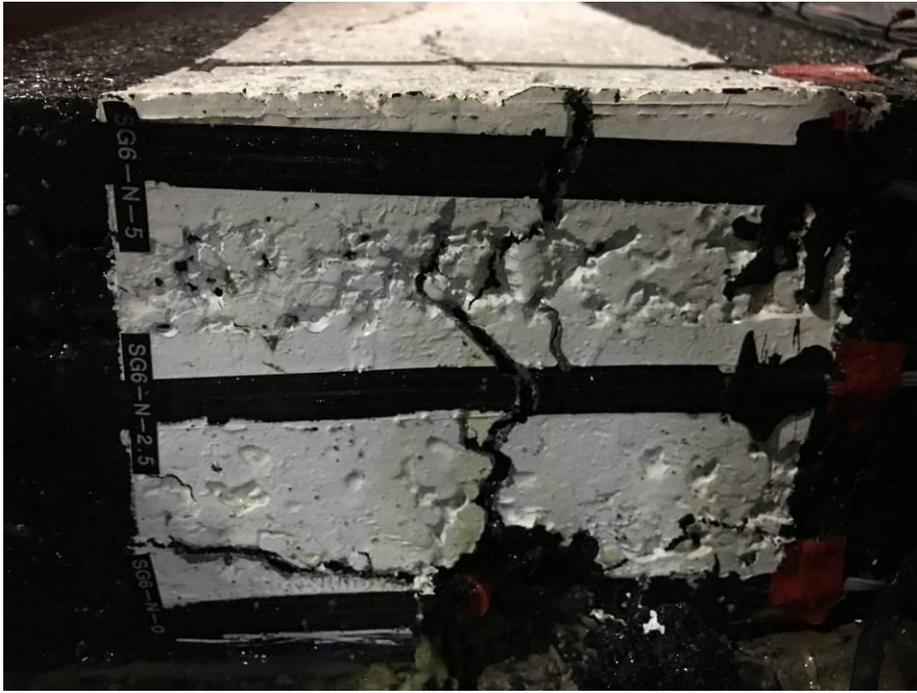
Fig 2 Bottom-up crack at north section outer edge reached top surface
