DO15 RC Indoor Phase VI Test Daily Notes

Date: June 20, 2019

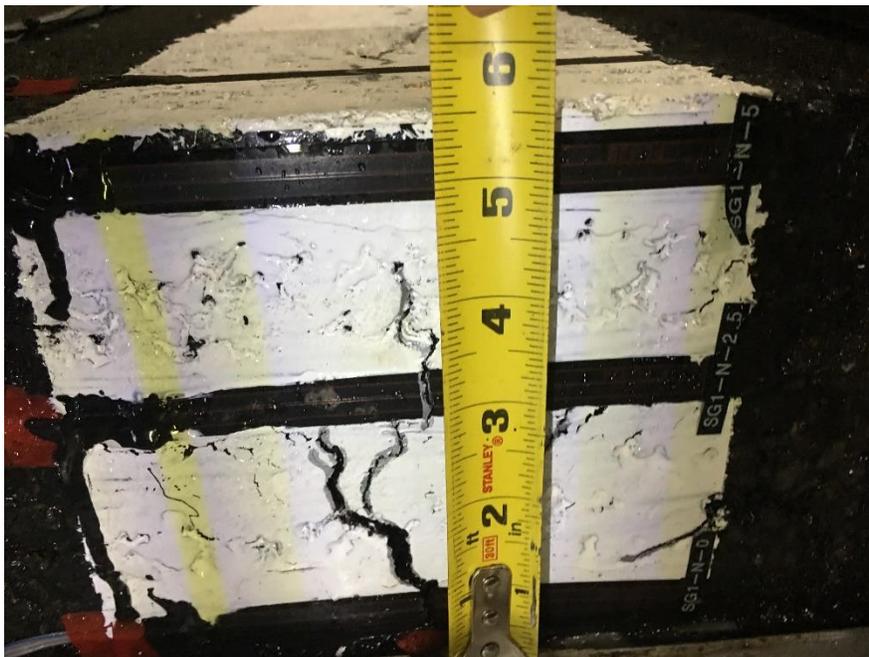
Fig 1 Bottom-up crack at SG1-N-0 and SG1-N-2.5 4.25 inch long

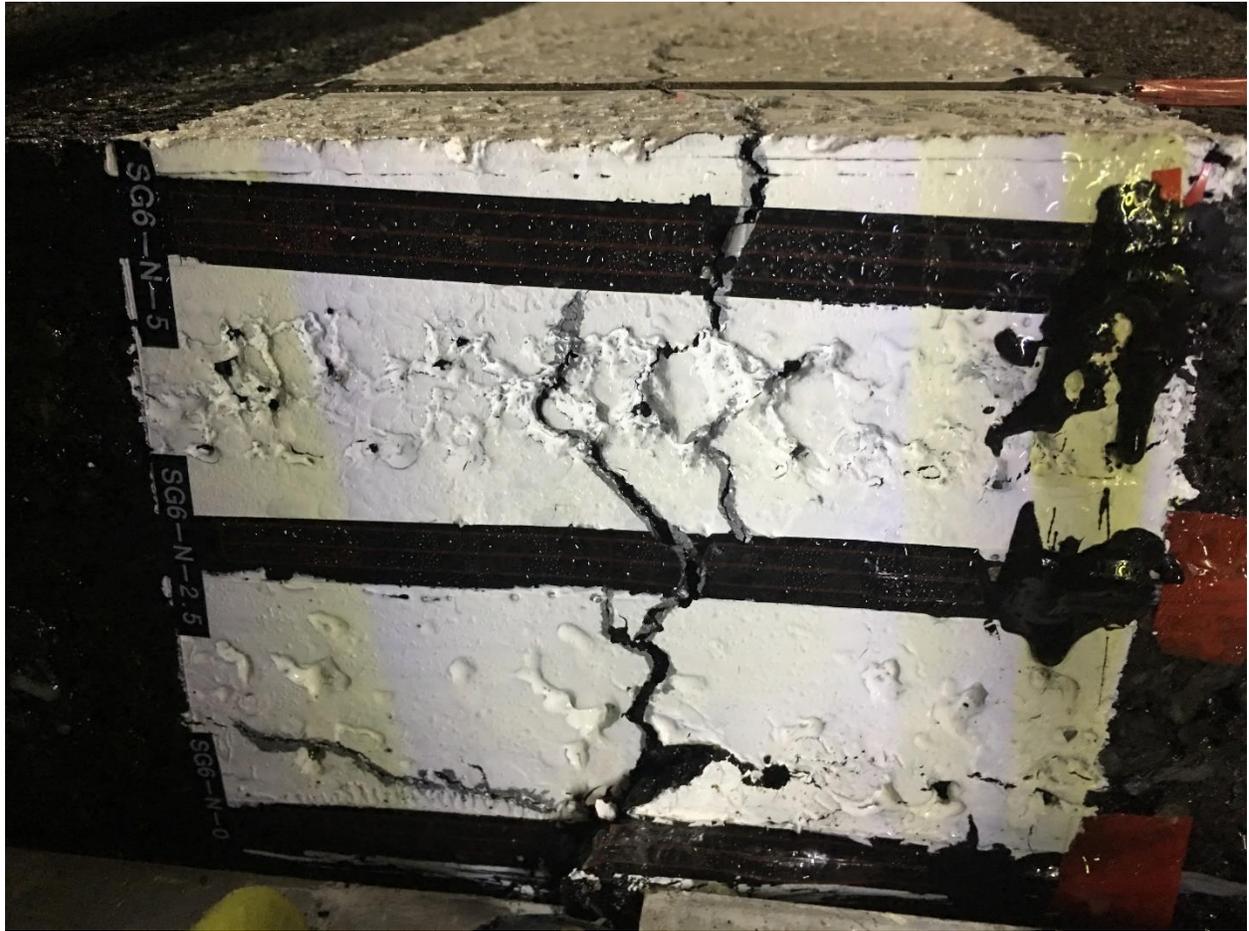
Fig 2 Bottom-up crack north outer edge reached top surface

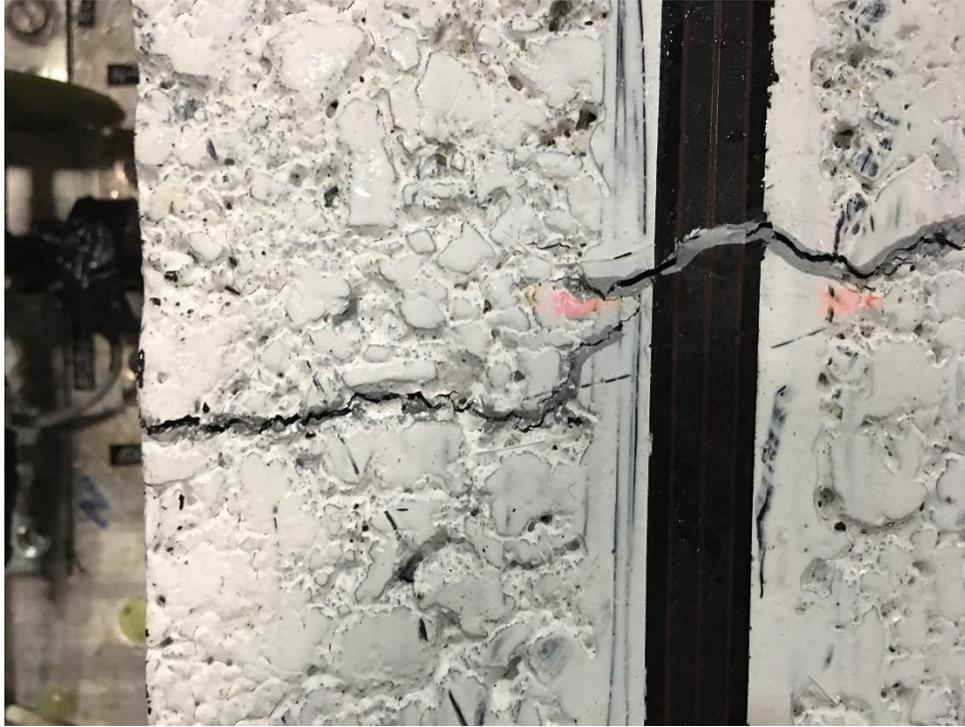
Fig 3 Surface crack on North Section reached outer edge

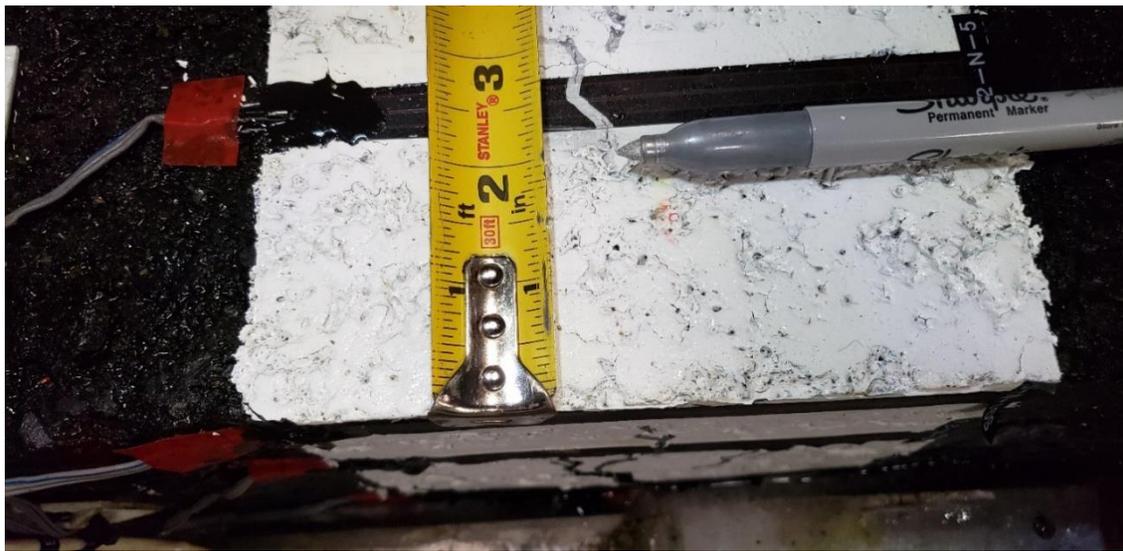
Fig 4 North section surface crack 2 inch from the inner vertical edge

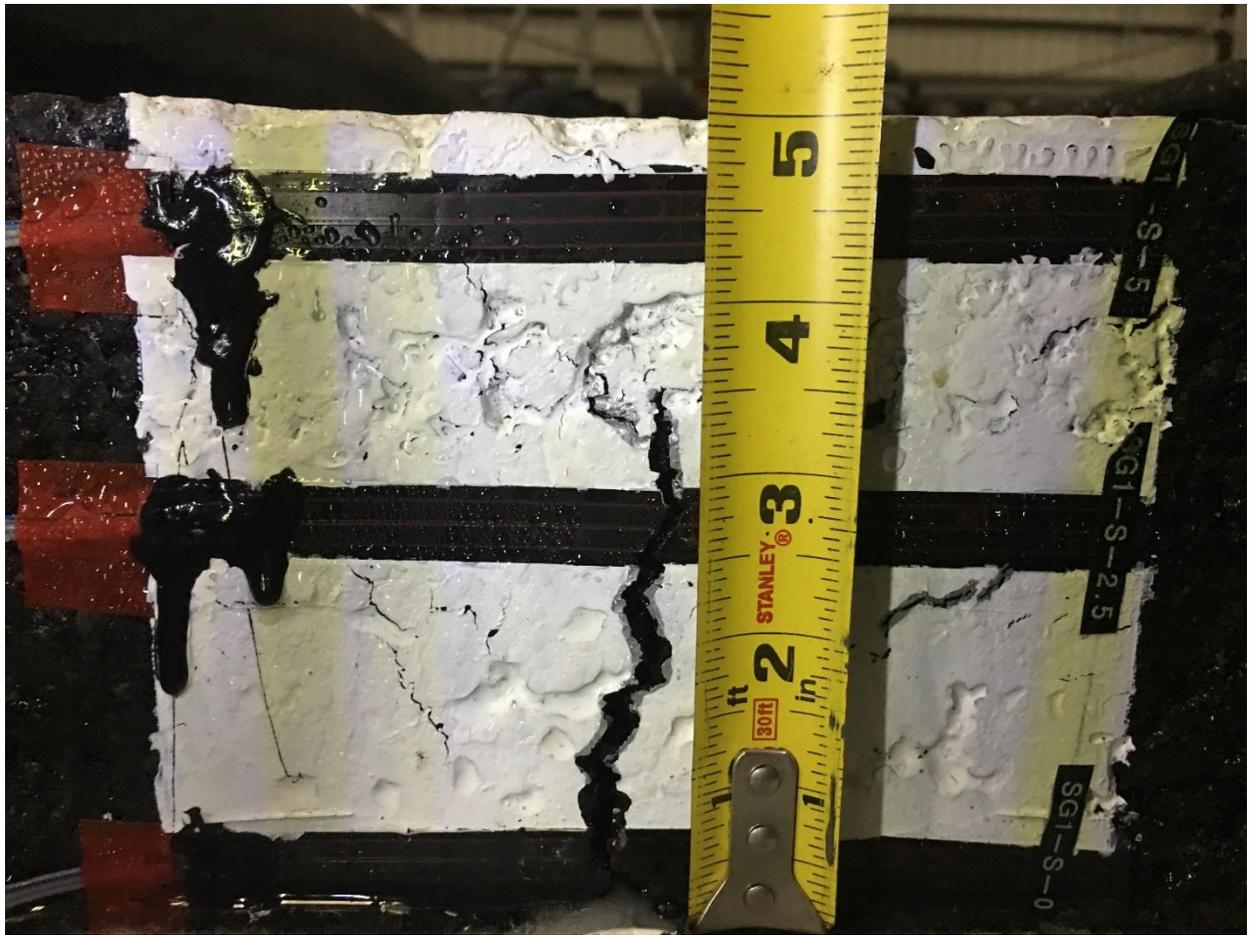
Fig 4 Bottom-up crack at SG1-S-0 4.25 inch long

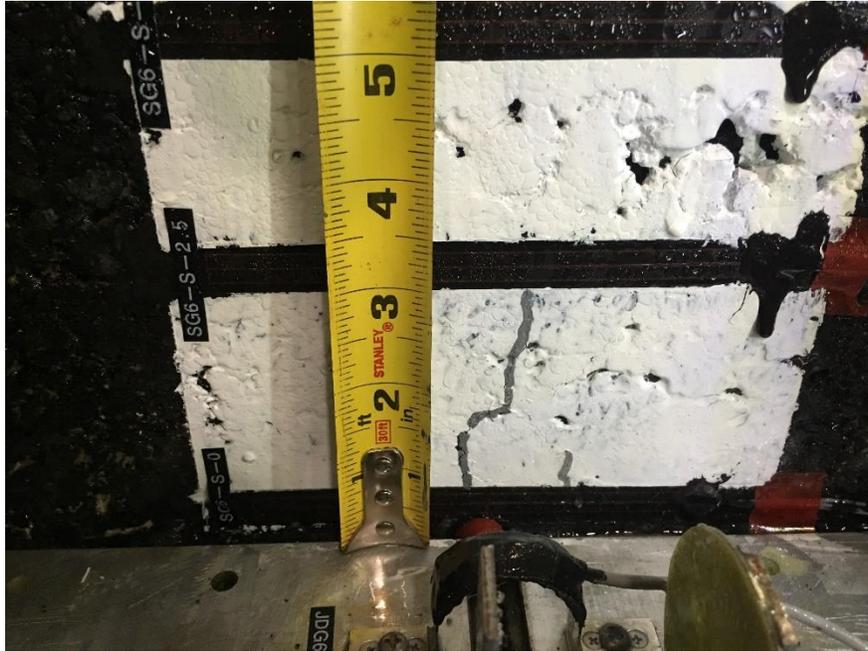
Fig 5 Bottom-up crack at SG6-S-0 3 inch long

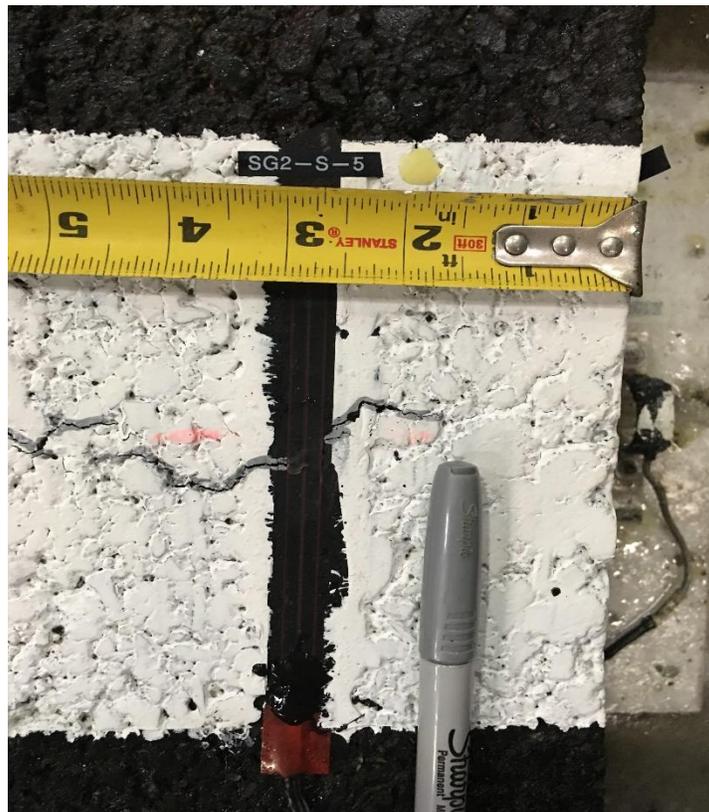
Fig 6 South section surface crack 1.5 inches from the inner vertical edge

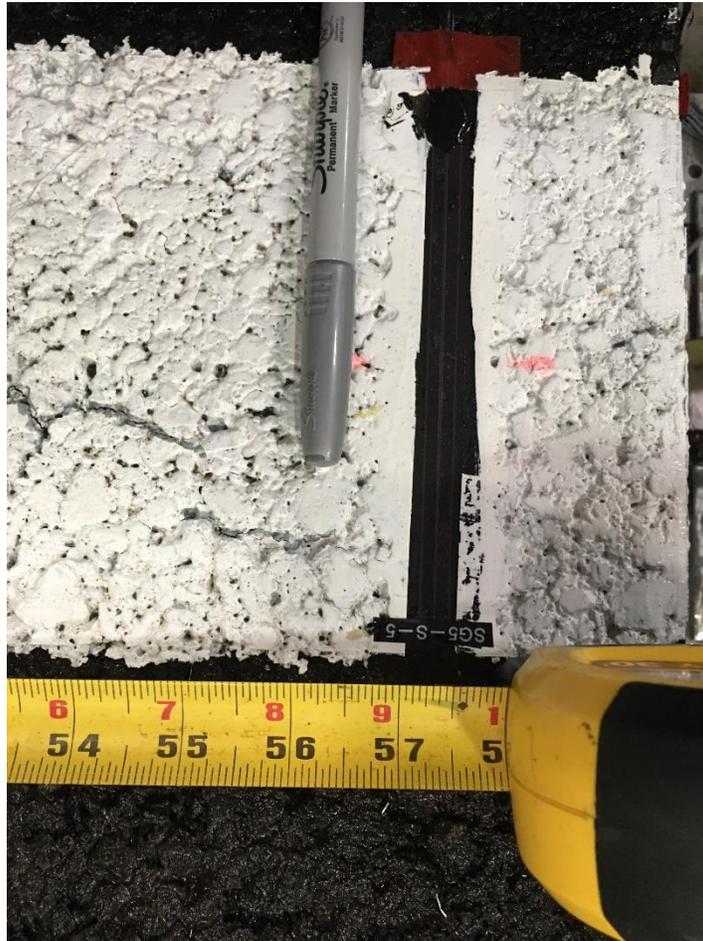
Fig 7 South section surface crack 3.5 inches from the outer vertical edge
