DO15 RC Indoor Phase VI Test Daily Notes

Date: June 28, 2019

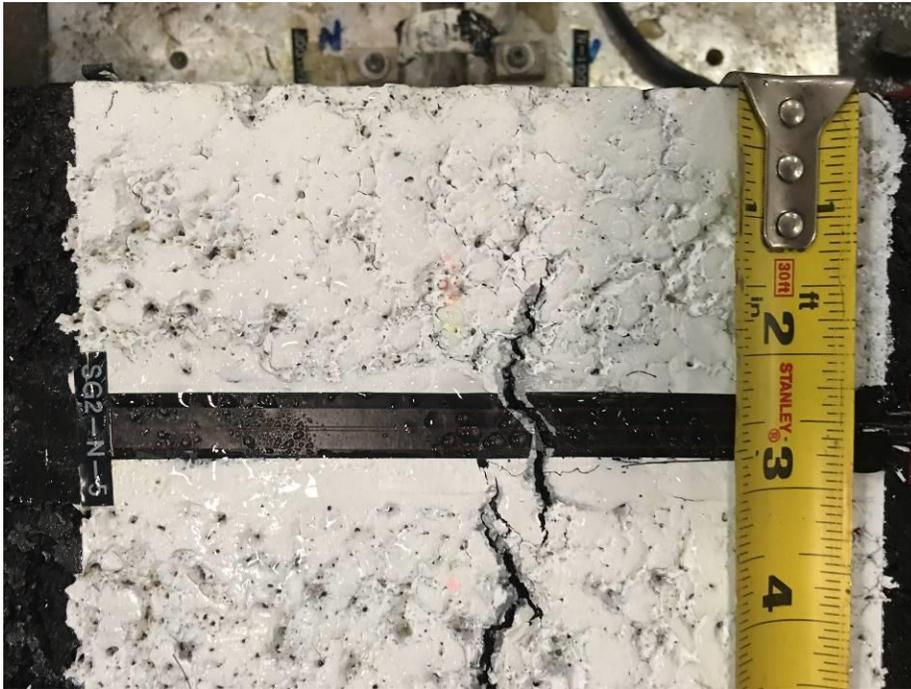
Fig 4 North section surface crack 1.5 inch from the inner vertical edge

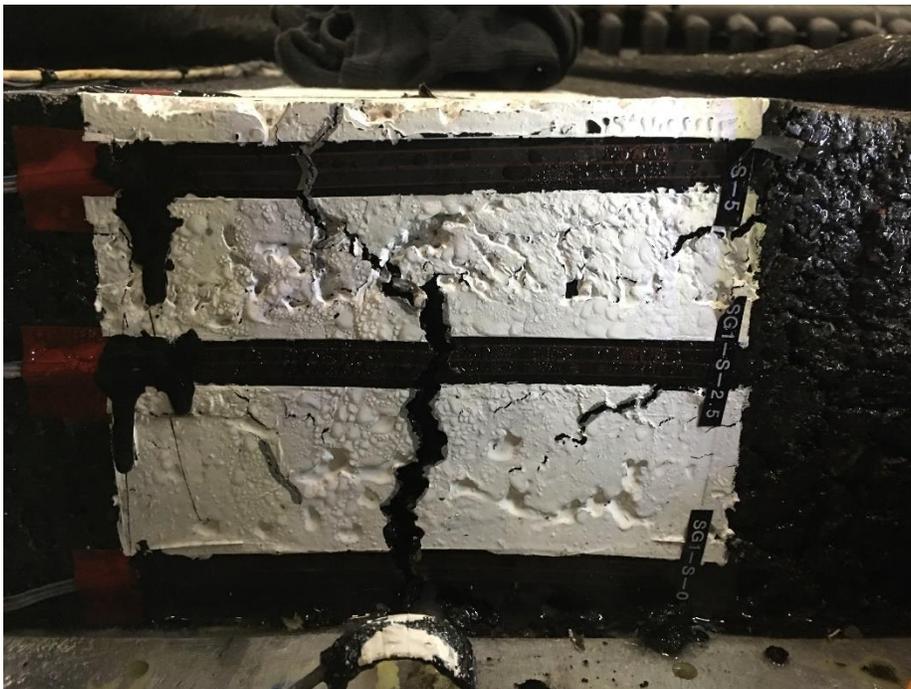
- Bottom up crack through SG1-S-0 reached top surface, connected with the surface crack
- 1 crack through SG6-S-0, approximately 3 inches, no change (Fig 6).
- Surface crack reached the inner vertical edge (Fig 7), approximately 3 inches from the outer vertical edge (Fig 8)

Fig 5 Bottom-up crack at SG1-S-0 reached top surface

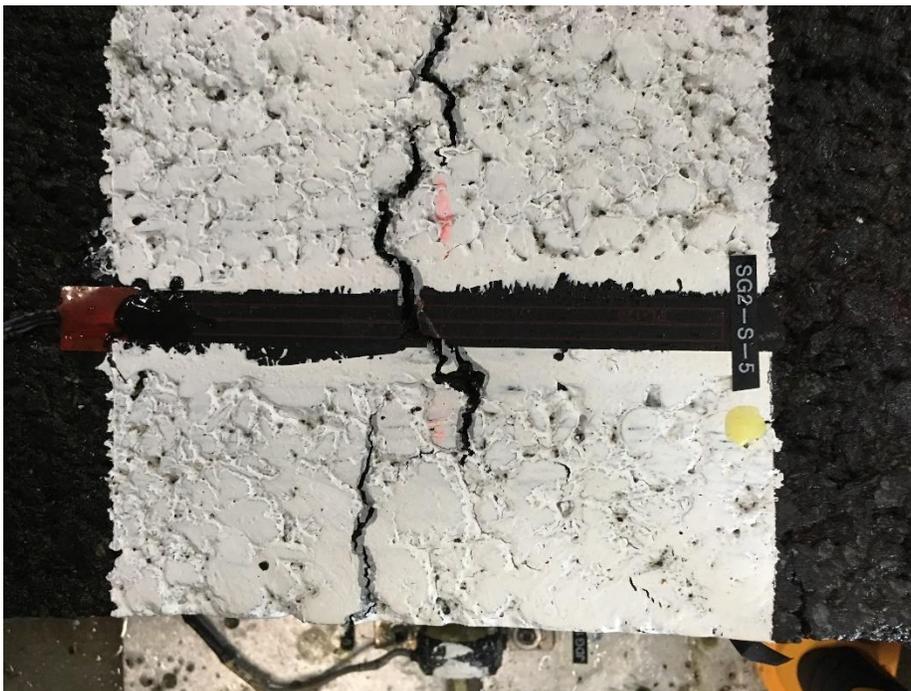
Fig 7 South section surface crack reached the inner vertical edge
