## DO15 RC Indoor Phase VI Test Daily Notes

*Date: July 16, 2019*

*Cycle count: 4015*

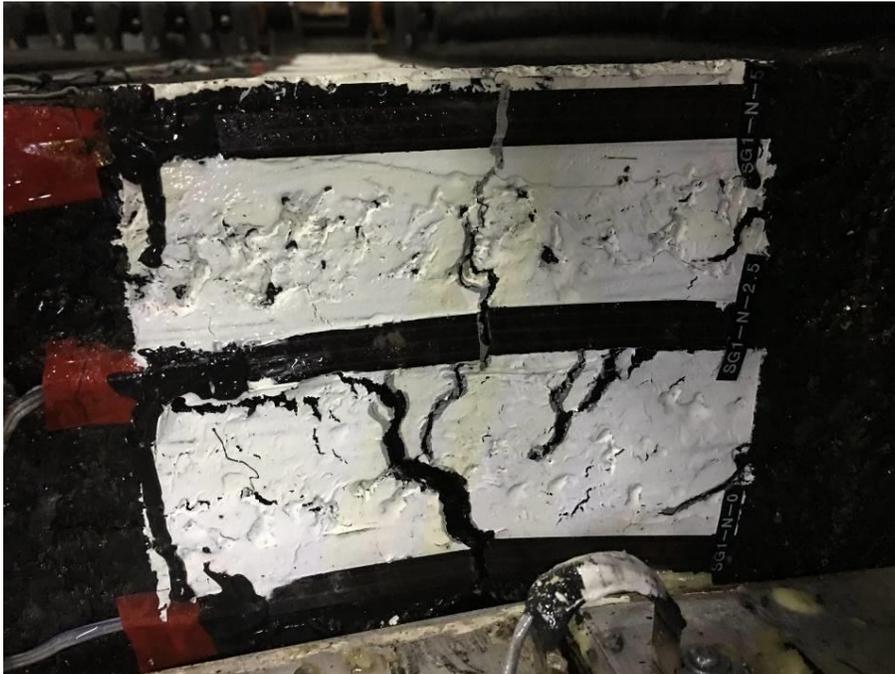
Fig 1 Bottom-up crack at north section inner vertical edge reached top surface

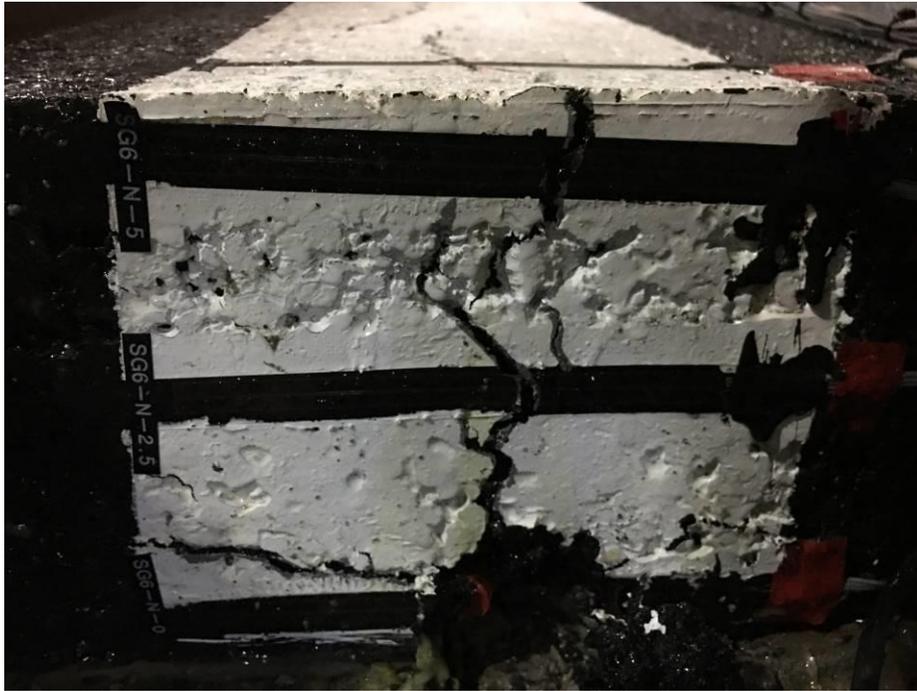
Fig 2 Bottom-up crack at north section outer edge reached top surface

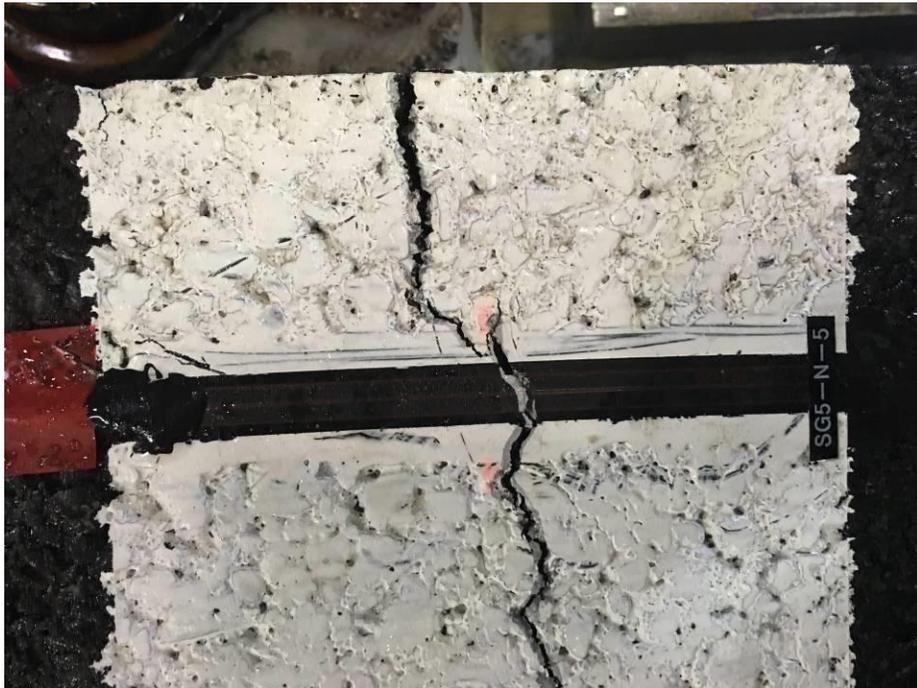
Fig 3 Surface crack on North Section reached outer edge

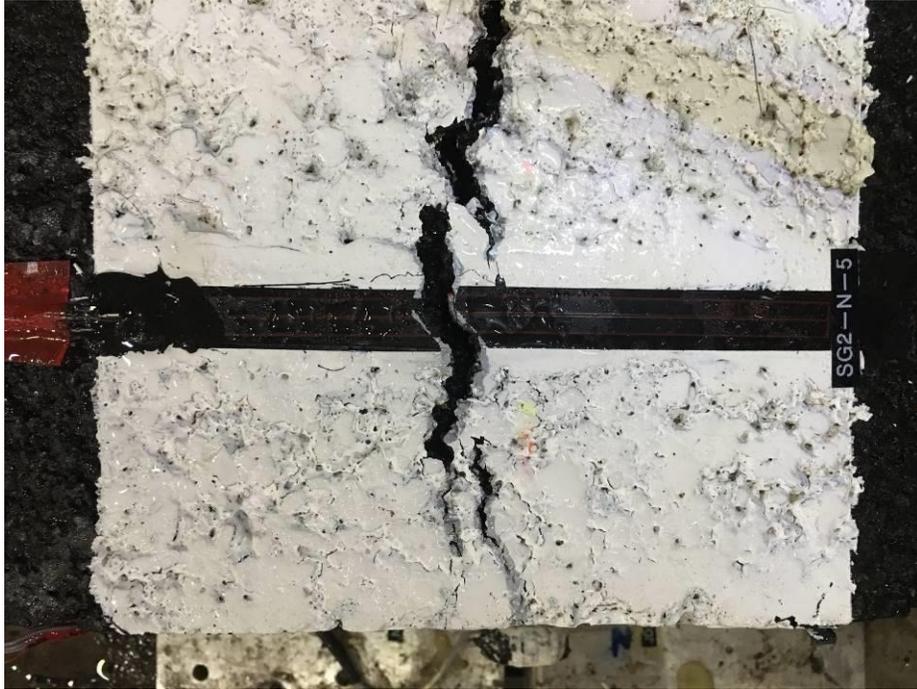
Fig 4 North section surface crack reached inner vertical edge

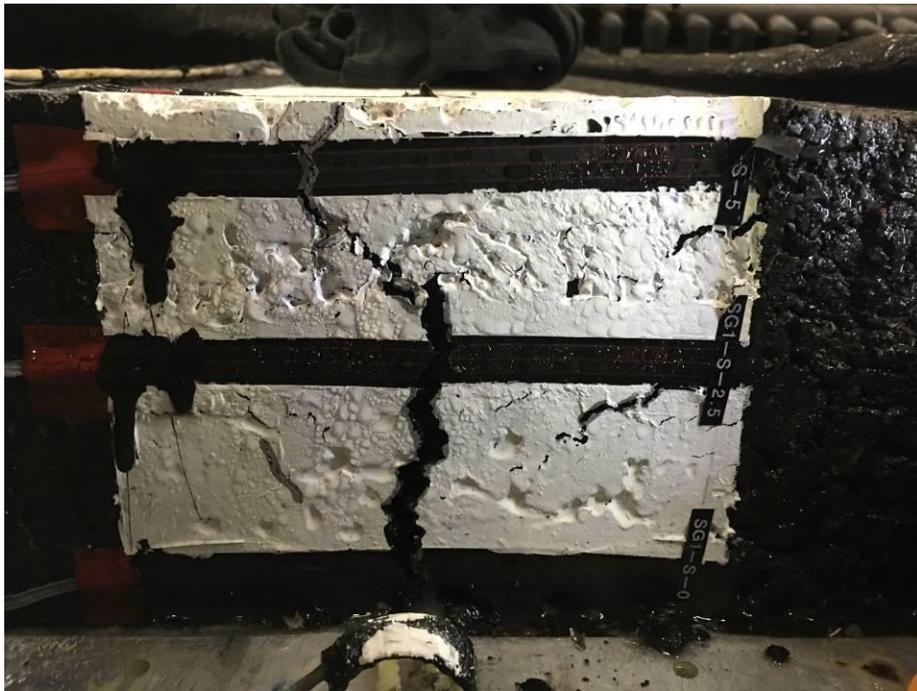
Fig 5 Bottom-up crack at inner vertical edge of south section reached top surface

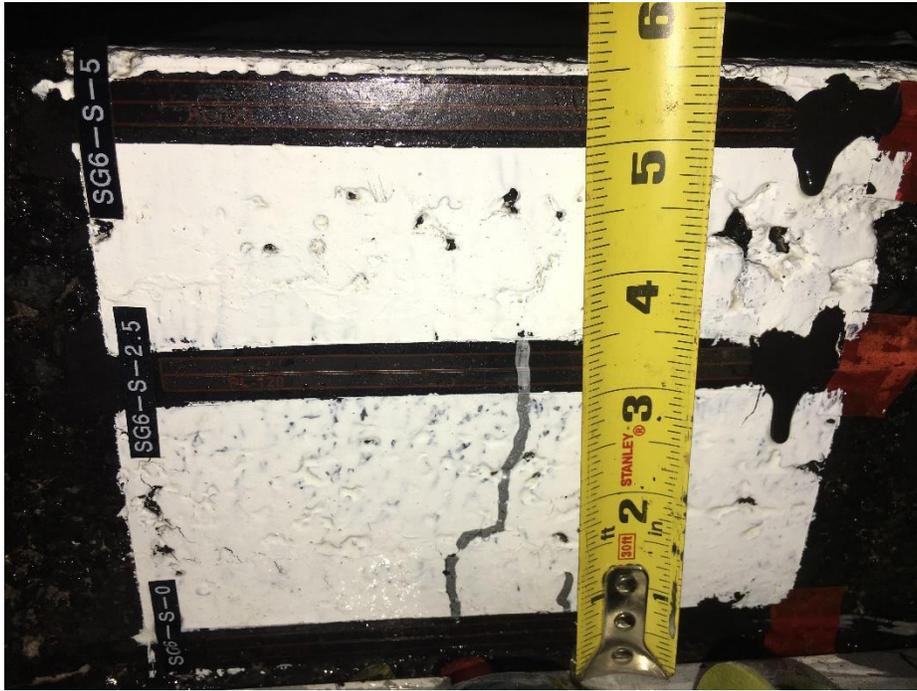
- No change from last observation.
- Bottom up crack at inner vertical edge (Fig5). Bottom up crack at outer vertical edge propagate approximately 0.5 inch resulting SG6-S-2.5 read open (Fig 6).
- Surface crack reached the inner vertical edge (Fig 7), approximately 3 inches from the outer vertical edge, no change (Fig 8)

Fig 6 Bottom-up crack at SG6-S-0, SG6-S-2.5 approximately 3.5 inch long

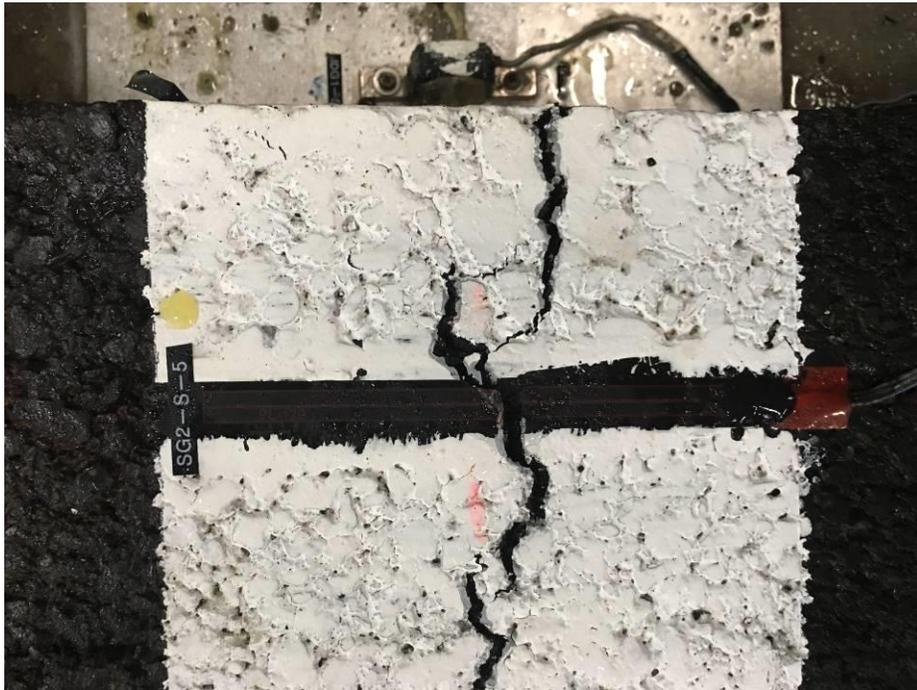
Fig 7 South section surface crack reached the inner vertical edge

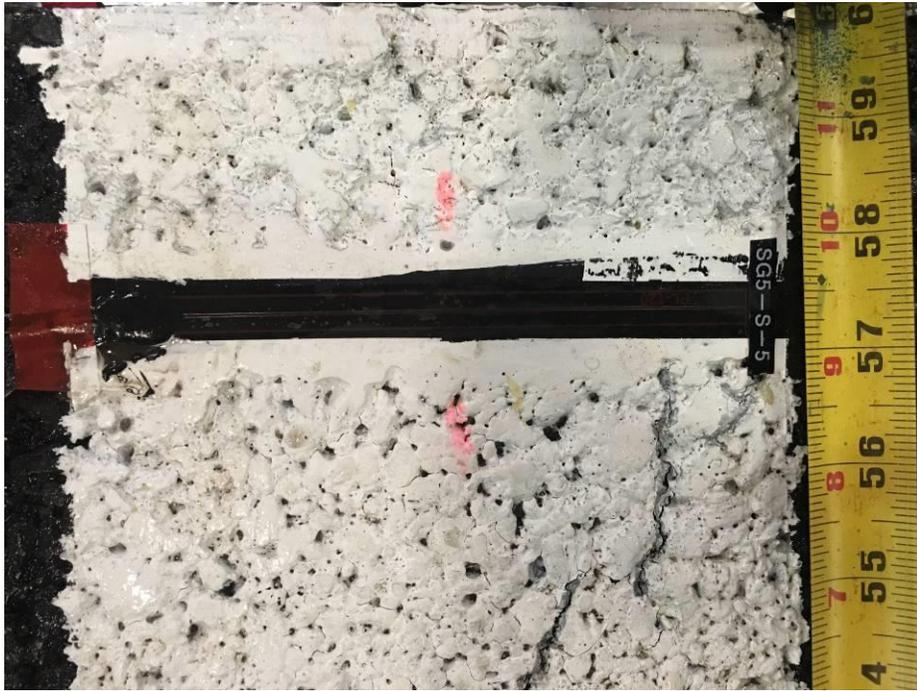
Fig 8 South section surface crack 3 inches from the outer vertical edge

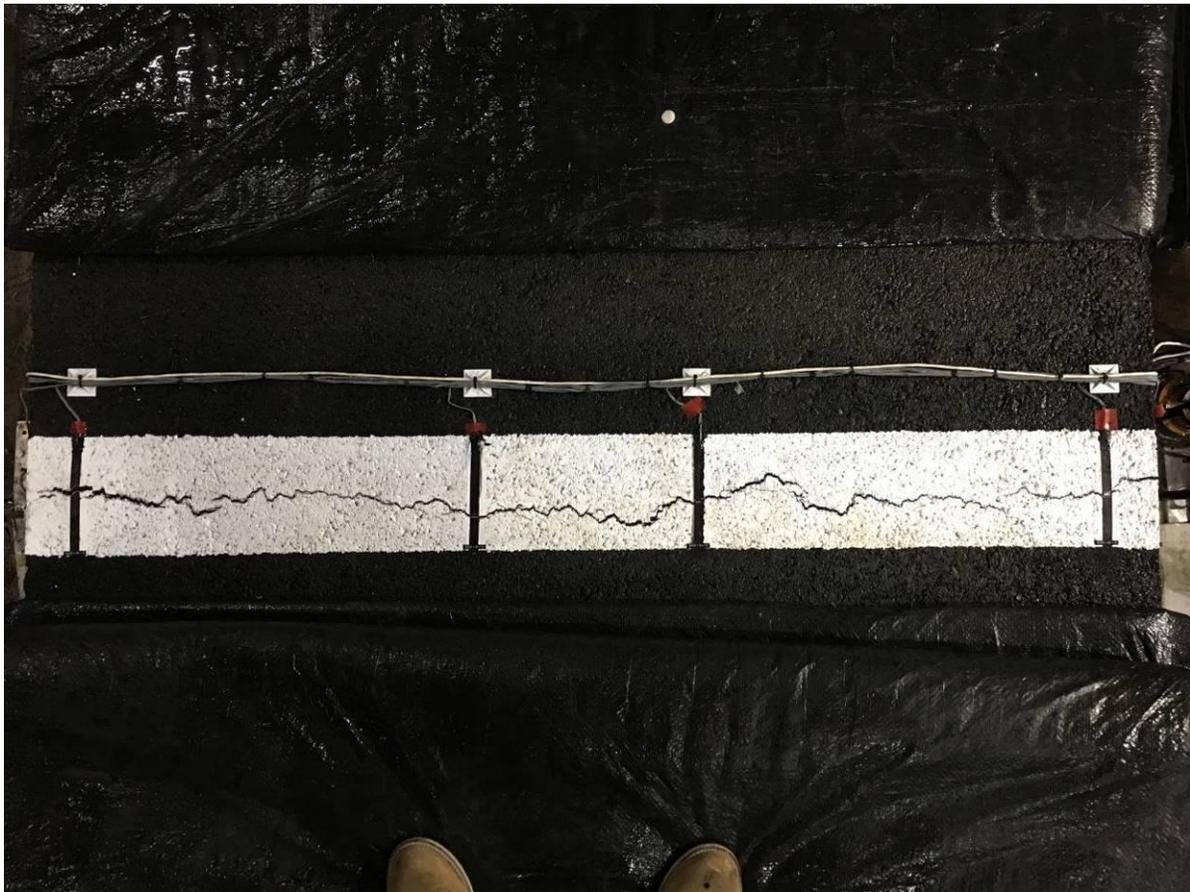
Fig 9 Surface crack on the north section

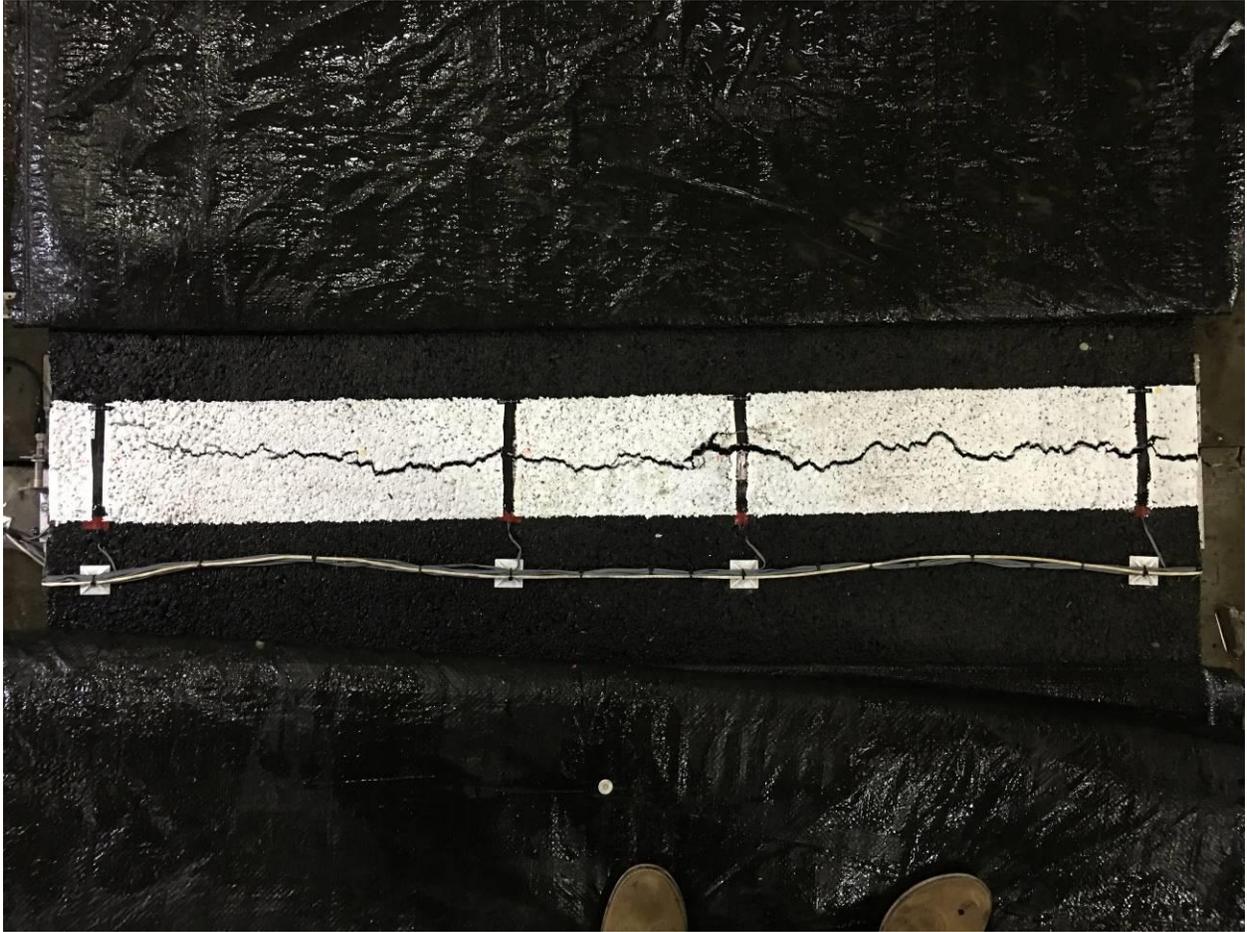
Fig 10 Surface crack on the south section
