DO15 RC Indoor Phase VI Test Daily Notes

Date: July 03, 2019

Cycle count: 2790

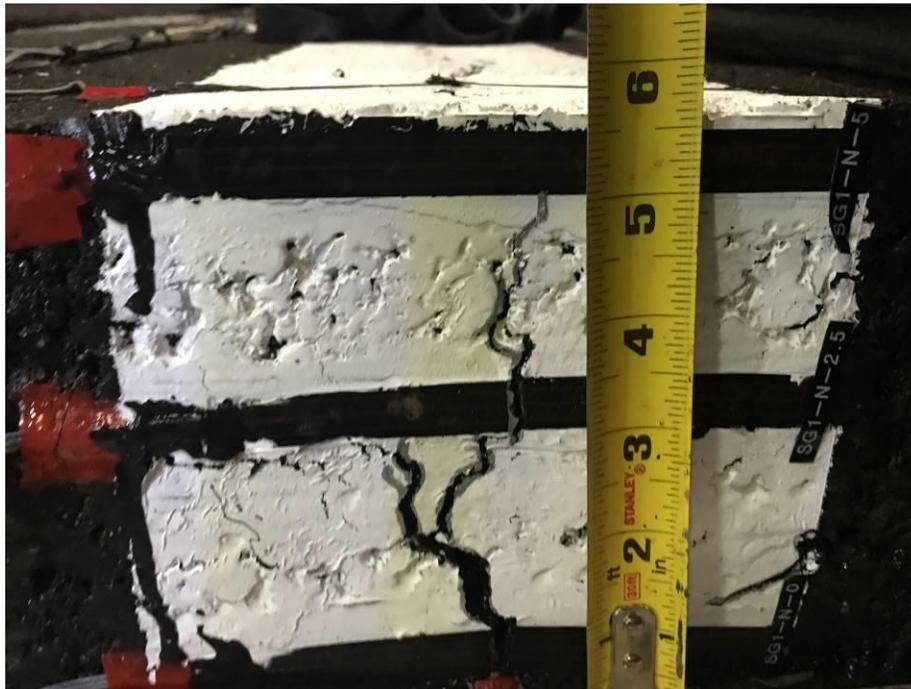
- 1 crack through SG1-N-0 and SG1-N-2.5 approximately 5 inches (Fig 1).
- 1 crack through SG6-N-0, SG6-N-2.5 and SG6-N-5 all the way to the top surface (Fig 2).
- Surface crack connected to the bottom-up crack of the outer edge (Fig 3), 0.5 inch from the inner vertical edge, no change (Fig 4).

Fig 1 Bottom-up crack at north section inner vertical edge 5 inch long

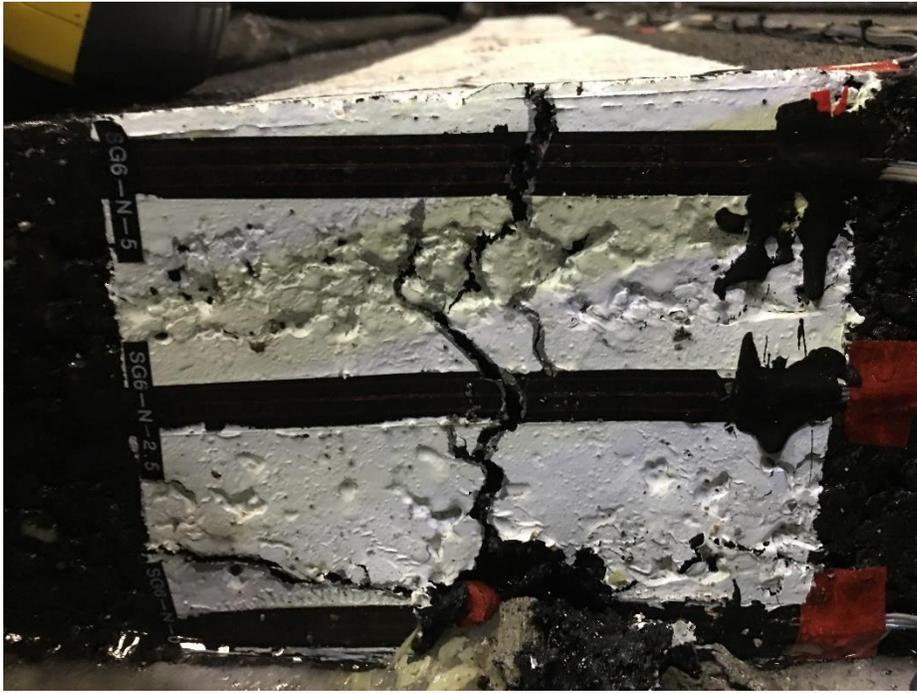
Fig 2 Bottom-up crack north outer edge reached top surface

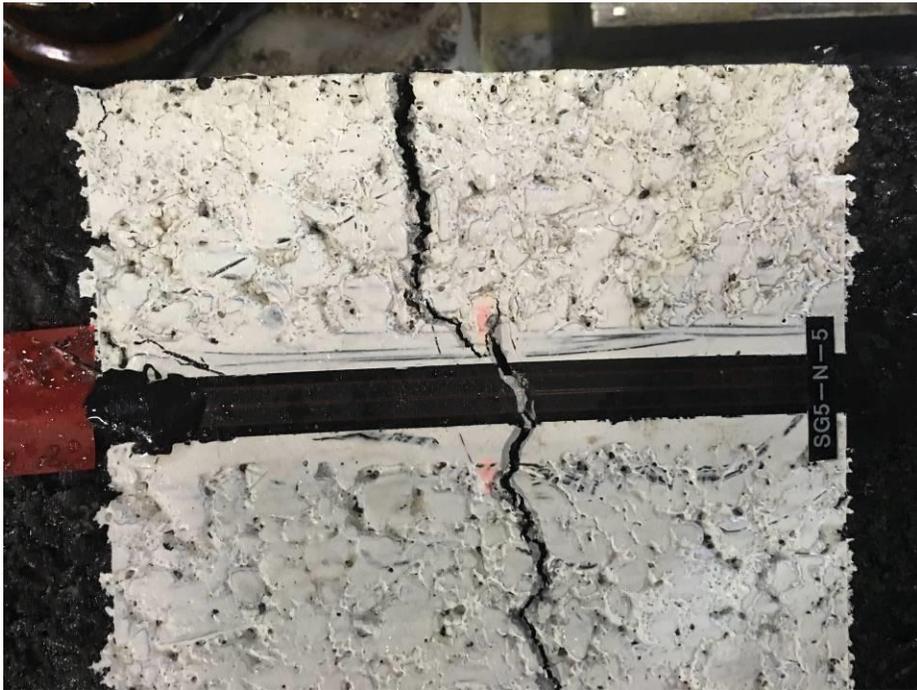
Fig 3 Surface crack on North Section reached outer edge

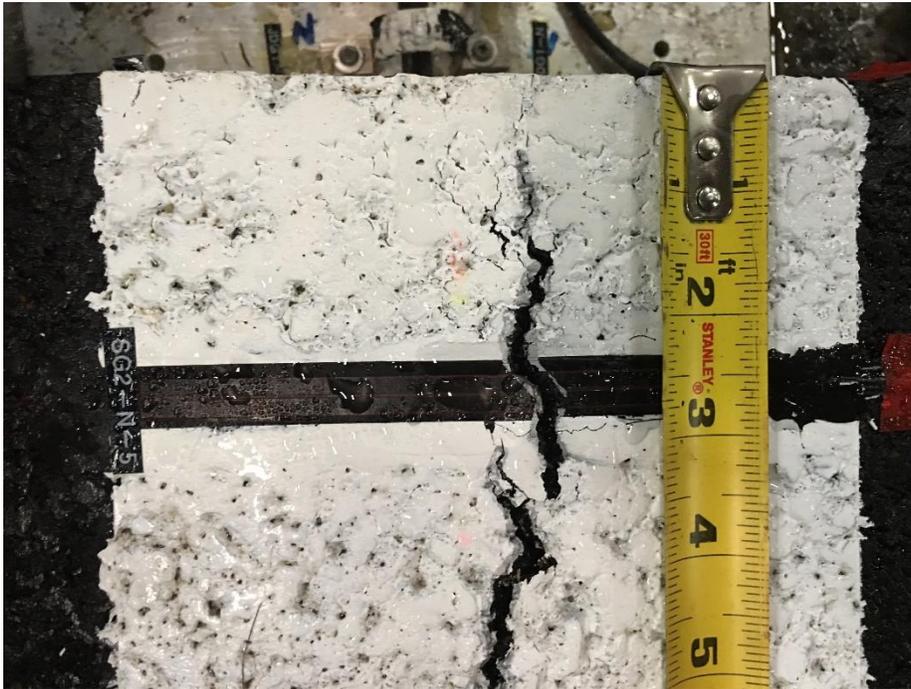
Fig 4 North section surface crack 0.5 inch from the inner vertical edge

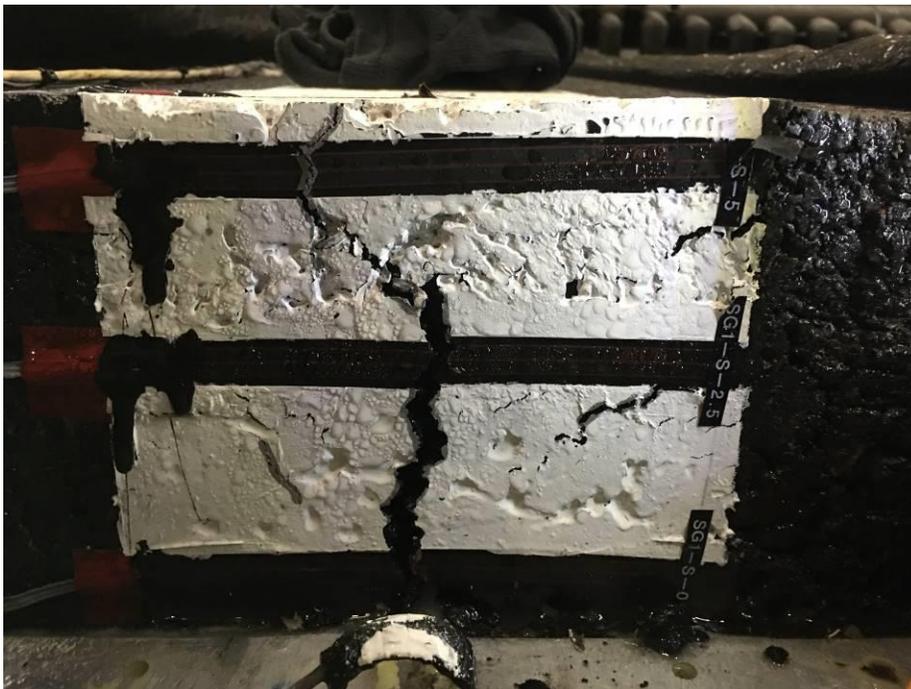
- Bottom up crack through SG1-S-0 reached top surface, connected with the surface crack
- 1 crack through SG6-S-0, approximately 3 inches, no change (Fig 6).
- Surface crack reached the inner vertical edge (Fig 7), approximately 3 inches from the outer vertical edge (Fig 8)

Fig 5 Bottom-up crack at inner vertical edge of south section reached top surface

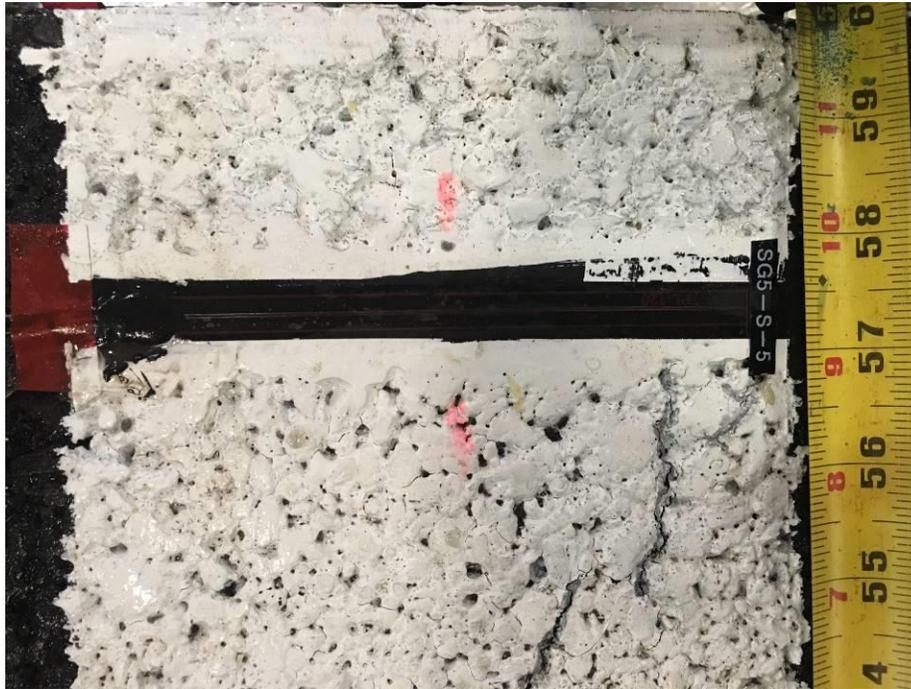
Fig 8 South section surface crack 3 inches from the outer vertical edge

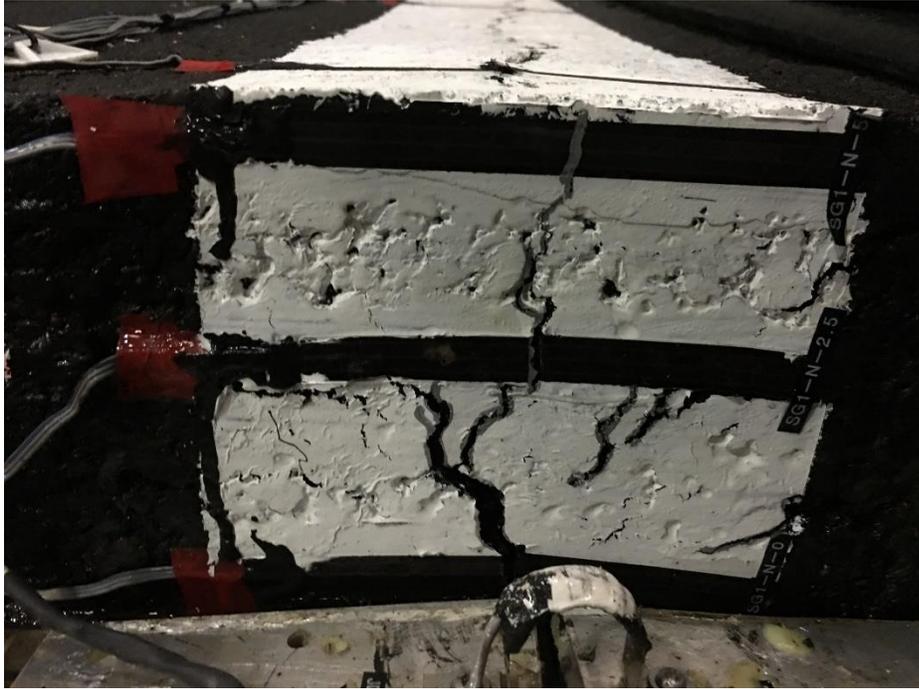
- Bottom up crack on the inner vertical edge of North Section reached the top surface. (Fig 9)

Fig 9 Bottom up crack on the inner vertical edge of North Section reached the top surface
