DO15 RC Indoor Phase VI Test Daily Notes

Date: July 17, 2019

Cycle count: 4130

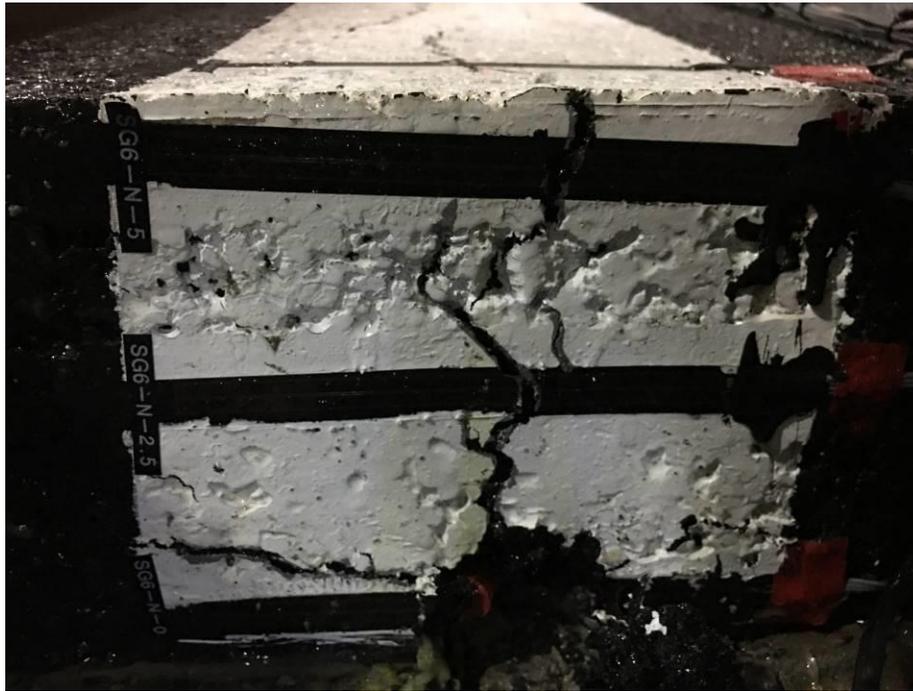
Fig 2 Bottom-up crack at north section outer edge reached top surface
