DO15 RC Indoor Phase VI Test Daily Notes

Date: July 02, 2019

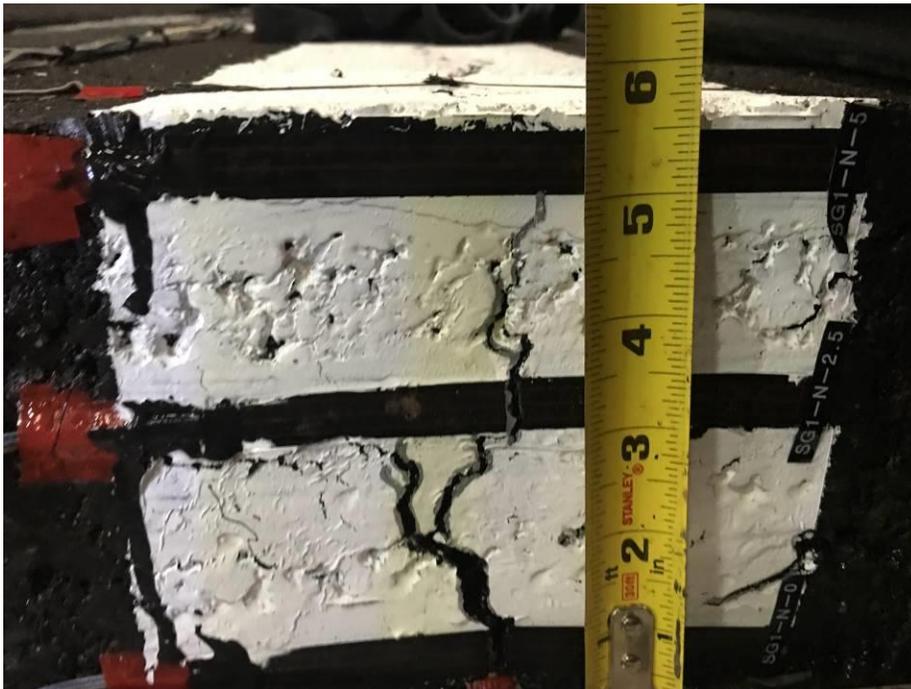
- 1 crack through SG1-N-0 and SG1-N-2.5 approximately 5 inches (Fig 1).
- 1 crack through SG6-N-0, SG6-N-2.5 and SG6-N-5 all the way to the top surface (Fig 2).
- Surface crack connected to the bottom-up crack of the outer edge (Fig 3), 0.5 inch from the inner vertical edge, no change (Fig 4).

Fig 1 Bottom-up crack at north section inner vertical edge 5 inch long
