## DO15 RC Indoor Phase VI Test Daily Notes

*Date: July 29, 2019*

*Cycle count: 5560*

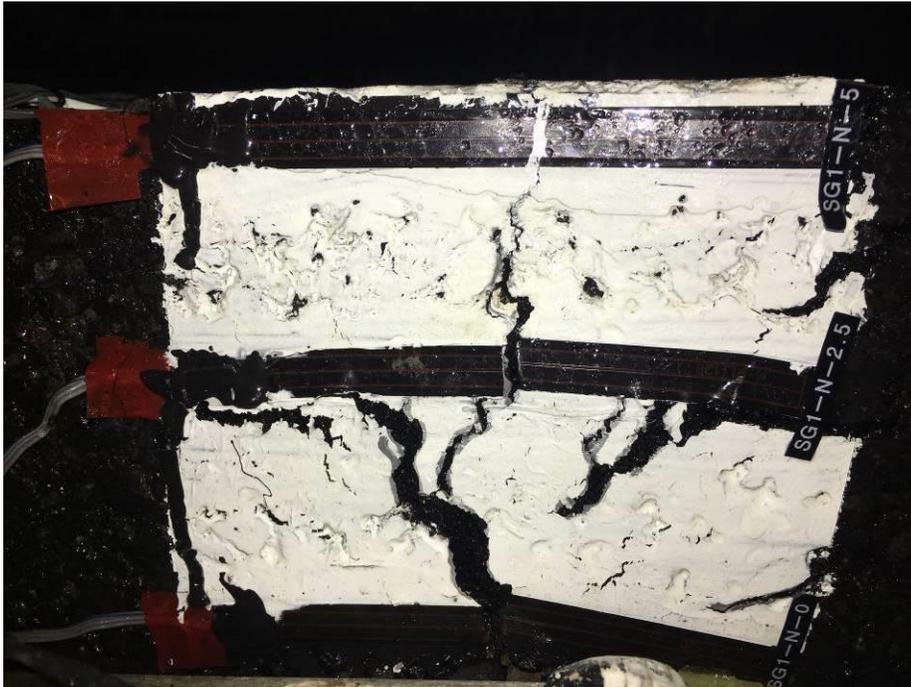
Fig 1 Bottom-up crack at north section inner vertical edge reached top surface

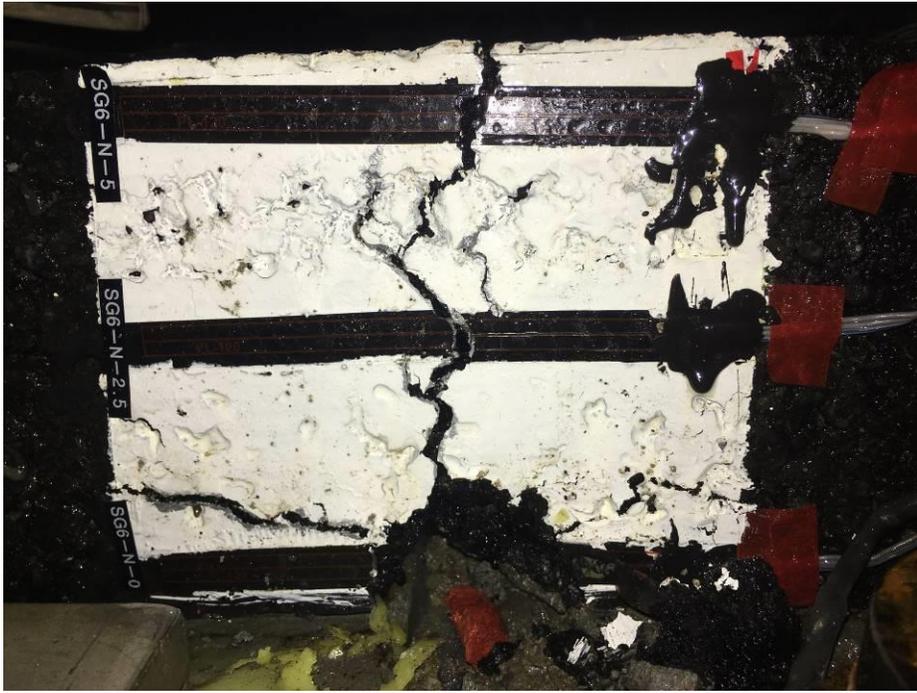
Fig 2 Bottom-up crack at north section outer edge reached top surface

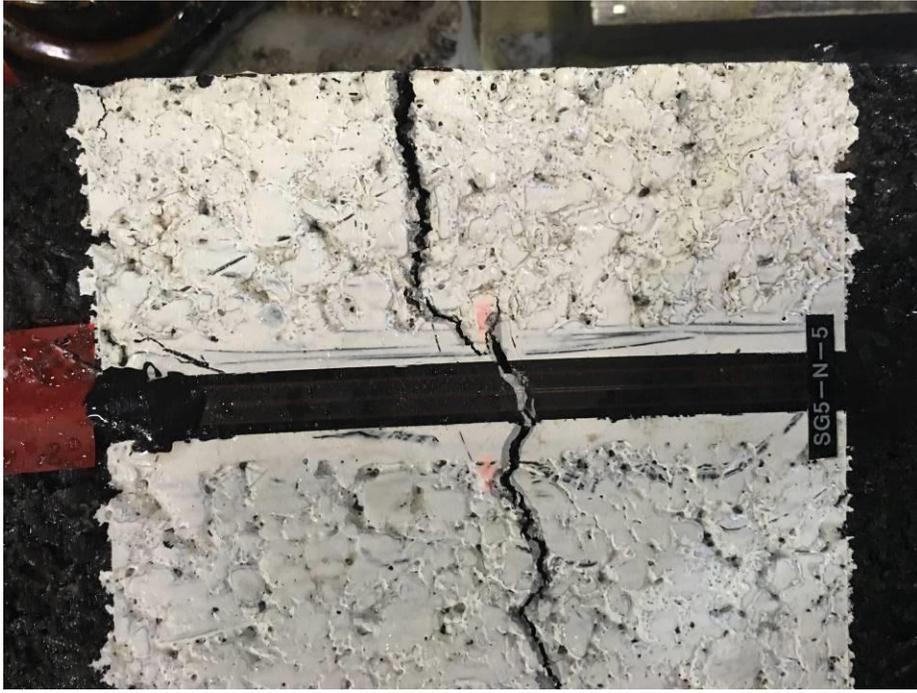
Fig 3 Surface crack on North Section reached outer edge

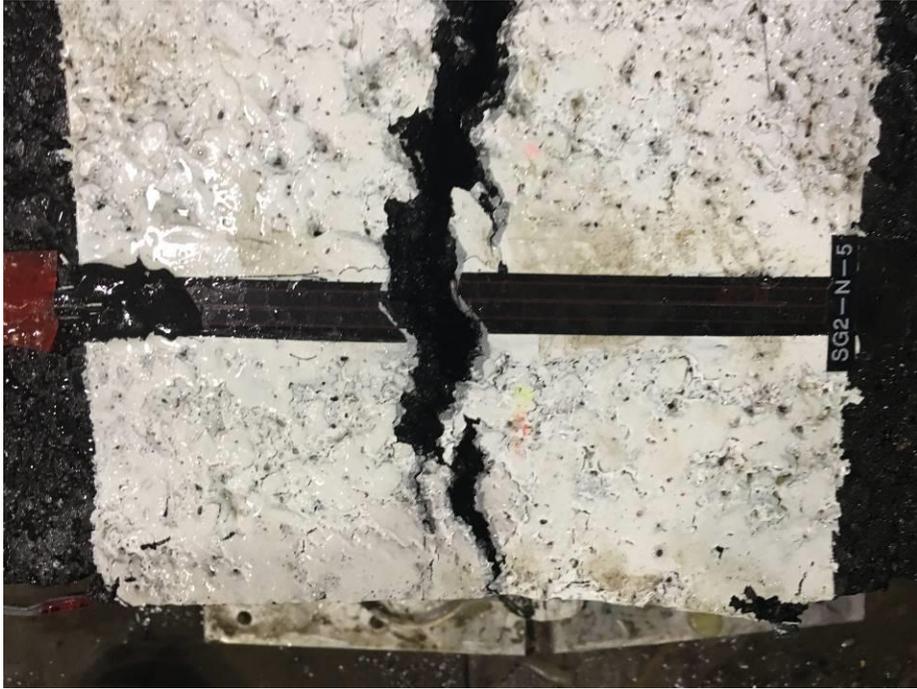
Fig 4 North section surface crack reached inner vertical edge

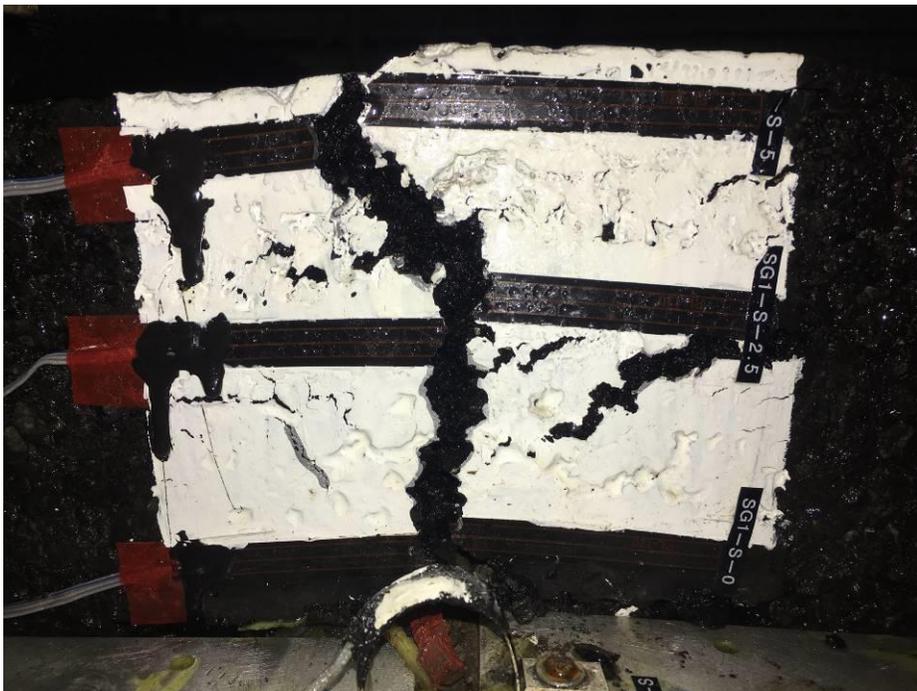
Fig 5 Bottom-up crack at inner vertical edge of south section reached top surface

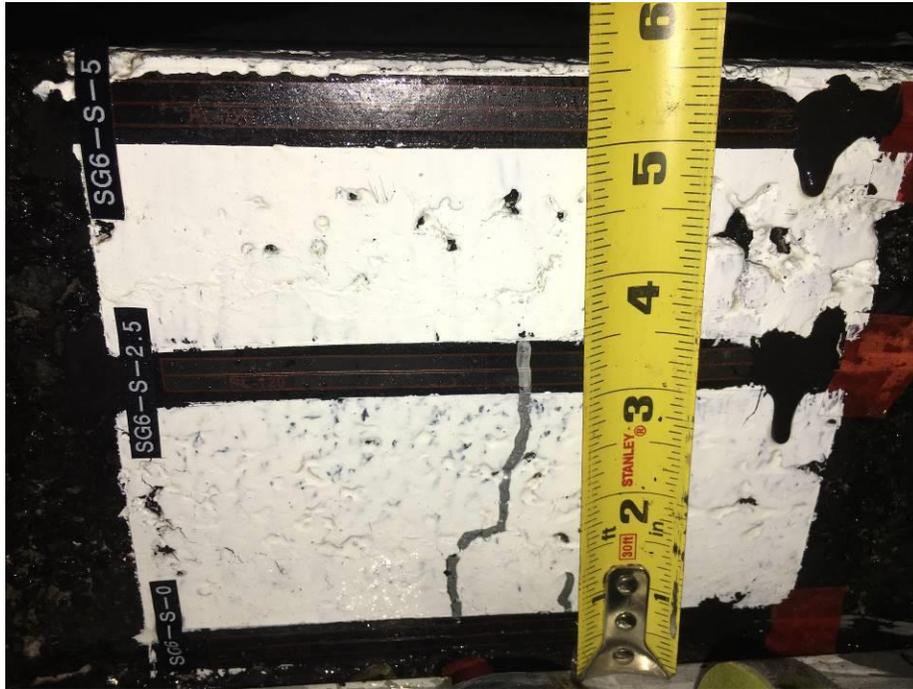
Fig 6 Bottom-up crack at SG6-S-0, SG6-S-2.5 approximately 3.5 inch long

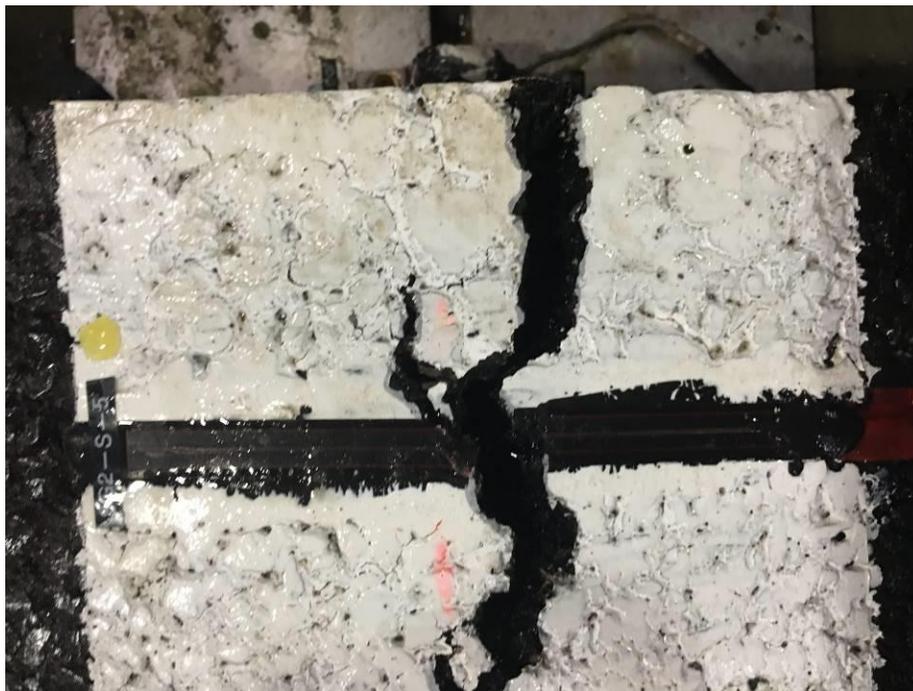
Fig 7 South section surface crack reached the inner vertical edge

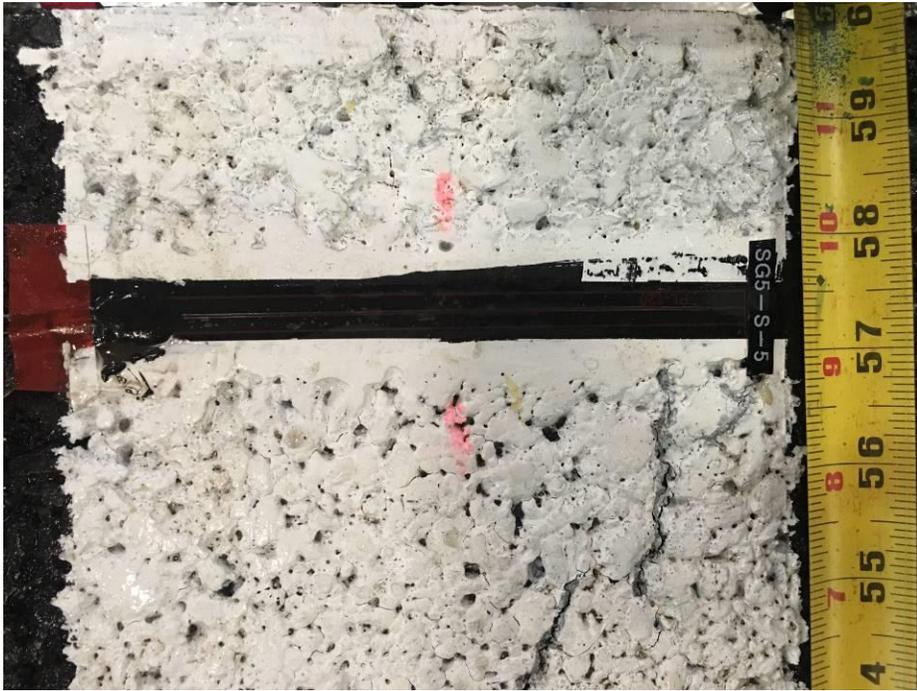
Fig 8 South section surface crack 3 inches from the outer vertical edge
