DO15 RC Indoor Phase VI Test Daily Notes

Date: June 24, 2019

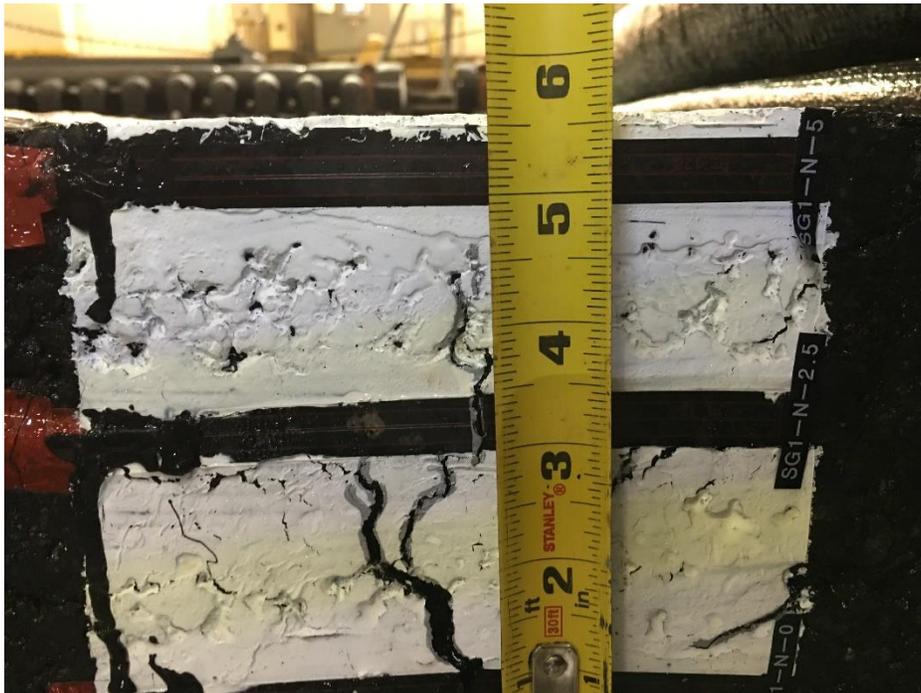
- 1 crack through SG1-N-0 and SG1-N-2.5 approximately 4.5 inches, no change (Fig 1).
- 1 crack through SG6-N-0, SG6-N-2.5 and SG6-N-5 all the way to the top surface (Fig 2).
- Surface crack connected to the bottom-up crack of the outer edge (Fig 3), 1.5 inch from the inner vertical edge, no change (Fig 4).

Fig 1 Bottom-up crack at SG1-N-0 and SG1-N-2.5 4.5 inch long

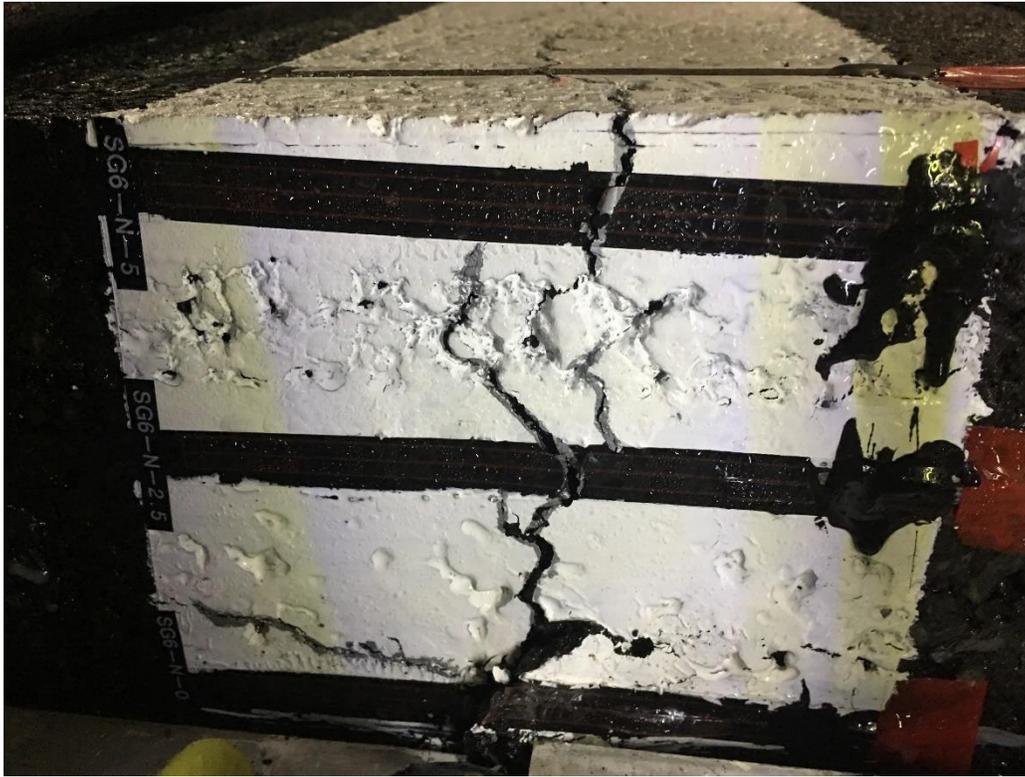
Fig 2 Bottom-up crack north outer edge reached top surface

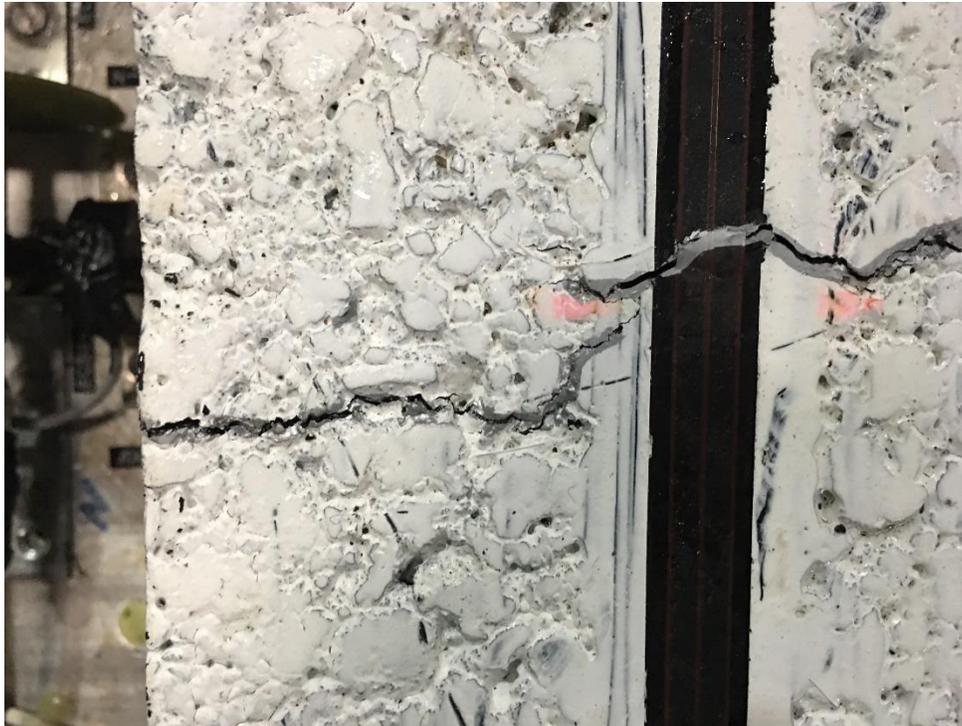
Fig 3 Surface crack on North Section reached outer edge

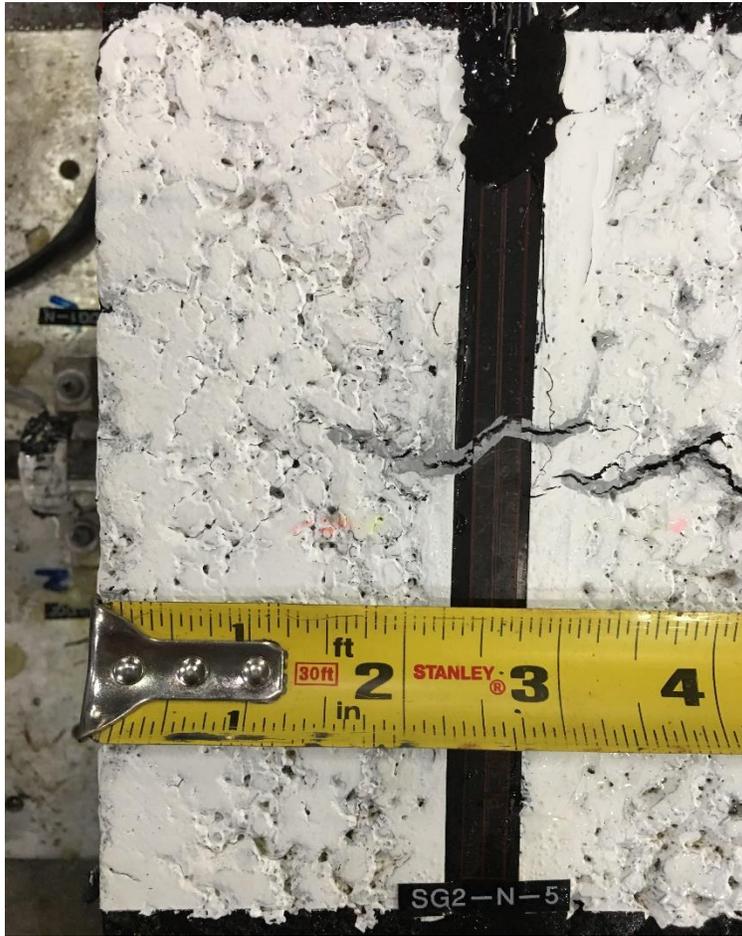
Fig 4 North section surface crack 1.5 inch from the inner vertical edge

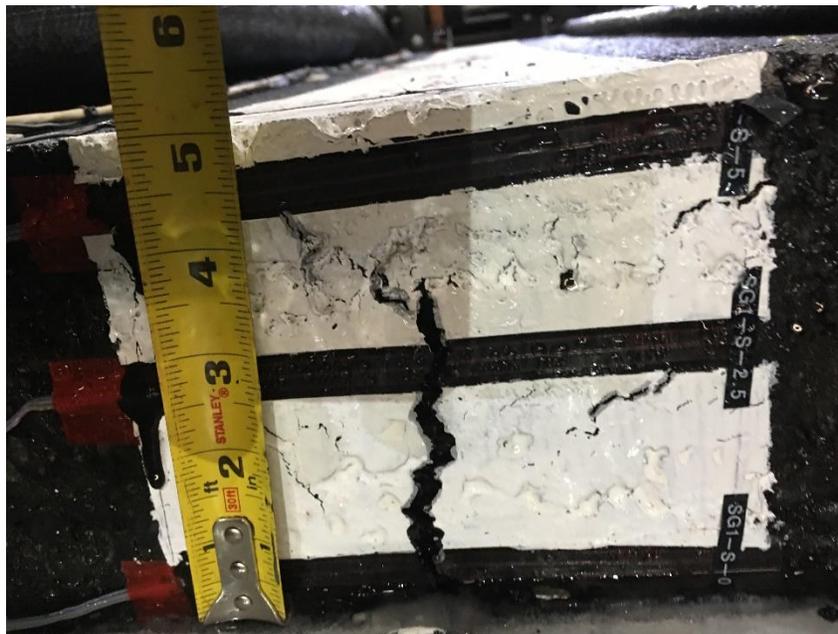
- 1 crack through SG1-S-0, approximately 4.25 inches (Fig 5).
- 1 crack through SG6-S-0, approximately 3 inches, no change (Fig 6).
- Surface crack is 1.0 inch from the inner vertical edge (Fig 7), approximately 3 inches from the outer vertical edge (Fig 8)

Fig 5 Bottom-up crack at SG1-S-0 4.25 inch long

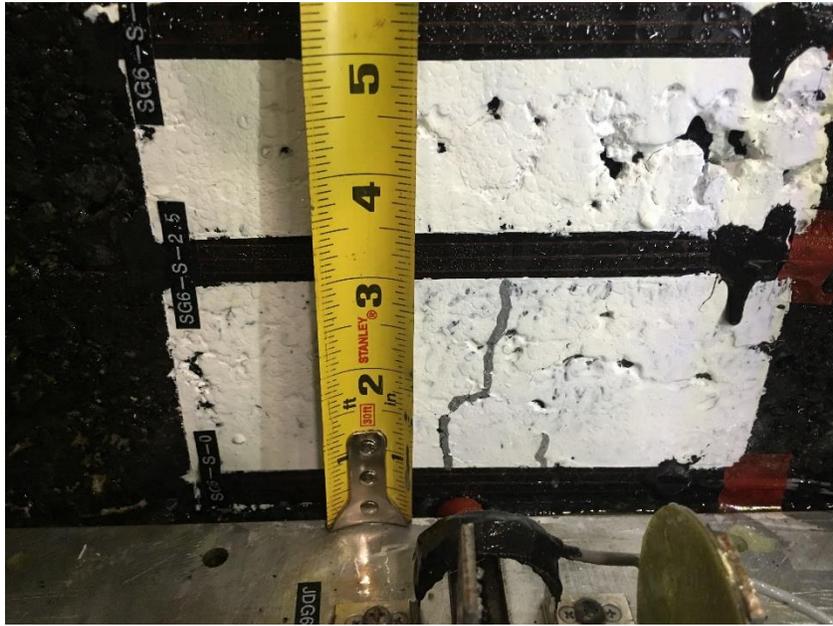
Fig 6 Bottom-up crack at SG6-S-0 3 inch long

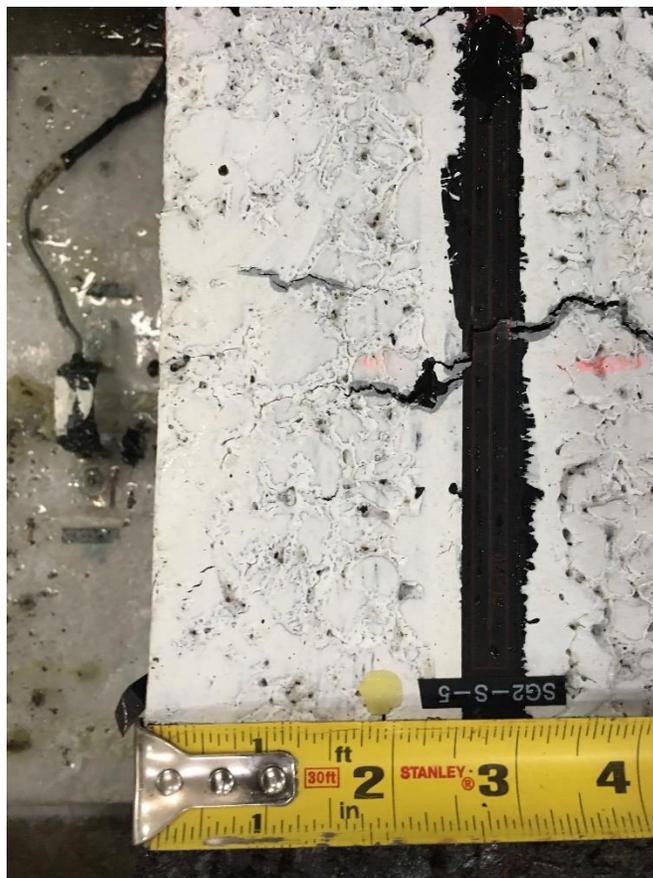
Fig 7 South section surface crack 1 inches from the inner vertical edge

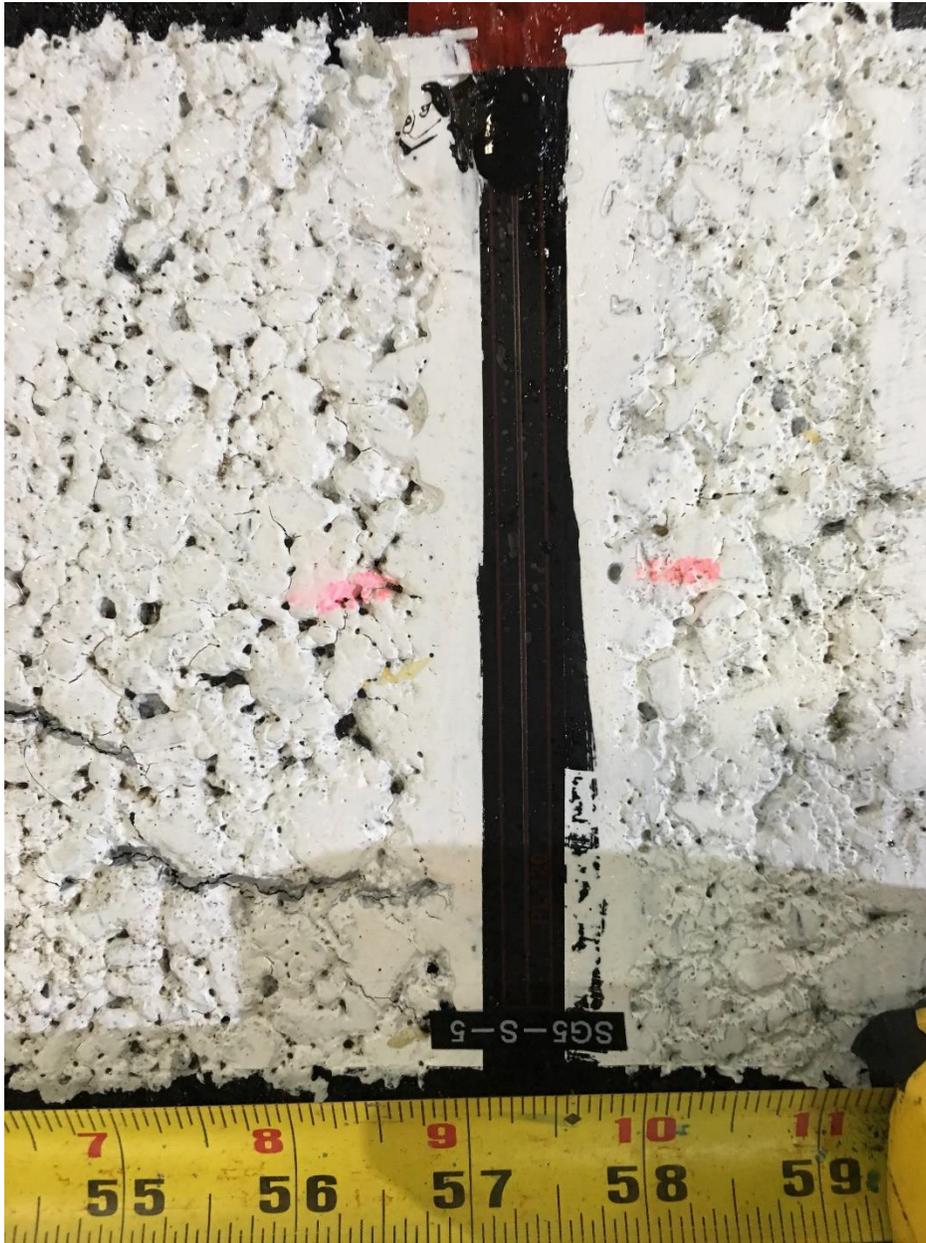
Fig 8 South section surface crack 3 inches from the outer vertical edge
