## DO15 RC Indoor Phase VI Test Daily Notes

*Date: June 14, 2019*

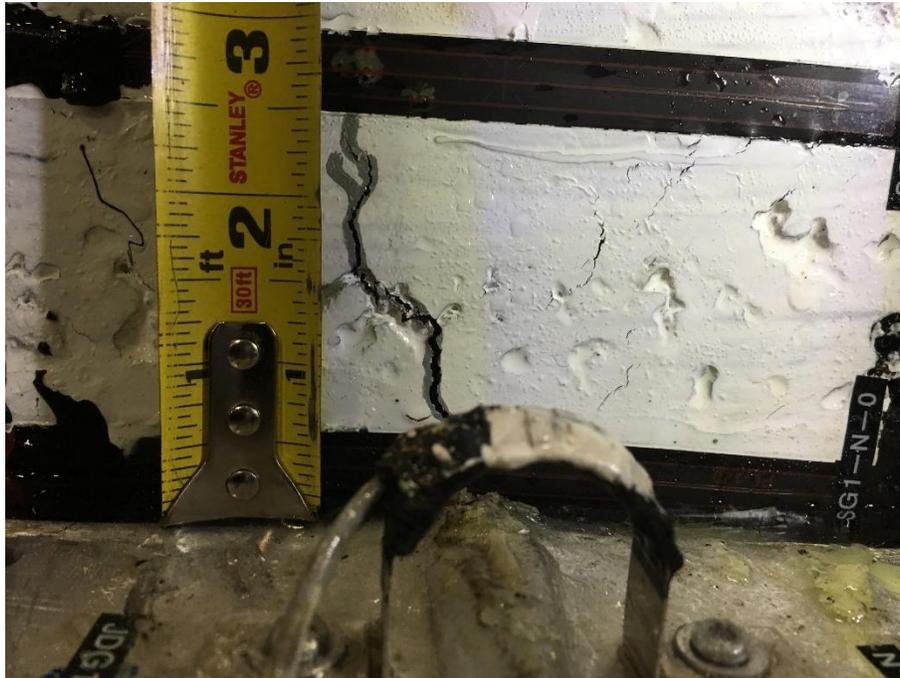
Fig 1 Bottom-up crack at SG1-N-0 2.5 inch long

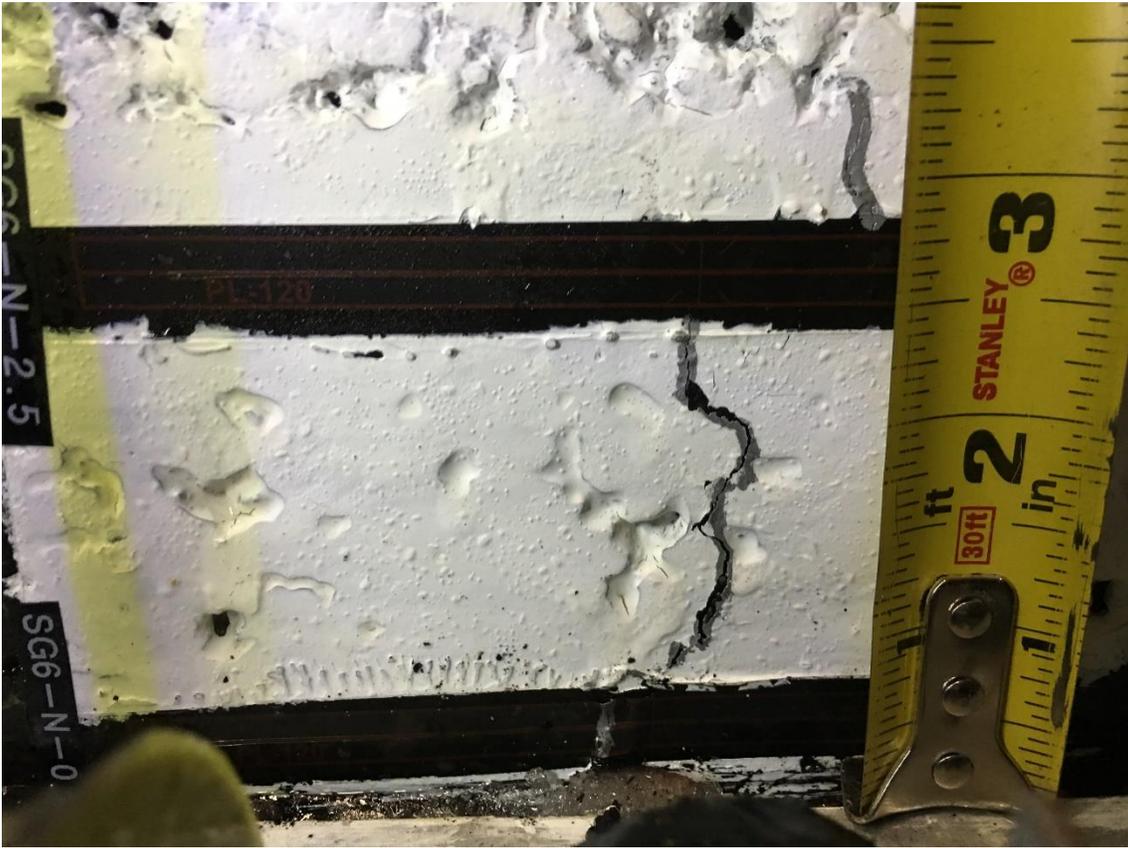
Fig 2 Bottom-up crack at SG6-N-0 3.5 inch long

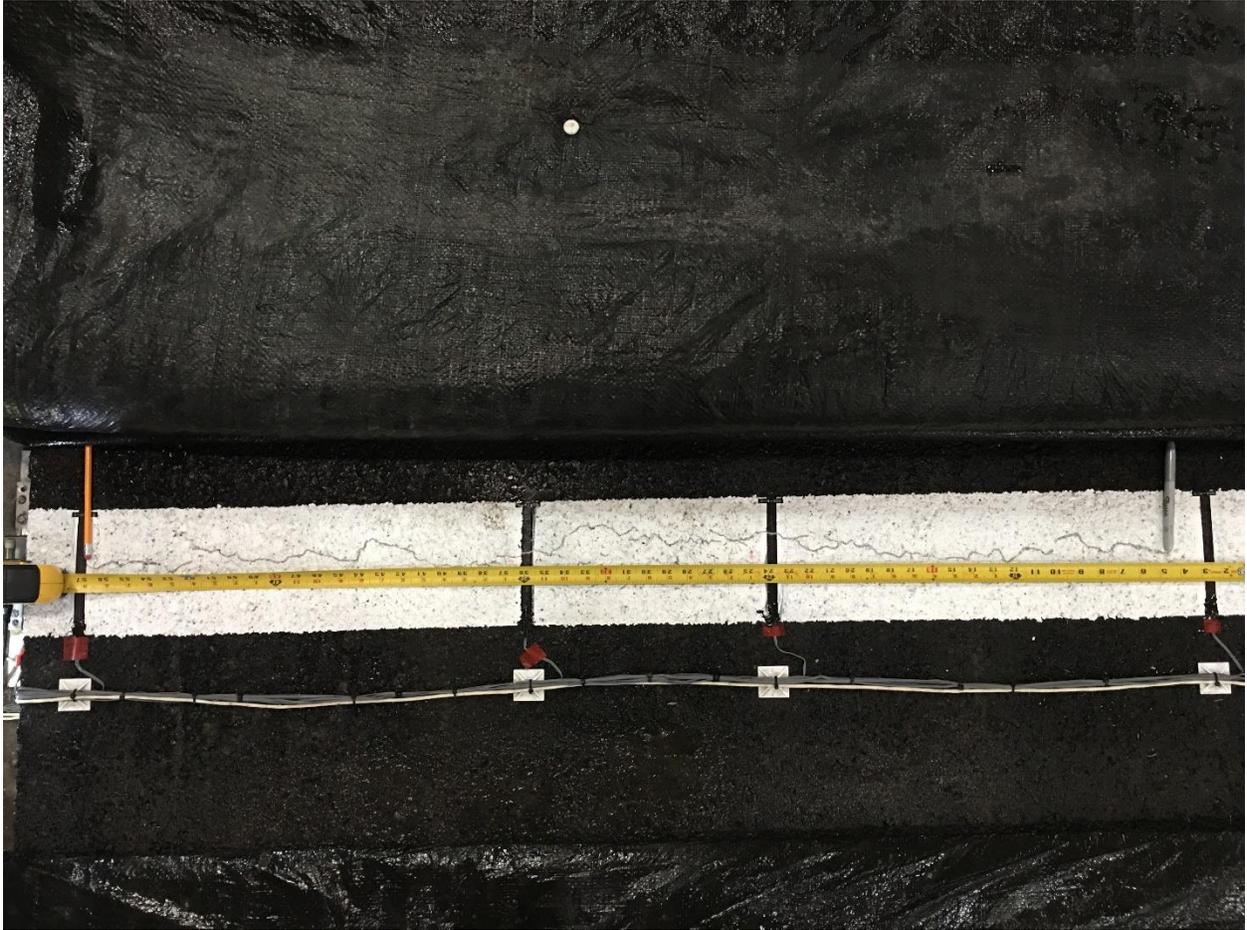
Fig 3 Surface crack on North Section approximately 4.5 to 57 inch

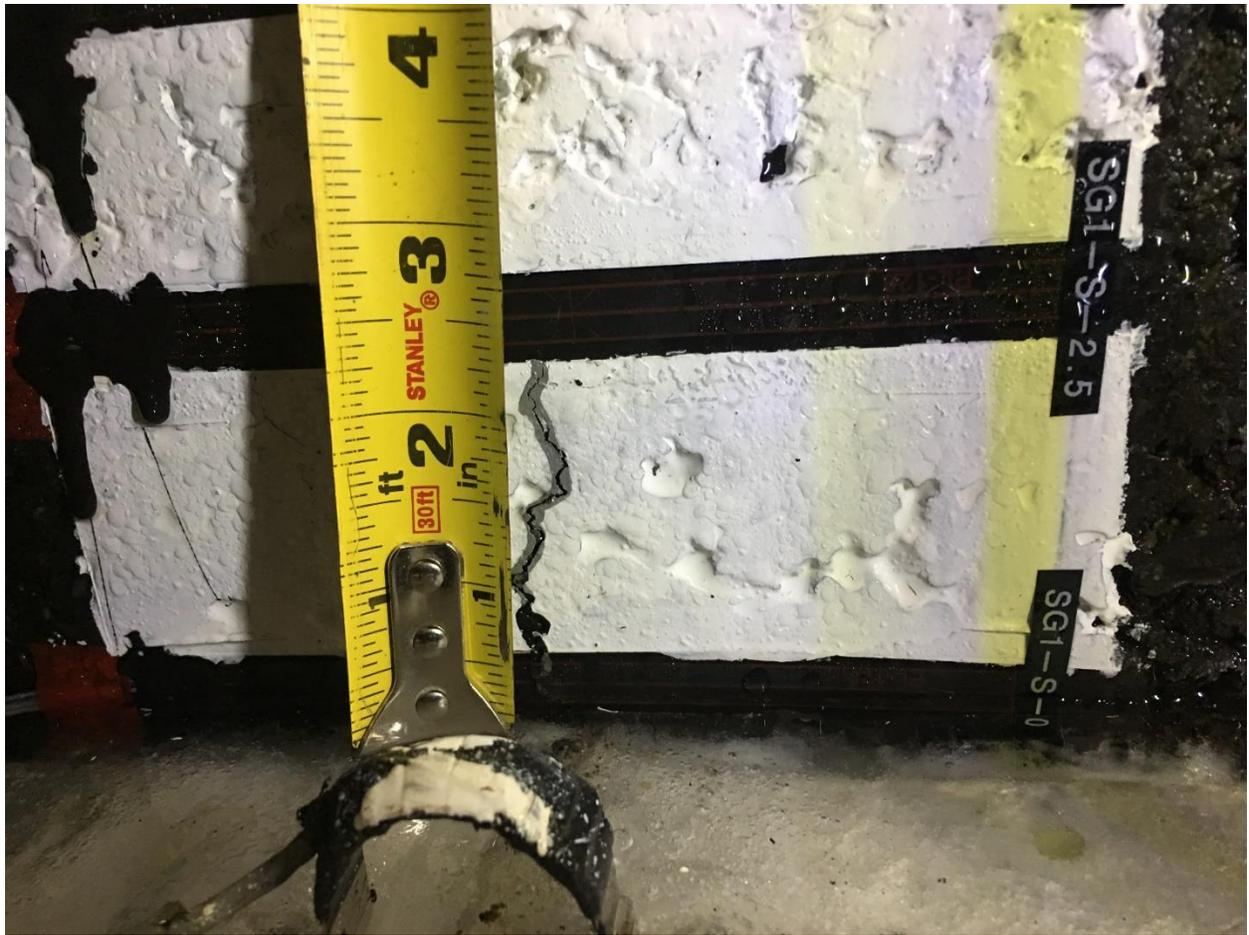
Fig 4 Bottom-up crack at SG1-S-0 2.5 inch long

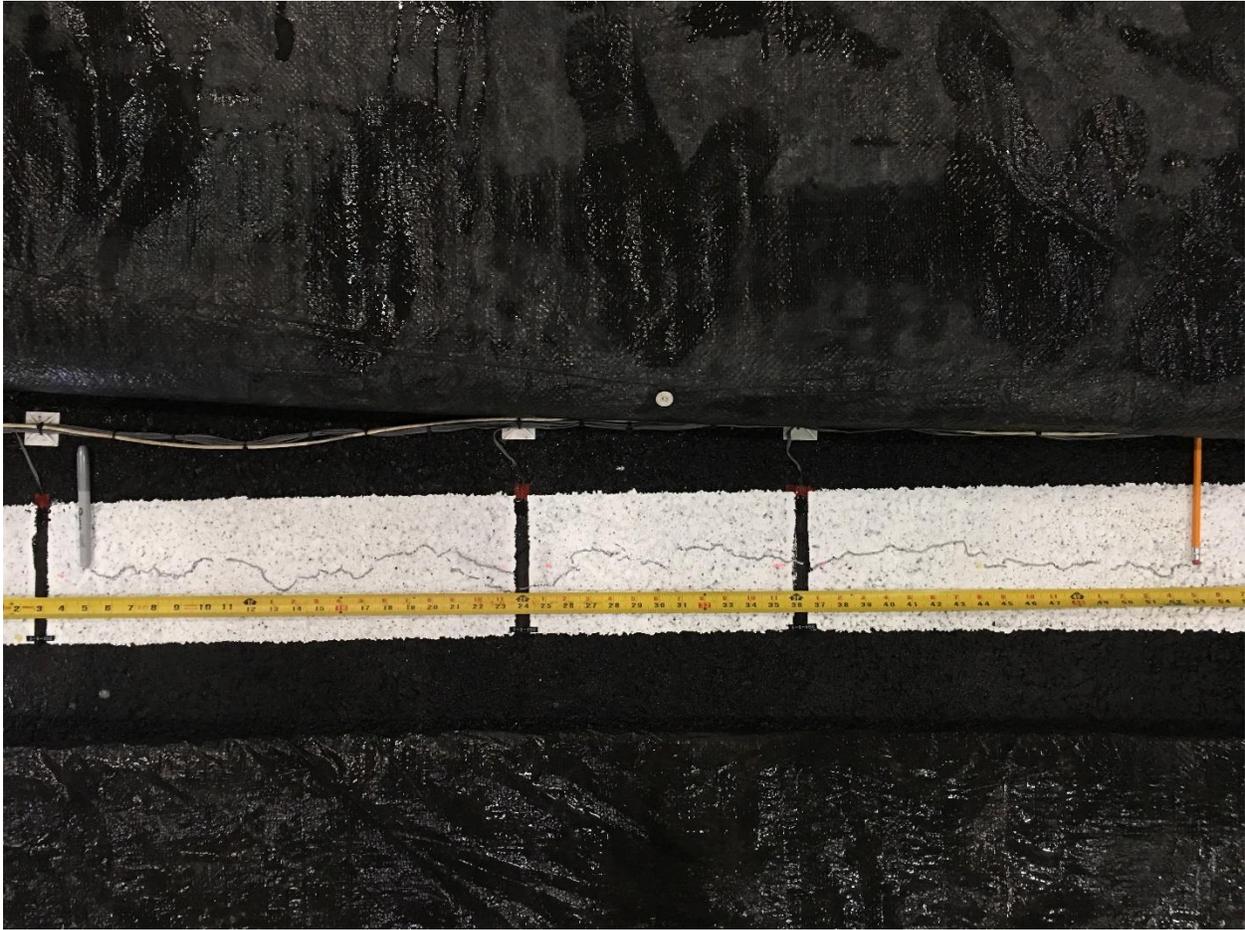
Fig 5 Surface crack on south section between 5'' and 53''

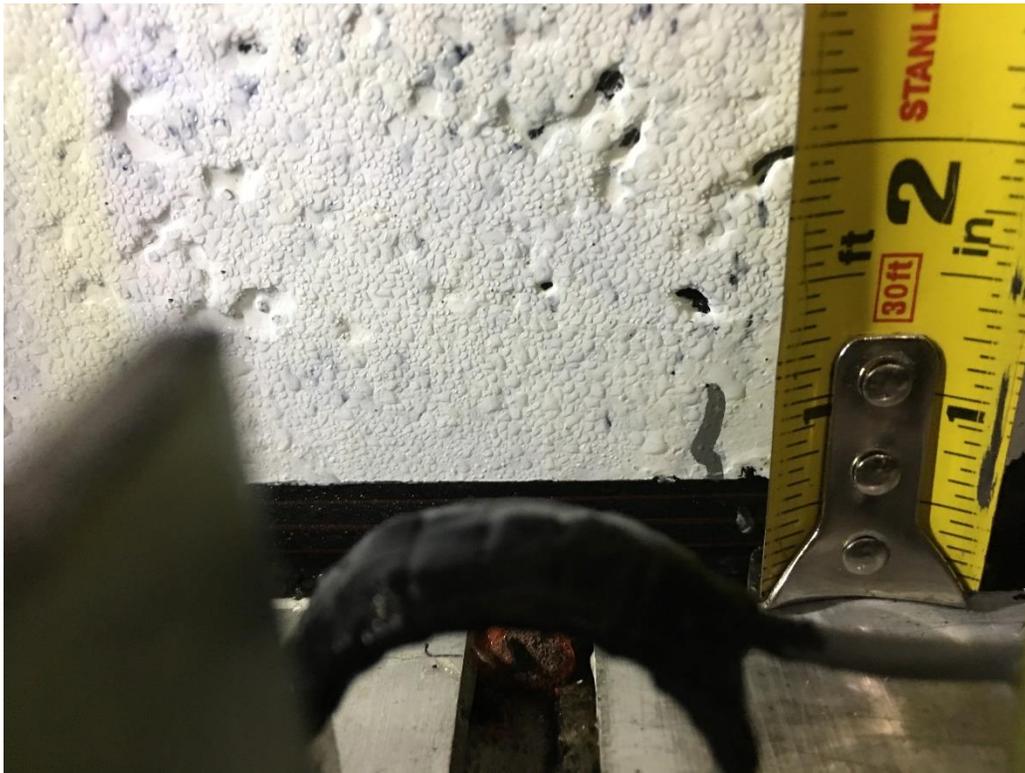
- Crack above surface strain gage SG6-S-0, measured from bottom approximately 1 inch long. (Fig 6)

Fig 6 Bottom-up crack at SG6-S-0 1.0 inch long
