DO15 RC Indoor Phase VI Test Daily Notes

Date: July 10, 2019

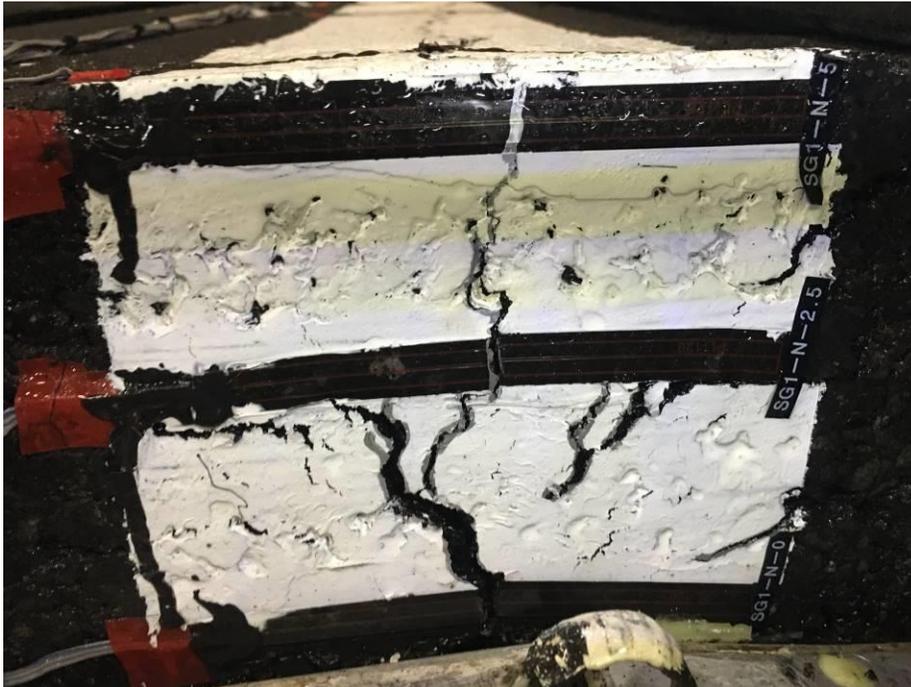
- No change from last observation.
- Bottom up crack at inner vertical edge (Fig 1). Bottom up crack at outer vertical edge (Fig 2).
- Surface crack connected to the bottom-up crack of the outer edge (Fig 3), and the inner vertical edge (Fig 4).

Fig 1 Bottom-up crack at north section inner vertical edge reached top surface

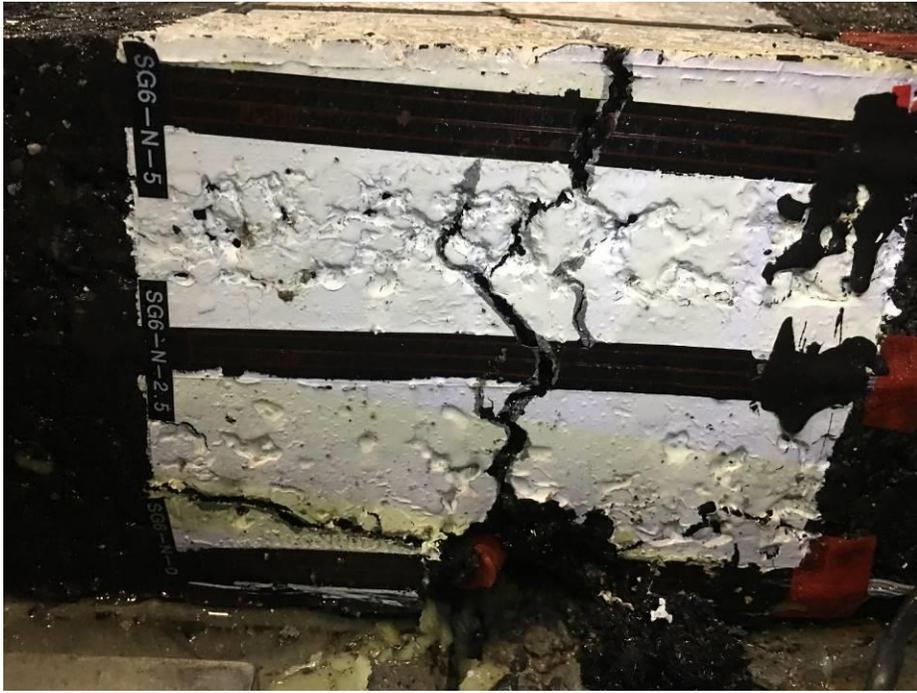
Fig 2 Bottom-up crack at north section outer edge reached top surface

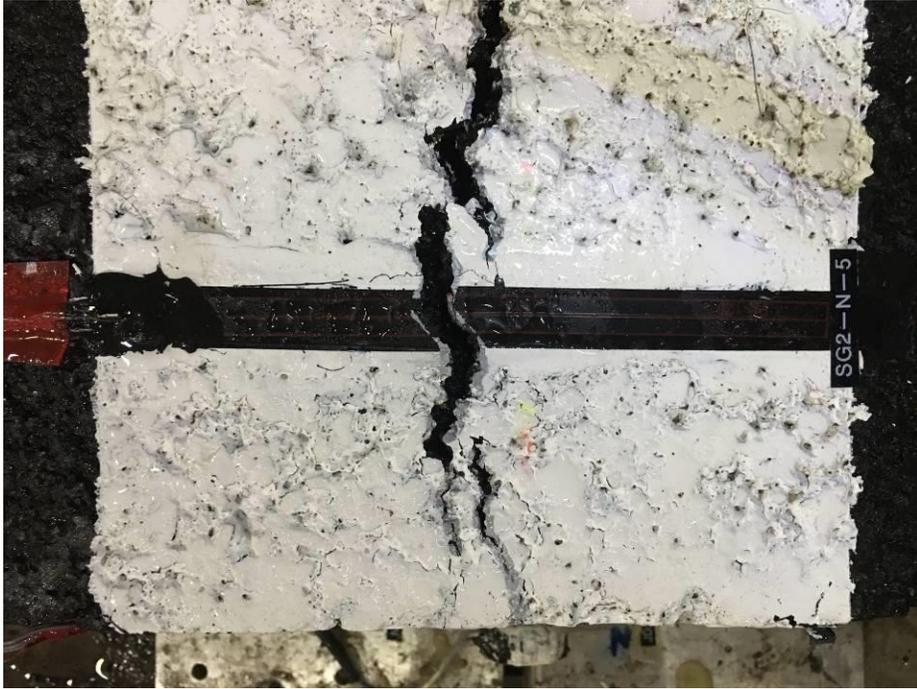
Fig 4 North section surface crack reached inner vertical edge

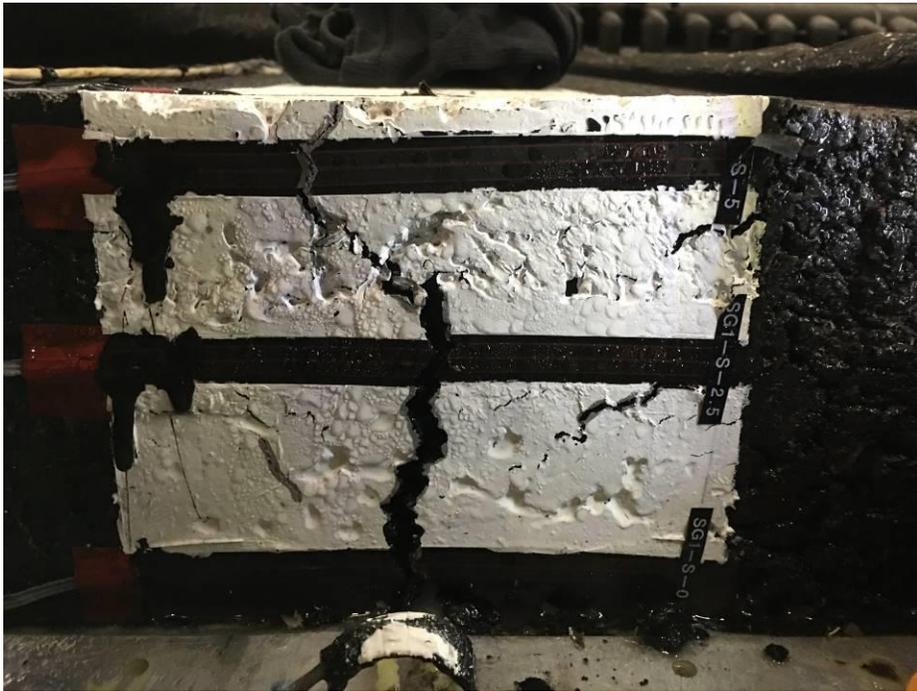
- No change from last observation.
- Bottom up crack at inner vertical edge (Fig5). Bottom up crack at outer vertical edge (Fig 6).
- Surface crack reached the inner vertical edge (Fig 7), approximately 3 inches from the outer vertical edge, no change (Fig 8)

Fig 5 Bottom-up crack at inner vertical edge of south section reached top surface

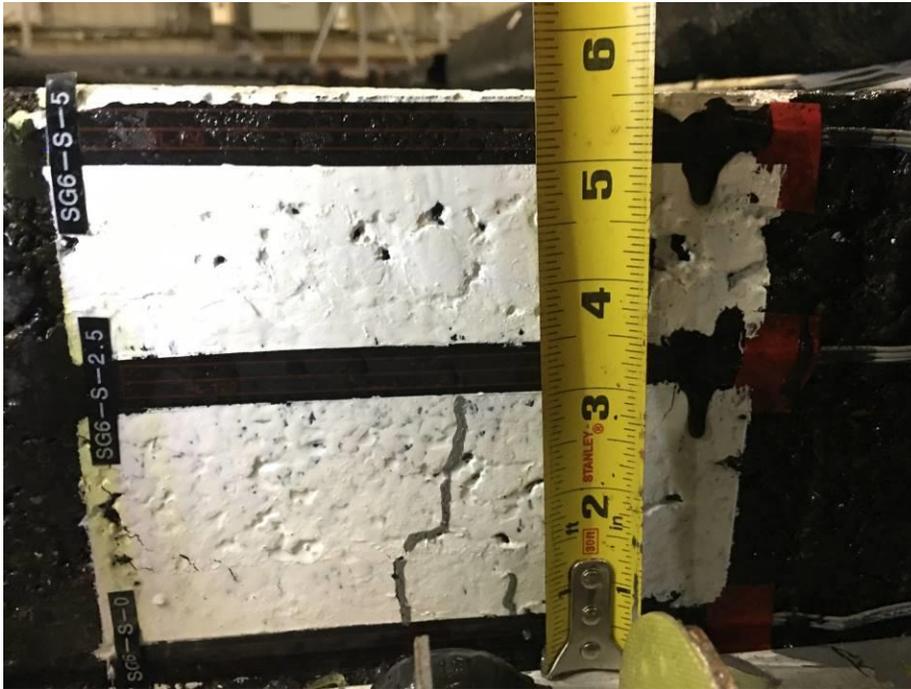
Fig 6 Bottom-up crack at SG6-S-0 3 inch long

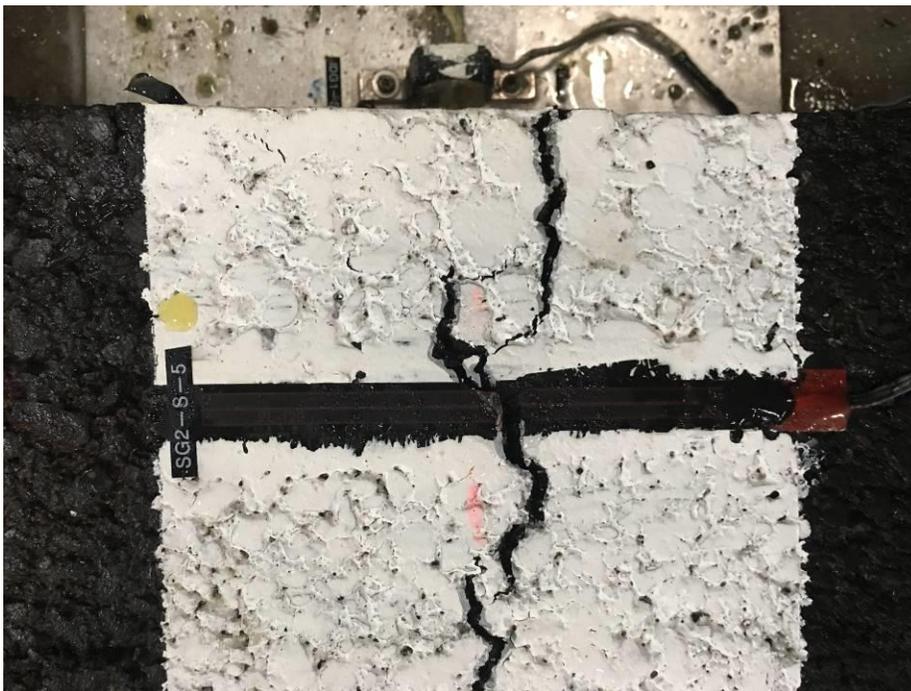
Fig 7 South section surface crack reached the inner vertical edge

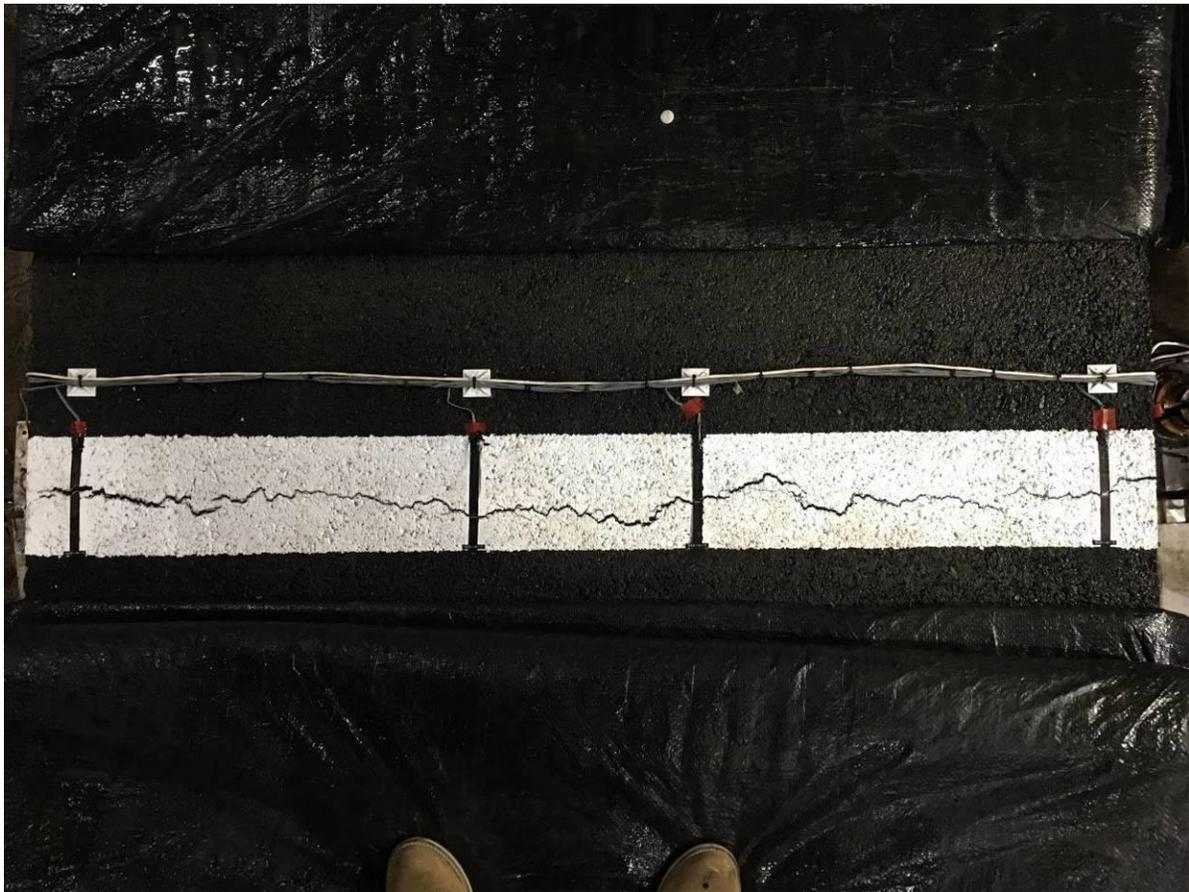
Fig 9 Surface crack on the north section

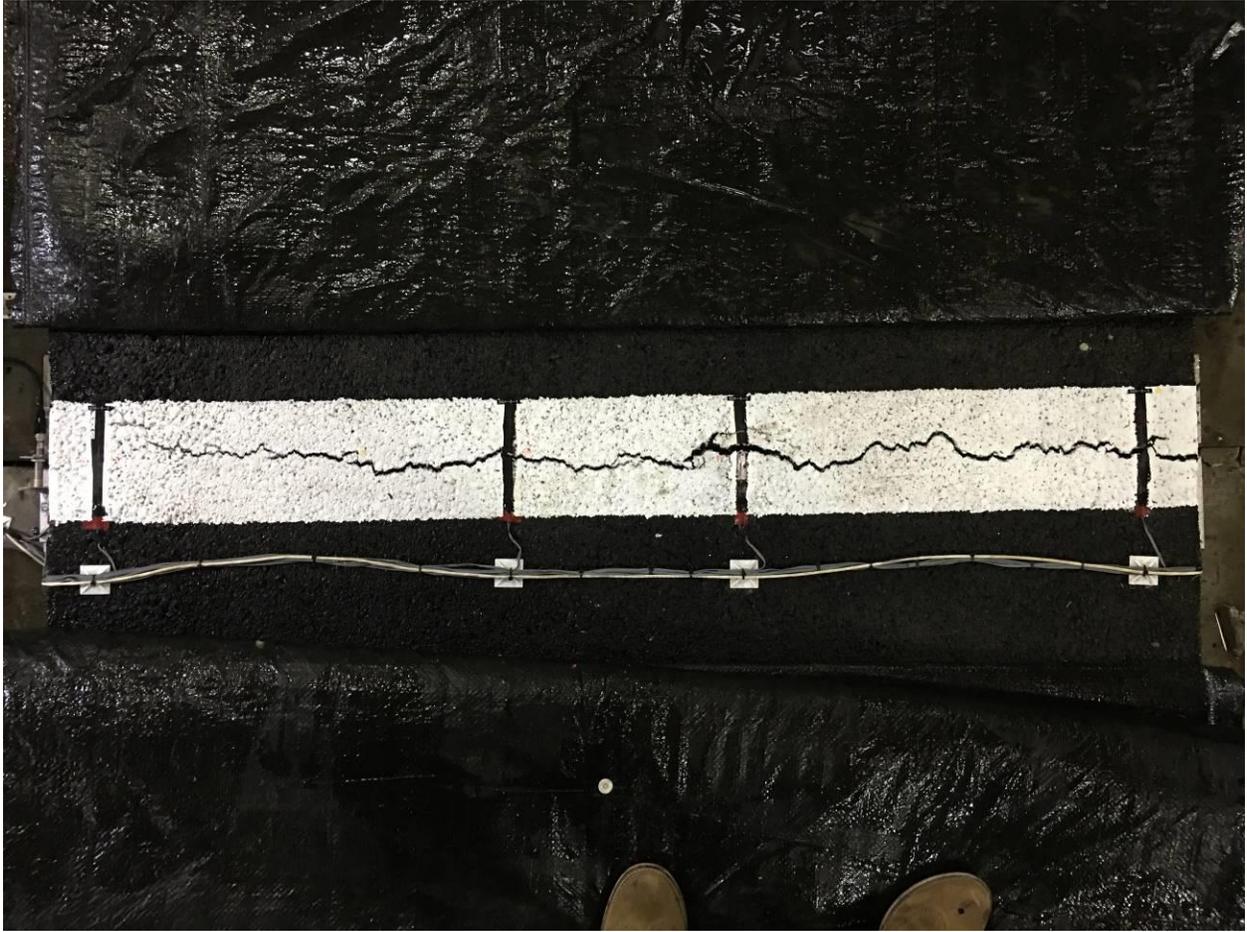
Fig 10 Surface crack on the south section
