Contract No. DTFACT-15-D-00007  
Construction Cycle 8: Phase I Test Report  
DELIVERABLE 4.9.2

February 2017

Prepared by Dr. Hao Yin, Gemini Technologies, Inc.

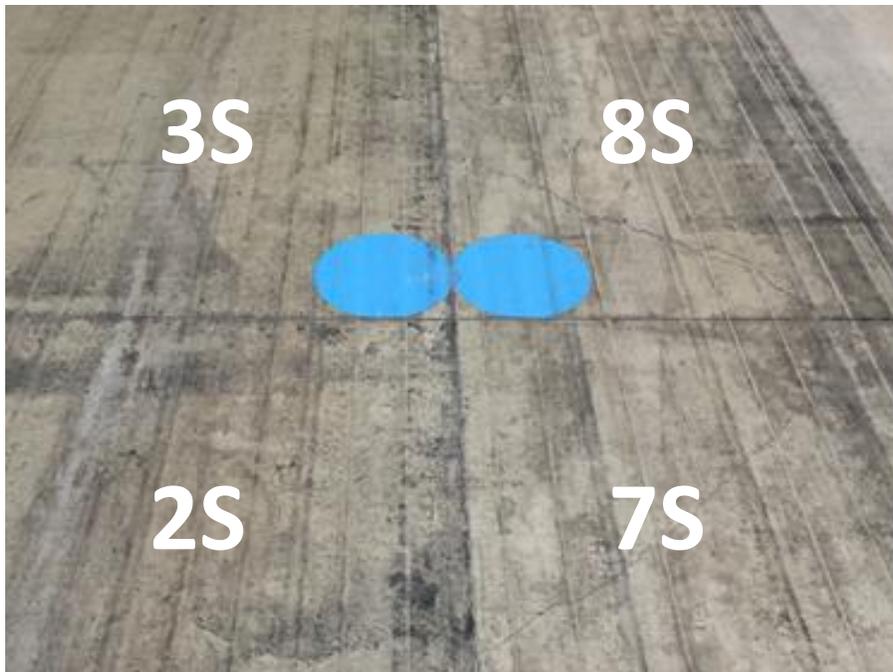
(a) South test item

Traffic testing was stopped on March 2 after 4,422 normally loaded passes at the increased wheel load level. A number of distresses were observed on the south test item near the transverse joint at Sta. 3+54, which caused the SCI value to drop from 100 to 68. The observed distresses were:

- 1 shrinkage crack on Slab 2S
- 1 low severity diagonal crack and 1 low severity corner spall on Slab 3S
- 1 low severity corner break on Slab 7S
- 1 medium severity corner break on Slab 8S

A photograph of the damaged pavement is shown in figure 4a. Examination of the distress patterns suggested the development of cracking near the slab surface as a result of tensile stresses due to slab counter-flexural bending.

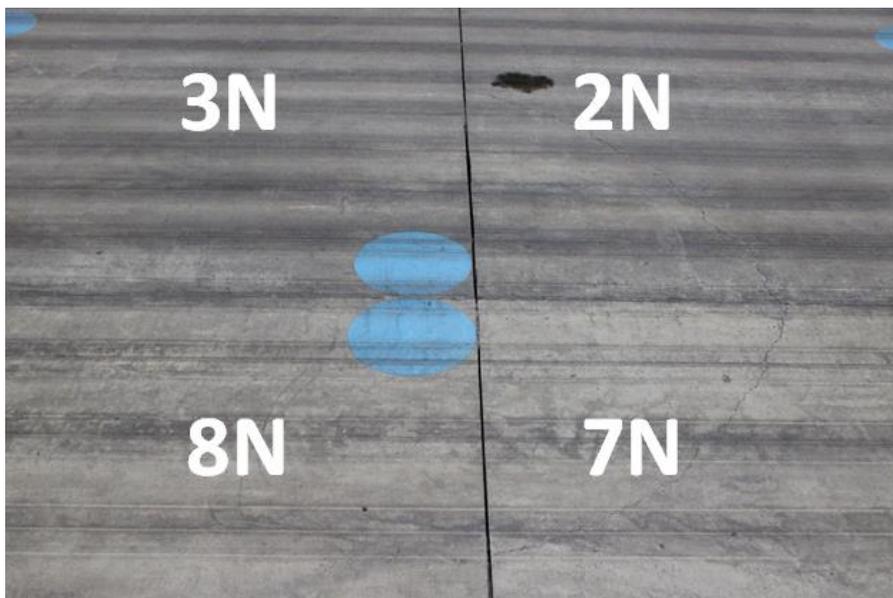
(b) North test item

After rest period of approximately six months, traffic resumed on the north test item only (September 14). Traffic on the north test item was stopped on September 19, after completion of 7,788 normally loaded passes at a wheel load of 28,000 lbs. (1,320 passes at the original load, plus 6,468 passes at the increased wheel load). A number of distresses were found on the south test item near the transverse joint at Sta. 3+54, causing the SCI value to drop from 100 to 79. The observed distresses were:

- 1 low severity corner break on Slab 2N
- 1 low severity corner break on Slab 7N
- 1 low severity corner break on Slab 8N

A photograph of the damaged pavement is shown in figure 4b. Similar to the south test item, the distresses observed in the north test item were consistent with top-down cracking.

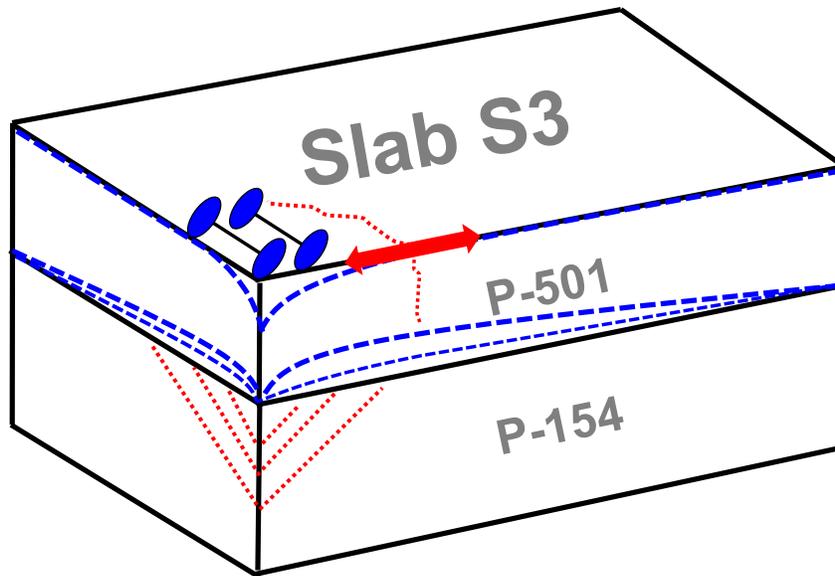
Figure 24. Failure Mechanism.

The observed distresses are the result of wheel load repetitions at slab corners that cause corner deflections and stresses in the top surface of the slab, resulting in fatigue damage and ultimate cracking. It is important to note that the top-down cracks did not occur under the action of the overloads themselves; rather, the overloads provided the opportunity for fatigue damage to take place earlier than it would otherwise. The magnitude and frequency of loads, the support conditions at slab corners, the uniformity of the subbase, and the degree of joint load transfer, all combine to permit excessive downward corner deflections. As the corner becomes progressively less supported and experiences correspondingly higher deflections and stresses under loads, distresses occur along the outer edge of the slab. A graphic demonstration of such localized failure is given in figure 12. Hypothetically, a stronger support from underlying layers (e.g., stabilized subbase) would provide protection against the observed distresses at slab corners.

Airfield rigid pavement thickness design has traditionally been based on the critical tensile bending stress at the bottom of the slab. Recent observations from Construction Cycle 6 (CC6) traffic tests at the FAA NAPTF have shown top-down cracking can occur under certain combined loading and pavement geometry situations (Brill and Kawa 2014). In addition, full-scale testing at the NAPTF has demonstrated that top-down cracks progress from initiation to full depth much more quickly than bottom-up cracks. The current FAARFIELD thickness design procedure does not consider this failure mode (FAA 2009). Instead, current FAA standards attempt to limit top-down cracks through joint spacing limitations based on experience and rules-of-thumb. As summarized in *Operational Life of Airport Pavements* (Garg et al. 2004), top-down cracking is typically expected in larger slabs and when curling is significant, and is also expected to appear in the form of corner breaks. A similar cracking pattern was observed during previous accelerated testing, and the causes have been thoroughly examined but not yet fully explained using finite element analysis (Evangelista and Roesler 2009). Small airports sometimes require accommodating a limited number of operations of an airplane heavier than the pavement was designed to support. For these thinner concrete slabs, the risk of top-down cracking becomes a major concern for allowing or rejecting the overload operations. In addition, field survey data for medium and large airports suggests that top-down cracks have to be considered for terminal pavements where heavy airplanes irregularly move near the slab corners (FAA 2013).
