Contract No. DTFACT-15-D-00007
Delivery Order 005 NAPTF Support
Deliverable 4.9.2.4
Construction Cycle 8 Phase II Overlay Testing Report

July 2018

**Prepared by Carlos Cary, Ph.D., Mesbah Ahmed, Ph.D. and Hao Yin, Ph.D. P.E.
Gemini Technologies, Inc.**

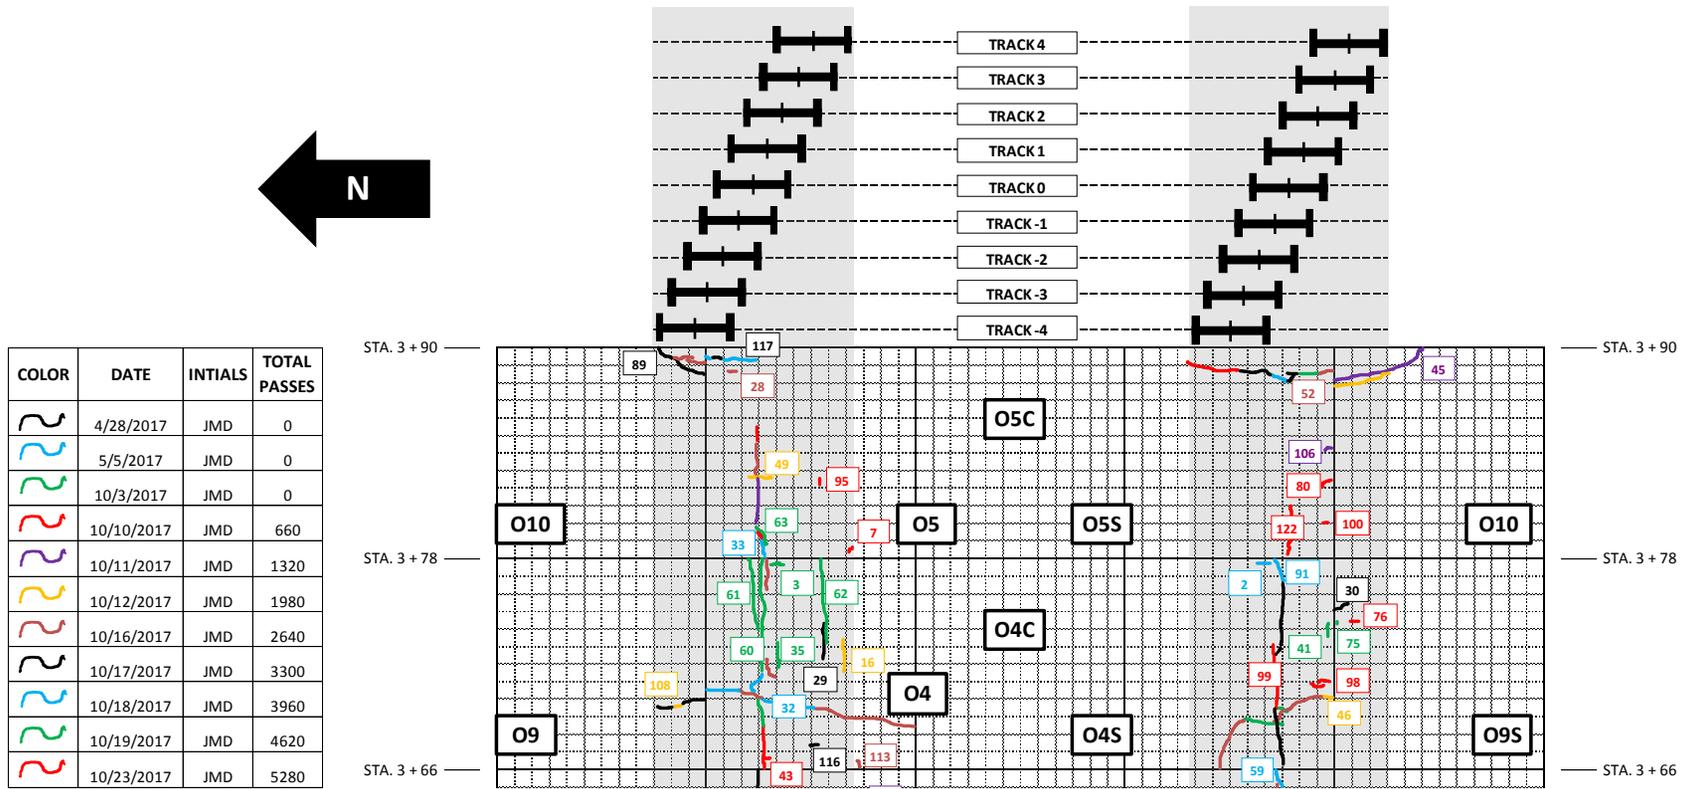
Minor surface cracking directly above some EGs that was observed prior to the traffic test is registered in the baseline distress survey. During the early stage of the traffic test, tight surface cracks isolated in the interior of slabs and developed in a random pattern, were observed in the north test item. In general, the south test item showed structural cracks and failed earlier than the north. Also, more corner breaks were observed on the south test item compared to the north. On both test items, corner breaks and longitudinal cracks were the dominant distress types. Development of reflective cracking from the underlay longitudinal joints was observed within the trafficked area on both test items. Additional analysis on the pattern of distress development will be elaborated in following sections of the report.

Figure 13. Example Section of Distress Map

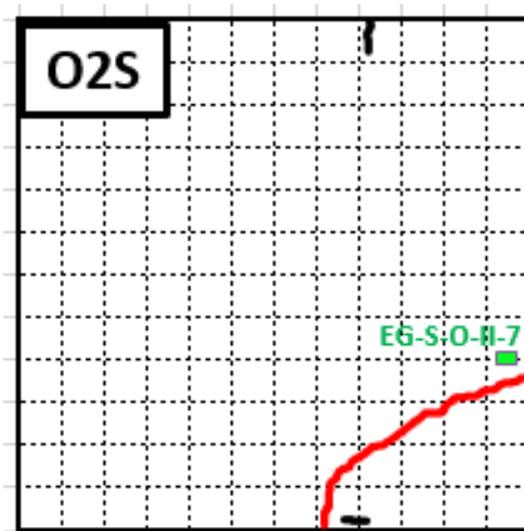
Figure 25. Corner Break Observed on Slab O2S during the 3rd Day of Traffic Test (Wander 21 to 30)

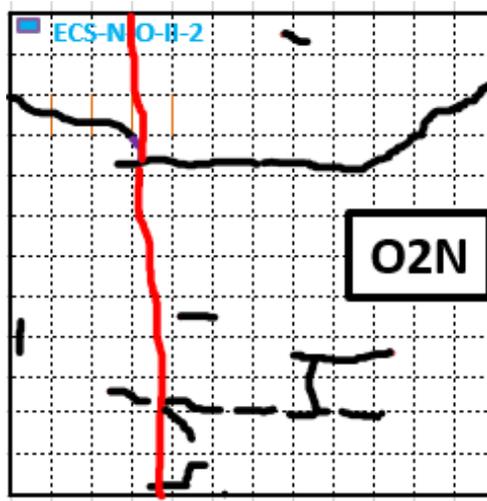
The response captured by the ECS corresponds to the separation between two concrete layers. Most ECSs showed nearly constant responses of negligible magnitude (i.e., less than 5 mil) throughout the course of the traffic test. However, the maximum deflections observed for ECS-N-O-II-2 and ECS-S-O-II-1 ranged between 10 and 20 mils, and the response of these two ECS were found to correlate with the occurrence of distresses within the sensor vicinity. In Figure 35, the maximum deflection of ECS-N-O-II-2 is initially observed to become more negative (i.e., increasing absolute deflection). Beyond wander 195 the trend reverted so that the maximum deflection became less negative (i.e., decreasing absolute deflection) with additional trafficking. This inflection point is consistent with the occurrence of a longitudinal crack (see red marked crack in Figure 36), which took place between wanders 195 and 205.

Figure 36. Longitudinal Crack Captured by ECS-N-O-II-2 Response

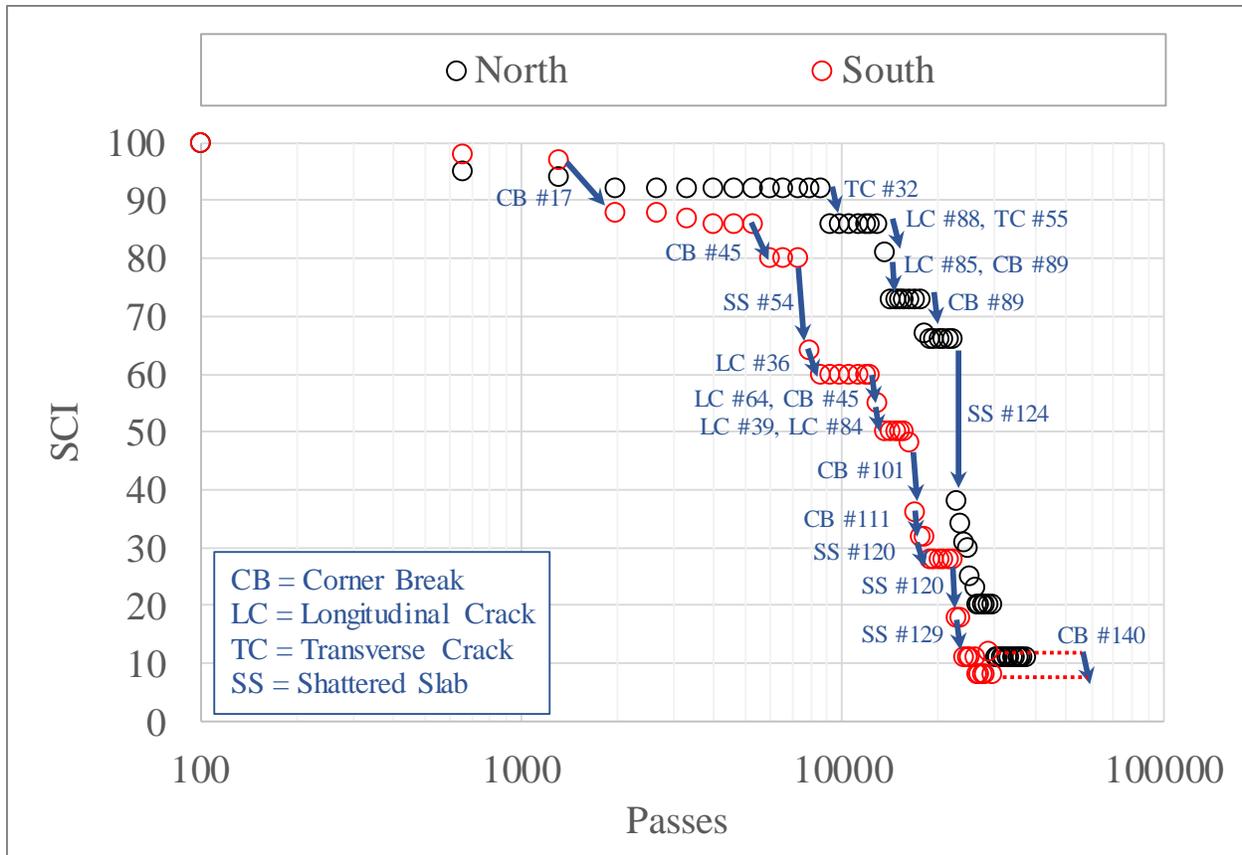
In Figures 45 to 49, a selection of distress maps obtained at different times over the course of traffic illustrate the observed distress pattern. The distress maps in Figures 45 and 46 capture the occurrence of CB #17 and CB #45 in the south test item, respectively. Note in Figure 46 that only random, tight and isolated interior surface cracks were observed on the north during the early stage of trafficking. The next sharp drop in SCI for the south test item is associated with the first shattered slab (SS #54) as indicated in Figure 44. This shattered slab was reported after the 12th day of traffic test with 7920 total cumulative passes as shown by the distress map in Figure 47. As seen in Figure 47, slab O2S was shattered mainly by linear cracks that reflected from the underlying longitudinal joints of CC8 Phase I overlay. It is speculated that the early occurrence of CB #17 triggered reflective cracking in the south side. Figure 48 shows evidences that by the time CB #89 appeared in the north test item, reflective cracking from the underlying pavement had spread over both test items. The difference between the north and south test item SCI began to narrow down after 22770 vehicle passes with the occurrence of the first shattered slab SS#124 on the north side (Figure 44). The gap in SCI between test items keeps decreasing with additional passes until the final overlay condition illustrated in Figure 49 was achieved.

Figure 44. Major Distresses Driving Sharp Drops in the Overlay SCI

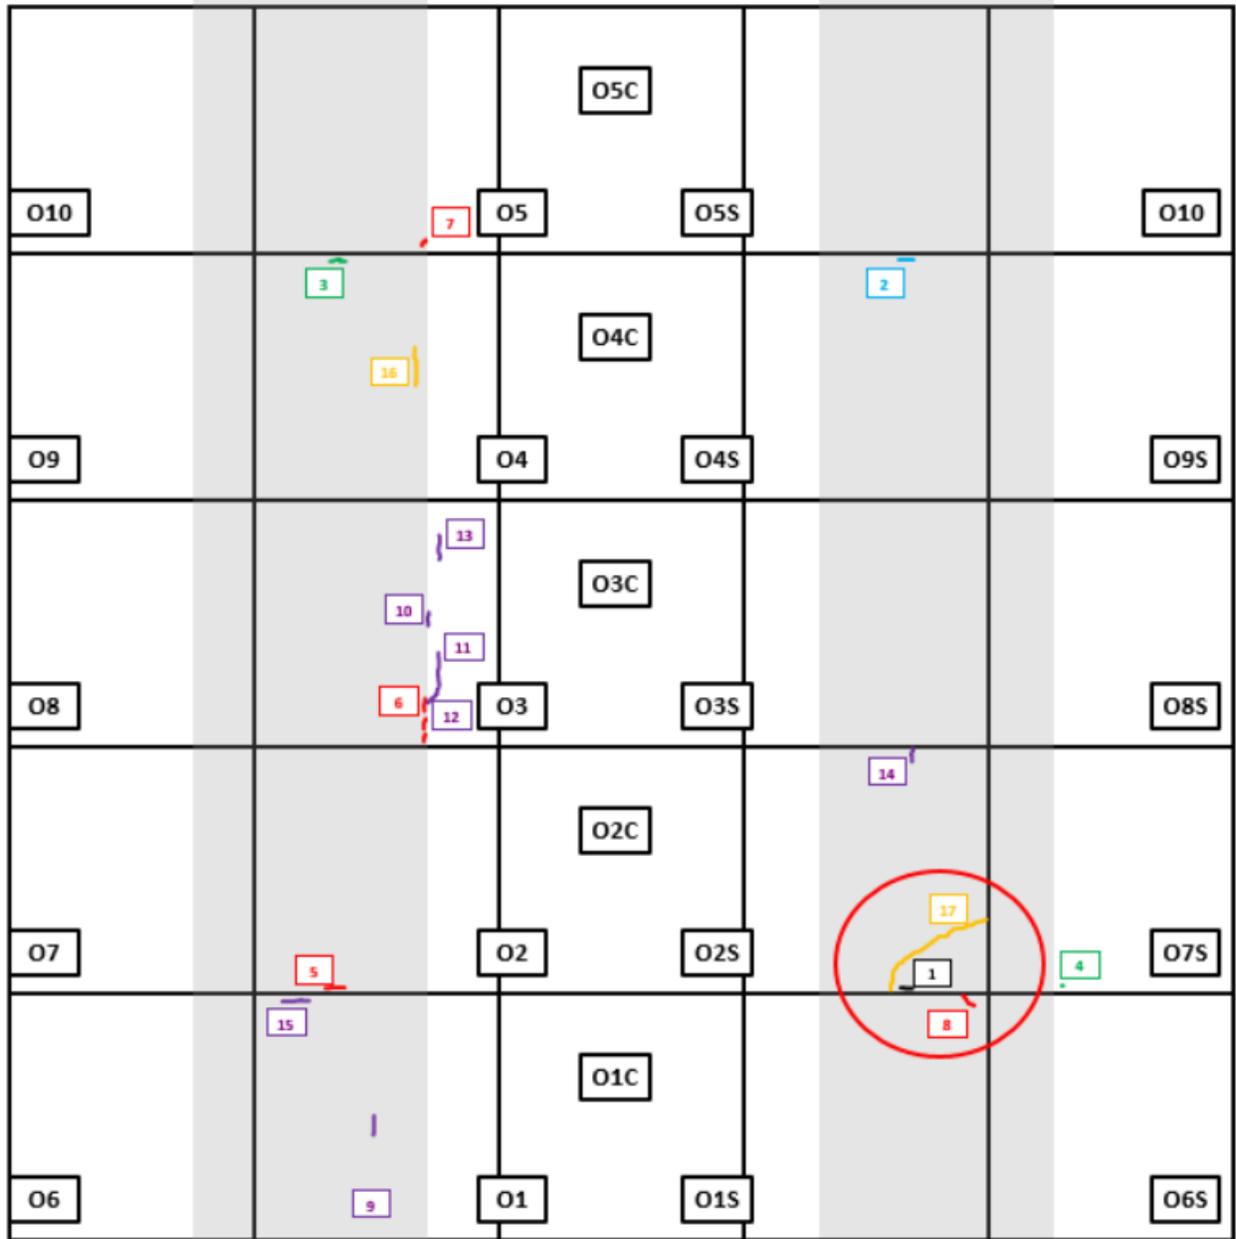
Figure 45. Distress Map - 3rd Day, 1980 Vehicle Passes

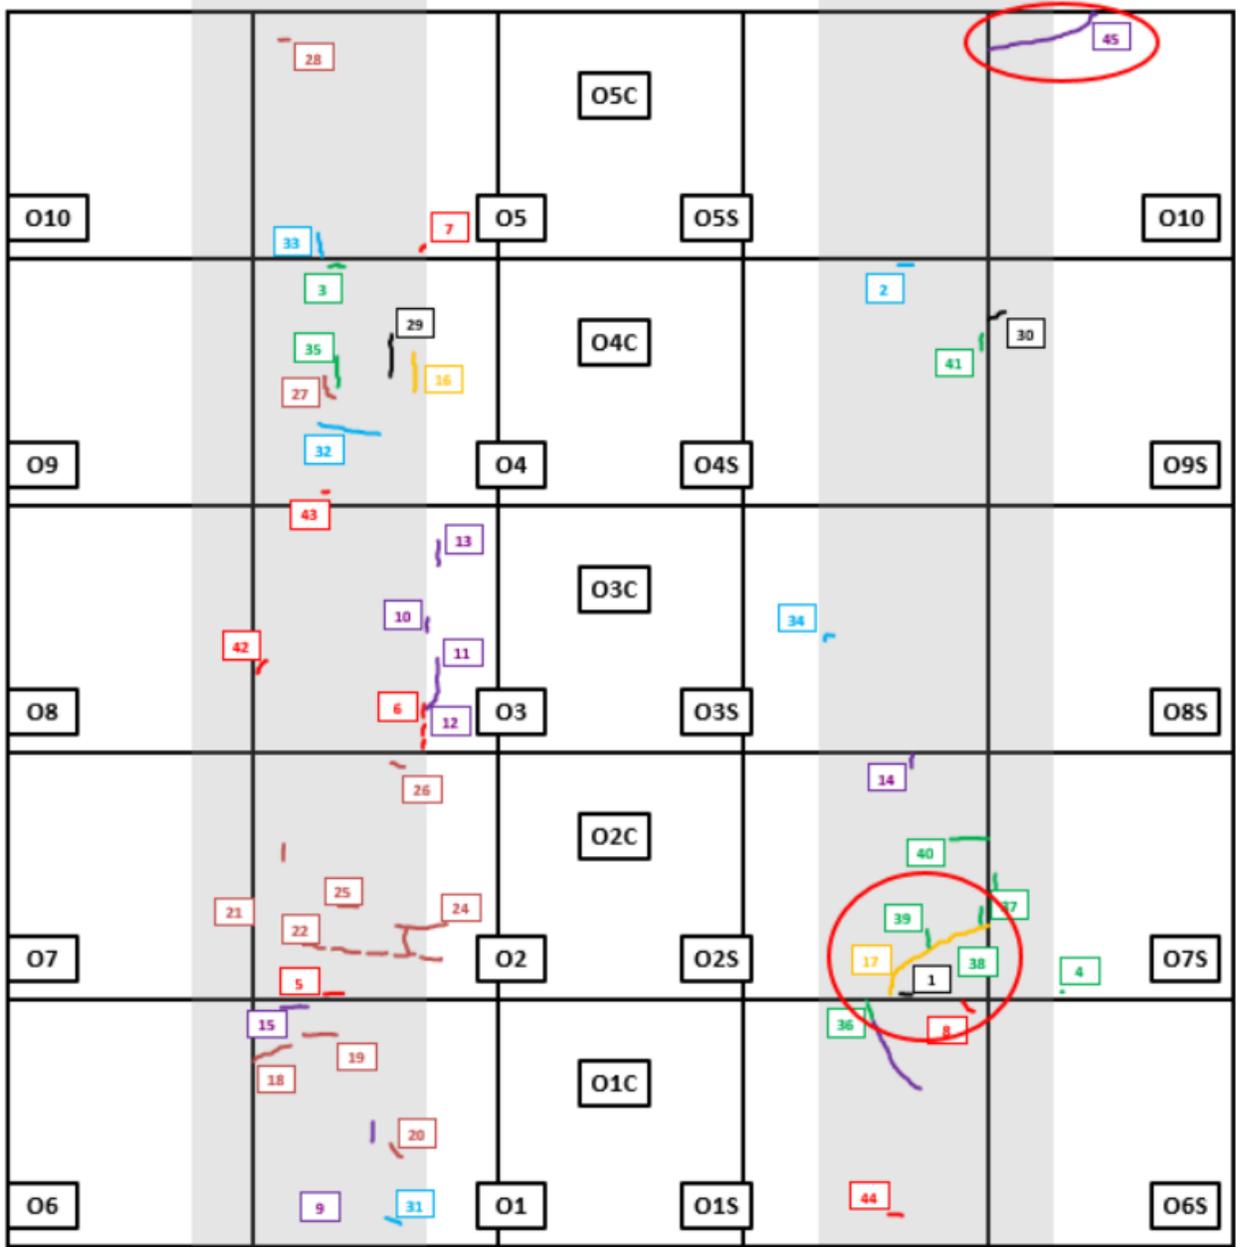
Figure 46. Distress Map – 9th Day, 5940 Vehicle Passes

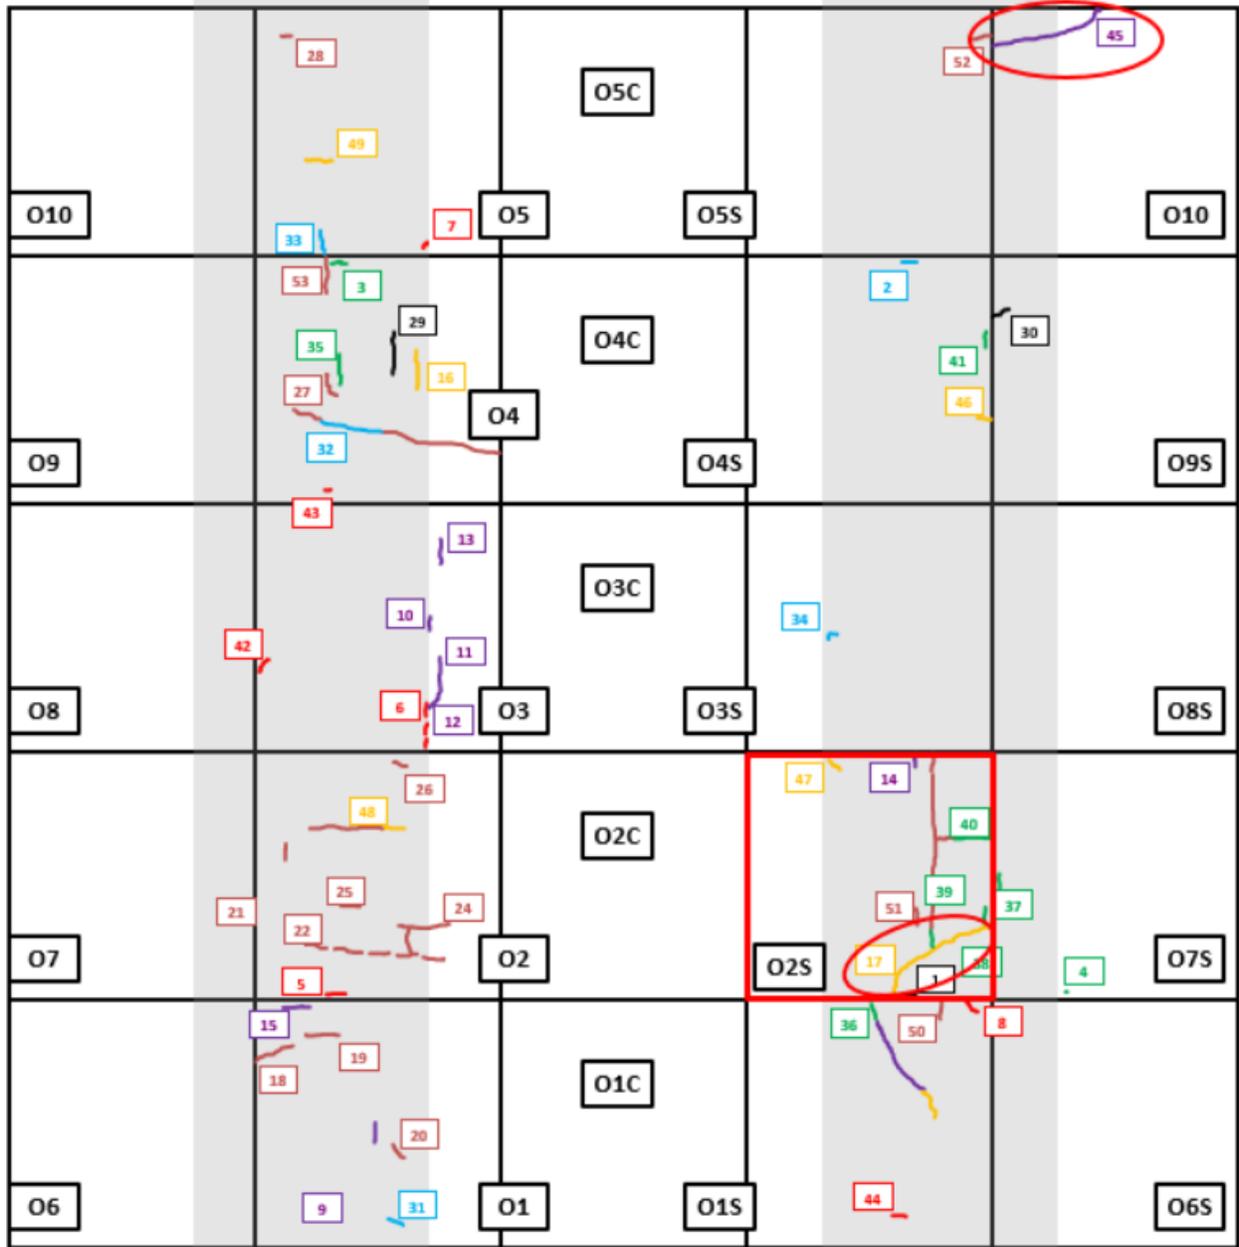
Figure 47. Distress Map – 12th Day, 7920 Vehicle Passes

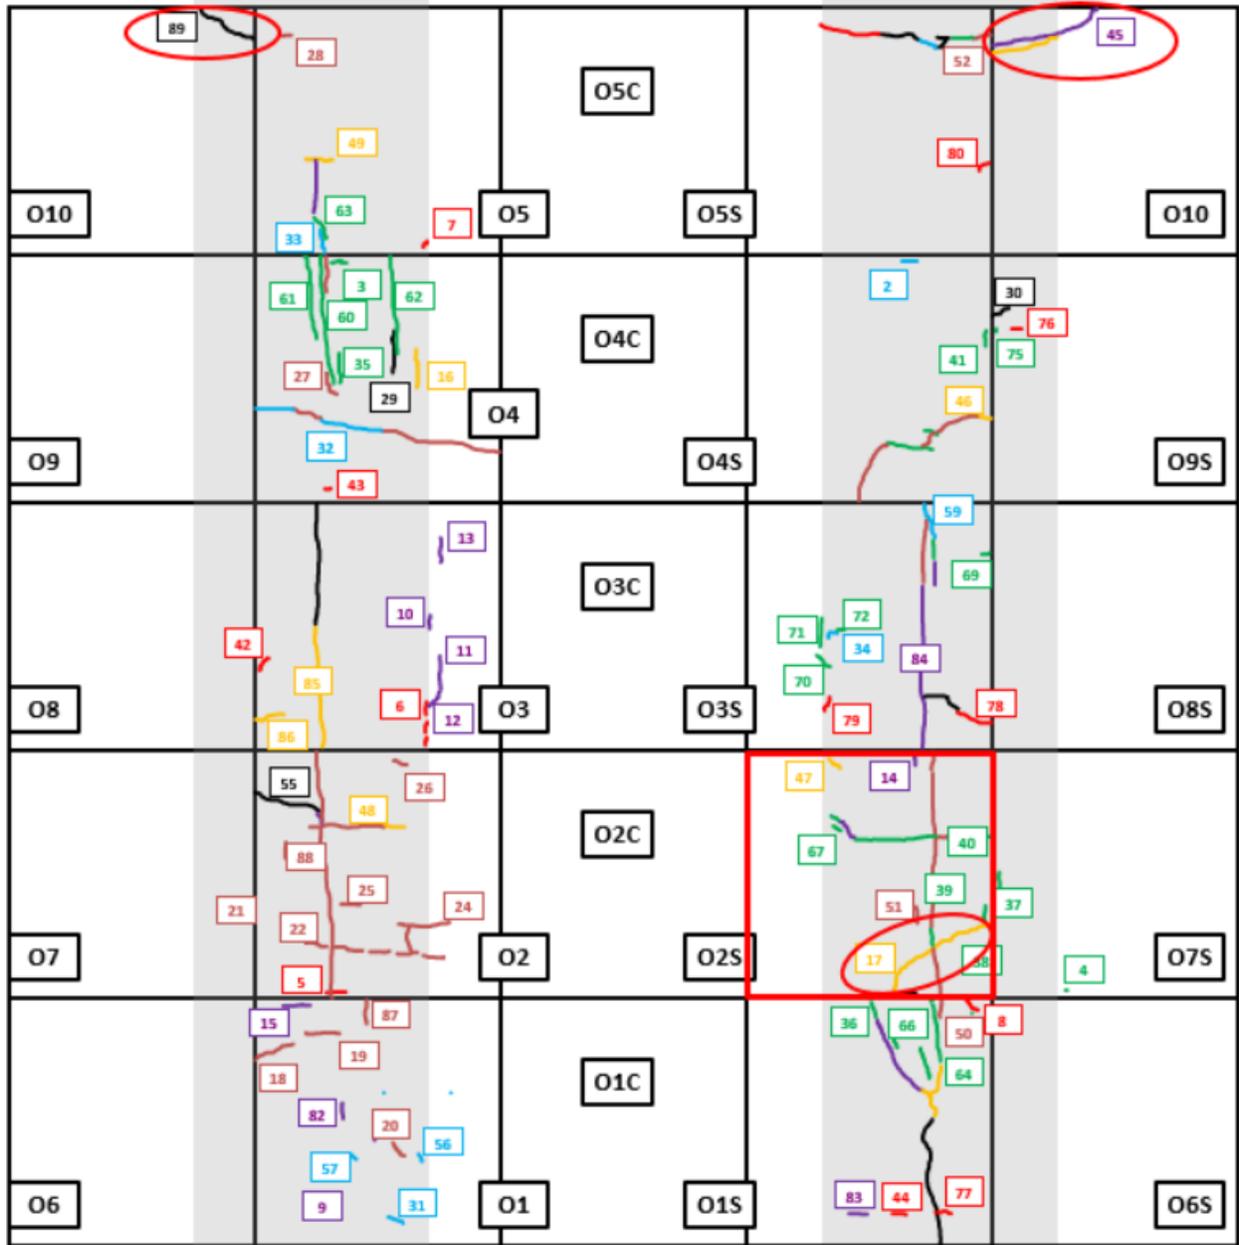
Figure 48. Distress Map – 22nd Day, 14190 Vehicle Passes

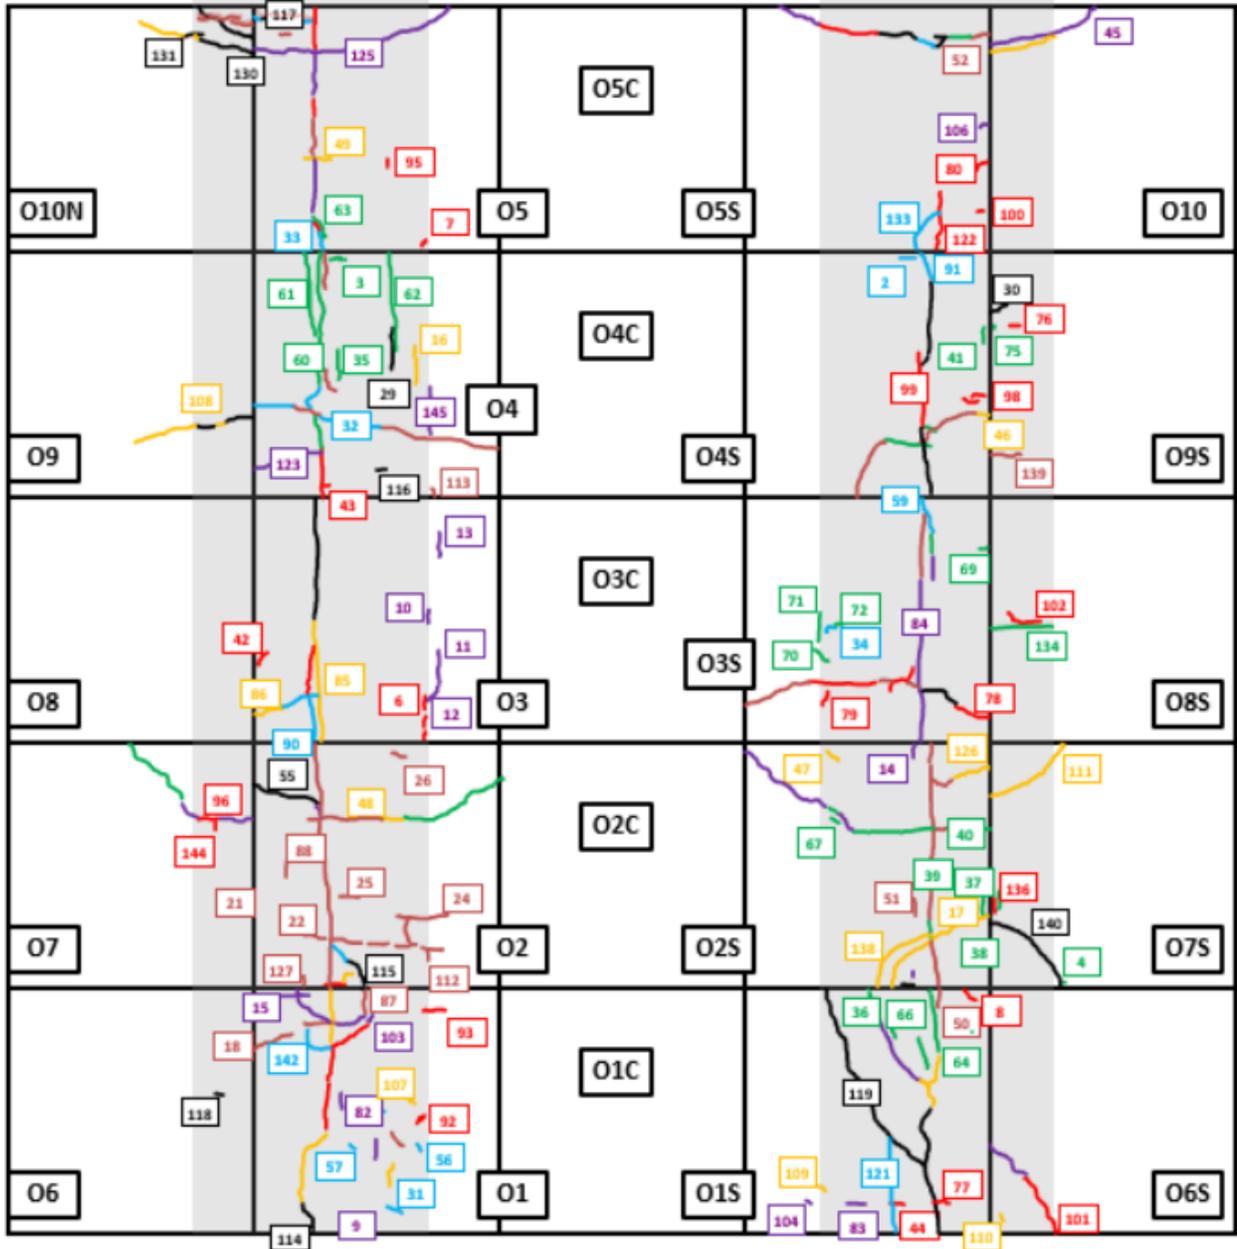
In general, corner breaks and longitudinal cracks were the dominant overlay distresses. A total of five corner breaks were reported in the south side whereas only one was reported in the north. The initial underlay SCI value for south test item was 68 whereas for the north test item the SCI was 79. This supports the speculation of underlay damage with higher incidence on the south side, during the overlay traffic test. Premature deterioration of the overlay south test item may have reflected the underlay pattern of deterioration. It is expected that an assessment of the underlay final condition as part of the CC8 forensic investigation will provide additional elements to explain the observed distress pattern.

Figure 49. Distress Map – 60th Day, Vehicle Passes: 37290 (North) and 29370 (South)
