### Construction Progress and Inspection Report

U.S. Department  
of Transportation  
**Federal Aviation  
Administration**

Inspection Date  
04/30/2019

Project Name  
TO#15 Ref.  
Crack.\_Outdoor\_Phase1

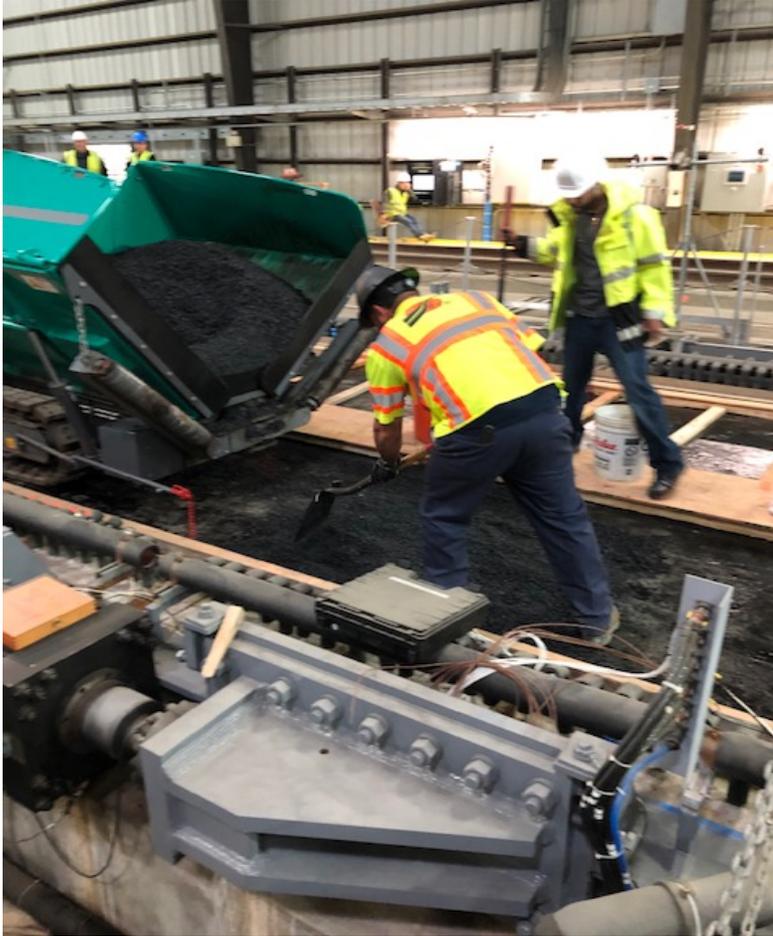
Placement of PG64-22 on north overlay.

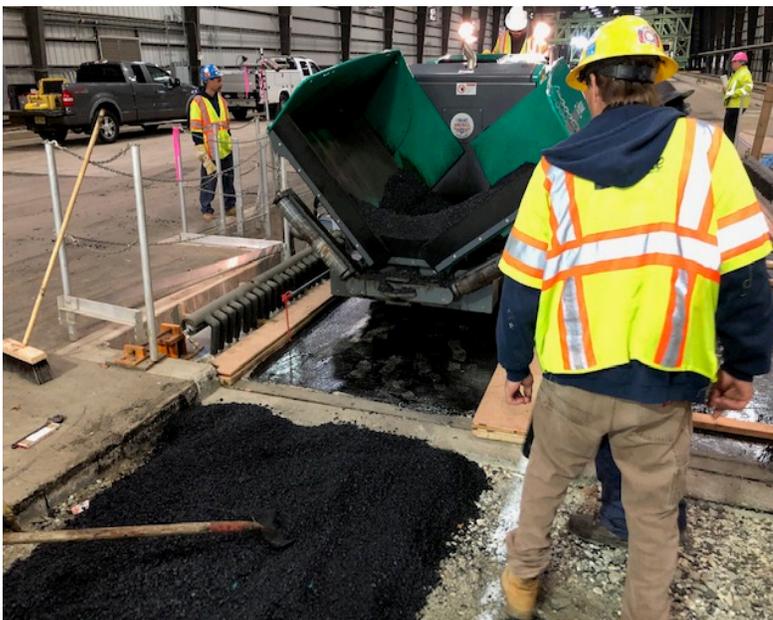
Placement of PG64-22 on south overlay (initial run).

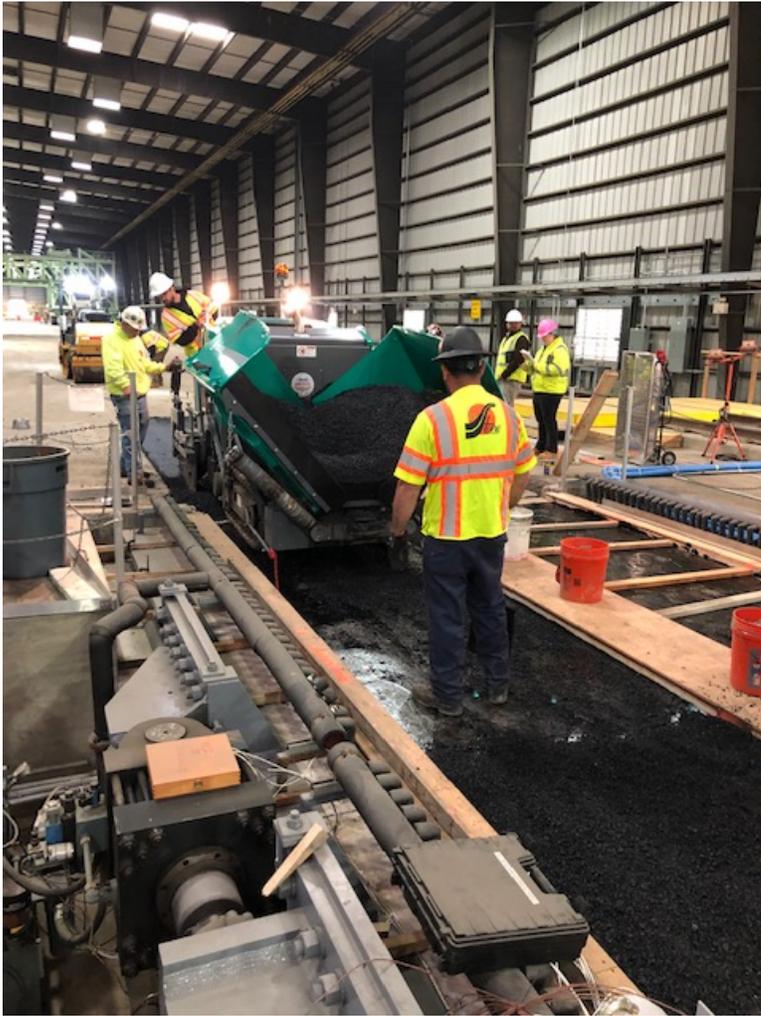
Placement of PG64-22 on south overlay.

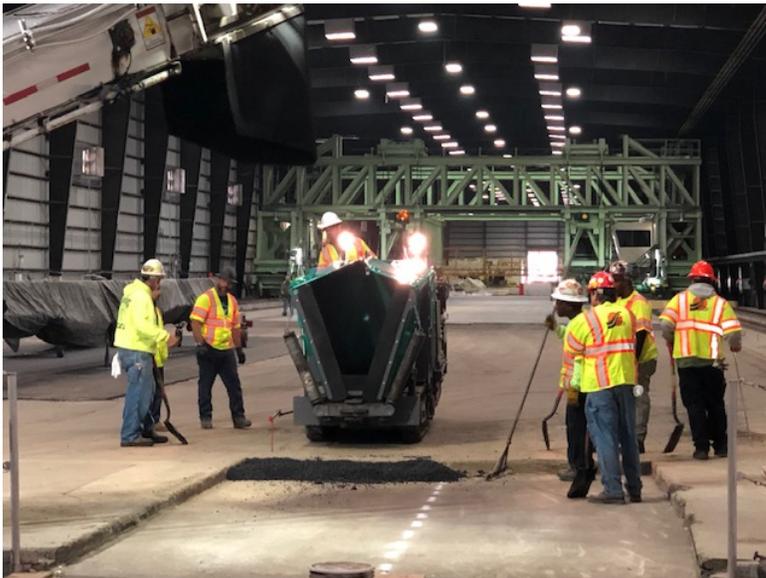
Placement of PG64-22 on material test area

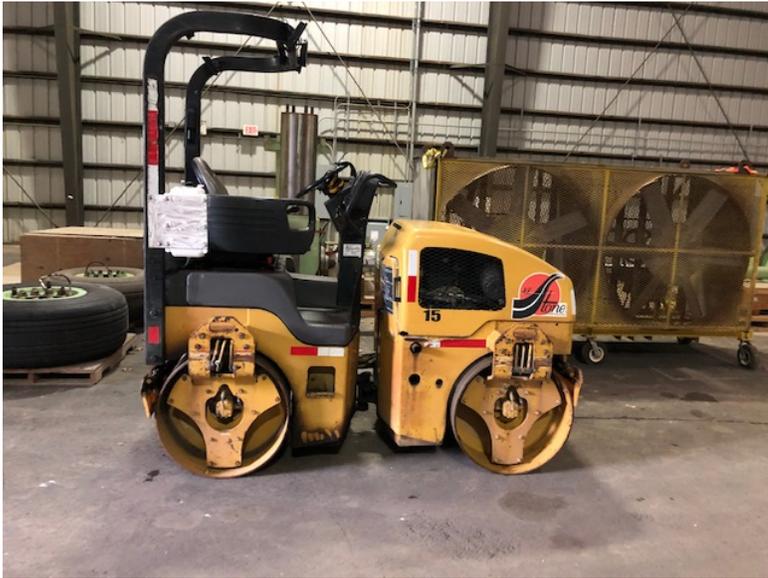
Hamm HD Vibratory Roller (Small roller)

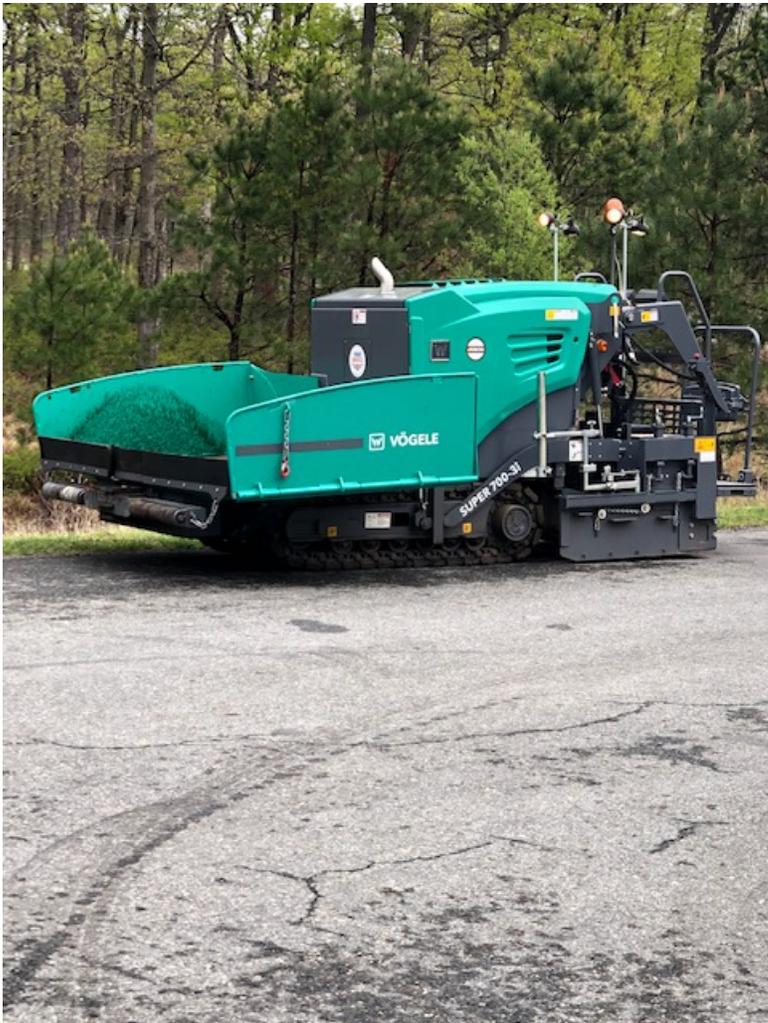
Vogele Super 700-31 (small paver)

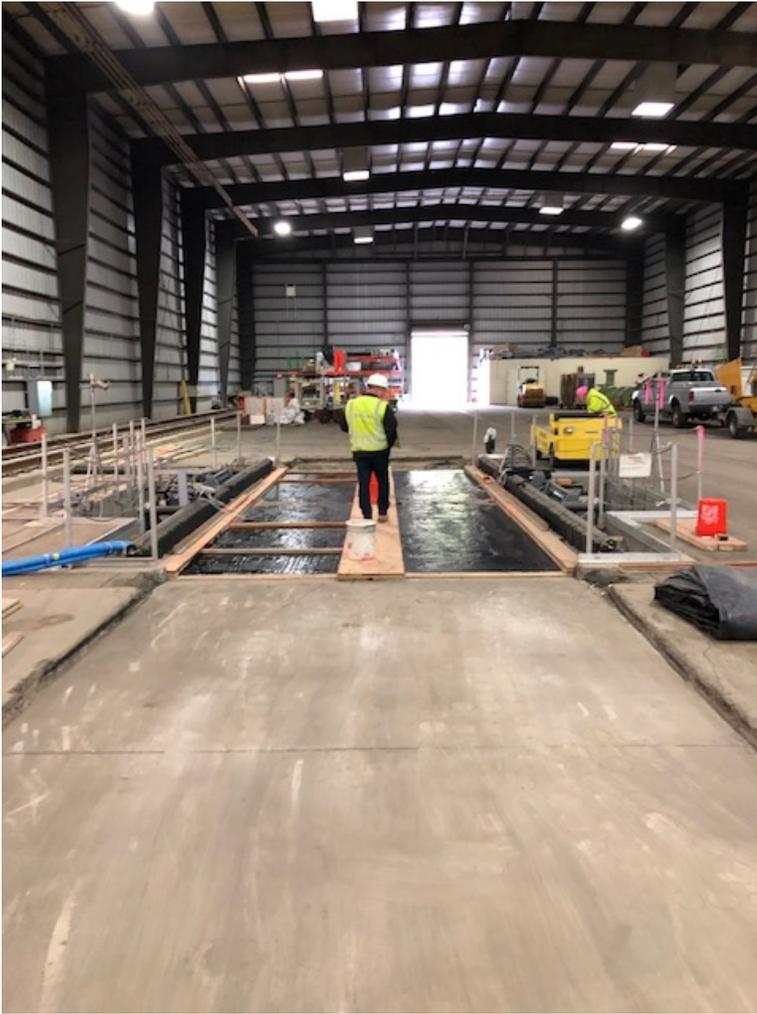
Checking the things out prior to paving.

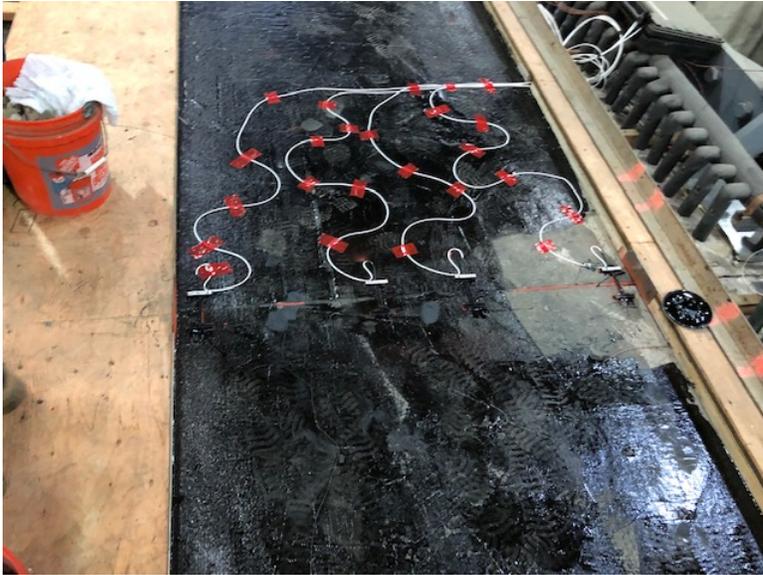
H-Bar placement on south overlay by joint.

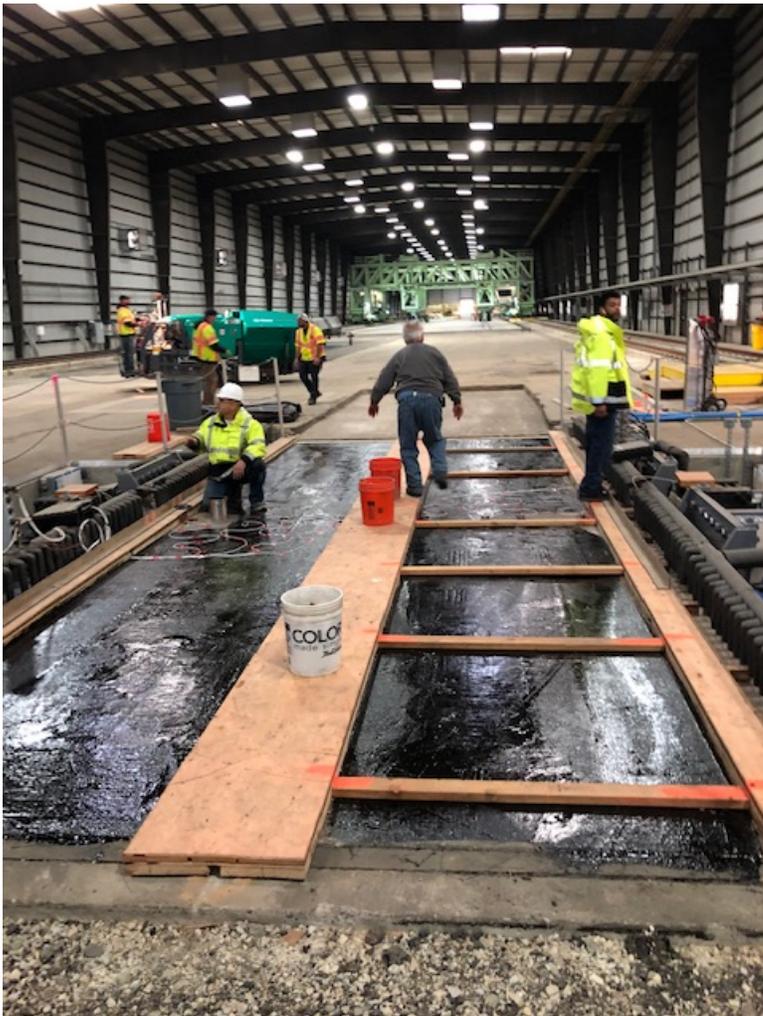
Placement H-Bar gages prior to paving

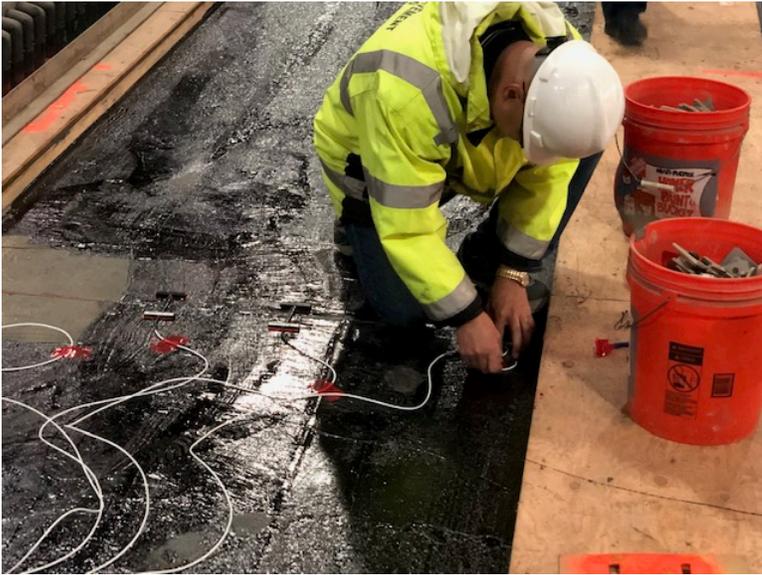
Placement H-Bar gages prior to paving.
