## TO15 RC Outdoor Phase 1 Daily Notes

**Date:** 02/12/2020

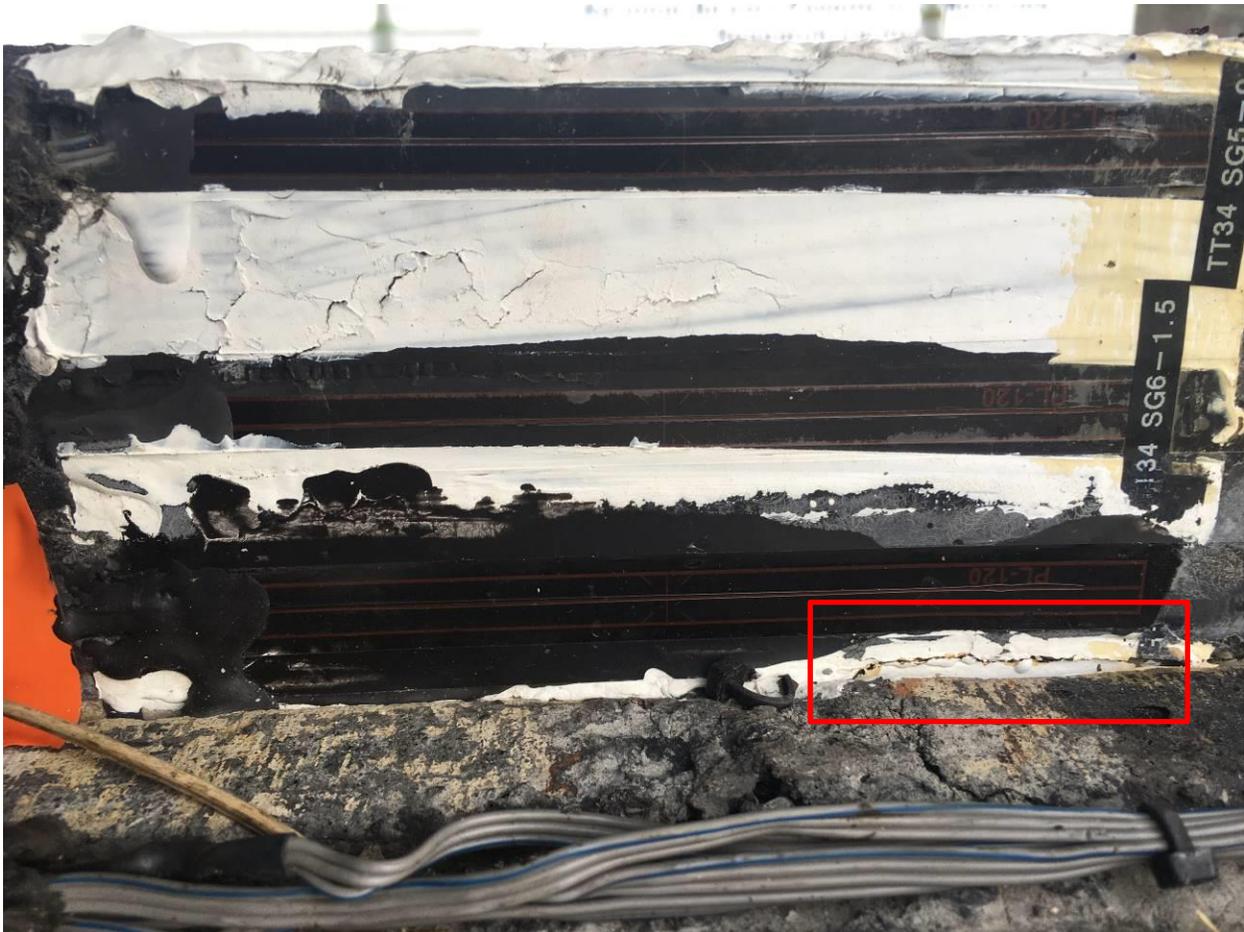
Figure 1 TT34 Joint West Side

TT34 Joint West Side. 3 mm (approximate) vertical hairline crack, in asphalt at concrete joint, then the hairline crack moved to the right for 40 mm (approximate) parallel to the concrete surface this shows surface de-bonding but may be just in paint, figure 1.

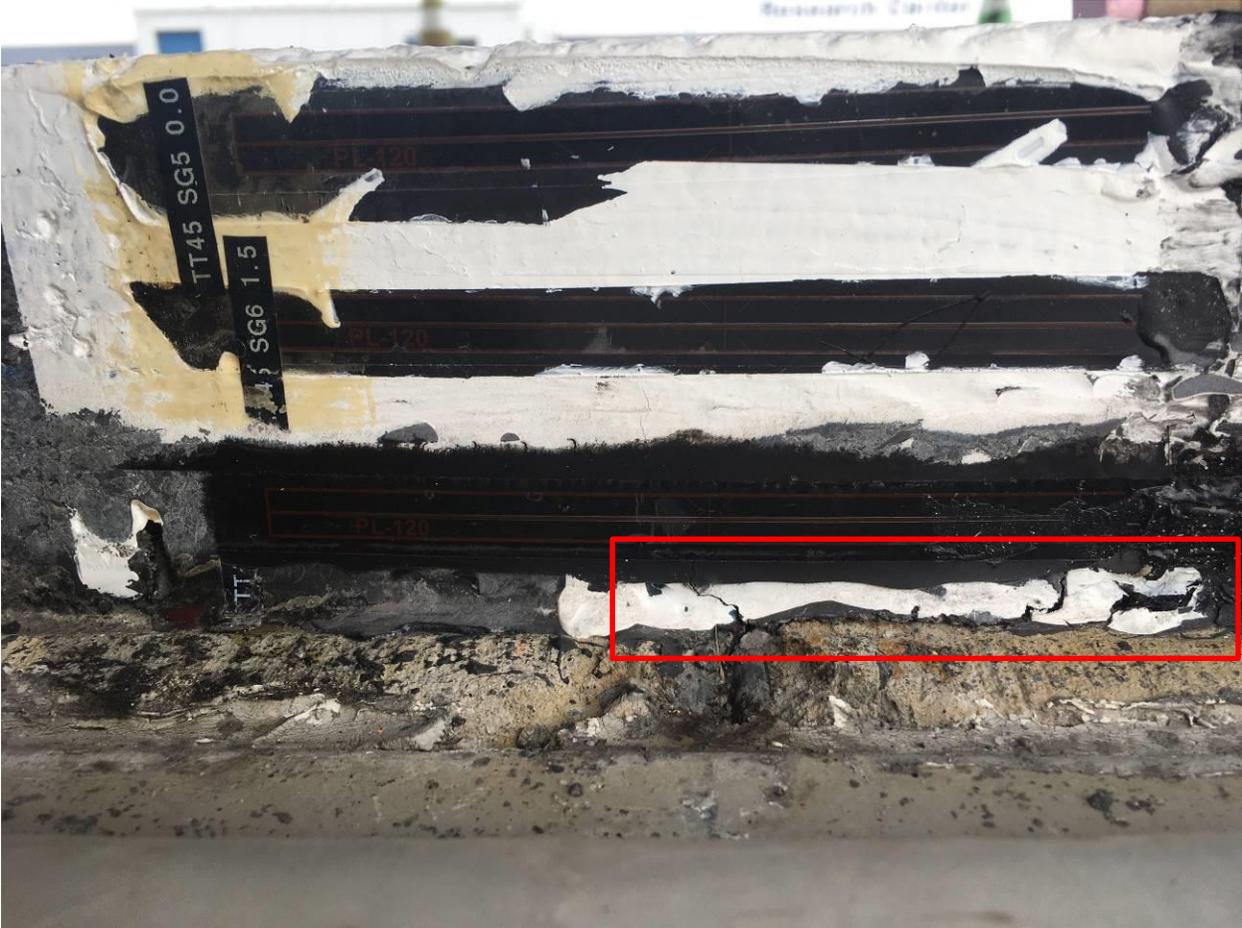
**Figure 2 TT45 Joint West Side**

TT45 Joint West Side. 10 mm (approximate) vertical hairline crack, in asphalt at concrete joint at approximately 45 degrees to the left, then the hairline crack moved to the right for 40 mm (approximate) parallel to the concrete surface, this shows surface de-bonding but may be just in paint then went 5 mm vertical again, figure 2.

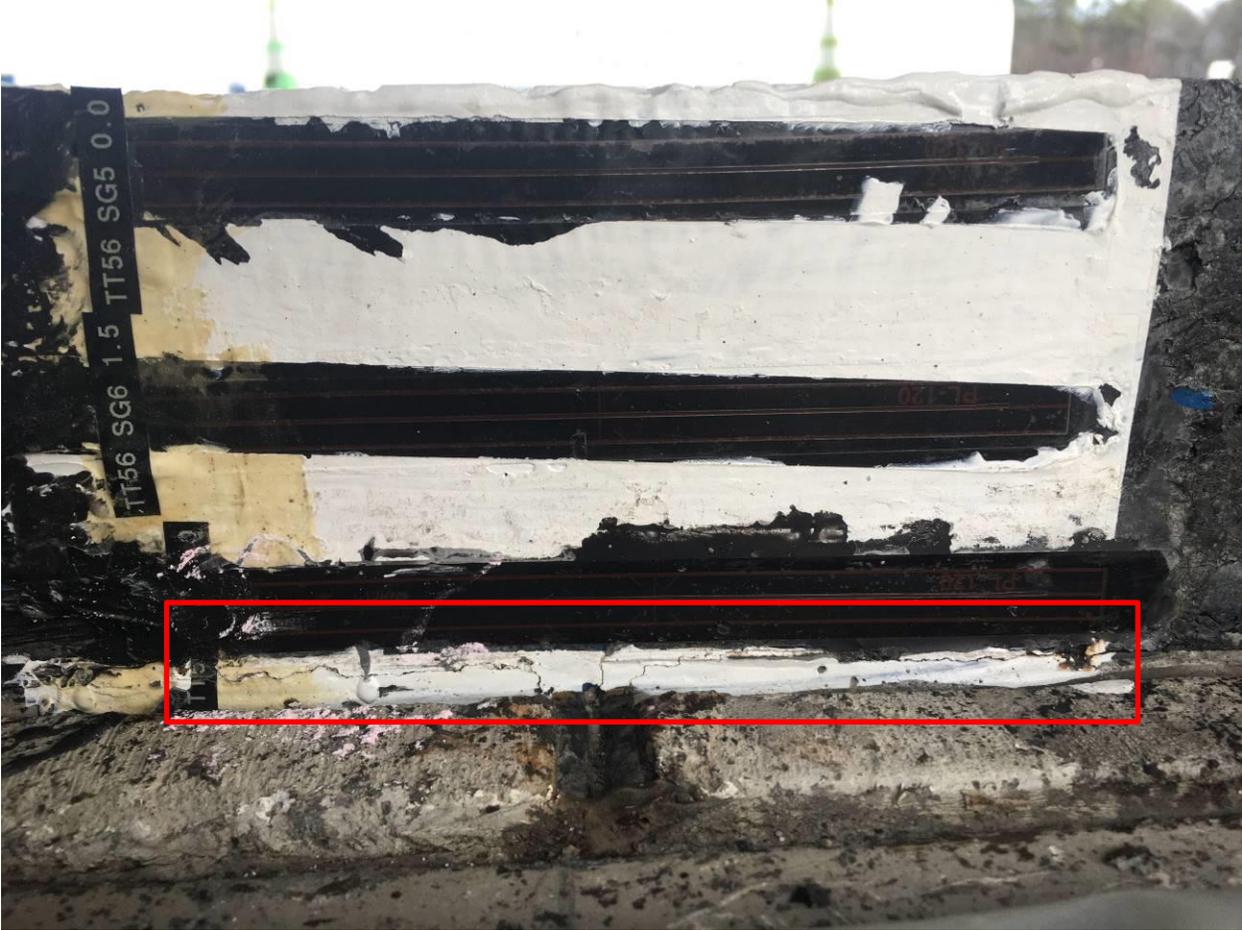
**Figure 3 TT56 Joint West Side**

TT56 Joint West Side. 2 hairline vertical cracks 4 mm each at the joint then moved 50 mm individually one to the right the other to the left of joint parallel to the concrete surface , this shows surface de-bonding but may be just in paint, figure 3.

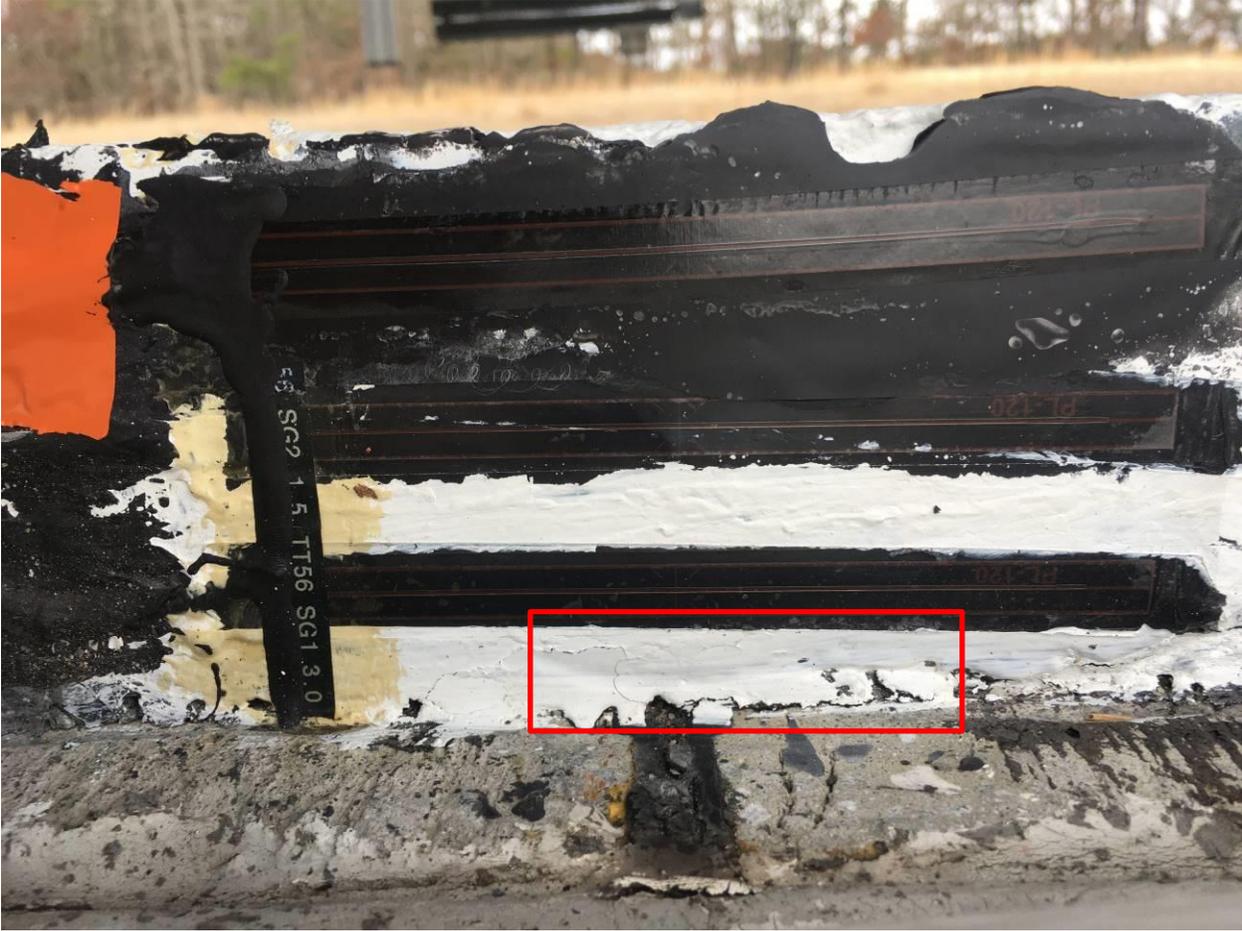
**Figure 4 TT56 Joint East Side**

TT56 Joint East Side. 4 mm (approximate) vertical hairline crack, in asphalt at concrete joint, then the hairline crack moved to the right for 30 mm (approximate) parallel to the concrete surface this shows surface de-bonding but may be just in paint, figure 4.

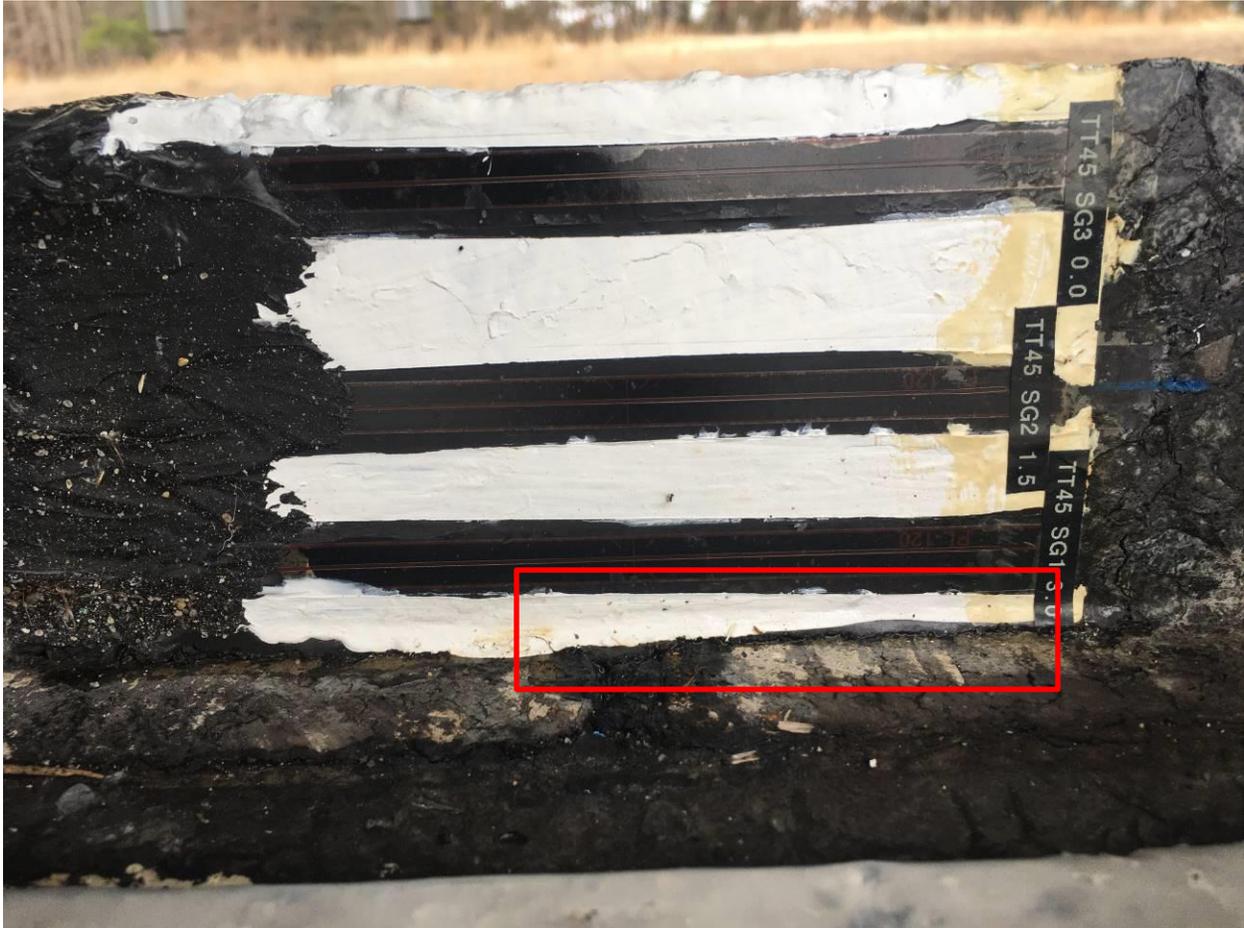
**Figure 5 TT45 Joint East Side**

TT45 Joint East Side. 4 mm (approximate) vertical hairline crack, in asphalt at concrete joint at approximately 45 degrees to the left, then the hairline crack moved to the right for 40 mm (approximate) parallel to the concrete surface, this shows surface de-bonding but may be just in paint, figure 5.
