TO15 RC Outdoor Phase 1 Daily Notes

Date: 02/13/2020

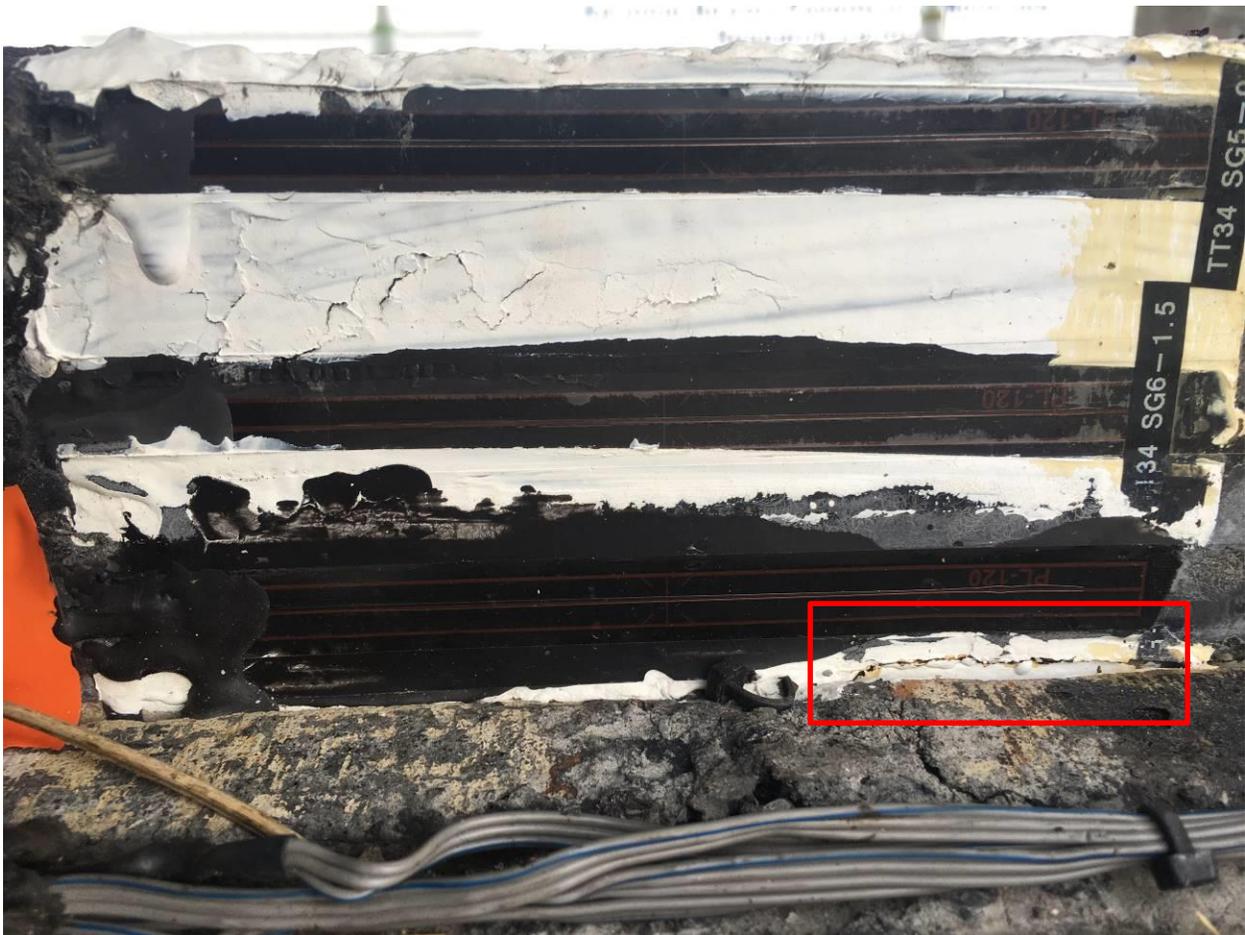
Figure 1 TT34 Joint West Side

Cracks were observed on the vertical edges, no further propagation observed compared to 02/12/2020.

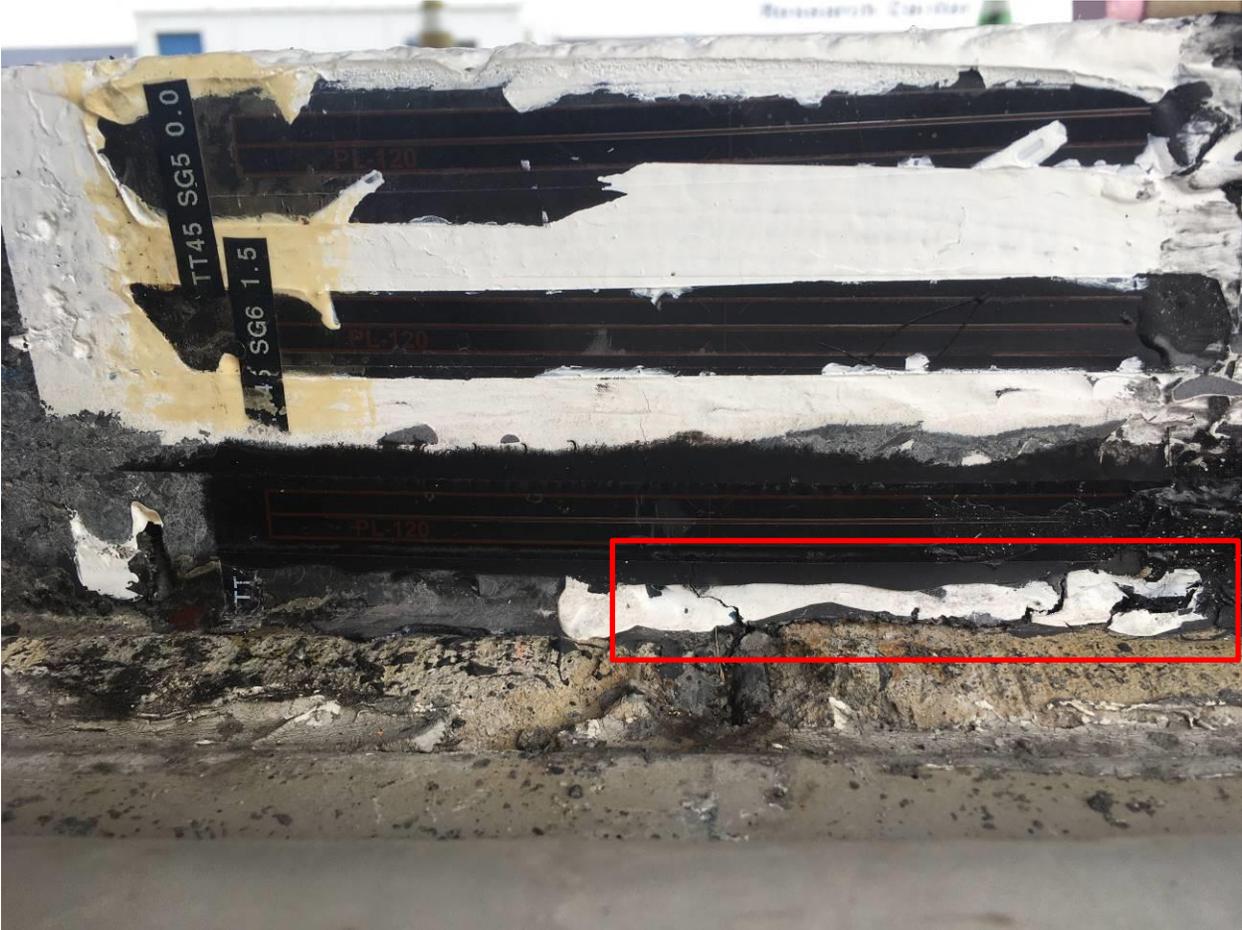
Figure 2 TT45 Joint West Side

TT45 Joint West Side. Same as yesterday, 10 mm (approximate) vertical hairline crack, in asphalt at concrete joint at approximately 45 degrees to the left, then the hairline crack moved to the right for 40 mm (approximate) parallel to the concrete surface, this shows surface de-bonding but may be just in paint then went 5 mm vertical again, figure 2.

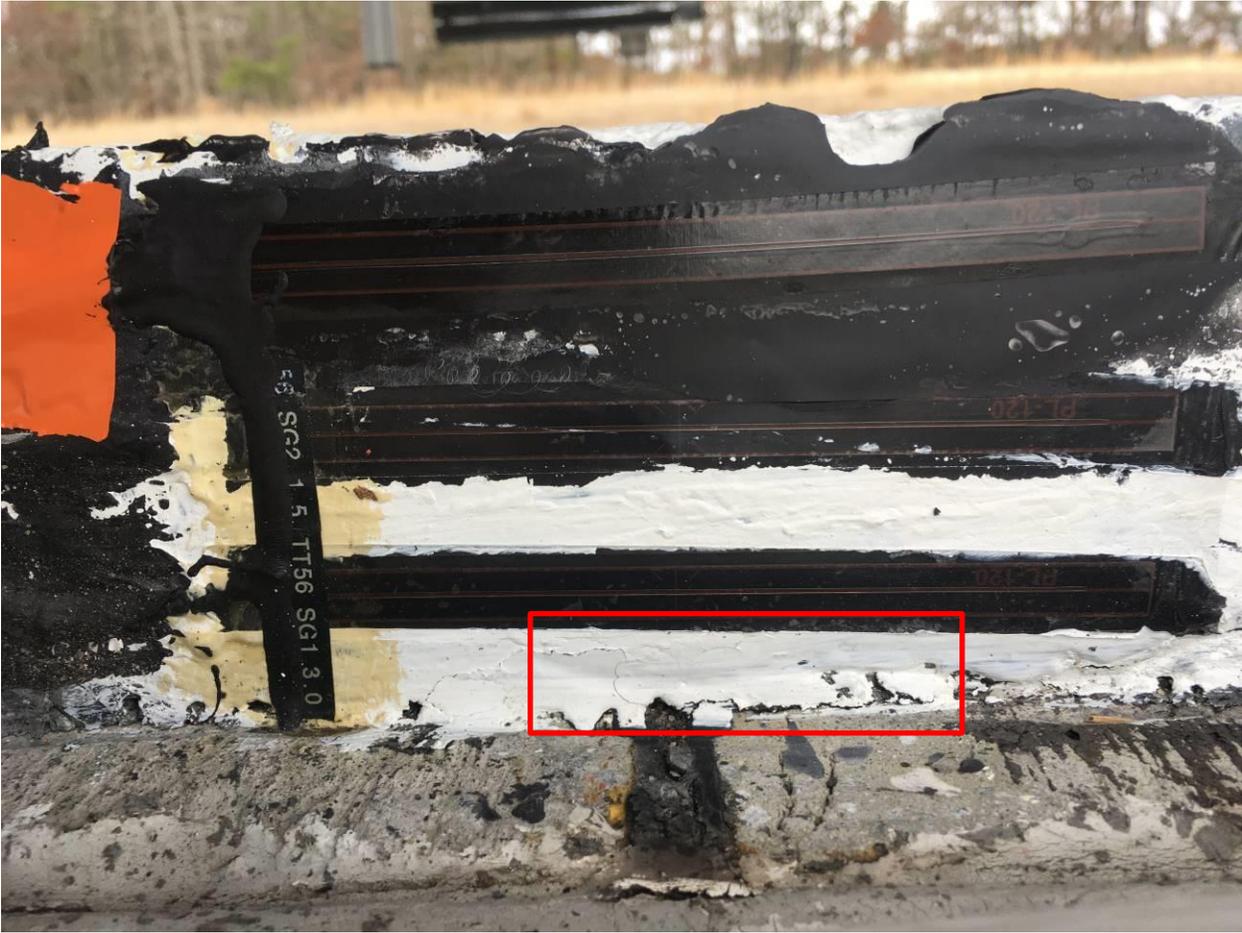
Figure 4 TT56 Joint East Side

TT56 Joint East Side. 4 mm (approximate) vertical hairline crack, in asphalt at concrete joint, then the hairline crack moved to the right for 30 mm (approximate) parallel to the concrete surface this shows surface de-bonding but may be just in paint, figure 4.

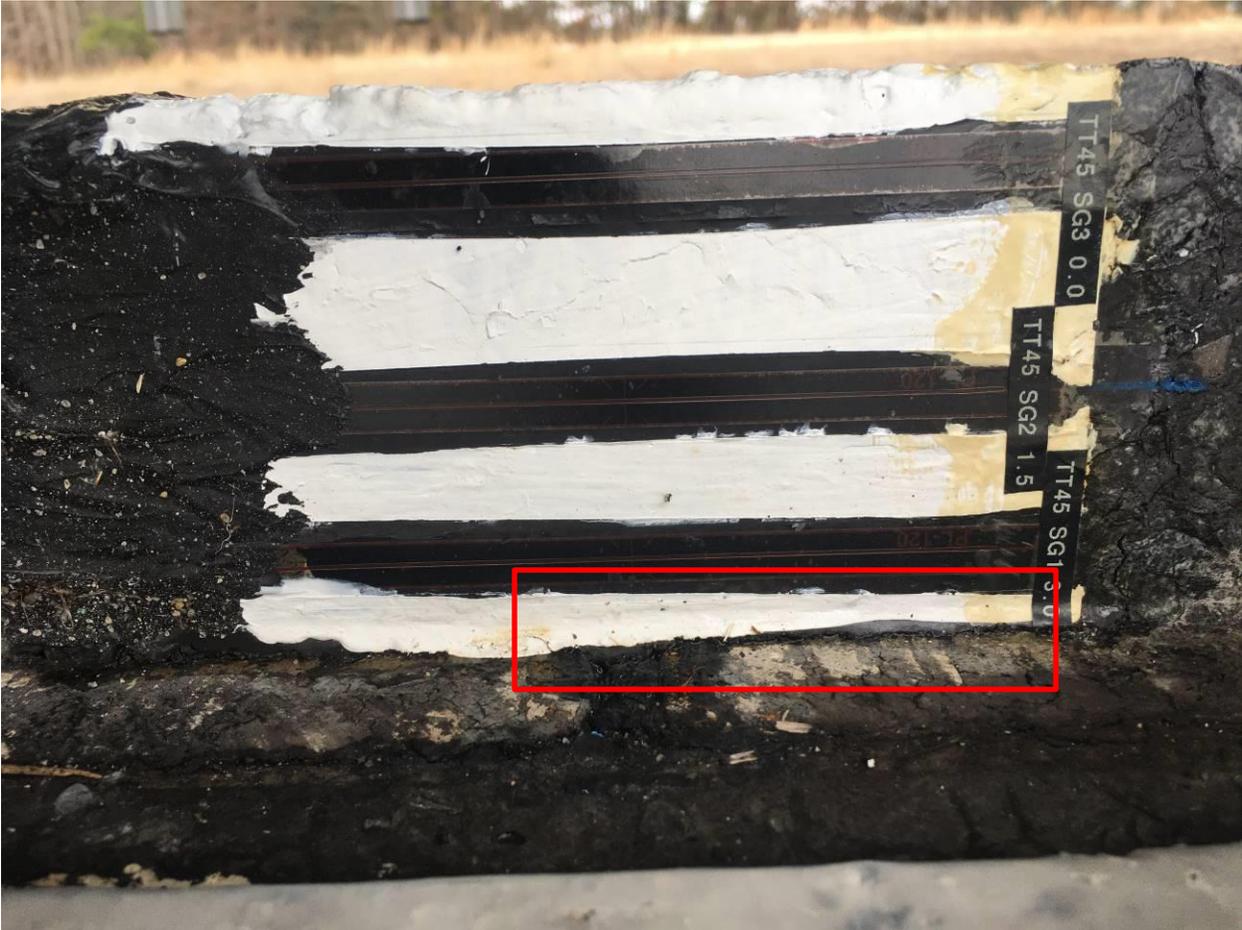
Figure 5 TT45 Joint East Side

TT45 Joint East Side. 4 mm (approximate) vertical hairline crack, in asphalt at concrete joint at approximately 45 degrees to the left, then the hairline crack moved to the right for 40 mm (approximate) parallel to the concrete surface, this shows surface de-bonding but may be just in paint, figure 5.
