Construction Progress and Inspection Report

NAPMRC

Project Name
TO#15 Ref.
Crack._Outdoor_Phase1

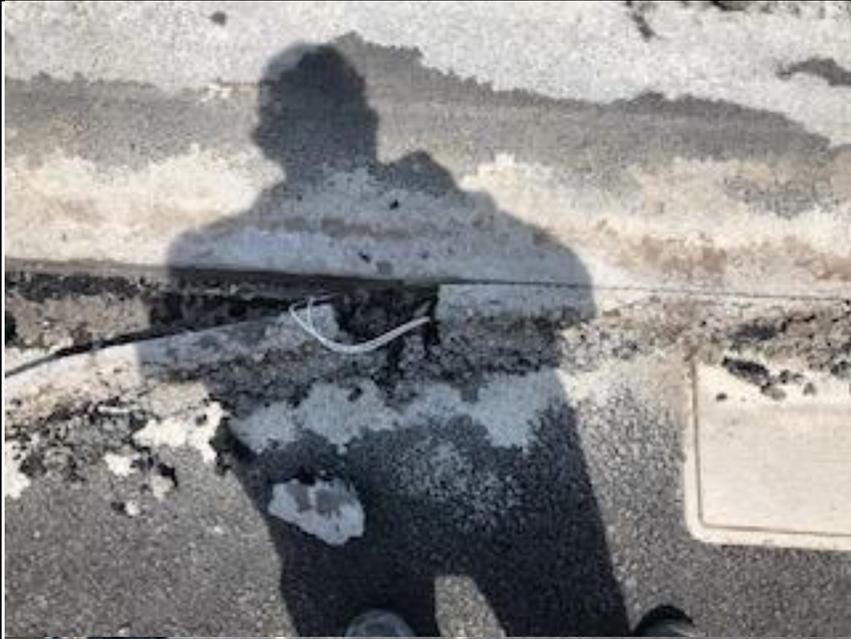
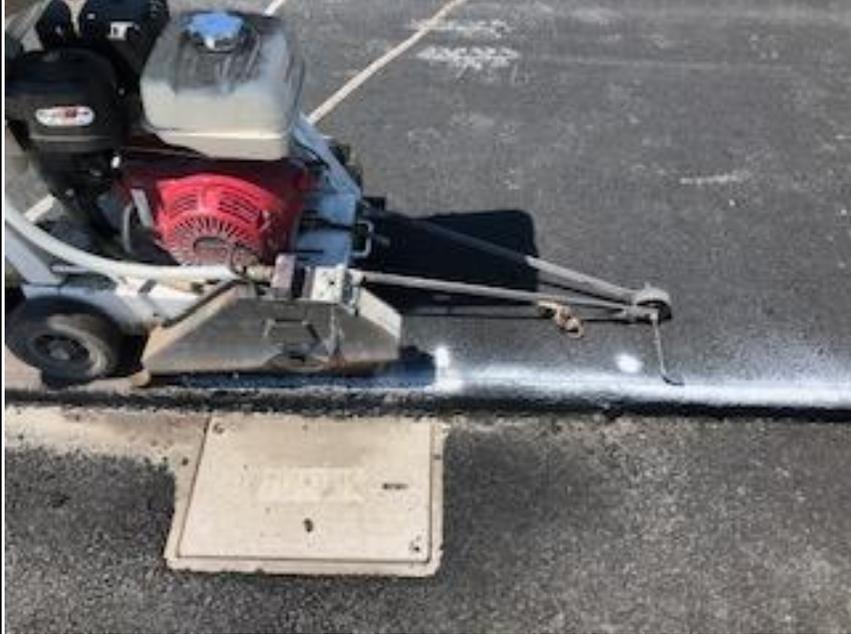
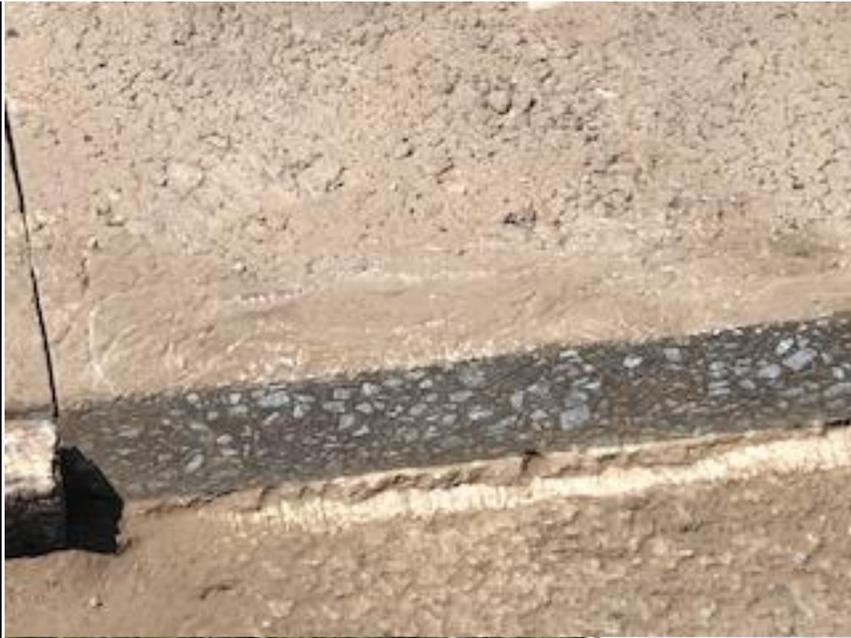
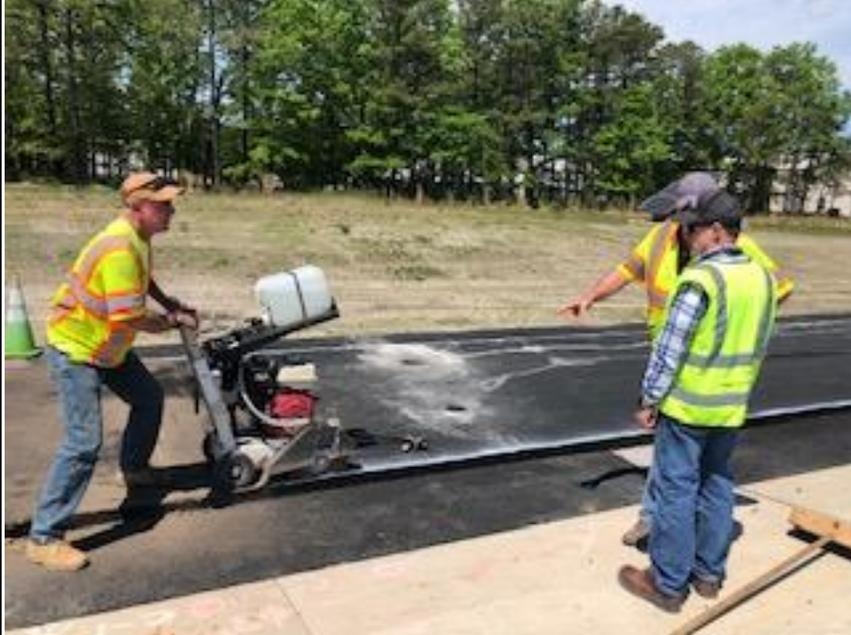
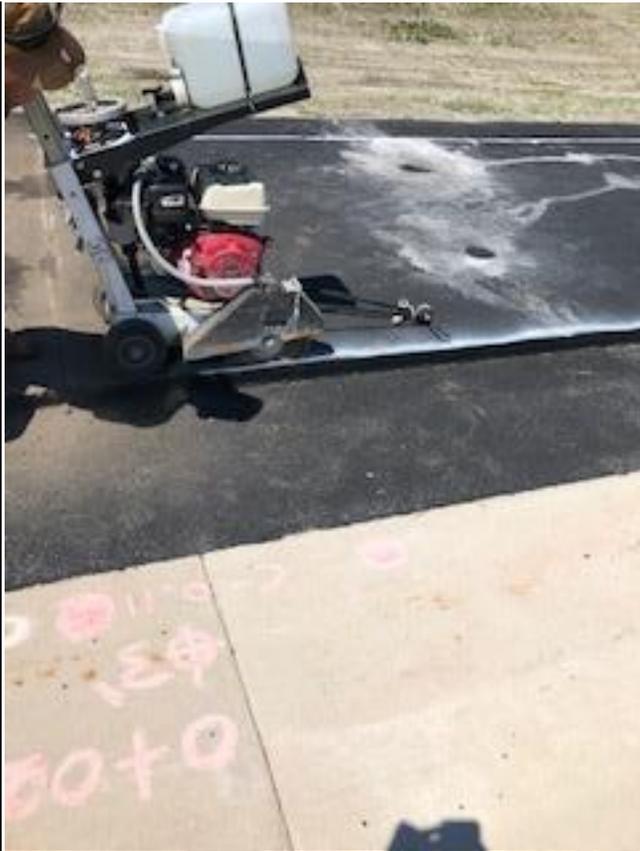
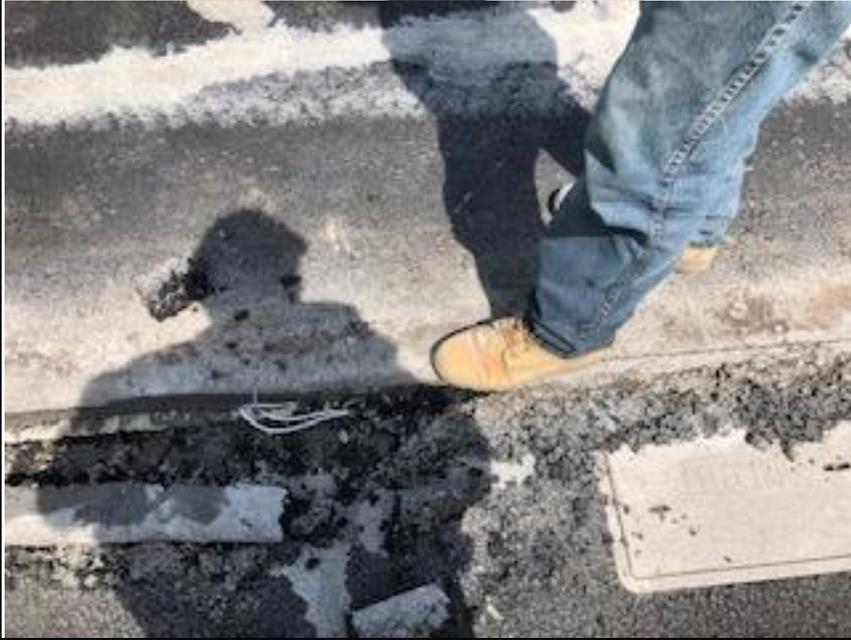
*Saw cut the edge to create a vertical smooth edge as per plan

Our instrumentation team marked the location of the gages wiring. While sawing the west edge the gage wires where cut, beyond the location of the mark. After investigation due to rolling operation the wire migrated 6"-8" parallel to the concrete slab and 1 ½" up into the P401, the good think is we can splice and reconnect the wiring for the gages

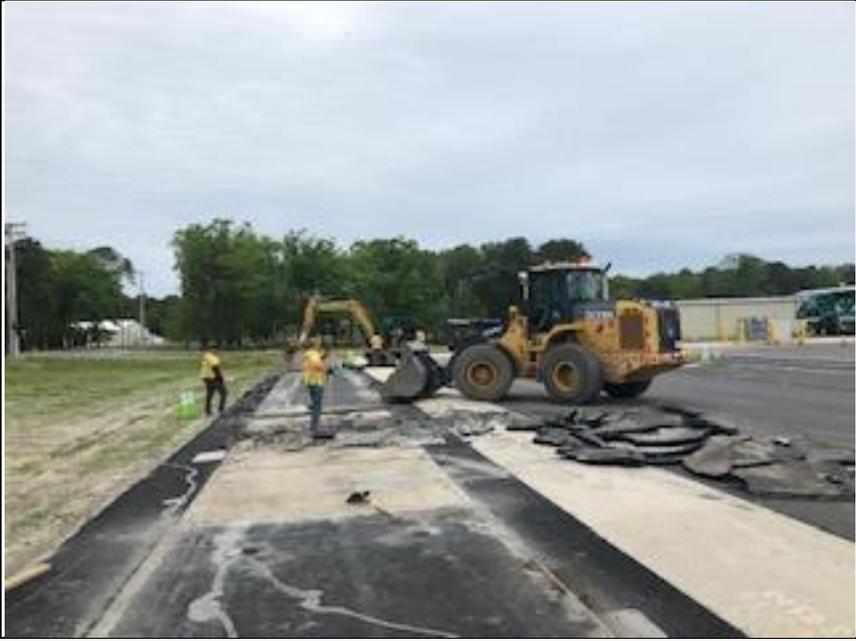
Site Activities
*clean the edge after saw, north end, south end, and middle 3 slabs
