Reflective Cracking Daily Testing Notes

Date: March, 2013

Project: Reflective Cracking Indoor Phase 2

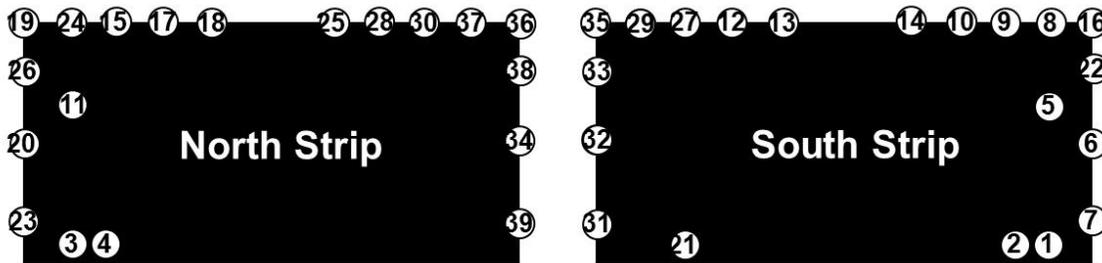
Figure 1. Crack Sequence, Profile View.

Based upon collected instrumentation data, it was concluded that reflection cracks first initiated at the overlay bottom then propagated in both vertical and horizontal directions. Such a two-directional propagation phenomenon is clearly shown in the crack map below. See Figure 1 and Table 1.

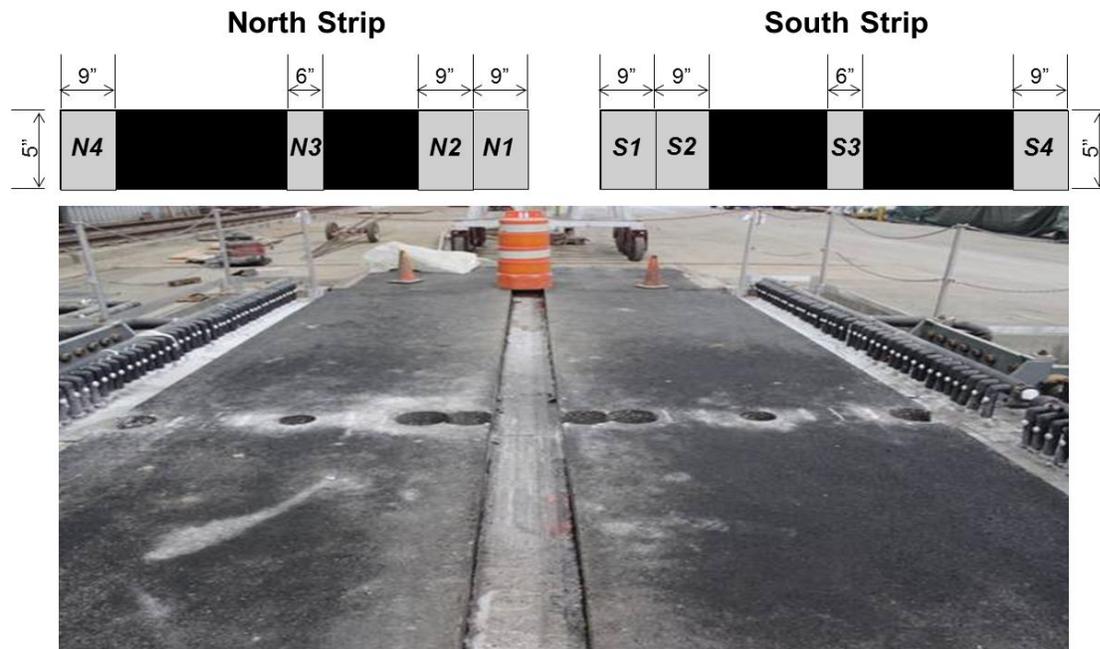
Figure 2. Core locations to determine the crack extent

The full-scale test ended on March 8, 2013. A total of 4869 loading cycles were completed. A number of cores were taken for future laboratory tests to verify the crack direction. For each overlay strip, three 9 inch and one 6 inch diameter cores were obtained as shown in Figure 2. The HMA overlay was then milled on March 20, 2013.

Since the majority of instrumentations were located on the surface, additional field cores were taken to determine the crack extent, Figure 2.
