Reflective Cracking Testing Notes

Date: March 12, 2015

Project: Reflective Cracking Indoor Phase IV

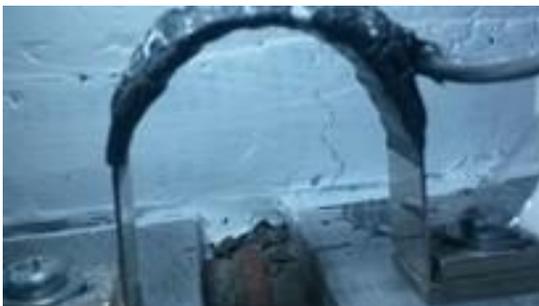
The 12 mil test cycle continued on the Phase IV test item. On the South test section, both the inner and outer vertical edges show no change, as shown in Figure 1 and 2 respectively. On the North test section, the inner vertical edge shows no change, as shown in Figure 3. The North outer vertical edge crack has propagated past SG6-N-2.5 and reaches 3 inches in length. SG6-N-2.5 is open, as shown in Figure 4.

Figure 1. South Inner Vertical Edge.

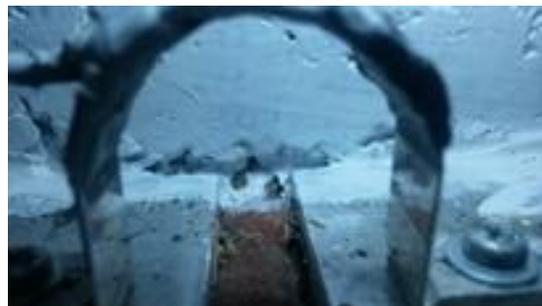
Figure 2. South Outer Vertical Edge.

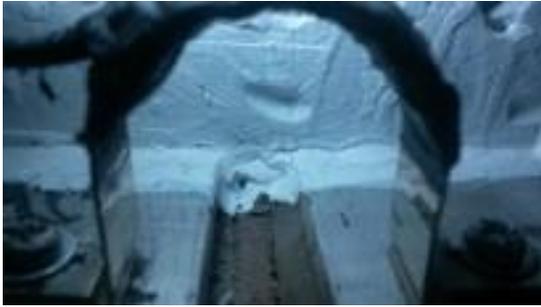
Figure 3. North Inner Vertical Edge.

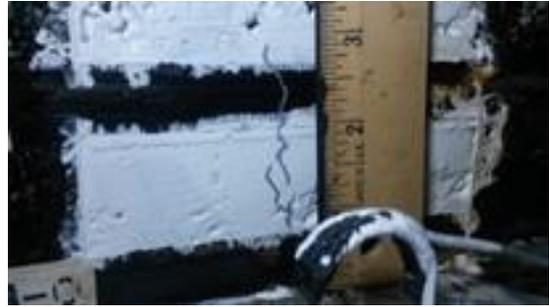
Figure 4. North Outer Vertical Edge.
