Reflective Cracking Testing Notes

Date: March 16, 2015

Project: Reflective Cracking Indoor Phase IV

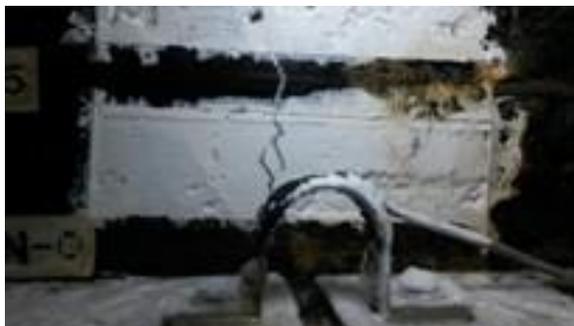
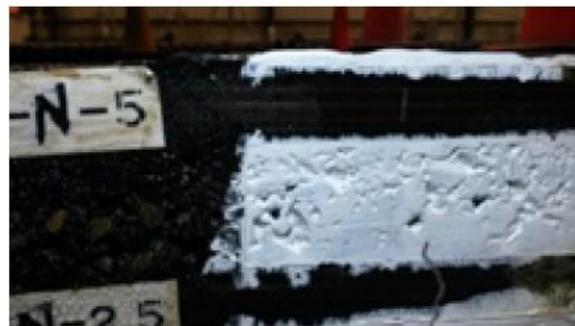
The 12 mil test cycle continued on the Phase IV test item. On the South test section, both the inner and outer vertical edges show no change. On the North test section, the inner vertical edge shows no change. The North outer vertical edge crack has reached the top of the 5-inch-thick pavement, as shown in Figure 1 below, and all the vertical edge surface gages (SG6-N-0, SG6-N-2.5, and SG6-N-5) are reading open. From the top edge, the crack has propagated across the top surface, as shown in Figure 2. The top surface gauge SG5-N-5 is open and SG4-N-5 is responding with a square wave which suggests that it will open shortly. Gauge response patterns are shown in Figure 3.

Figure 1. North Outer Vertical Edge - Large Change.

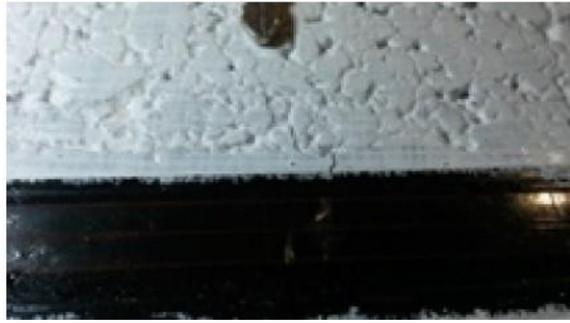
There is currently no visible crack between SG5-N-5 and SG4-N-5, however, there is a visible crack that extends to 1 inch above SG5-N-5.

Figure 2. North Vertical Crack at SG5-N-5.

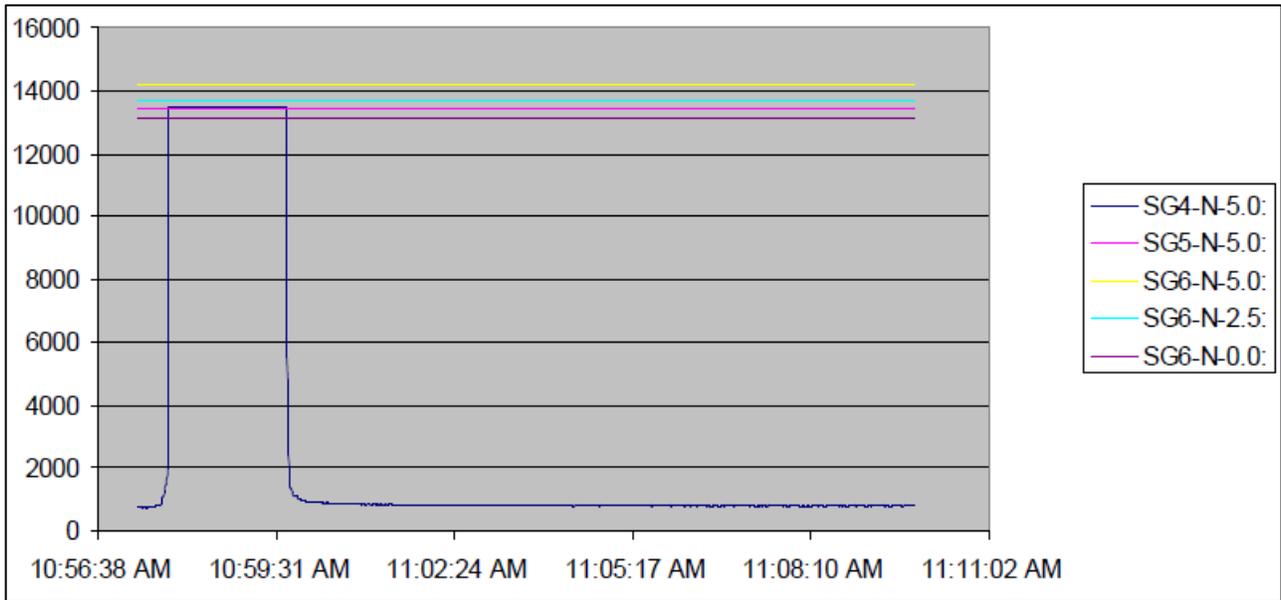
Figure 3. Surface Gauge Responses.
