Reflective Cracking Testing Notes

Date: March 19, 2015

Project: Reflective Cracking Indoor Phase IV

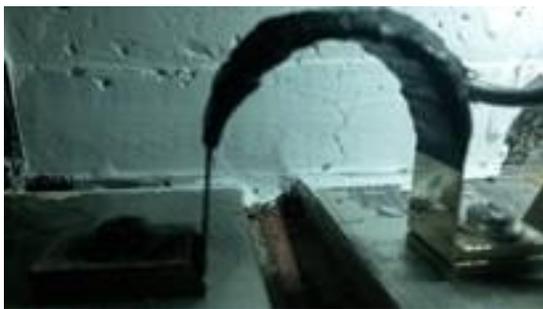
The 12 mil test cycle continued on the Phase IV test item. On the South test section, the inner vertical edge shows no change, as shown in Figure 1. The South outer vertical edge shows evidence of movement between the concrete and asphalt interface, as shown in Figure 2.

Figure 1. South Inner Vertical Edge.

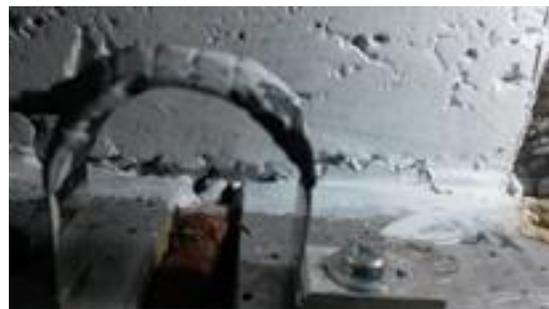
Figure 2. South Outer Vertical Edge.

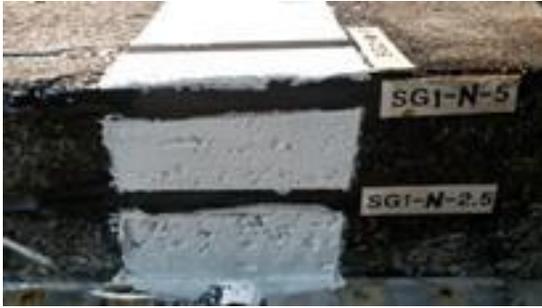
On the North test section, the inner vertical edge shows no change, as shown in Figure 3. The North test section surface crack has become visible since yesterday (3/19/2015), as shown in Figure 4. Another crack is visible along the outer vertical edge as before, as shown in Figure 5. The crack is more readily visible at SG5-N-5, as shown in Figure 6. The crack has become visible between SG5-N-5 and SG4-N-5, as shown in Figure 7. The crack has become visible between SG4-N-5 and SG3-N-5, as shown in Figure 8. The crack has propagated from SG3-N-5 and reached the 54 inch mark (on the 60-inch tape measure), as shown in Figure 9 and 10 below. The end of the crack is currently 6 inches away from the inner edge.

Figure 3. North Inner Vertical Edge.

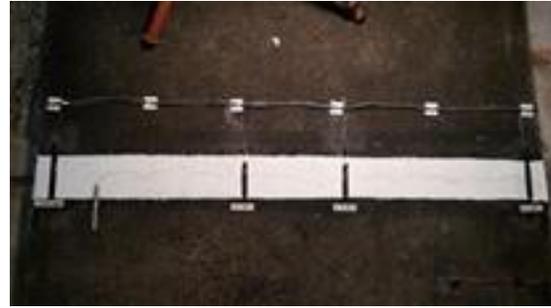
Figure 4. North Test Section Surface.

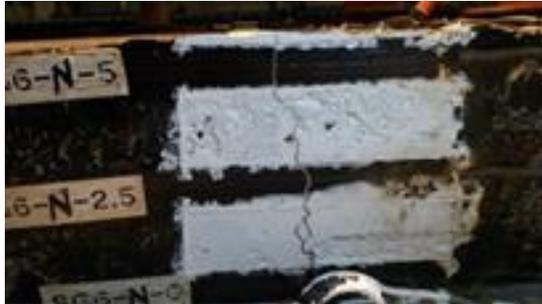
Figure 5. North Outer Vertical Edge.

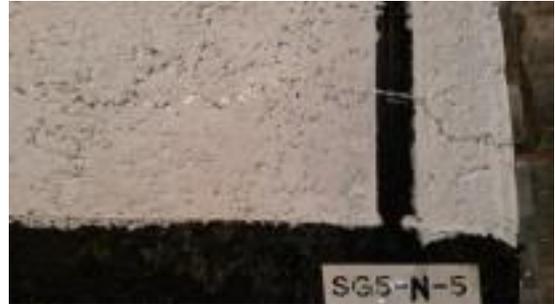
Figure 6. North Surface Crack at SG5-N-5.

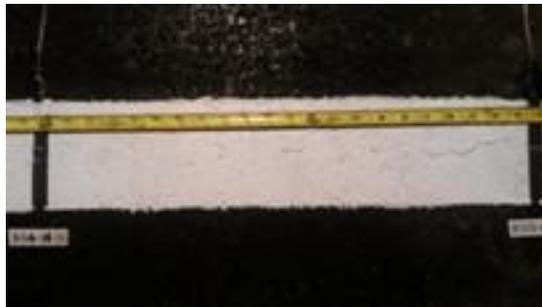
Figure 7. North Surface - SG5-N-5 to SG4-N-5.

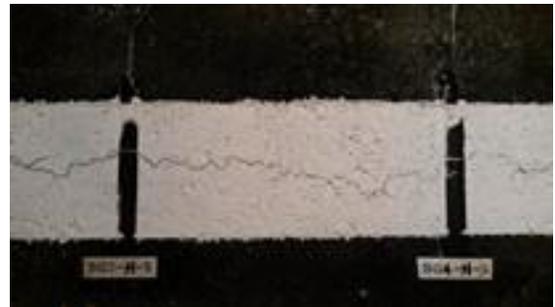
Figure 8. North Surface - SG4-N-5 to SG3-N-5.

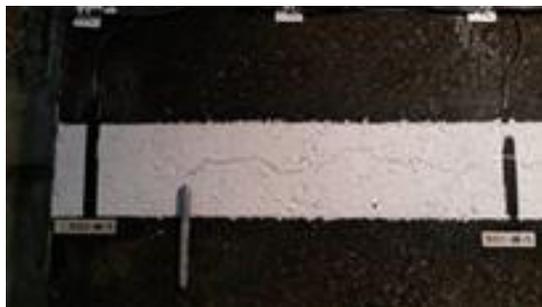
Figure 9. North Surface - SG3-N-5 to SG2-N-5.

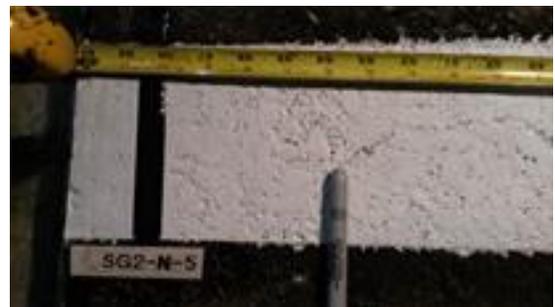
Figure 10. North Surface - Crack at 54 inches.
