Reflective Cracking Testing Notes

Date: March 20, 2015

Project: Reflective Cracking Indoor Phase IV

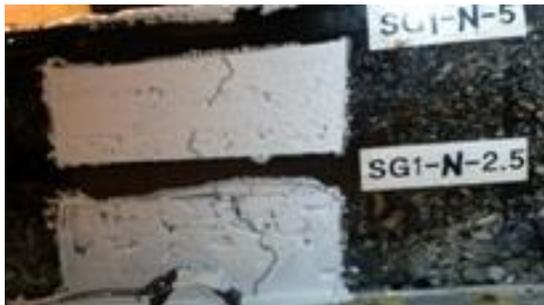
The 12 mil test cycle continued on the Phase IV test item. On the South test section, both the inner and outer vertical edges show no change from yesterday (3/19/2015). On the North test section, the inner vertical edge has a bottom-up crack that is now visible up to SG1-N-5, shown in Figure 1 below. There is currently no crack between SG1-N-5 and SG2-N-5, as shown in Figure 2. No additional propagation was observed in the top surface crack of the North test section. As shown in Figure 3, the end of this crack is still 6 inches from the edge of the pavement.

Figure 1. North Inner Vertical Edge.

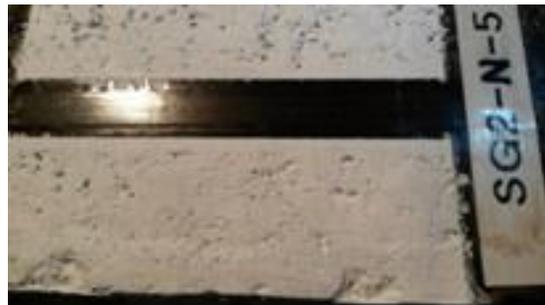
Figure 2. North Inner Edge - Top Surface.

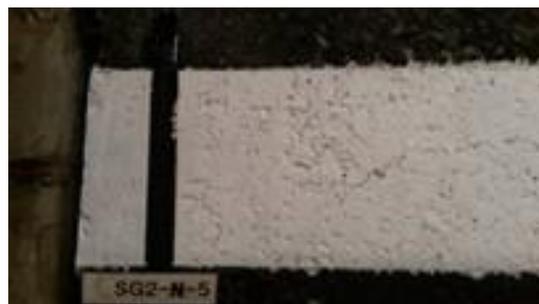
Figure 3. North Top Surface Crack.
