## Reflective Cracking Testing Notes

**Date:** March 26, 2015

**Project:** Reflective Cracking Indoor Phase IV

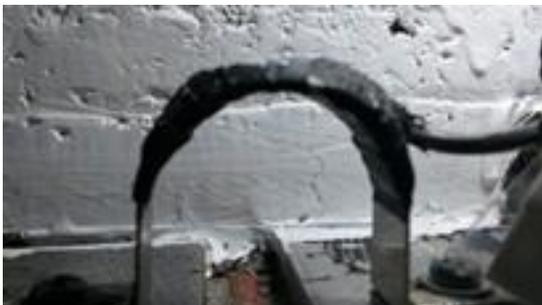
The 12 mil test cycle continued on the Phase IV test item. On the South test section, the inner vertical edge shows no change. The South outer vertical edge shows no change other than the horizontal crack along the interface, as shown in Figure 1 and 2. All of the South side surface gauges are responding. These gauges do not indicate the presence of cracks as none of them are open, as shown in Figure 8.

Figure 1. South Inner Vertical Edge.

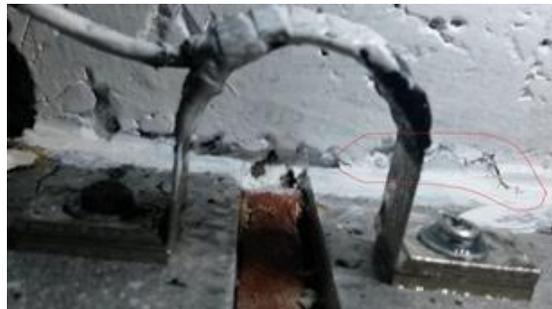
Figure 2. South Outer Vertical Edge.

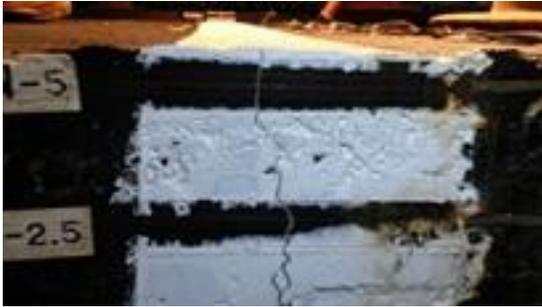
On the North test section, cracking has propagated through the pavement structure. The bottom-up crack originated on the outer vertical edge, as shown in Figure 3. The surface crack propagated from the outer structure toward the inner structure, as shown in Figure 4. The crack stopped at the 54 inch mark leaving 6 inches to go before it reaches the inner edge. A bottom-up crack became visible on the inner vertical edge, as shown in Figure 5. The surface crack propagated 6 more inches reaching the inner edge, as shown in Figure 6. All but (1) of the North side surface gauges are reading open, with SG1-N-2.5 is still responding. North side gauge responses are shown in Figure 7.

Figure 3. North Outer Vertical Edge.

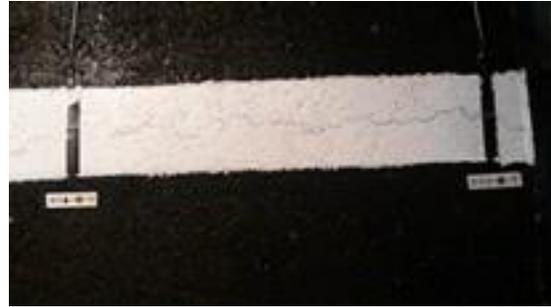
Figure 4. North Right Side of Test Facing West.

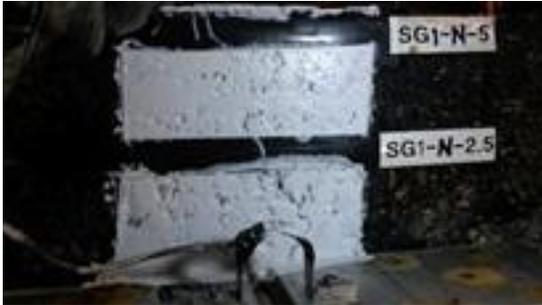
Figure 5. North Inner Vertical Edge.

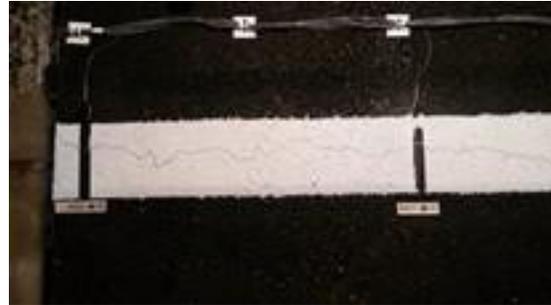
Figure 6. North Surface Crack.

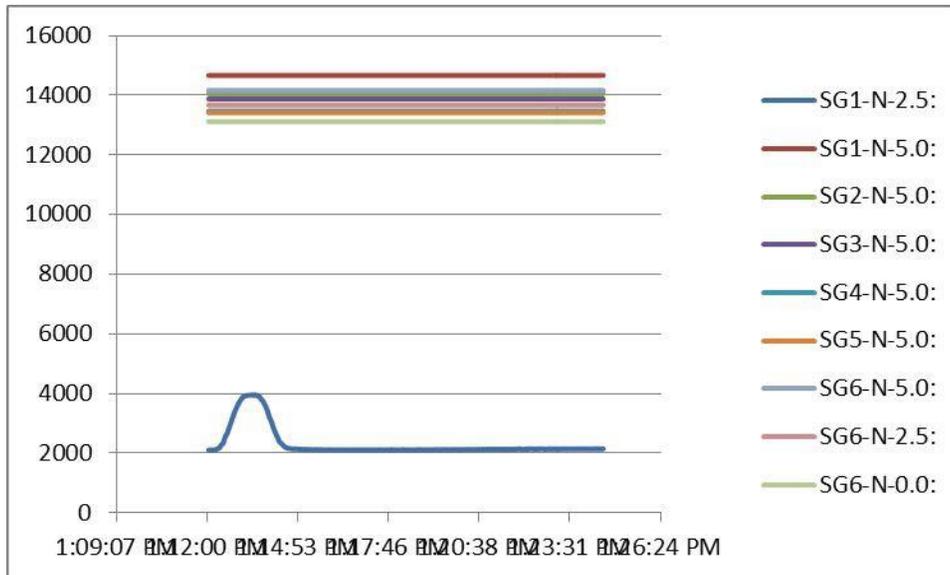
Figure 7. North Surface Gauges Response.

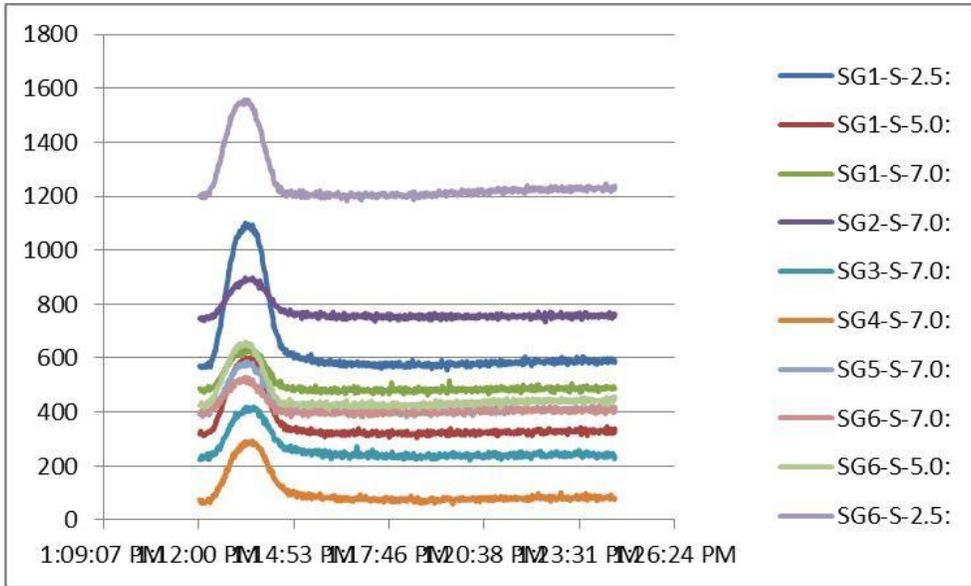
Figure 8. South Surface Gauge Response.
