Reflective Cracking Testing Notes

Date: April 1, 2015

Project: Reflective Cracking Indoor Phase IV

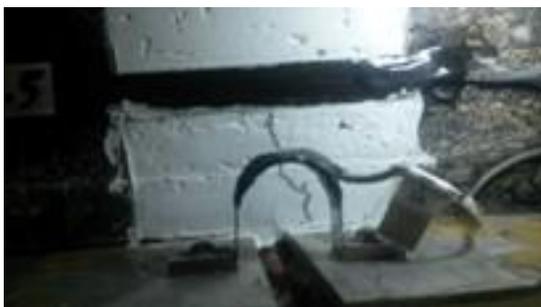
The 18 mil test cycle continued on the South section of the test item. The South inner vertical edge crack has propagated from 1.5 to 2 inches, as shown in Figure 1. The South outer vertical edge shows no crack, as seen in Figure 2.

Figure 1. South Inner Vertical Edge.

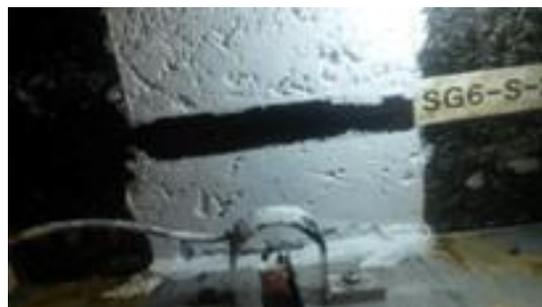
Figure 2. South Outer Vertical Edge.
