Reflective Cracking Testing Notes

Date: March 06, 2017

Project: Reflective Cracking Indoor Phase 5

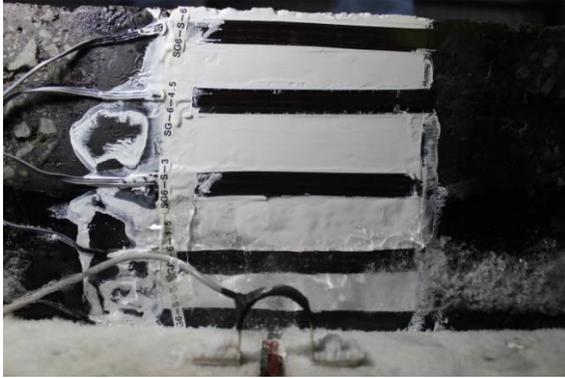
- Outer vertical edge:
 - Thin crack through SG6-S-0 and SG6-S-1.5. Crack stopped at SG6-S-3 as shown in Figure 1.
 - Ice formation over SG6-S-0 and SG6-S-1.5.
- Joint surface area:
 - Start from the South outer edge and work toward the inner edge, none of the surface gauges show evidence of a crack as shown in Figures 2, 3, 4 and 5.
- Inner vertical edge:
 - No evidence of a crack on inner vertical edge as shown in Figure 6.

Figure 1. Crack through SG6-S-0 & SG6-S-1.5.

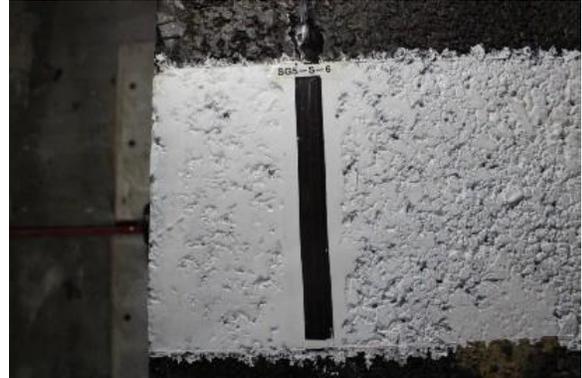
Figure 2. SG5-S-6, no crack. No crack on SG6-S-3, SG6-S-4.5 and SG6-S-6.

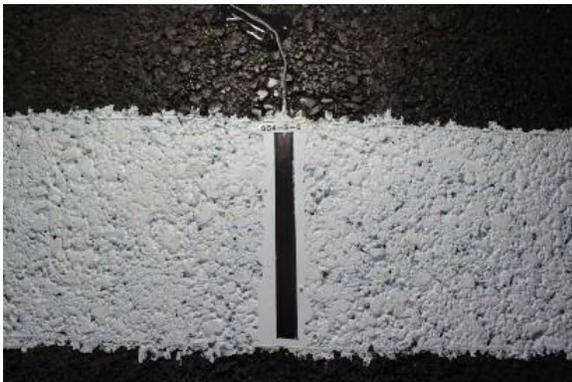
Figure 3. SG4-S-6, no crack.

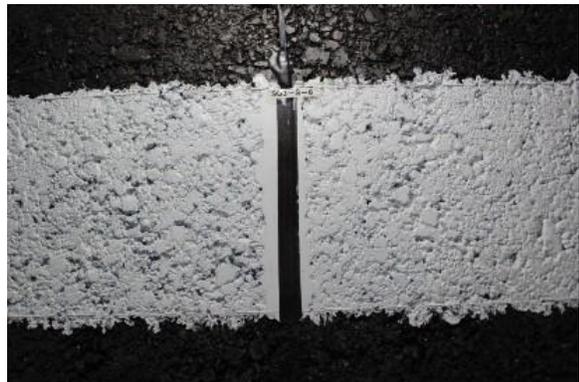
Figure 4. SG3-S-6, no crack.

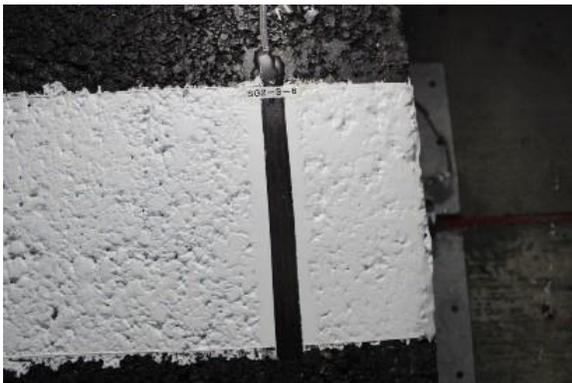
Figure 5. SG2-S-6, no crack.

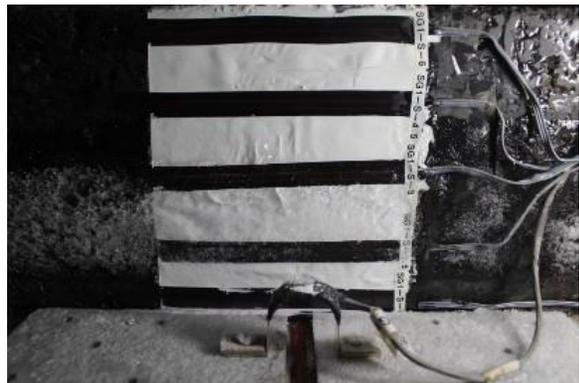
Figure 6. SG1-S-0 through SG1-S-6, no crack.

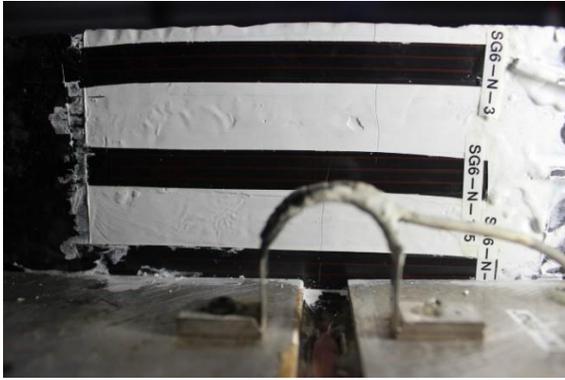
- Outer vertical edge:
 - Thin crack through outer vertical edge. SG6-N-0, SG6-N-1.5 and SG6-N-3.
 - Bottom up crack appears to have propagated through the vertical edge as shown in Figure 7.
- Joint surface area:
 - Start from the North outer edge and work toward the inner edge. Crack appears to have propagated up to SG5-N-3.
 - Sporadic surface cracks from SG4-N-3 through SG3-N-3 as shown in Figures 8, 9, 10 and 13.
 - SG5-N-3 and SG4-N-3 read open.
 - No crack on SG2-N-3 as shown figure 11.
- Inner vertical edge:
 - No crack on the inner vertical edge (see Figure 12).

Figure 7. SG6-N-0, SG6-N-1.5 & SG6-N-3 bottom up crack complete.

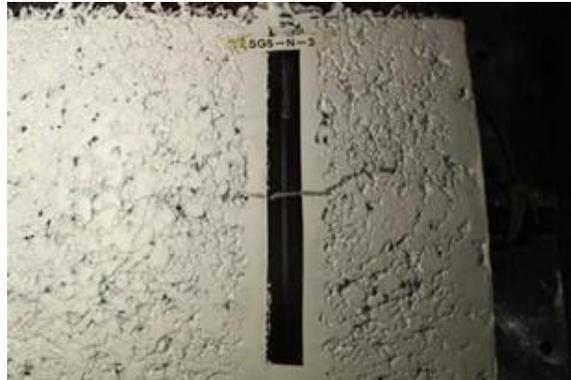
Figure 8. SG5-N-3, crack propagation from vertical edge to SG5 surface.

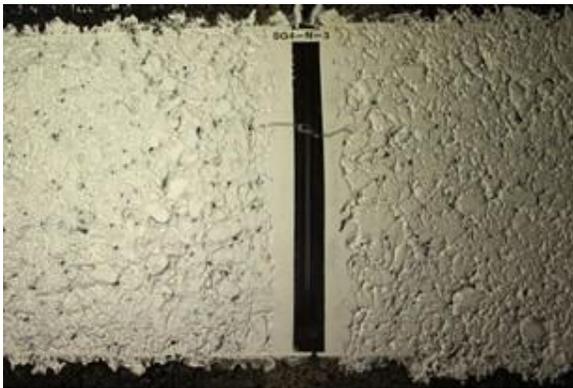
Figure 9. SG4-N-3, incomplete crack.

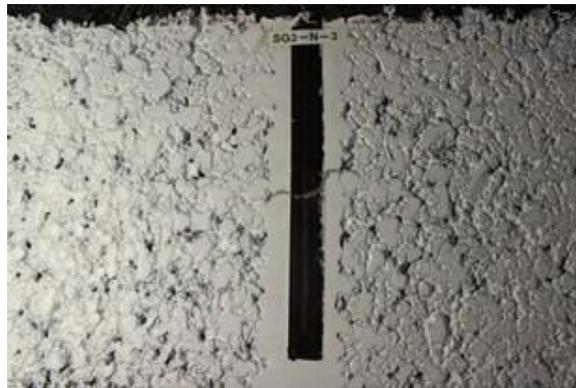
Figure 10. SG3-N-3, incomplete crack.

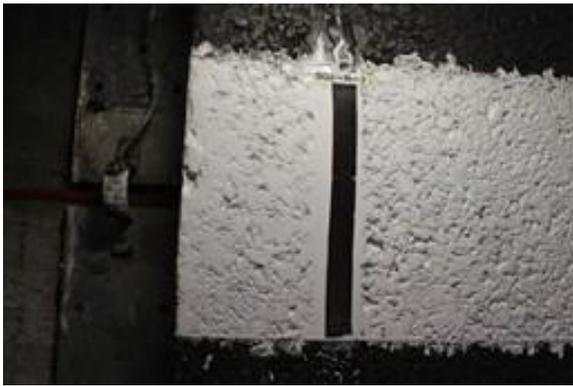
Figure 11. SG2-N-3, no crack.

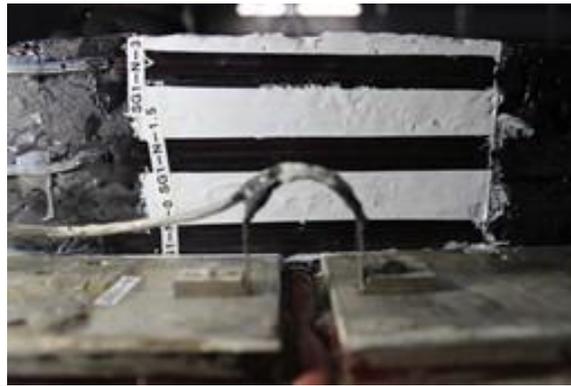
Figure 12. SG1-N-0, SG1-N-1.5 & SG1-N-3, no crack.

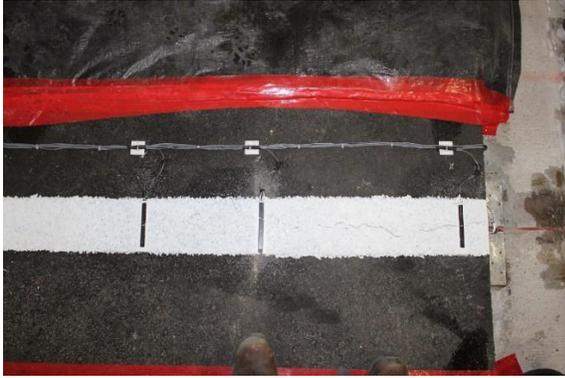
Figure 13. Top view of North test item surface crack.
