Reflective Cracking Testing Notes

Date: March 09, 2017

Project: Reflective Cracking Indoor Phase 5

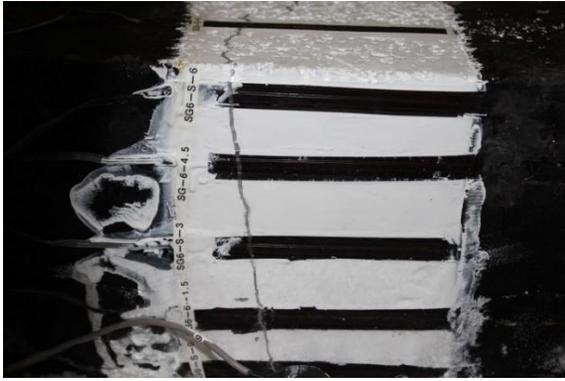
- Outer vertical edge:
 - The entire vertical edge is now cracked. SG6-S-0, SG6-S-1.5, SG6-S-3, SG6-S-4.5 and SG6-S-6 as shown in Figure 1.
 - The propagation of the vertical crack began to deviate from center of the slab.
 - The upper most vertical gauge, SG6-S-6 is not open as shown in Figure 2.
 - Note: Any value higher than 12,000us is an open gauge.
- Joint surface area:
 - The crack has propagated past the vertical edge and gone through SG5-S-6 as shown in Figure 3.
 - SG5-S-6 is open.
 - The crack stopped before reaching SG4-S-6 as shown in Figure 4.
 - There are no cracks around SG3-S-6 and SG2-S-6 as shown in Figure 5.
- Inner vertical edge:
 - None of the inner vertical edge gauges show evidence of cracking.

Figure 1. Crack through the South vertical edge

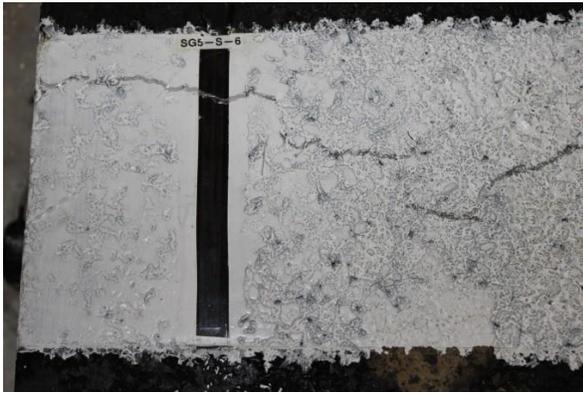
Figure 3. Crack propagate through SG5-S-6

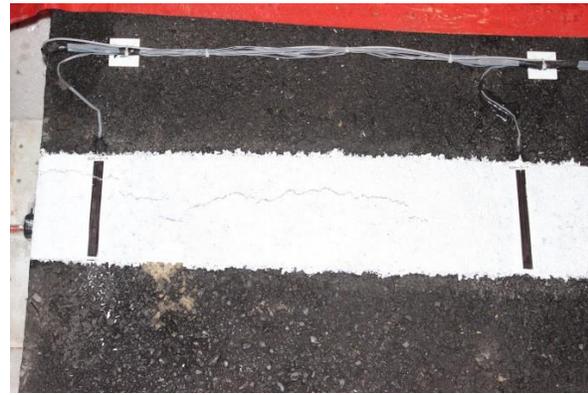
Figure 4. Plan view of South crack propagation

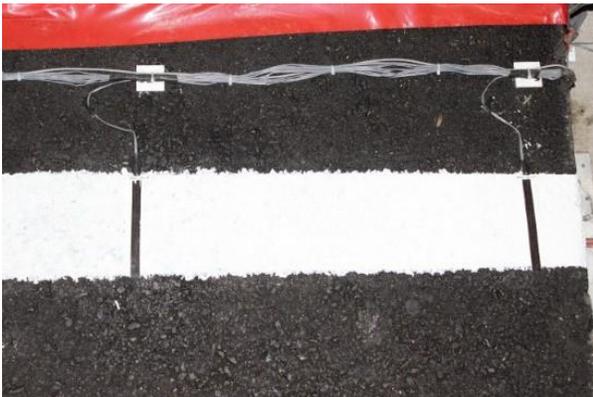
Figure 5. No cracks around SG3-S-6 and SG2-S-6

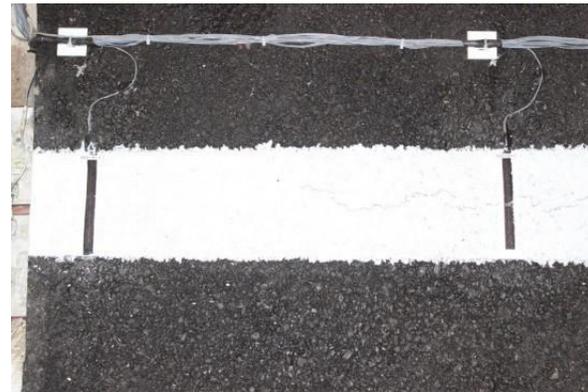
- Outer vertical edge:
 - The vertical edge is completely cracked.
 - No changes were observed.
- Joint surface area:
 - No noticeable surface crack propagation as shown in Figure 6.
- Inner vertical edge:
 - No crack on the inner vertical edge.
 - No changes were observed.

Figure 6. Plan view showing no observed changes to the North side surface
