**DOT/FAA/AR-10/33**

# **Performance Assessment of a Radar-Based Foreign Object Debris Detection System**

February 2011

Final Report

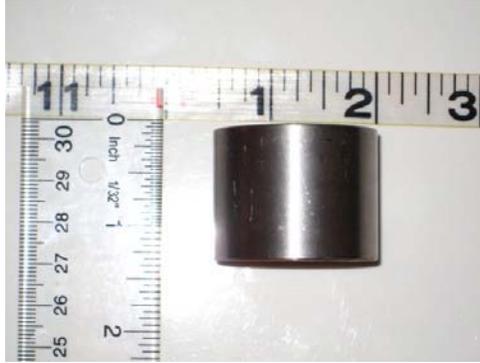
Figure 4. Primary Target Used to Assess the Tarsier FOD Detection System

The standard FOD item used in the Tarsier FOD detection system performance assessment conformed to the specifications in AC 150/5220-24. The target was a metal cylinder, measuring 1.2 in. (3.1 cm) high and 1.5 in. (3.8 cm) in diameter, which was painted on each end with ultraviolet and fluorescent paint to enable after-dark visual detection by CEAT researchers. The target, shown in figure 4, provided a consistent reflectivity for radar detection (a nominal -20 decibel below milliwatt<sup>2</sup> (dBm<sup>2</sup>) radar cross section (RCS)) and conformed to QinetiQ's specifications for a standard target. The target was used in all Tarsier performance assessments and was also used to determine system performance under inclement weather conditions.

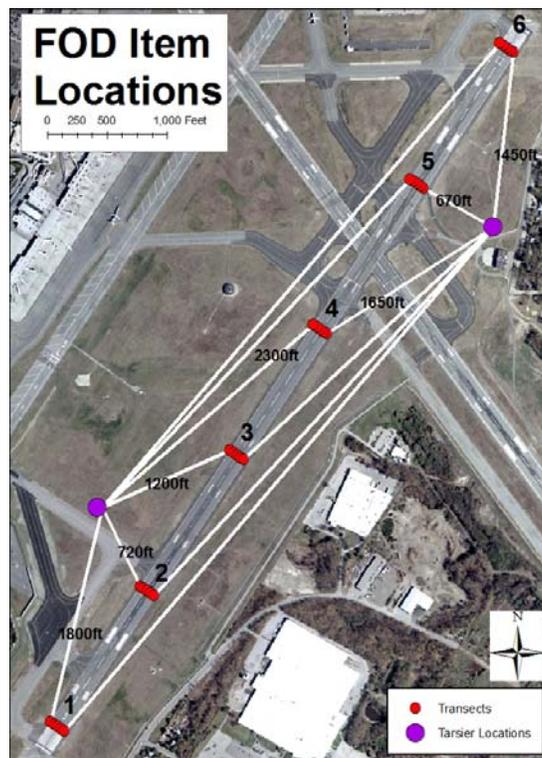
Figure 5. Target Locations Along the Length of Runway 5/23 (Distances rounded)

Runway test procedure development at PVD was initiated with the identification of target placement locations. Target placement included consideration of radar coverage and overlap and range-to-targets based on expected system performance, figure 5. As shown in table 2, six target placement locations were identified:

- two at the runway ends approximately 16 ft (5 m) from the end light location
- four at approximately 1750 ft (530 m) intervals along the runway

Transect	Distance From North Radar 1 ft (m)	Distance From South Radar 2 ft (m)
1	5494 (1675)	1821 (555)
2	4160 (1268)	723 (220)
3	2834 (864)	1168 (356)
4	1647 (502)	2322 (708)
5	668 (204)	3738 (1140)
6	1454 (443)	5075 (1547)

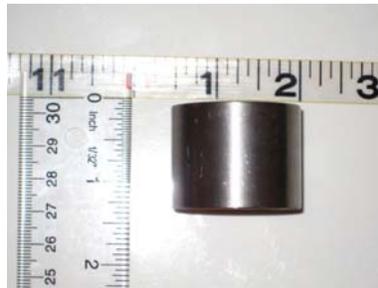
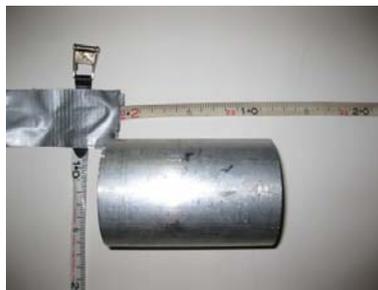
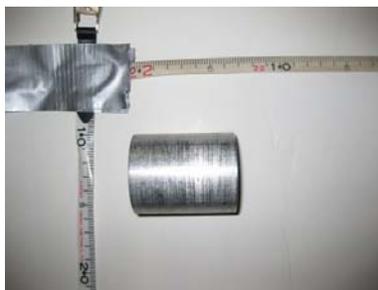
Figure 7. Calibration Items

Standard targets with a nominal  $-20\text{-dBm}^2$  RCS and targets with a nominal  $-10\text{-dBm}^2$  and  $0\text{-dBm}^2$  RCS were used for testing under variable weather conditions. The larger targets were a cylinder measuring 2.5 in. (6.3 cm) high and 2.0 in. (5 cm) in diameter with a nominal  $-10\text{-dBm}^2$  RCS and a cylinder measuring 4.5 in. (11.4 cm) high and 3.0 in. (7.6 cm) in diameter with a nominal  $0\text{-dBm}^2$  RCS. The targets are shown in figure 7.

$-20\text{-dBm}^2$  cylinder

$-10\text{-dBm}^2$  cylinder

$0\text{-dBm}^2$  cylinder

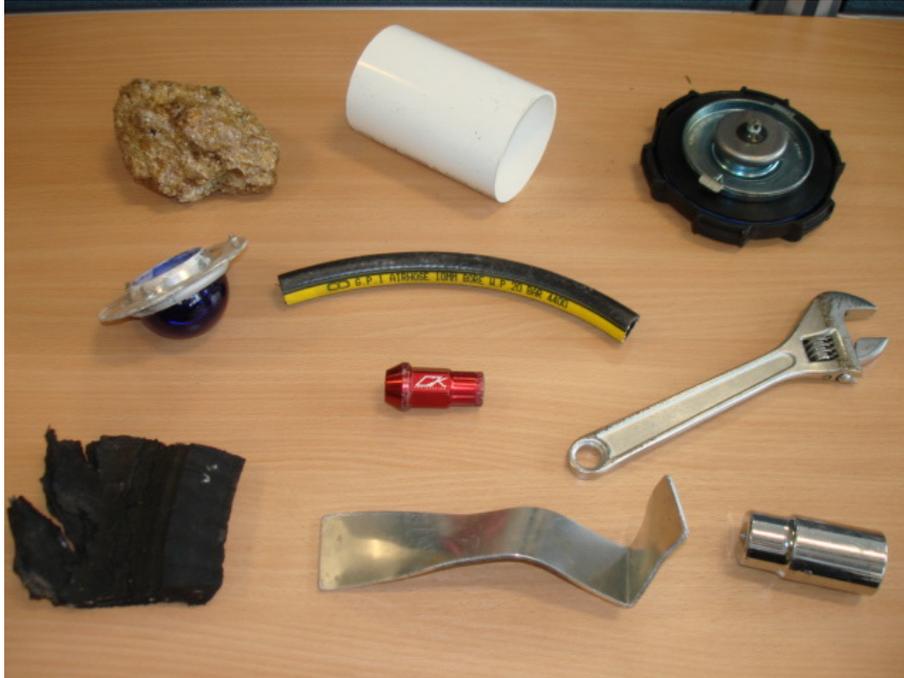
Figure 9. Items Selected by QinetiQ to Meet AC Detection Requirements

QinetiQ selected a group of targets that were then presented to CEAT, as shown in figure 9. CEAT observed the placement of 10 items, one from each category listed in the AC, in a rectangle approximately 100 by 100 ft (30 by 30 m). In the observed test, the Tarsier FOD detection system detected 100% of the FOD items. CEAT also observed tests in which FOD items were placed no more than 10 ft (3 m) from each other and confirmed that these items were detected.

A test conducted by QinetiQ was observed by CEAT. The test placed items from the ten categories of FOD listed in the AC in a test rectangle located a minimum of 1000 ft (300 m) from the radar sensor. All the items were detected by the Tarsier FOD Detection System using normal operational modes of the system. CEAT also observed tests that detected FOD items less than 10 ft (3 m) from each other.

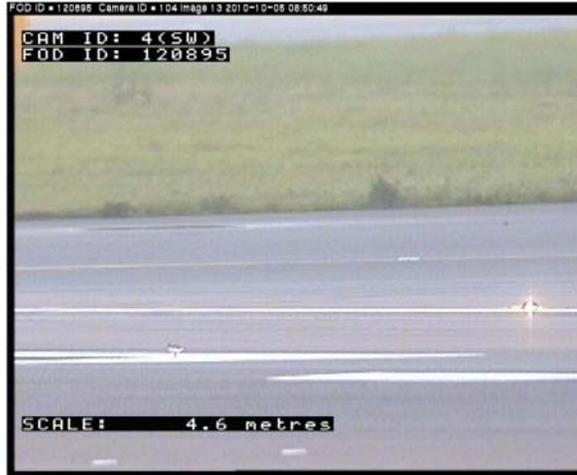
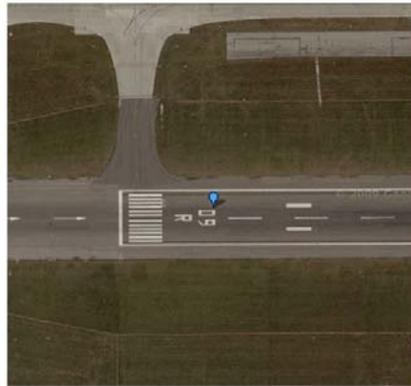
Figure 13. An Example of the QinetiQ FOD Toolbox Report Elements Providing Reporting Data Table, FOD Item Picture, and Location of FOD

Event Type	Time	Initiator	Username	Radar ID	Radar Count	Latitude	Longitude	Zone	Comments
DETECTED	07:46 Oct 05 2010	System	_	4	1	51.464855155934	-0.481138180597937	SOUTH_WEST_1	_
ACKNOWLEDGED	07:46 Oct 05 2010	User	Admin	4	1	51.464855155934	-0.481138180597937	SOUTH_WEST_1	_
RE-ARMED	07:56 Oct 05 2010	System	_	4	1	51.464855155934	-0.481138180597937	SOUTH_WEST_1	_
ACKNOWLEDGED	07:57 Oct 05 2010	User	Admin	4	1	51.464855155934	-0.481138180597937	SOUTH_WEST_1	_
NO_LONGER_DETECTED	07:57 Oct 05 2010	System	_	4	0	51.464855155934	-0.481138180597937	SOUTH_WEST_1	_
MARK_AS_FOUND	07:58 Oct 05 2010	User	Admin	4	0	51.464855155934	-0.481138180597937	SOUTH_WEST_1	pied wagtail sitting on lamp seagull team detailed
CLOSED	07:58 Oct 05 2010	User	Admin	4	0	51.464855155934	-0.481138180597937	SOUTH_WEST_1	_

QinetiQ has developed an advanced GUI, which is a FOD data “toolbox” application that integrates FOD detection information and camera images. This toolbox addresses issues in Section 6 of AC 150-5210-24 related to data collection and analysis and provides the foundation for a FOD reporting system. For example, the toolbox provides access to FOD information on date and time of detection and retrieval, an image of the FOD item and its location, the prevailing weather, and personnel information. Figures 10 through 14 show examples of the QuintiQ toolbox components.
