## DO15 RC Indoor Phase VI Test Daily Notes

*Date: June 12, 2019*

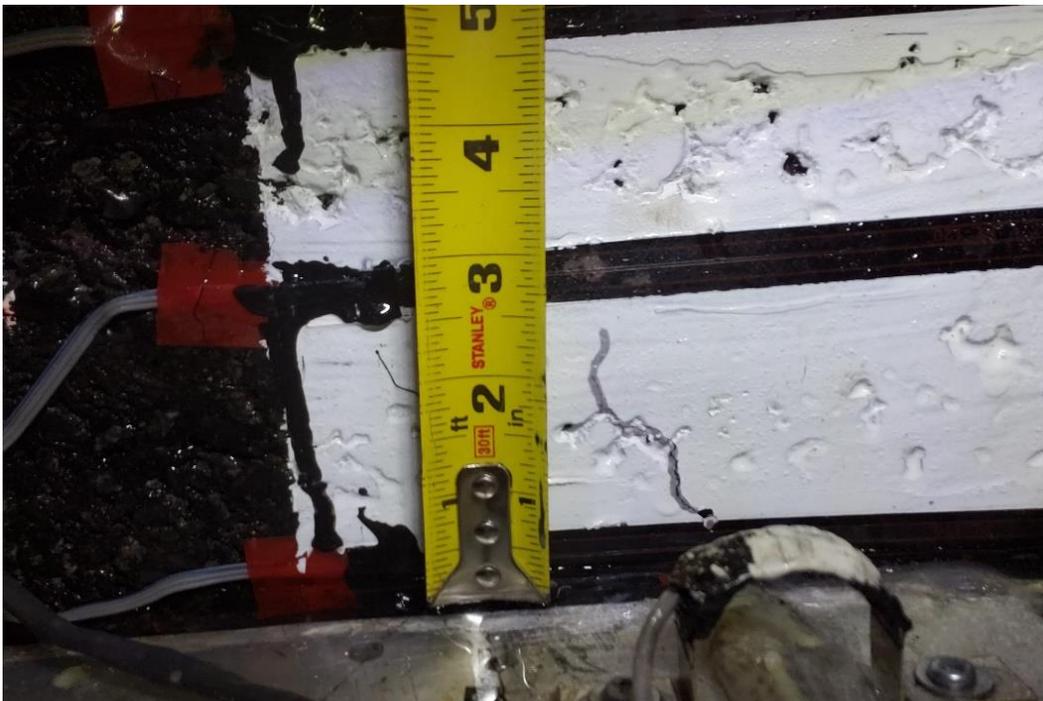
- 1 crack through SG1-N-0, approximately 2.5 inches (Fig 1).
- 1 crack through SG6-N-0, approximately 2.5 inches (Fig 2).
- Surface gage SG1-S-0 failed, and SG3-S-5 reads high strain.

Fig 1 Bottom-up crack at SG1-N-0

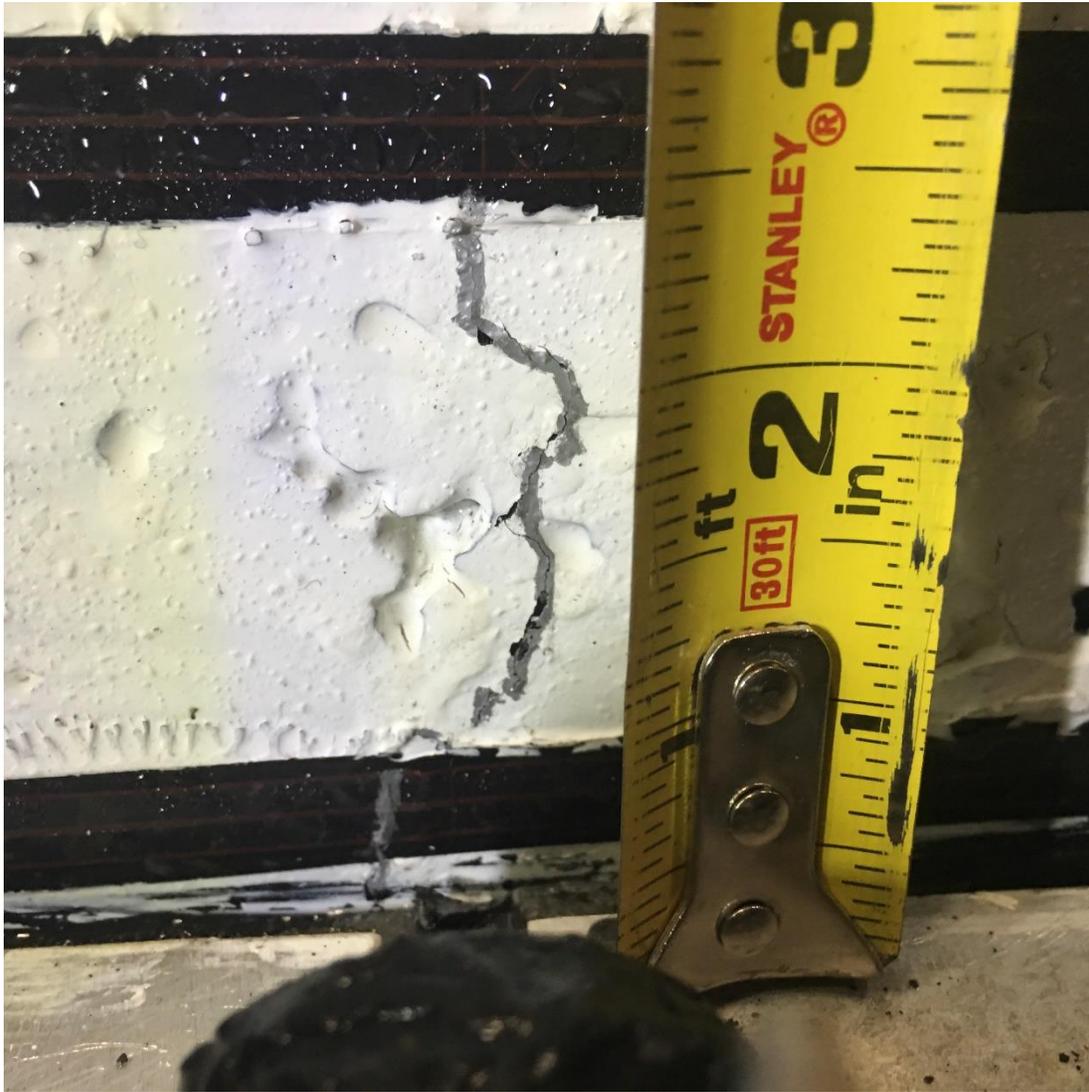
Fig 2 Bottom-up crack at SG6-N-0

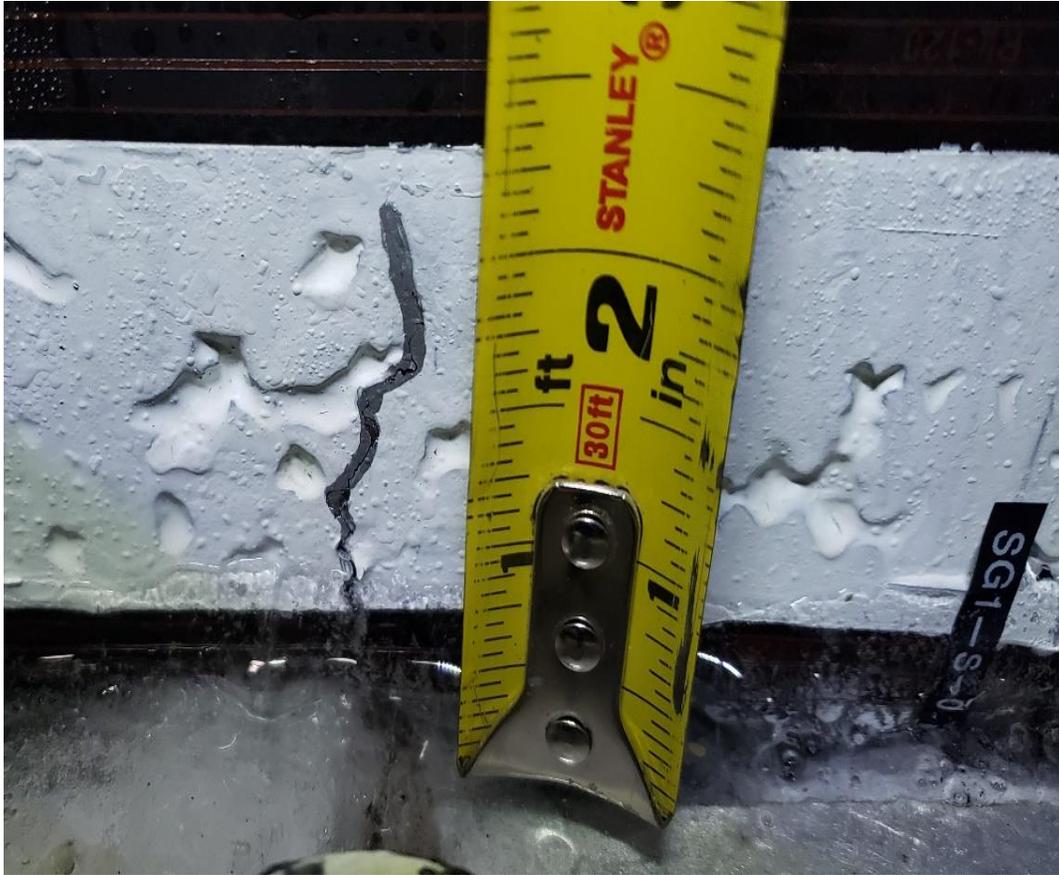
- 1 crack through SG1-S-0, approximately 2.25 inches (Fig 3).
- Surface crack runs through SG3-S-5, length approximately from 14 to 34.5 inch (Fig 4)

Fig 3 Bottom-up crack at SG1-S-0

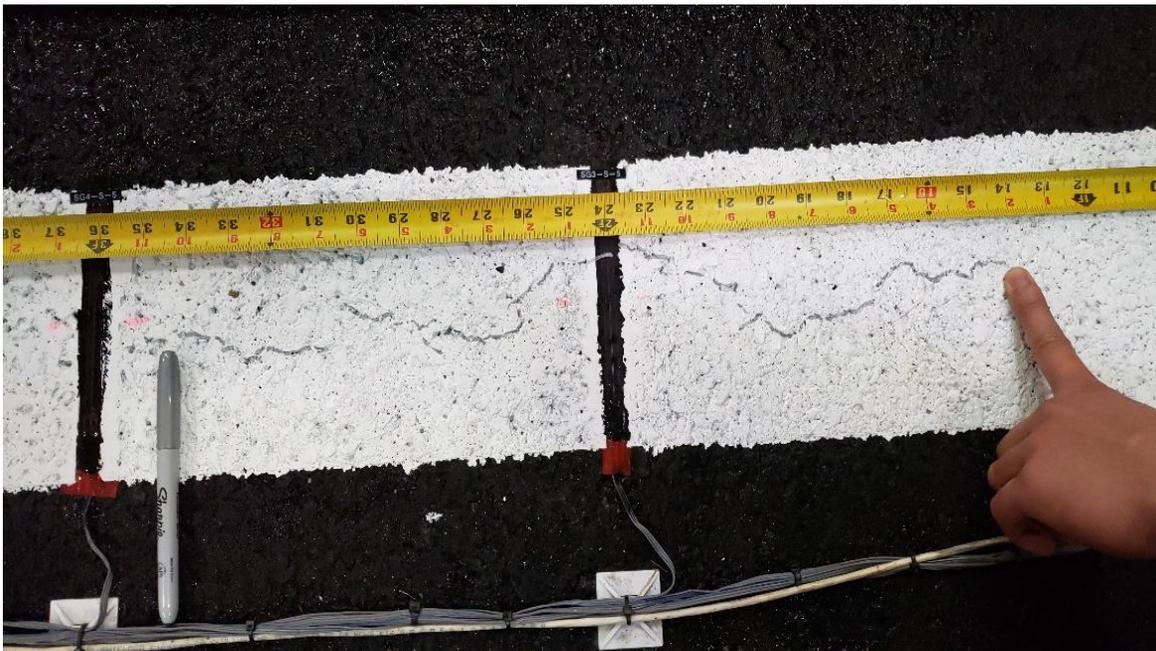
Fig 4 Surface crack on south section between 14'' and 34.5''
