Contract No. DTFACT-15-D-00007
Delivery Order 005 NAPTF Support
Deliverable 4.9.5.1
National Airport Pavement Construction Cycle 1 (CC1)
Comprehensive Report

December 2019

Submitted by General Dynamics Information Technology
Prepared by Applied Research Associates, Inc.

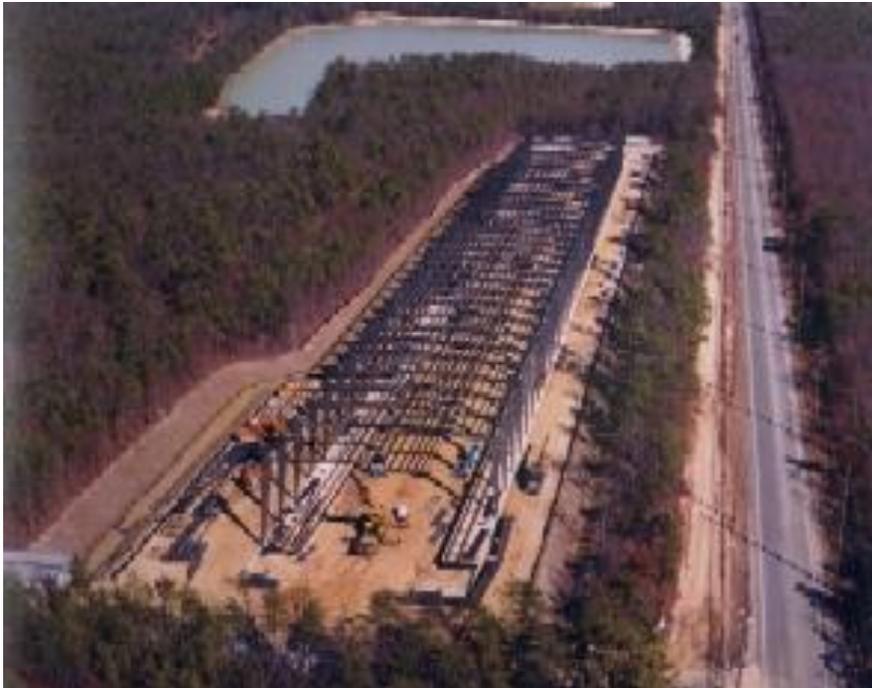
Figure 1. NAPTF Building Construction

The NAPTF is a 1200 ft. (365.8 m) long and 100 ft. (30.5 m) wide with a 900 ft. (274.3 m) long and 60 ft. (18.3 m) wide test area, fully enclosed, instrumented test track located at the FAA's William J. Hughes Technical Center, Atlantic City International Airport, New Jersey. Figure 1 and Figure 2 show the NAPTF building during construction.

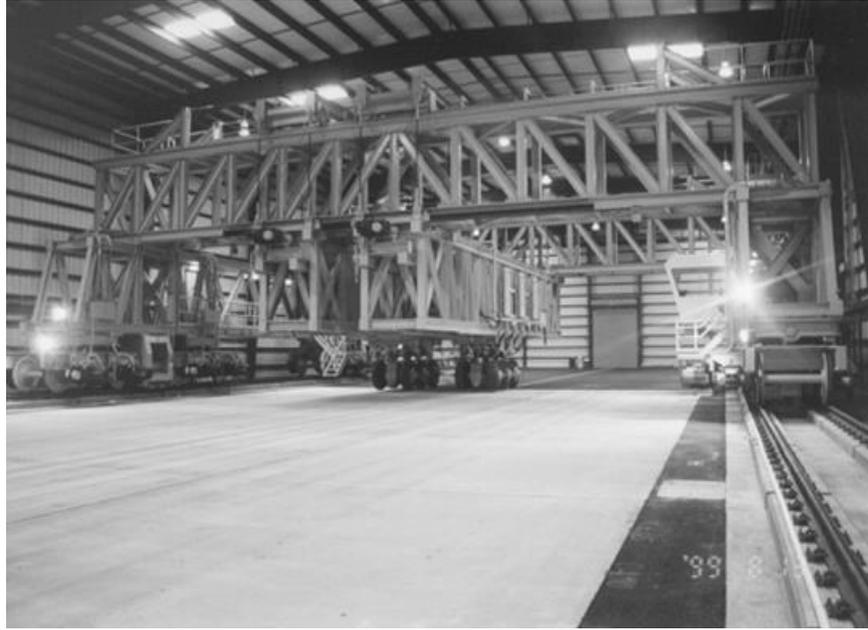
Figure 3. National Airport Pavement Test Vehicle (NAPTV)

As constructed in 1995-1999, the NAPTV has up to 6 wheels on each carriage, arranged as three independent modules. The NAPTV can be configured to represent a range of landing gear types, from single wheel (S) to 6 wheel (3D) gears. Data collection and testing at the NAPTF are arranged by construction cycles (CCs). A construction cycle (CC) includes test pavement construction with embedded instrumentation, materials testing data, traffic testing to failure, post-traffic testing, and pavement removal (Figure 4).

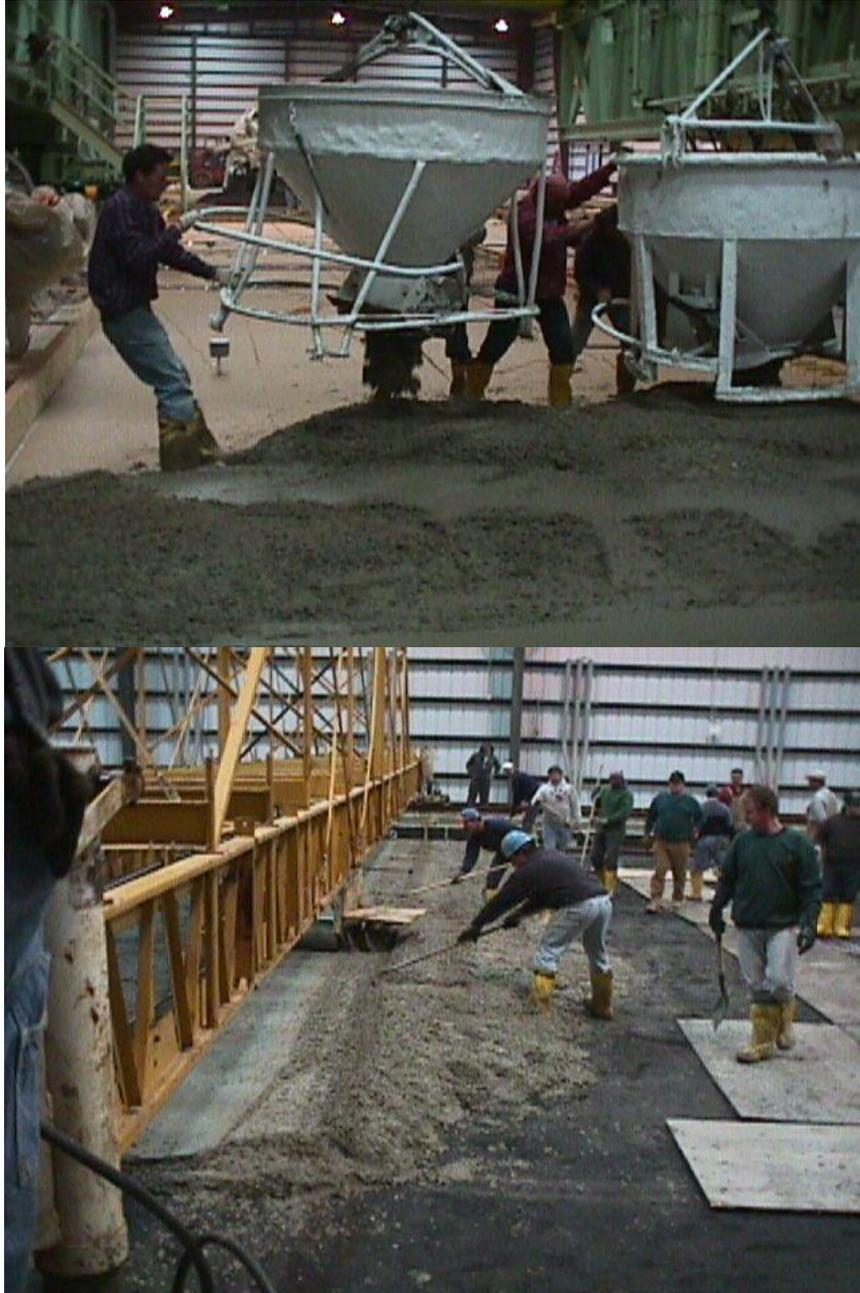
Figure 15. CC1 Concrete Placement for Test Section Construction, Completed May 1999

Figure 15 shows the placement of concrete for the slabs during construction of the test sections, completed in May 1999. QC for Item P-501 PCC was based on slump, air content, and compressive strength. This data is available for download on FAA Airport Pavement Technology website (<https://www.airporttech.tc.faa.gov/Airport-Pavement/National-Airport-Pavement-Test-Facility-/NAPTF-Databases/CC-1>).

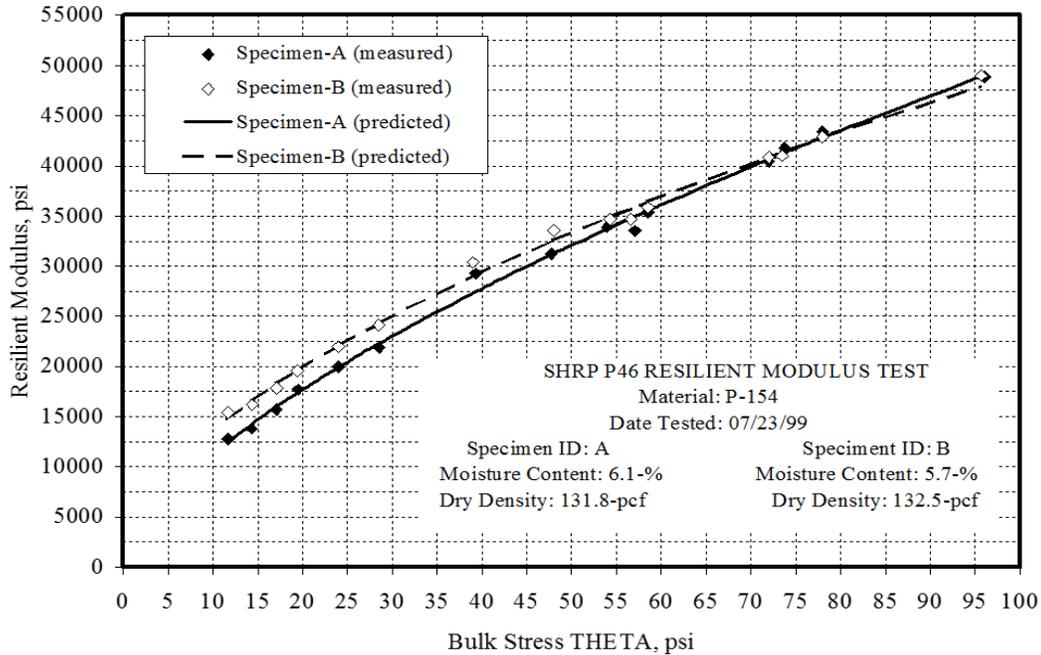
Figure 16. Resilient Modulus Test Results for P-154 Subbase Material (Garg 1999)

Resilient modulus tests were conducted following the Strategic Highway Research Program (SHRP) Protocol P-46 testing procedure (Hayhoe and Garg 2001). Current AASHTO test procedures did not exist at that time. AASHTO adopted SHRP P-46 as AASHTO T 294 in 1994 but have since withdrawn it. The current standard for resilient modulus of soils is AASHTO T 307 (20123). Resilient modulus test results for subbase and base material are presented in Figure 16 and Figure 17 (Garg 1999).

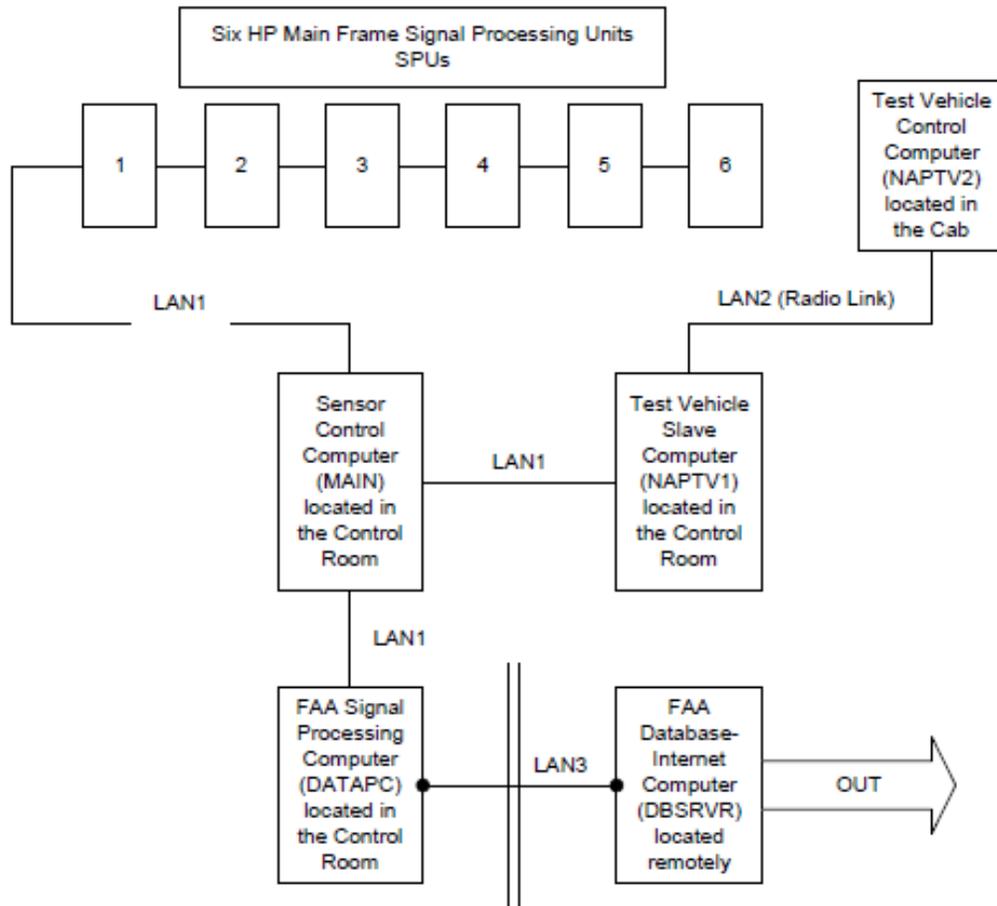
Figure 18. HSDAS Schematic (Hayhoe, et al. 2001)

Data was acquired, processed, stored, and disseminated from the individual sensors using 6 data collection systems interconnected by wire and wireless local area networks (Teubert, Brill et al. 2002). The signal processing units (SPUs) and test vehicle computer were located in the test building; however, they could be remotely operated from the control room, located in the administrative building. The HSDAS was used to collect data from the dynamic pavement sensors and transmit the data to a computer in the control room. The HSDAS consisted of six Hewlett Packard VXI Mainframe SPUs. Each SPU had a 133- MHz Pentium computer system card and three analog to digital converter (ADC) cards with a 64-channel multiplexer on each card. Each rigid test item had a dedicated SPU. Each pair of flexible test items on a given strength subgrade had a dedicated SPU. The schematic for data collection is shown in Figure 18 (Hayhoe, et al. 2001).

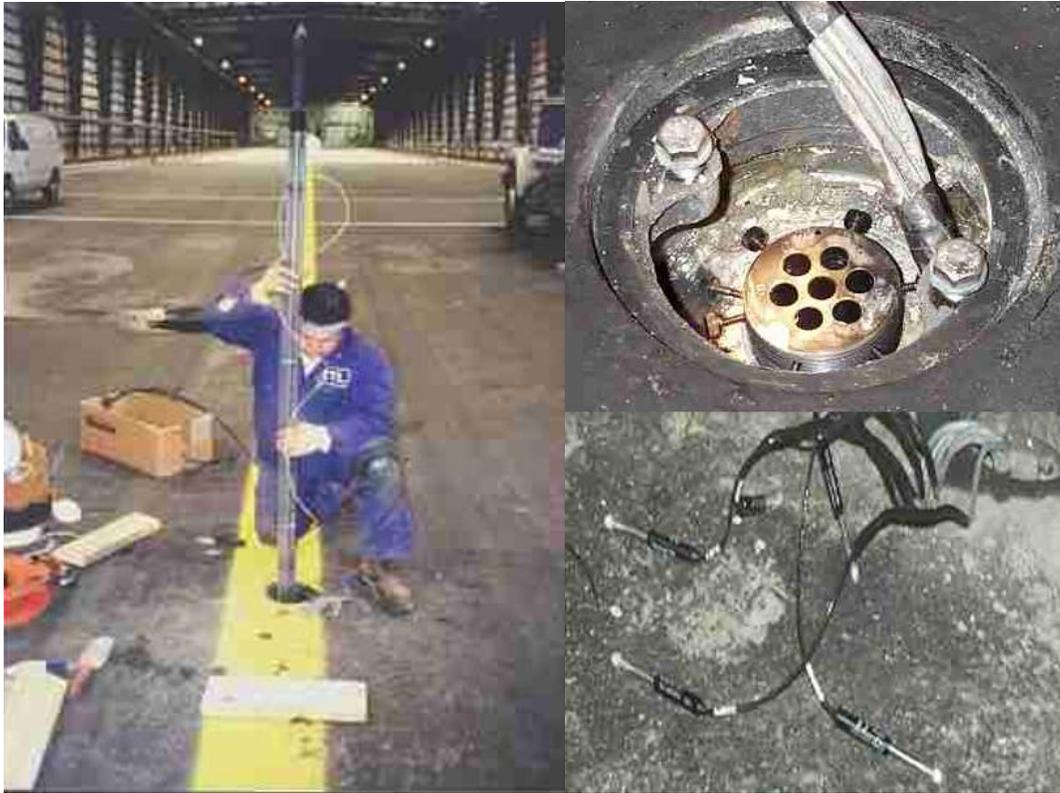
Figure 19. Installation of Multi-Depth Deflectometer (MDD) (Garg 2003)

MDDs, manufactured by Construction Technology Laboratories (CTL), were used to measure deflections of pavement layers at multiple vertical locations referenced to a stable point. Each MDD is an array of seven potentiometer Displacement Transducer (DT) physically connected via a graphite rods to snap anchor discs placed at strategic locations to capture the multiple-wheel load interaction (Figure 19). The MDDs work by recording the deflection of the individual sensors in relation to an anchor sensor that is buried below the zone of influence of the anticipated loads. The anchor depth is 9-feet (2.7 m) for the medium-strength subgrade test sections. The surface sensor is actually the only sensor to be directly connected to the anchor; the other sensors measure deflections in relation to the surface sensor. The absolute movement of an individual sensor is then calculated by subtracting the sensor reading from the surface sensor reading. Accordingly, individual layer response is calculated by subtracting the lower sensor reading from the higher sensor reading.

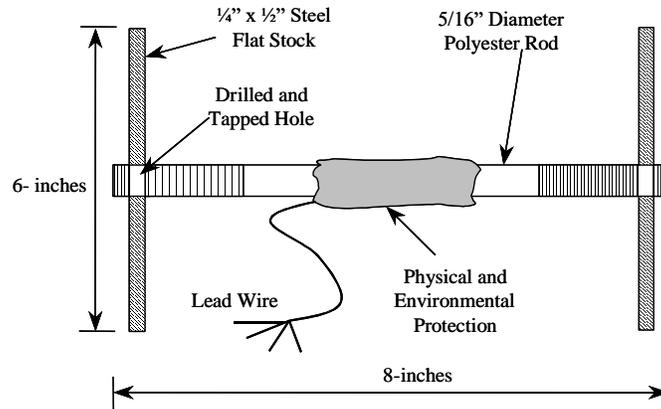
Figure 22. Asphalt CSG (Garg and Hayhoe 2001)

The ASGs for the NAPTF were fabricated by the manufacturer (CTL). Each ASG is a full-bridge assembly consisting of four foil gauges affixed to a 5/16 inch polyester rod as shown in Figure 22. Due to the configuration (polyester rod joining two steal flanges), the ASGs are referred to as “H-bar”. According to manufacturer specifications, the ASG instrument had an accuracy of 1 microstrain and a resolution of 0.1 microstrain. The measurement range was 2000 microstrain and the temperature range was from 0 to 150°C.

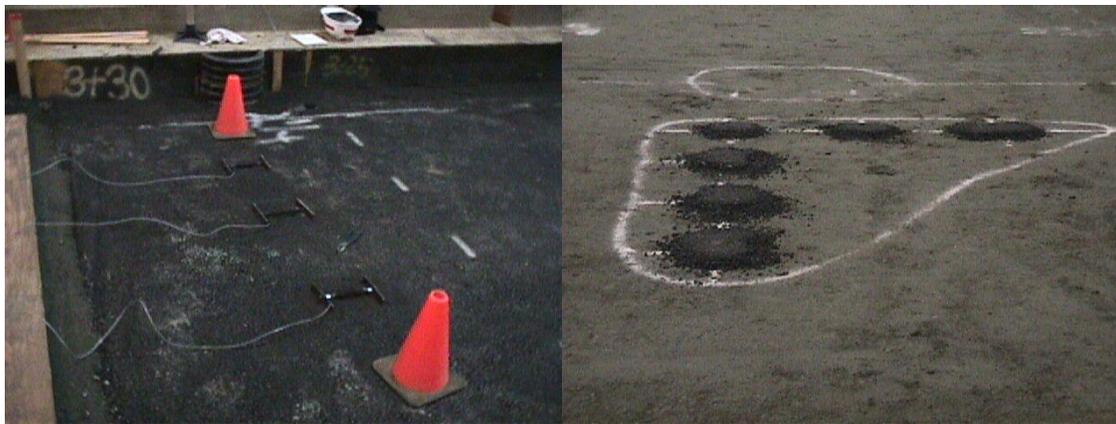
Figure 23. ASG Installation

ASGs were installed in both longitudinal and transverse directions at the bottom of the surface asphalt layer and at the bottom of the stabilized base asphalt layer of the stabilized base test items. Figure 23 shows the installation of ASG in the AC layer. A total of 96 H-bar type ASGs (transverse and longitudinal) were installed at the time of construction. Figure 24 shows the location of the ASGs in flexible test sections (CTL 1998).

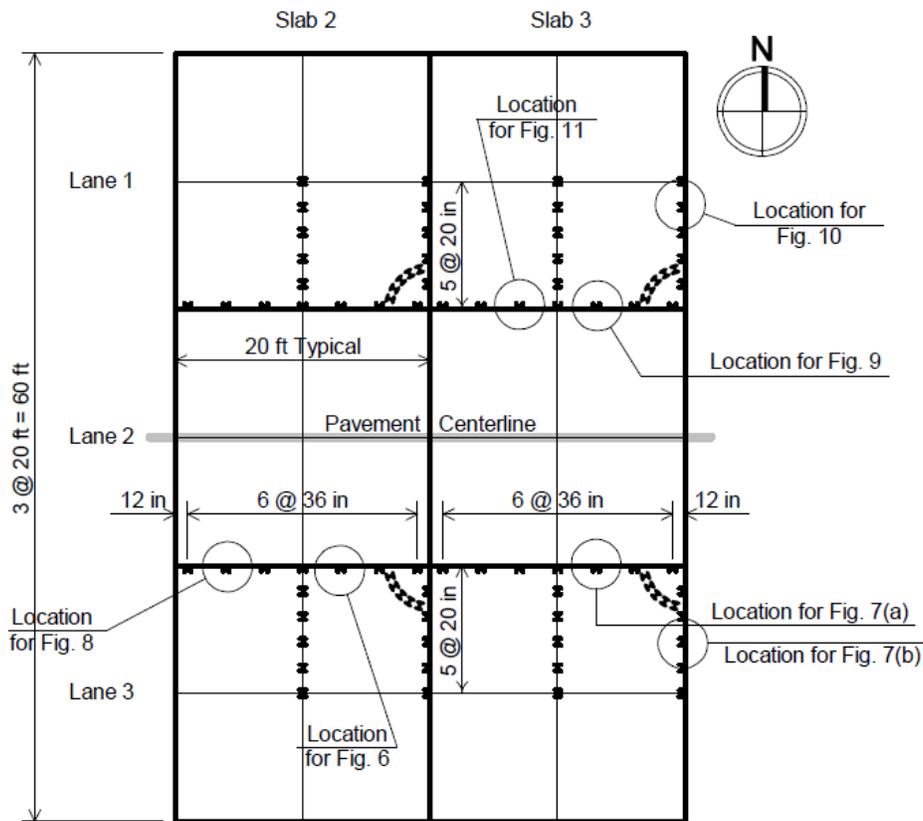
Figure 25. Locations of CSGs in Rigid Pavement Test Items (Guo et al. 2002)

Figure 25 shows the strain gauge locations in the rigid pavement test items (Guo et al. 2002). Only slabs 2 and 3 in each lane were instrumented. Sensors were installed near both the top and bottom surfaces of the slabs to provide measurements of the tensile and the compressive strains that developed during loading. Figure 26 shows the installation of CSGs in the NAPTF rigid pavement test items. A total of 154, 156, and 153 CSGs were installed in test items LRS, MRS, and HRS, respectively. Of the total of 463 CSGs, 40 were found to be not performing, including 14 sensors (9.1%) in LRS, 12 sensors (7.7%) in MRS and 14 sensors (9.1%) in HRS (Guo et al. 2002). The details about the location of the sensors are documented by Guo et al. (2002).

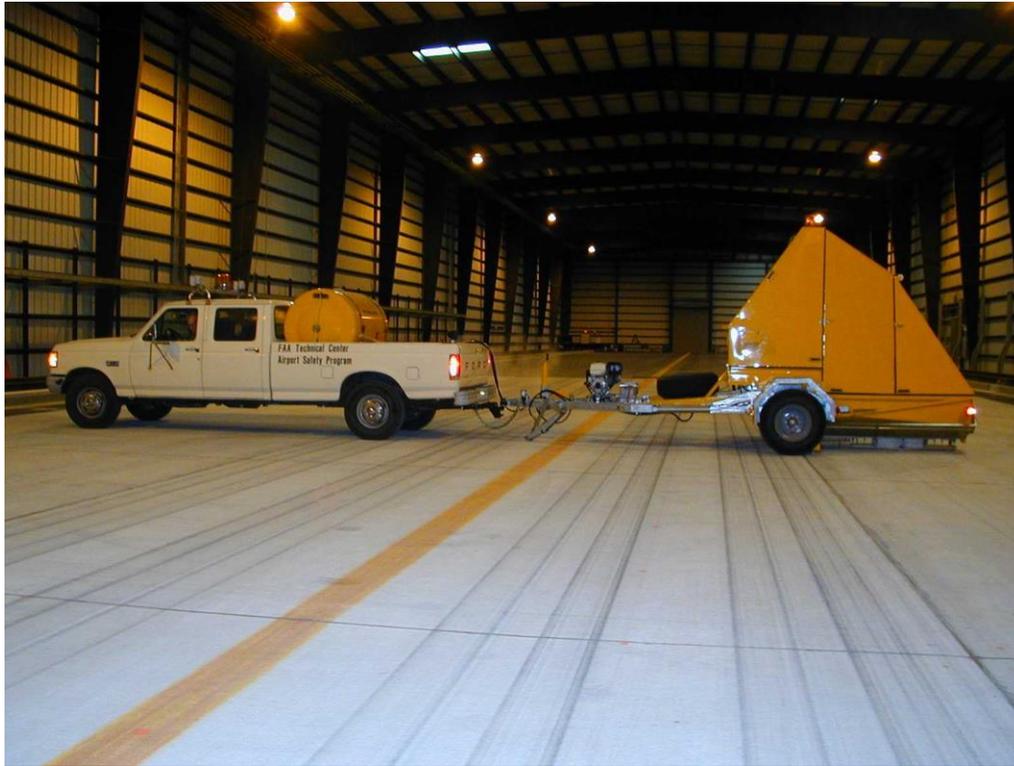
Figure 30. FAA's KUAB Model 240 HWD Equipment

In 1999, the FAA purchased a KUAB Model 240 Heavy Falling Weight Deflectometer (HWD) device for evaluation of the test pavements at the NAPTF (Figure 30). The KUAB operates on the principle of dropping weights on a series of hard, rubber buffers separated by a second series of weights and buffers which are connected to a loading plate resting on the pavement surface. In the

KUAB device, the loading plate is segmented into quarters to ensure that the loading force is evenly distributed. Weights and buffers can be added or removed as necessary to adjust peak load and loading time. The loading pulse shape is also influenced by the combination of weights and buffers used. The main objectives of conducting HWD tests were to verify the uniformity of the pavement construction, particularly subgrade strength before the start of traffic testing.

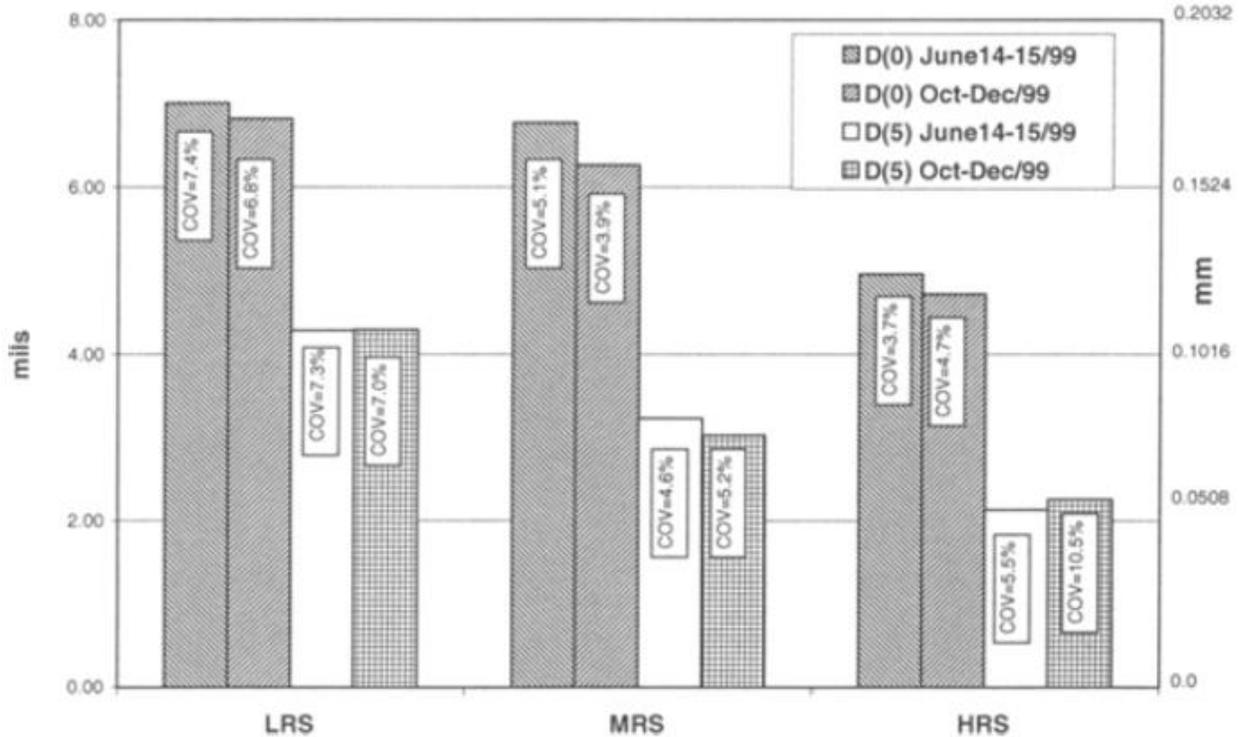
Figure 34. Average Deflections D0 and D5 at the Center of the Slabs (Guo and Marsey 2001)

The mean of the measured deflections under the plate load (D0) and at 60 inches (D5) at the center of slabs are presented in Figure 34. The average D0 and D5 deflections were higher in the LRS sections with low strength subgrade. The average deflections from the June and October testing (see section 2.4.2) were relatively uniform within each test item.

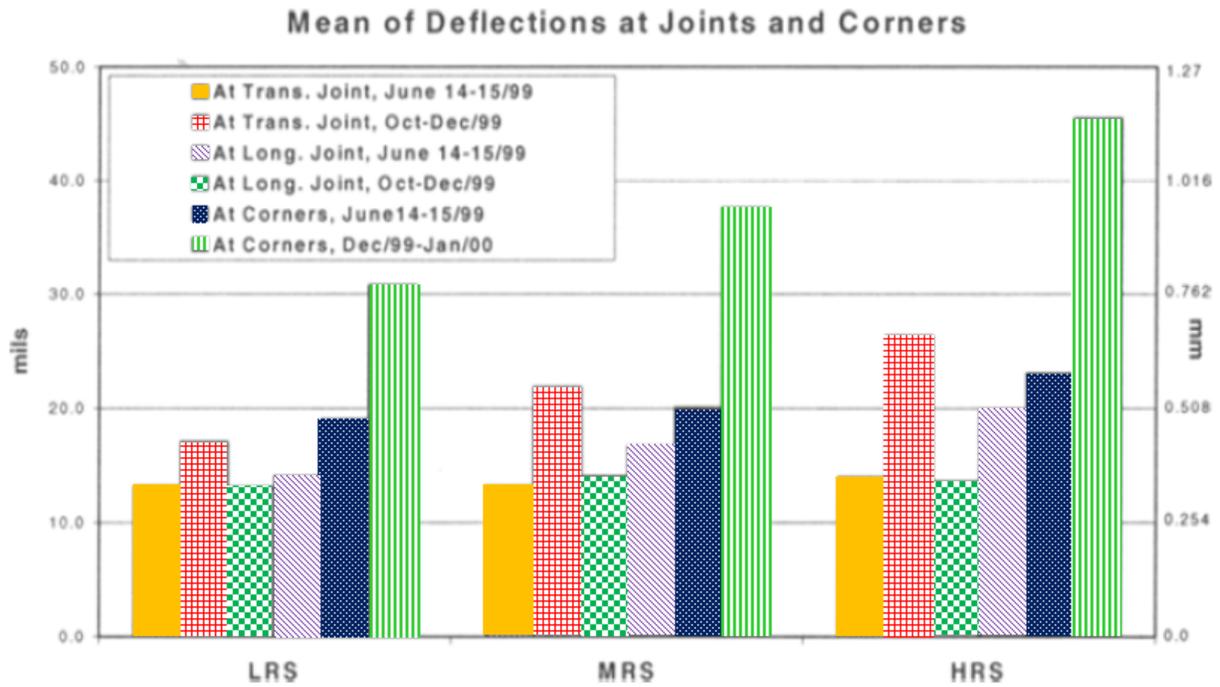
Figure 35. Deflection D0 at the Joints and Corners (Load = 24,000 lbs.) (Guo and Marsey 2001)

Guo and Marsey (2001) evaluated deflections D0 at the joints and corners for LRS, MRS, and HRS test items. Deflection tests were conducted from June 1999 through January 2000. While the FWD loads were dropped on only one side of the joints in June 1999 testing, both sides of the joints were tested in the HWD testing in October 1999 to January 2000. The mean values of D0 at the joints and corners for LRS, MRS, and HRS test sections are displayed in Figure 35. It can be observed from the figure that the mean D0 measured at the transverse and longitudinal joints were fairly similar in June 1999 testing (4 months after construction). The deflections of transverse joints were higher than the longitudinal joints deflections in October, due to the lower load transverse efficiency of the dummy joints. The longitudinal and transverse joint deflections, as well as corner deflections, were higher in the winter testing compared to those during the summer testing. This can be attributed to higher upward slab curling in winter. The differences were more pronounced in the PCC slabs on top of the high strength subgrade.

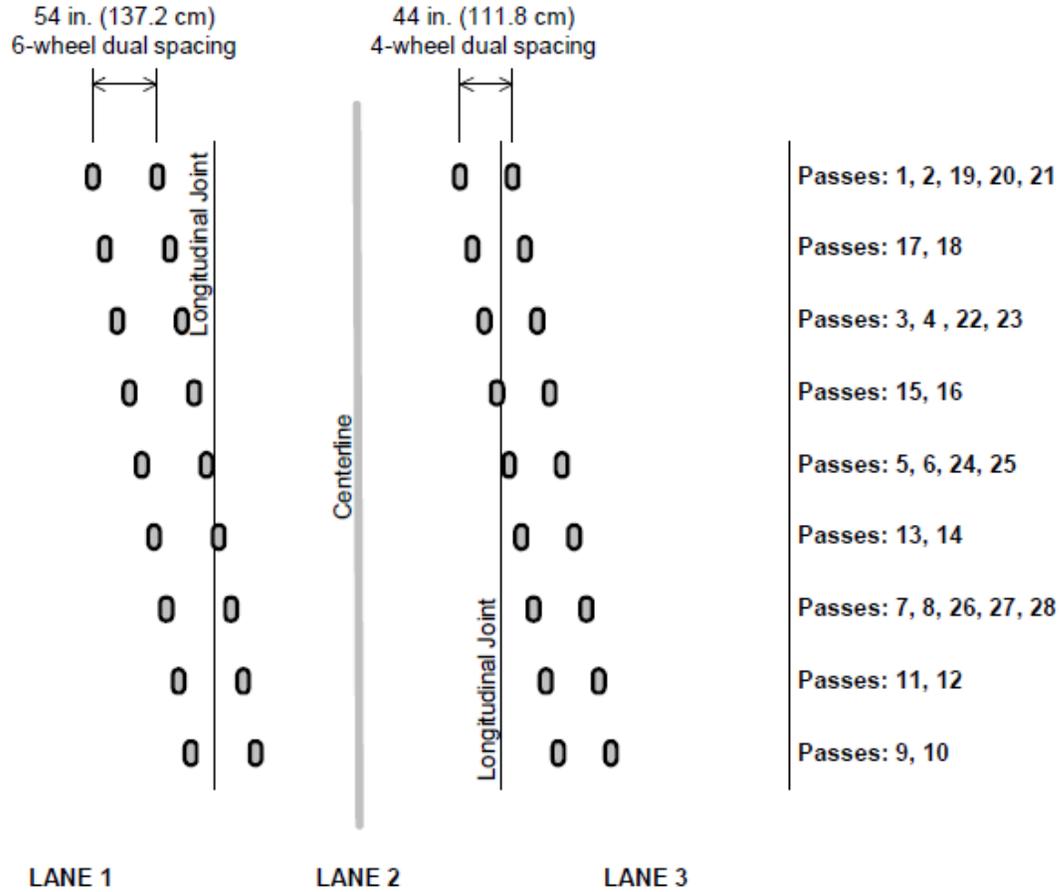
Figure 36. 6-Wheel and 4-Wheel Wander Patterns (Guo et al. 2002)

Traffic tests started after the completion of the response tests in February 2000. To simulate aircraft wander, a wander pattern consisting of a fixed sequence of 66 vehicle passes (33 in east to west and 33 in west to east directions) was defined. The 66 passes were arranged in nine equally spaced wander positions at intervals of 10.25 inches (260 mm) (Figure 36, Guo et al. 2002). Figure 37 shows the number of repetitions at each wander position in a complete wander cycle (Hayhoe and Garg 2002). The wander pattern was intended to approximate a normal distribution of aircraft traffic with a “wander width” of 70 inches; that is the normal distribution that results in 75% of traffic passes concentrated in a 70-inch wide width. It can be shown that the standard deviation of such a distribution is 30.54 inches (Ho song, 1975).

Guo et al. (2002) analyzed the strain gauge data from the first phase of CC1 rigid pavement traffic testing. Figure 42 (a) and (b) shows a typical strain gauge response before crack initiation for the top and bottom sensor during passes 1 and 5 of the 4-wheel load. The peak strains for pass 1 are smaller than those from pass 5, because in pass 5, both tires were on the same side of the longitudinal joint, while in pass 1 the tires straddled the joint and only a portion of the wheel load was transferred through the joint (see Figure 36).

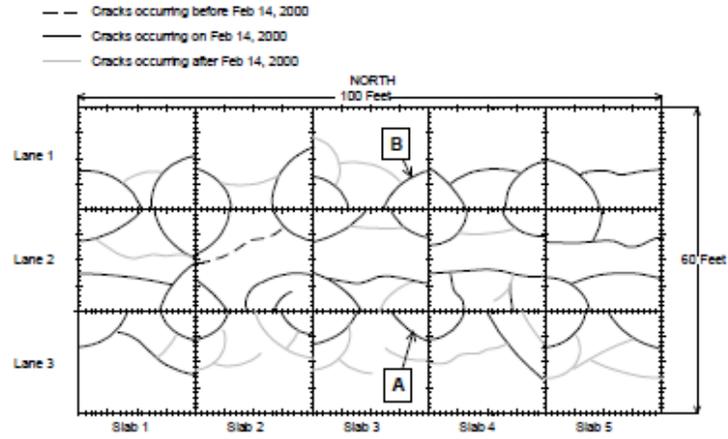
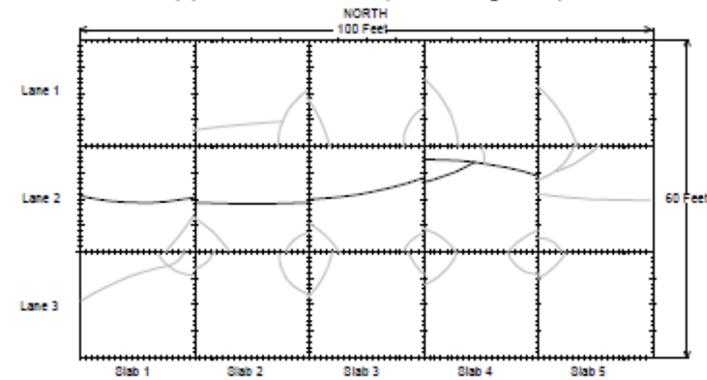
Figure 40. Crack Patterns in Rigid Test Items (Guo et al. 2002)

The distresses observed in the rigid test items are presented in Figure 40 (Guo 2008). In test item LRS, only four longitudinal cracks were observed after the initial 28 passes. After additional traffic was applied to test item LRS in March 2000, corner cracks started to develop. Figure 41 shows the definition of corner crack dimensions when reporting crack size (Guo et al. 2002). The “a” and “b” values were measured for the two sides of corner cracks and the average is presented in Table 14 for different test items (Guo et al. 2002). The largest and smallest corner cracks developed in the HRS and LRS test items, respectively.

(a) Test Item HRS (after 236 passes)

(b) Test Item MRS (after 646 passes)

(c) Test Item LRS (after 1164 passes)

Traffic testing began on February 14, 2000. After completion of the initial 28 passes, corner cracks were observed in the test items MRS and HRS. No corner cracks were found in LRS after the first 28 passes. However, longitudinal cracks were observed in all slabs in lane 2 (centerline) of LRS. Trafficking was resumed in March 2000 and was continued until all the slabs were cracked.

Measurements of crack dimensions showed that the HRS slabs exhibited the largest, and the LRS slabs exhibited the smallest corner cracks. Furthermore, it was found that all pavement slabs were curled up at the corners, with the HRS slabs exhibiting the greatest amount of curling, and the LRS slabs exhibiting the least amount of curling. The high levels of slab curling were unexpected due to the protection from sunlight afforded by the NAPTF’s roof, which meant that the daily temperature cycles experienced by concrete slabs were minimal. Post-failure analysis found that slab curling was probably caused by relatively thin slabs combined with a PCC mixture susceptible to moisture-related shrinkage.

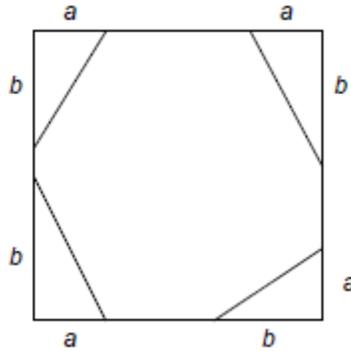
Figure 41. Definition of Corner Crack Dimensions in Table 14 (Guo et al. 2002)

Corner Crack Dimensions	Test Item		
	HRS	MRS	LRS
Average a, in. (cm)	78 (198)	72.5 (184)	54.9 (139)
Average b, in. (cm)	98.3 (250)	92.2 (234)	79.1 (201)

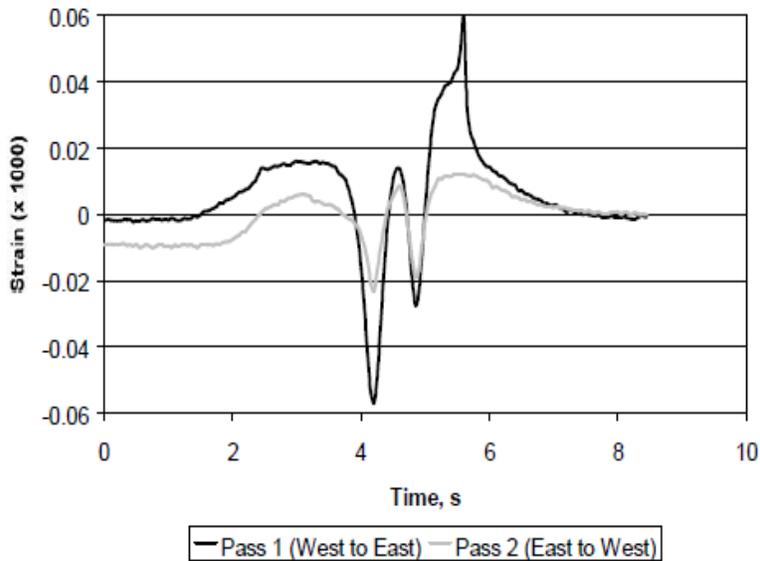
(a) Strain Gauge at Top of Slab, Longitudinal Joint (CSG – 109)

Figure 43 (a) and (b) shows an example of strain gauge response after the corner crack developed (Guo et al. 2002). The unusually high strain readings are attributed to the crack passing through the strain gauge location. Guo et al. 2002 verified that crack A in Figure 40 (a) initiated during the first pass of the vehicle implying a lack of structural support attributable to curling, rather than a fatigue failure. Similarly, the majority of corner cracks identified in the HRS item along lane 3 developed during the first vehicle pass (Guo et al. 2002).

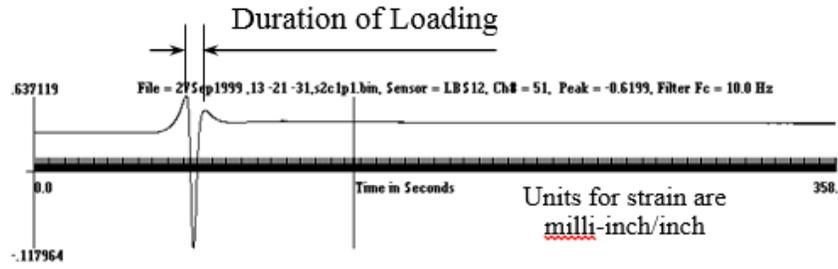
Figure 50. Longitudinal ASG Response Signal (Dual Loading) (Garg and Hayhoe 2001)

Figure 50 shows a typical response signal for a longitudinal ASG with dual wheel loading (Garg and Hayhoe 2001). Longitudinal ASG response signal time histories were similar in shape even if the tire did not pass directly over the gauge. There was always negative strain first, then positive strain, and subsequently negative strain. After the axle had passed over the gauge, the strain level reduced rapidly with very little residual strain. In the case of 4- and 6-wheel loading, negative strain was always observed between axles. The longitudinal ASG response to 6-wheel loading is shown in Figure 51.

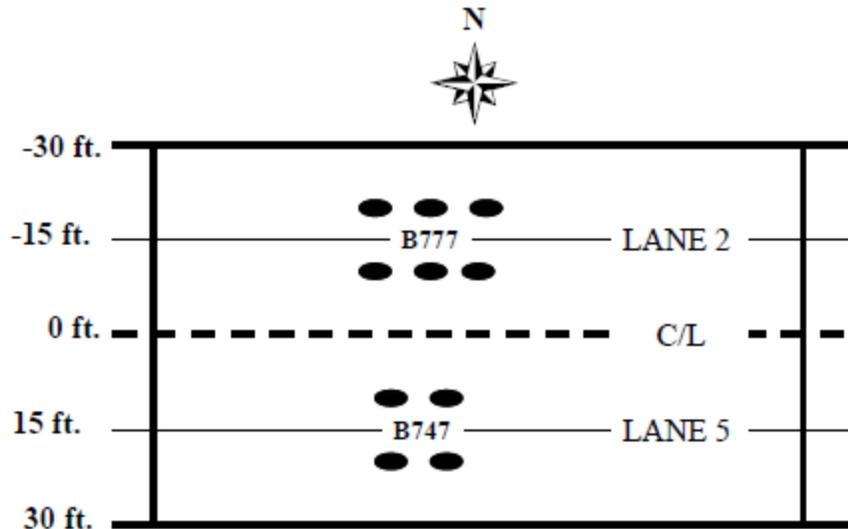
Figure 54. Location of HWD Test Lanes Results

HWD tests were conducted on all flexible test items to monitor the pavement structural degradation with traffic and time. These tests were performed on the non-trafficked centerline (C/L), 6-wheel traffic lane (north), and 4-wheel traffic lane (south) at 10 ft. (3.05 m) offsets, as illustrated in Figure 54. Deflection basins were characterized by measuring deflections at the center of the load plate (D0) and at 12, 24, 36, 48, and 60 inch offsets (D1, D2, D3, D4, and D5).

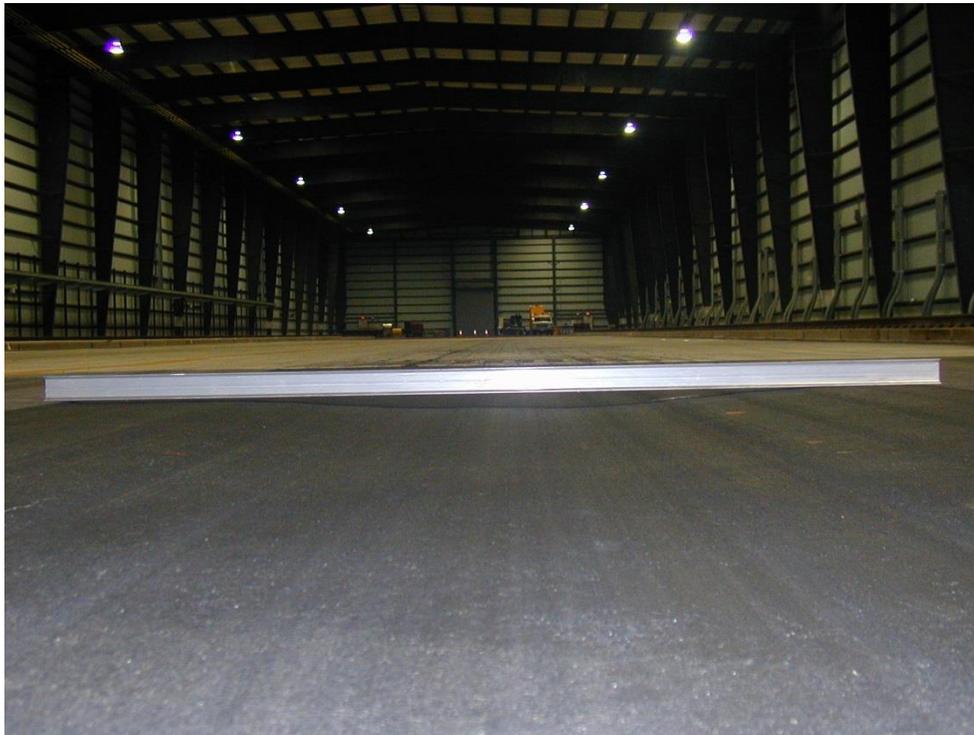
Figure 58. Straightedge Used for Rut Depth Measurements in CC1

The rut depth was measured initially with a 12 ft. (3.6 m) and later with a 16 ft. (4.9 m) long straightedge concurrent with TSP measurements. The straightedge was transverse to the traffic wheel path and placed on the center of wheel path (Figure 58). The recorded rut depth was the maximum deviation of the pavement surface from the straightedge. The traffic wheel path had the same width as the straightedge, therefore measurements indicated the permanent deformation inside the wheel path. To exclude the rut depth accumulated during the slow rolling tests, the final rut depth before the start of regular traffic testing was subtracted from the subsequent measurements.

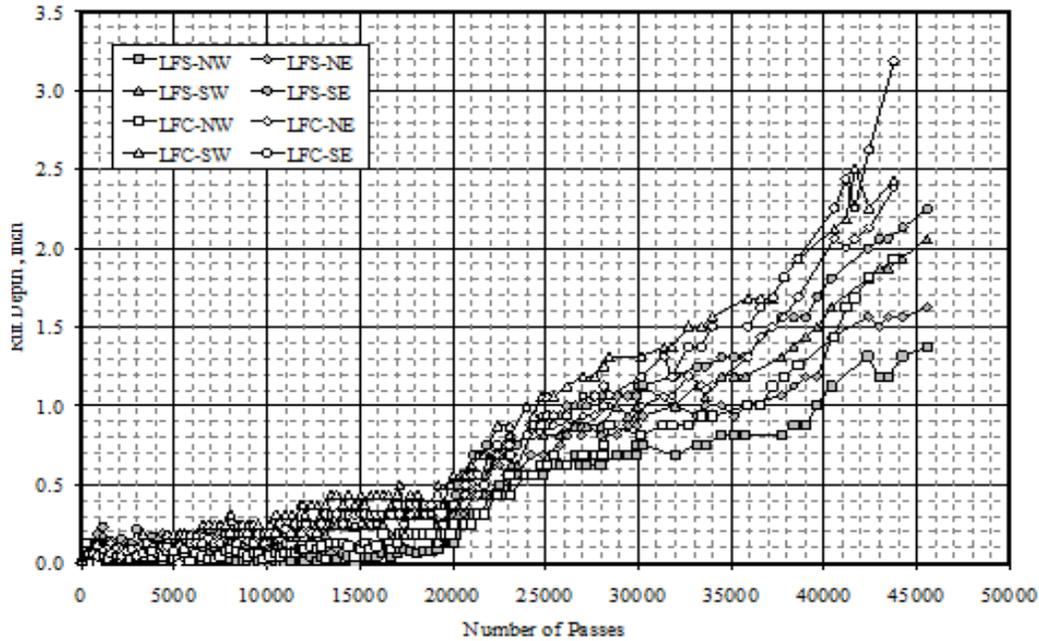
Figure 61. Straight Edge Rut Depth Measurements for Low Strength Subgrade Test Items (Hayhoe and Garg 2004)

Figure 61 shows the cumulative rut depths from physical straightedge measurements for low-strength subgrade test items. Rut depth increased gradually while the wheel loads were 45,000 lbs. (20.4 tonnes), remaining less than 0.5 inch up to 20,000 passes. Rutting increased after the wheel load was increased to 65,000 lbs. (29.4 tonnes).

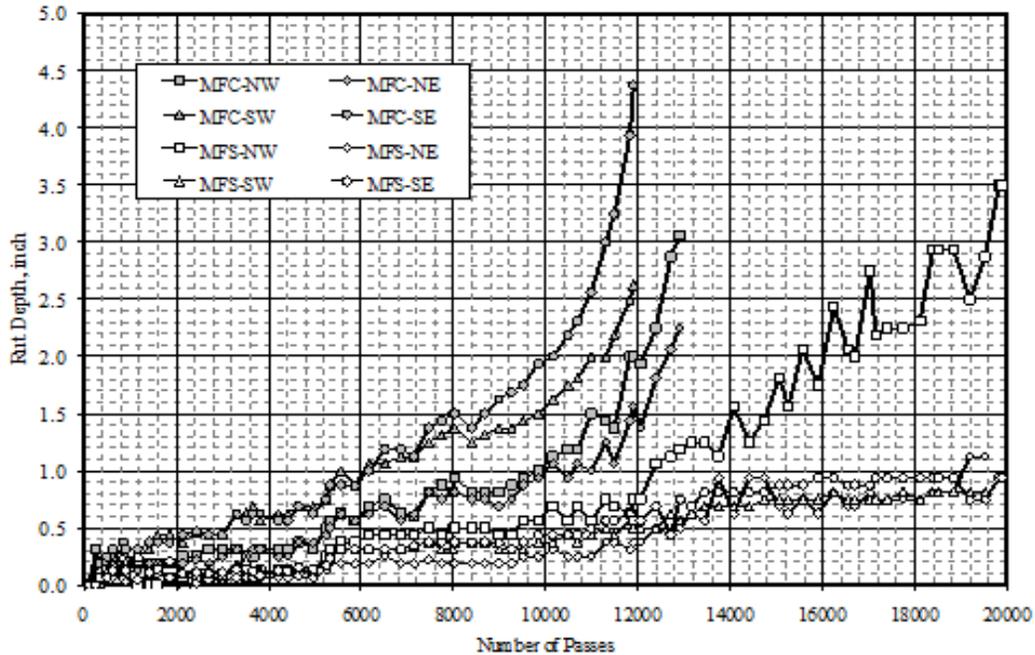
Figure 62. Straight Edge Rut Depth Measurements for Medium Strength Subgrade Test Items (Hayhoe and Garg 2004)

Figure 62 shows cumulative rut depths obtained from physical straightedge measurements for medium strength subgrade test items. Test item MFC failed at approximately 12,000 passes with rut depths ranging from 2 to 4.5 inches. Test item MFS, localized failure was observed on the north traffic lane (6-wheel). The traffic tests were discontinued on the north, but continued on the south. The south lane failed after approximately 29,000 passes and exhibited severe rutting. The rutting rate was stable until about 10,000 passes but increased rapidly as test items MFS and MFC approached failure.

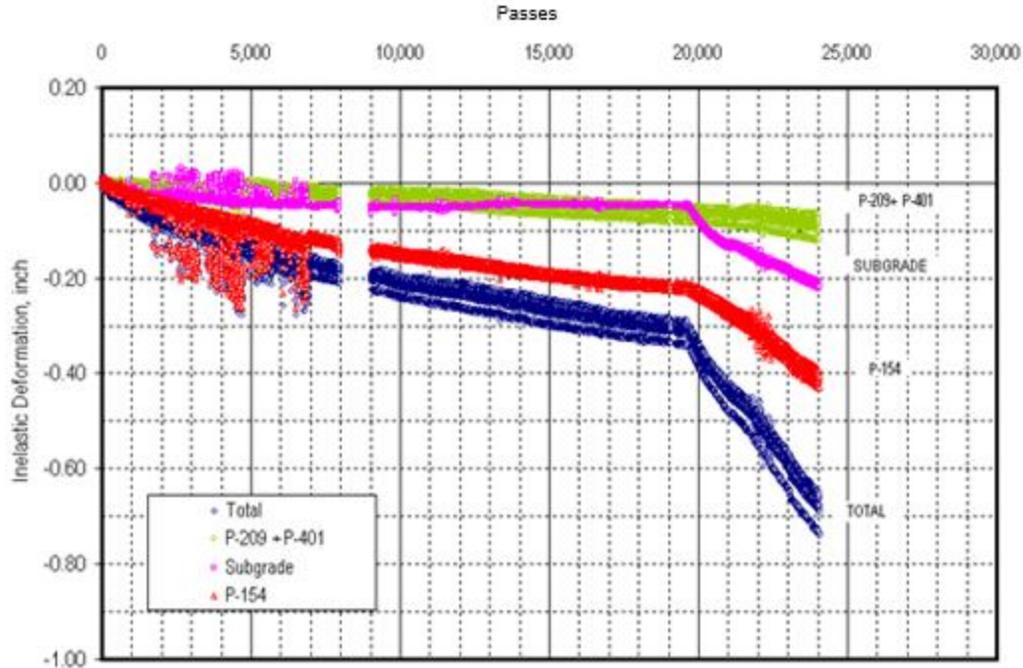
Figure 63. Permanent Deformation from MDD for Test Item LFC under 4-Wheel Loading (Hayhoe and Garg 2004)

The accumulation of permanent deformations measured with MDD under the 4-wheel loading are shown in Figure 63 for the LFC test item. The subbase P-154 layer contributed the most to the pavement deformation up to 20,000 passes. After 20,000 passes, when the wheel loads increased from 45 kips (20.4 tonnes) to 65 kips (29.4 tonnes), the rutting rate increased significantly and the subgrade started to contribute more to the total pavement deformation.

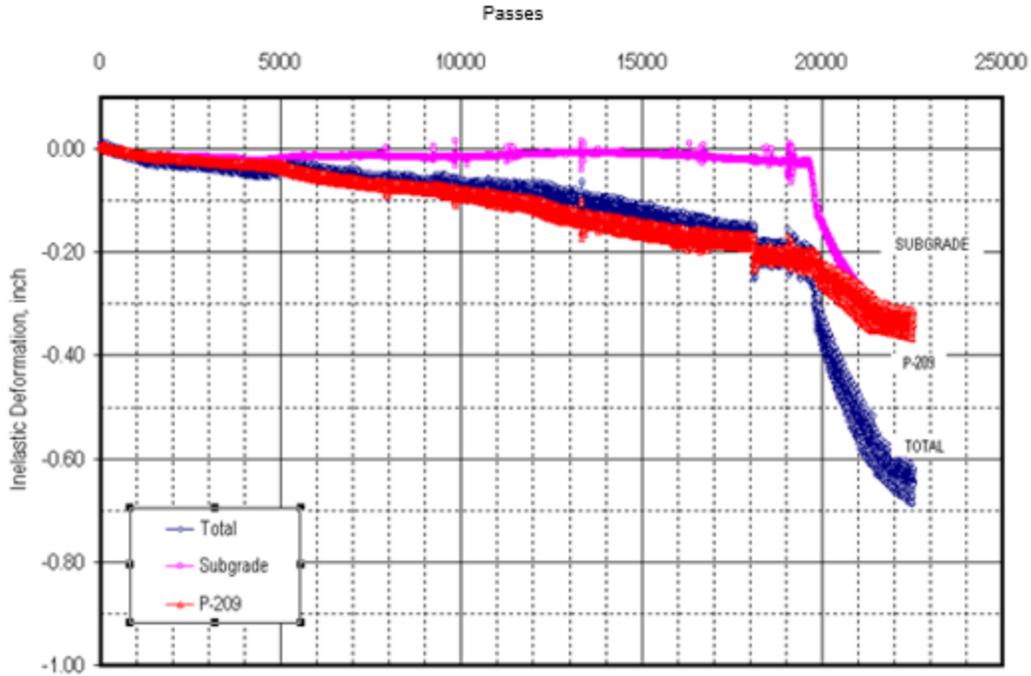
Figure 64. Permanent Deformation from MDD for Test Item LFS under 6-Wheel Loading (Hayhoe and Garg 2004)

Figure 64 shows the accumulation of permanent deformations from MDD data under 6-wheel loading for the LFS test item. As long as the wheel loads remained at 45 kips (up to 20,000 passes), the rutting of the P-209 base layer dominated the total deformation. As with the LFC test item, when the load was increased from 45 to 65 kips, there was a qualitative change, and the subgrade layer contribution became more significant. As shown in Figure 64, at failure the relative contributions of the subgrade and P-209 base layers were approximately the same.

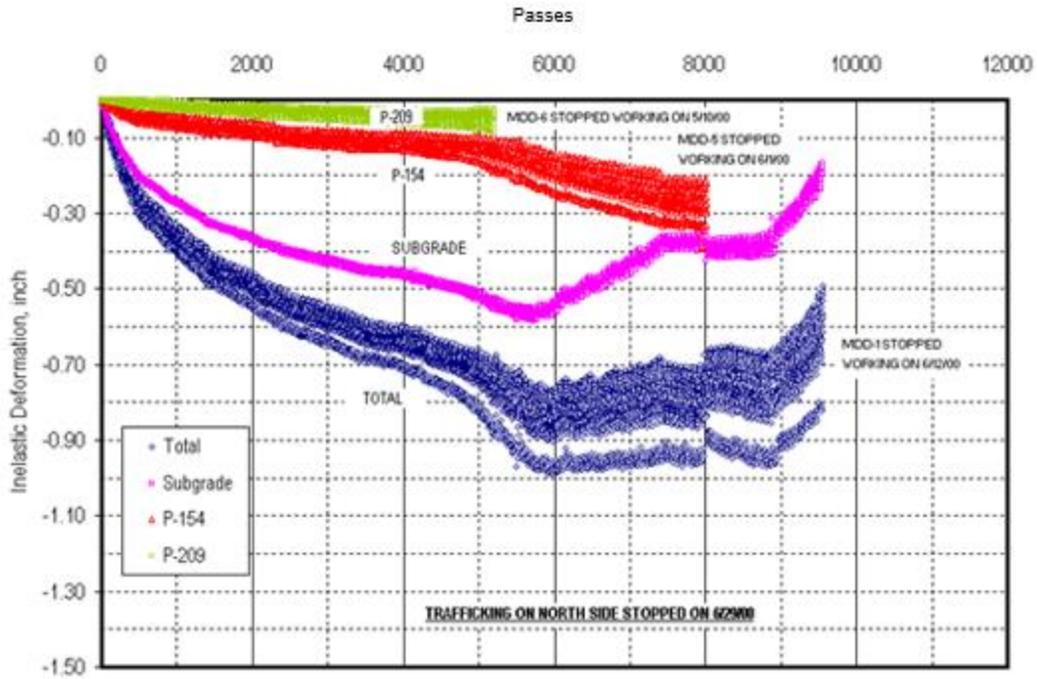
Figure 65. Permanent Deformation from MDD for Test Item MFC under 6-Wheel Loading (Hayhoe and Garg 2004)

The permanent deformation measurements from MDDs for the MFC test item are shown in Figure 65 and Figure 66 for the 6-wheel and 4-wheel loads respectively. Initially, the subgrade contributed the most to the permanent deformation under 6-wheel loading. At approximately 5,500 passes, subgrade deformation started to decrease. Hayhoe and Garg (2004) related this behavior to the transverse movement of the subgrade material as it undergoes shear flow when approaching failure.

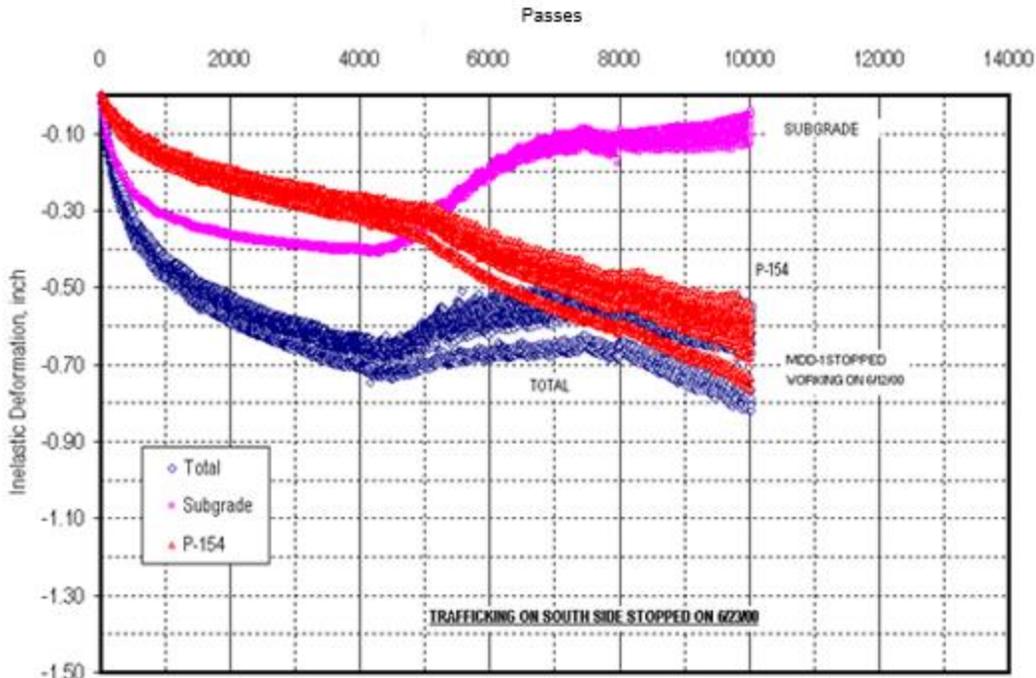
Figure 66. Permanent Deformation from MDD for Test Item MFC under 4-Wheel Landing Gear (Hayhoe and Garg 2004)

Permanent deformation of the subgrade showed similar trends under 4-wheel loading, as shown in Figure 66. Subgrade deformation started to decrease at about 4,500 passes. The overall pavement deformation was mostly due to the deformation of the subbase layer.

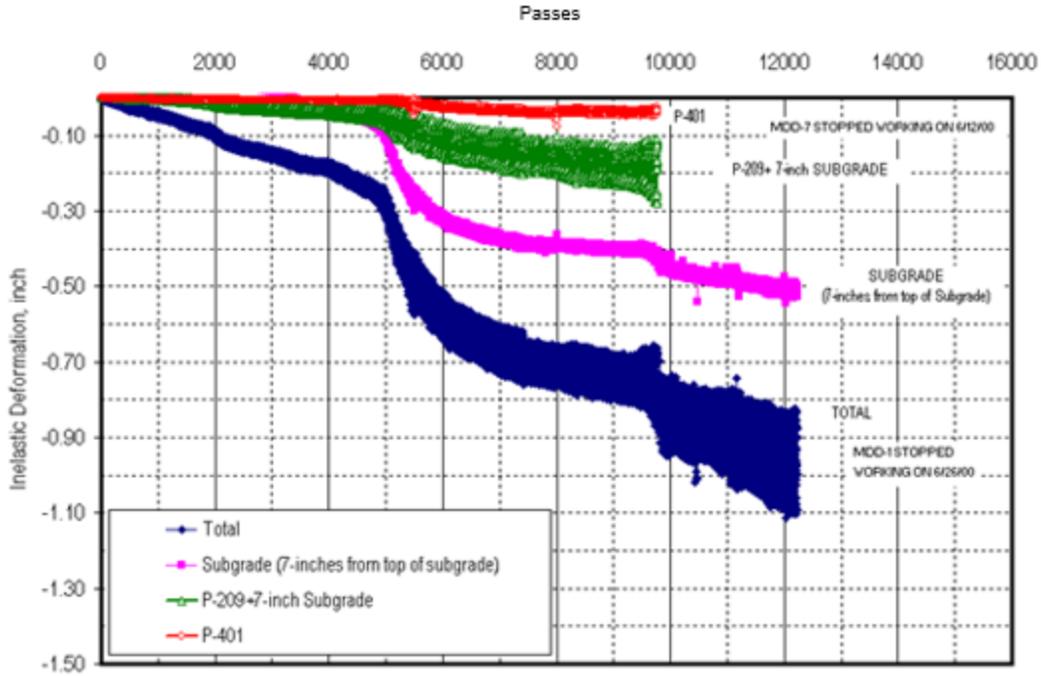
Figure 67. Permanent Deformation from Test Items MDD for MFS under 6-Wheel Loading (Hayhoe and Garg 2004)

Figure 67 and Figure 68 show the permanent deformation measurements from MDDs for the test item MFS for the 6- and 4-wheel loading respectively. Hayhoe and Garg (2004) concluded that variations in the asphalt surface layer temperature during the testing impacted the permanent deformation behavior of the test item MFS. As shown in Figure 69, the average asphalt layer temperature was approximately 11°C up to 5,000 passes, and the surface layer deformation exhibited no sudden changes during this period. After 5,000 passes, the asphalt temperature (and consequently the rutting rate) started to increase. Another increase in asphalt temperature occurred at approximately 9,500 passes. This temperature increase was accompanied by another abrupt increase in the rutting rate. The same trends were observed for 4-wheel loading.
