Contract No. DTFACT-15-D-00007
Delivery Order 005 NAPTF Support
Deliverable 4.9.5.1
National Airport Pavement Construction Cycle 1 (CC1)
Comprehensive Report

December 2019

Submitted by General Dynamics Information Technology
Prepared by Applied Research Associates, Inc.

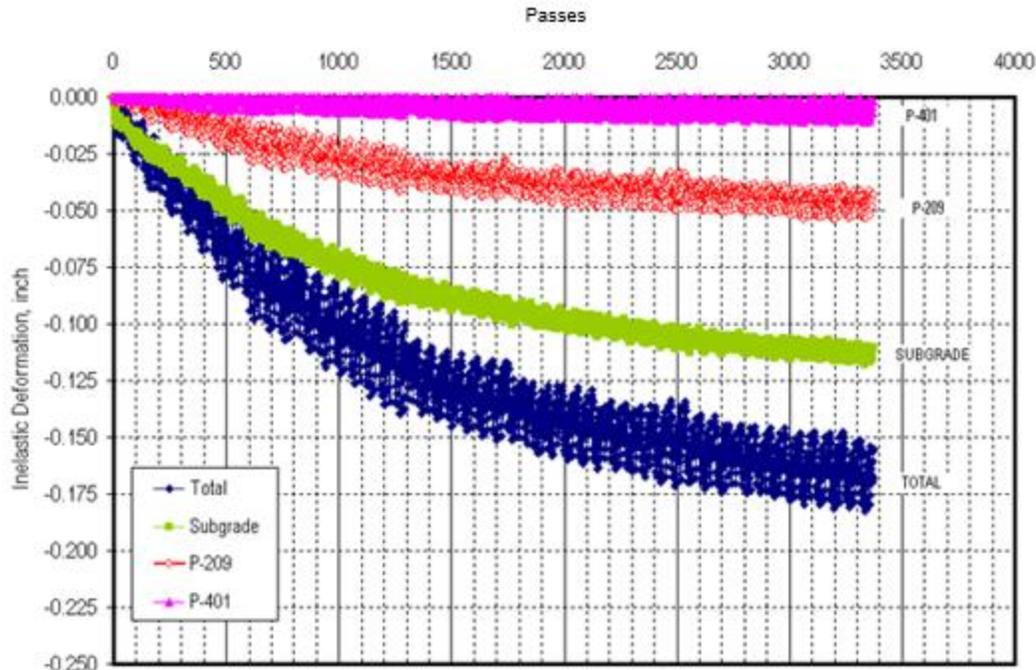
Figure 70. Permanent Deformation from MDD for HFC Test Item under 6-Wheel Loading (Hayhoe and Garg 2004)

Testing was terminated at 5,000 passes in the test items with high strength subgrade. Figure 70 shows the permanent deformation of each layer of the HFC test item measured by MDD (Hayhoe and Garg 2004). As can be seen, the permanent deformation of the subgrade layer contributed the most to the overall permanent deformation of the section. The trend in permanent deformation tends to be asymptotic, indicating that the depth of deformation would not reach the 1-inch failure criteria. This further verifies the assumption that high strength subgrade test items were unlikely to fail. The pavement deformation after 3,400 passes was less than 0.2 inches (5 mm).

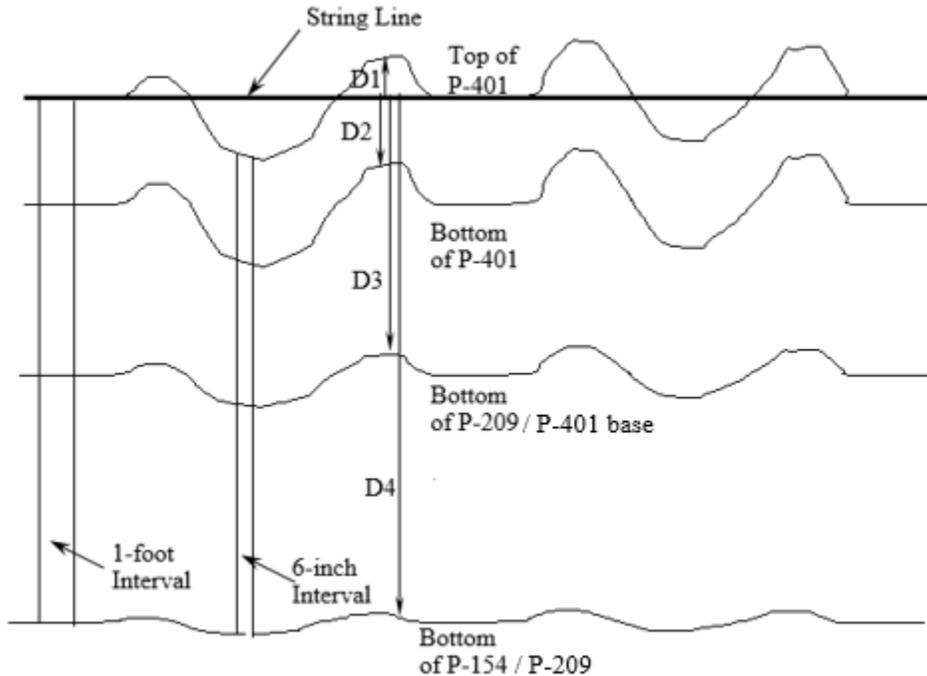
Figure 77. Profile Measurements on a Trench Wall

Tests and measurements were performed on the various layers of the pavement structure. To measure the contribution of each component layer to the total pavement rutting and upheaval, pavement layer profile measurements were made. For layer profile measurements, a string line was run at the pavement surface from south to north along the west face of the trench. Figure 77 shows an example of profile measurement on a trench wall. The vertical distances between the string line and P-401 top (D1), P-401 bottom (D2), P-209/ P-401 base bottom (D3) (test items with conventional/stabilized base), and bottom of P-154/ P-209 (D4) (test items with conventional/stabilized base) at 1ft. (maximum) intervals were measured (figure 68). Within the two traffic lanes, measurements were made at maximum 6-inch intervals.

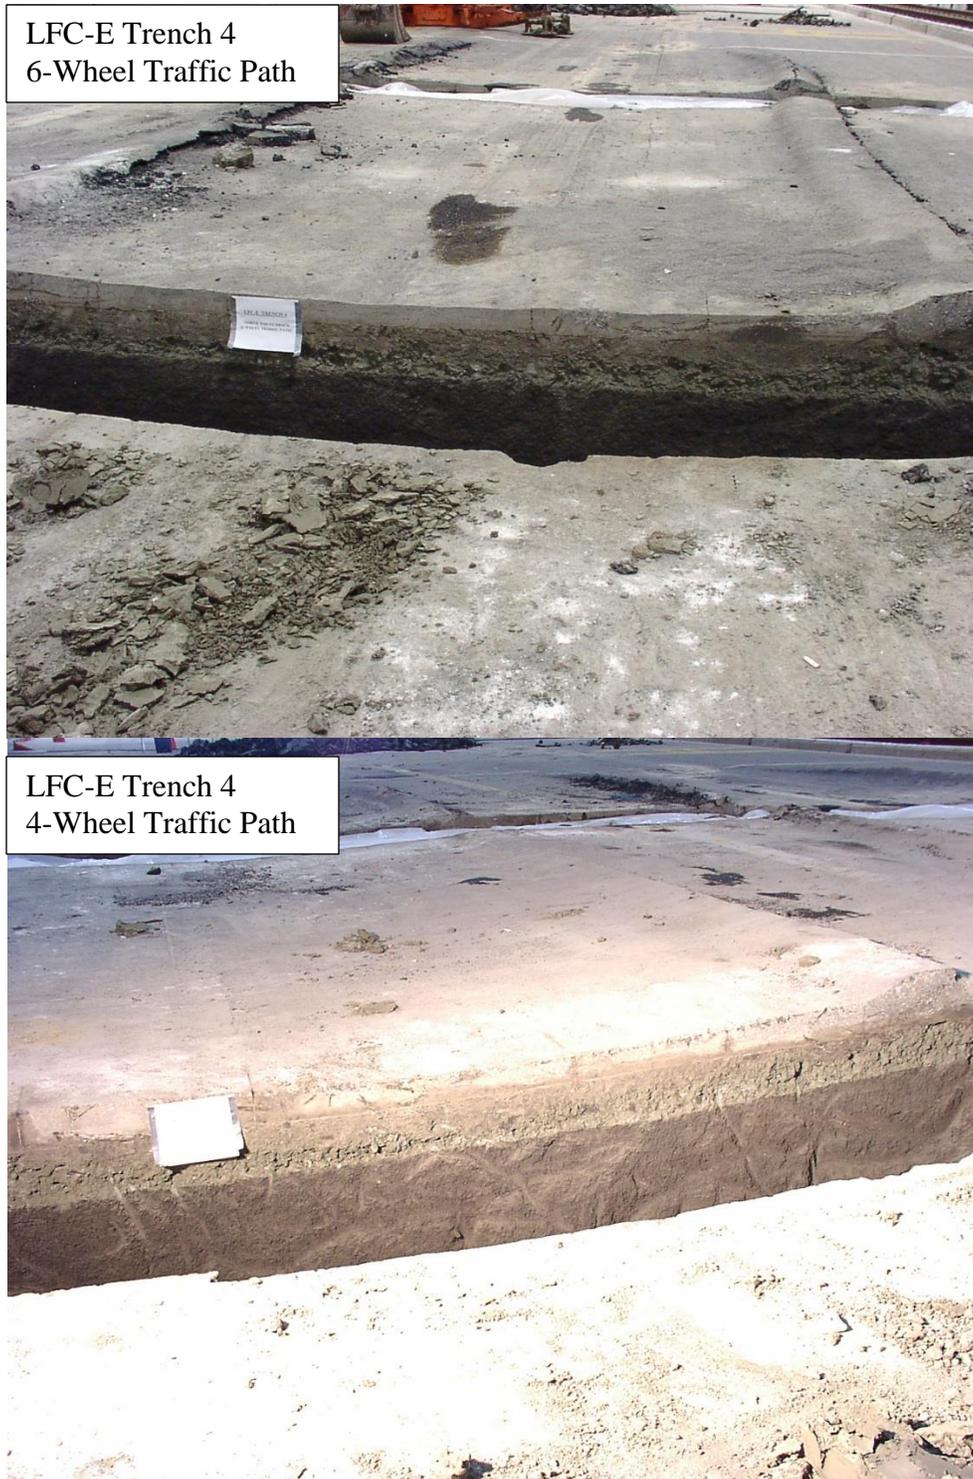
Figure 79. LFC Trench Section

As discussed before, during traffic testing the test items with low strength subgrade did not show any signs of failure at 20,000 passes and the wheel load was increased from 45 kip (20.4 tonnes) to 65 kip (29.4 tonnes). Trafficking was stopped in the LFC test item at approximately 22,000 passes with the final TSP rut depths of 3.2 inches (81 mm) in the 6-wheel traffic lane and 3.1 inches (79 mm) in the 4-wheel traffic lane. Following trafficking, Trench LFC-E was excavated at station 1+75. Figure 79 shows the LFC test item after trenching.

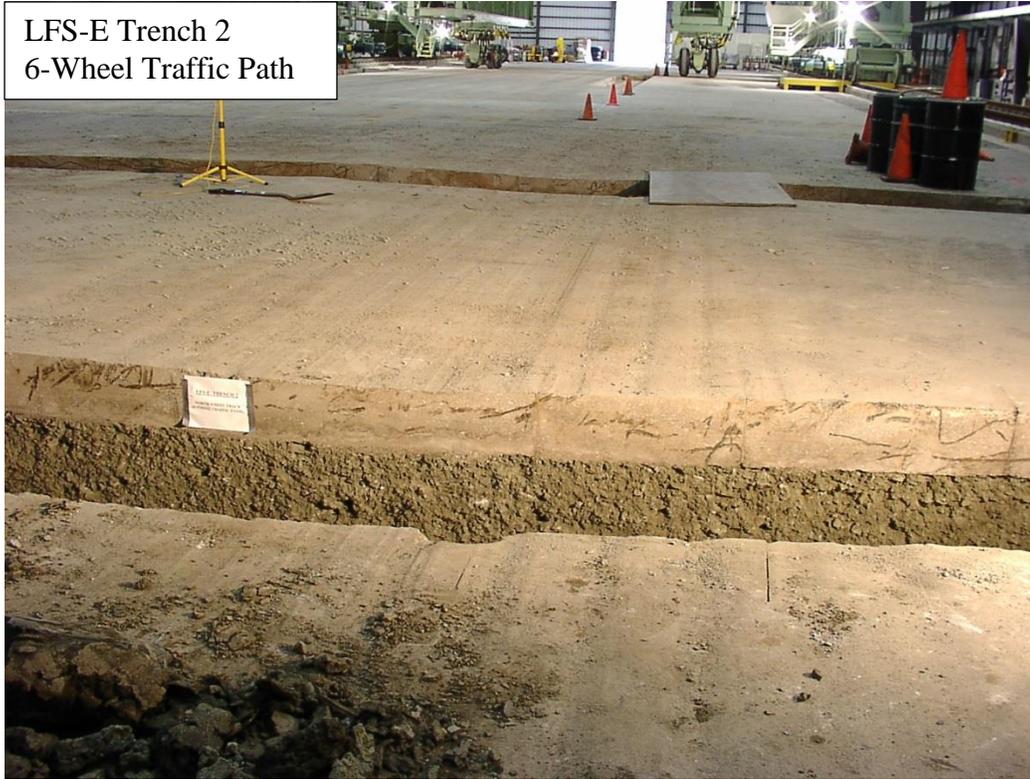
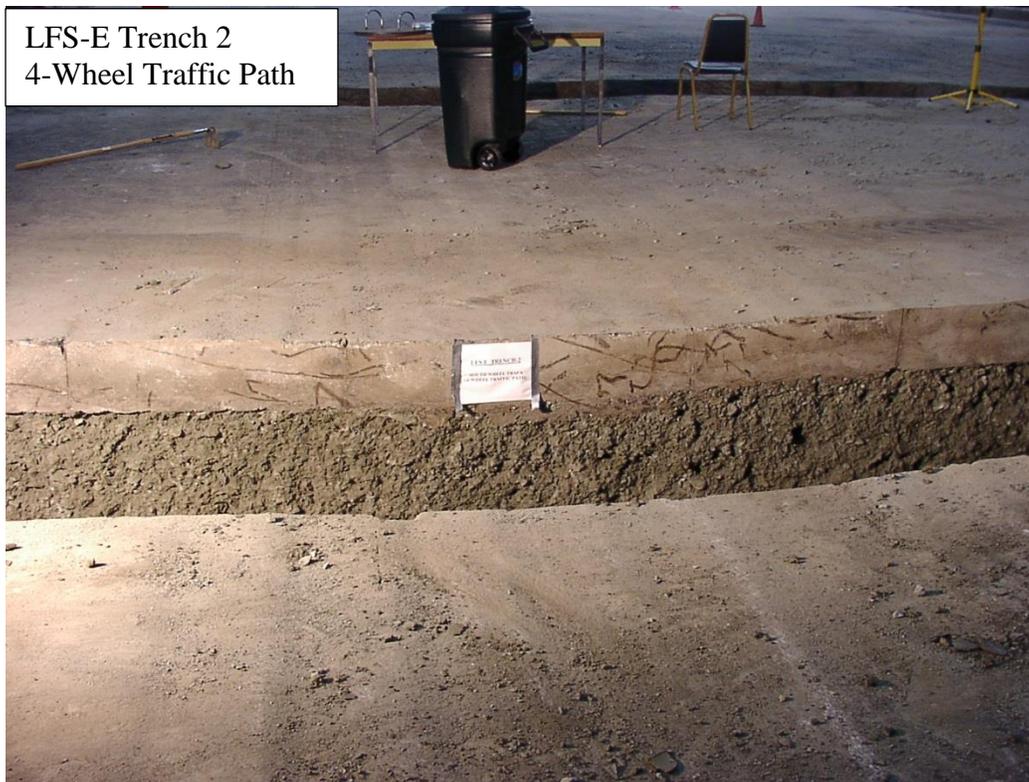
(b) South (4-Wheel) Side Looking West
Figure 84. LFS-E Trench Views

In the LFS item, traffic was stopped after 45,000 passes. At that point, the rut depth was 2.4 inches (61 mm) in the 6-wheel traffic path and 2.7 inches (69 mm) in the 4-wheel traffic path. The LFS test item did not meet the 1 inch (25.4 mm) surface upheaval failure criteria at the end of traffic

testing, thus it was not considered failed. Following trafficking, Trenches LFS-W and LFS-E were excavated at stations 2+50 and 2+75, respectively. Figure 84 shows LFS-E north and south of the centerline.

(a) North (6-Wheel) Side Looking West

Figure 85 and Figure 86 show pavement layer profiles for the west and east faces of the LFS-E trench. Layer profile thicknesses for the west and east faces of the LFS-E trench are shown in Figure 87 and Figure 88, respectively. Some rutting was observed in the P-401 AC and P-209 base layers in both traffic paths; however, as mentioned before, LFS failed at surface layer by the formation of cracks. In addition, shoving occurred in the P-401 AC layer resulting in upheaval outside the traffic path.

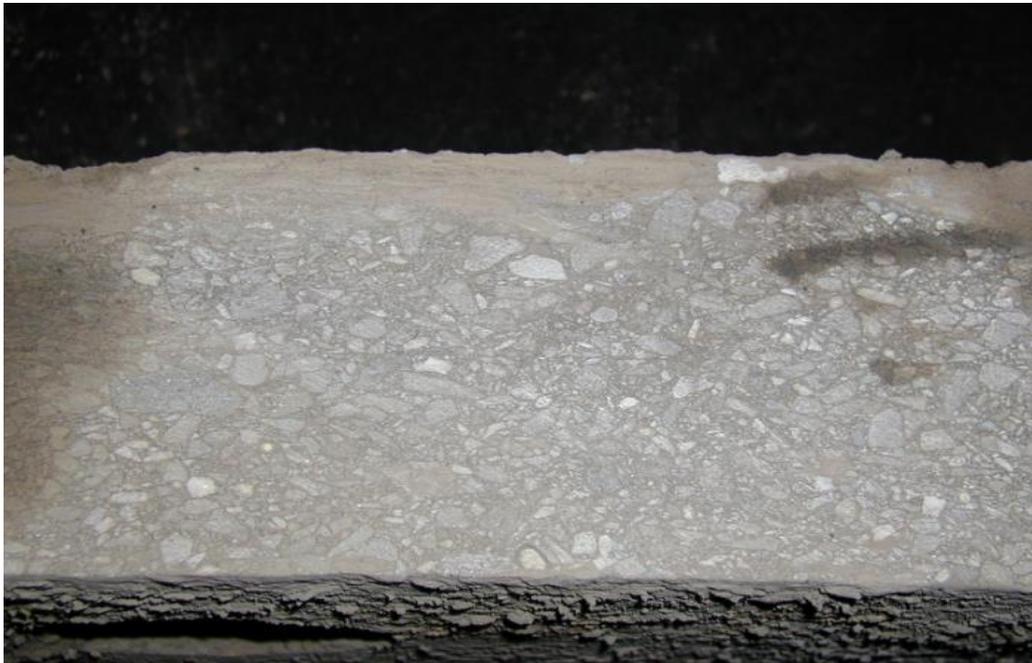
Figure 93. P-401 from Maximum Rutting Location (Center of 6-Wheel Traffic Path)

Figure 93 shows the P-401 layer at the location of maximum rutting (center of the 6-wheel traffic path). No signs of rutting in the P-401 layer were observed.

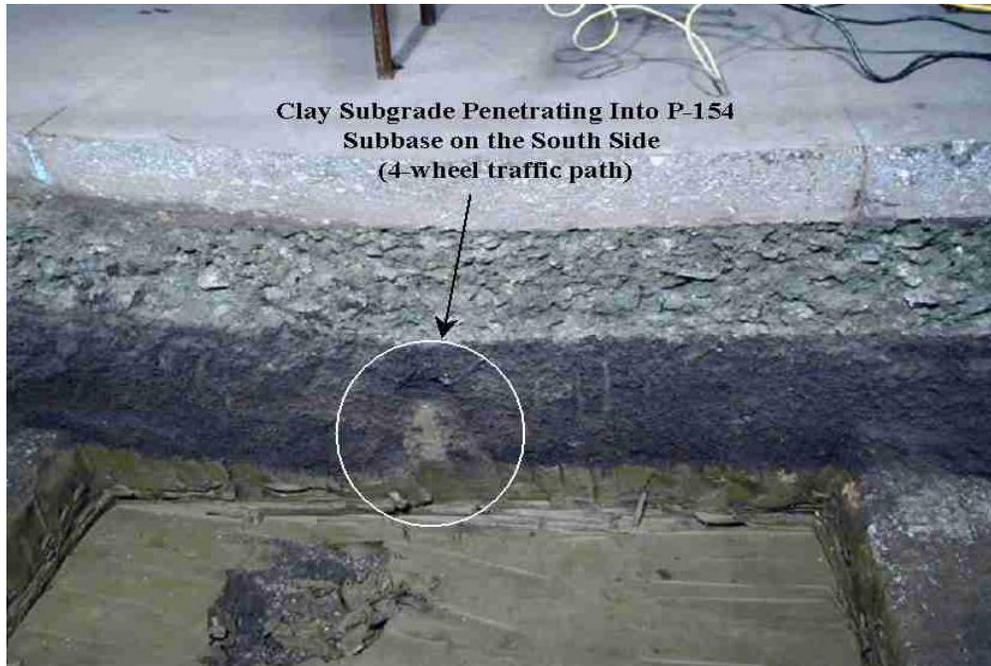
Figure 94. Lateral Movement of P-154 Subbase in Test Item MFC at the Center of 4-Wheel Traffic Path (South Side) (Garg 2003)

The loss of confining stress at the bottom of the granular material provided an opportunity for the clay subgrade material to intrude upwards into the subbase layer, which was observed at several locations in the trench (Figure 94 and Figure 95). Figure 94 shows the lateral movement of the subbase material at the subbase/subgrade interface at the center of 4-wheel traffic path.

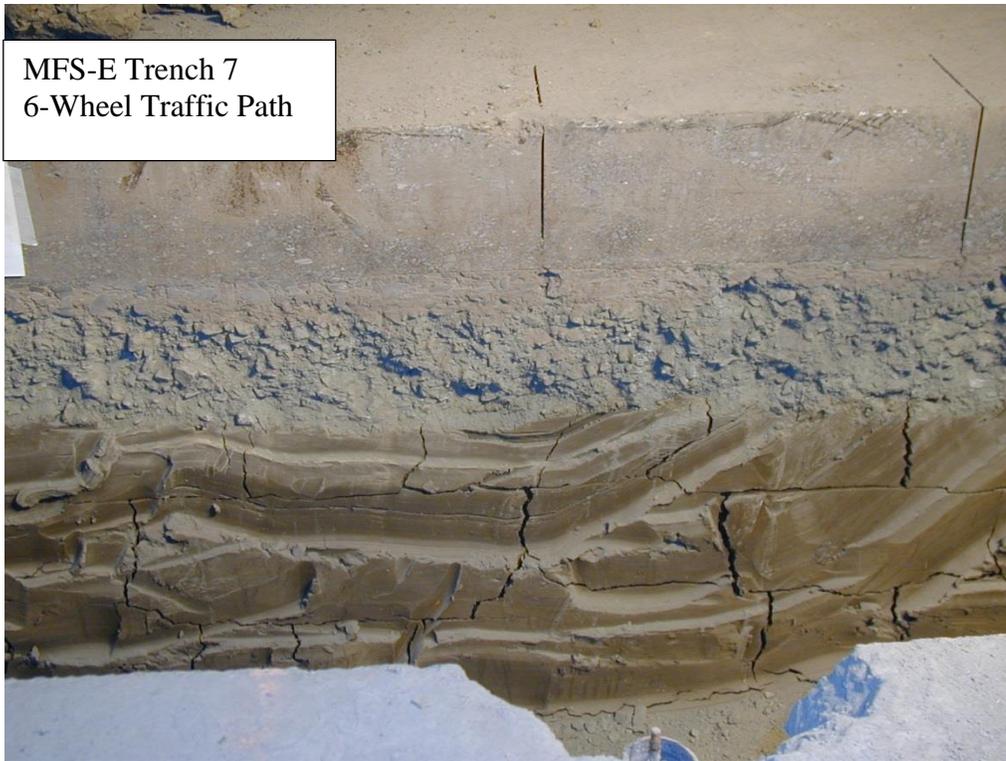
Figure 97. MFS East Trench Section

The final rut depth on the east location was 0.7 inches (1.78 cm) under 6-wheel traffic (north) and 5.1 inches (12.95 cm) under 4-wheel traffic (south) (Hayhoe and Garg 2004). Figure 97 shows the MFS East trench section.

(a) North (6-Wheel) Side 0.7 Inch Rut

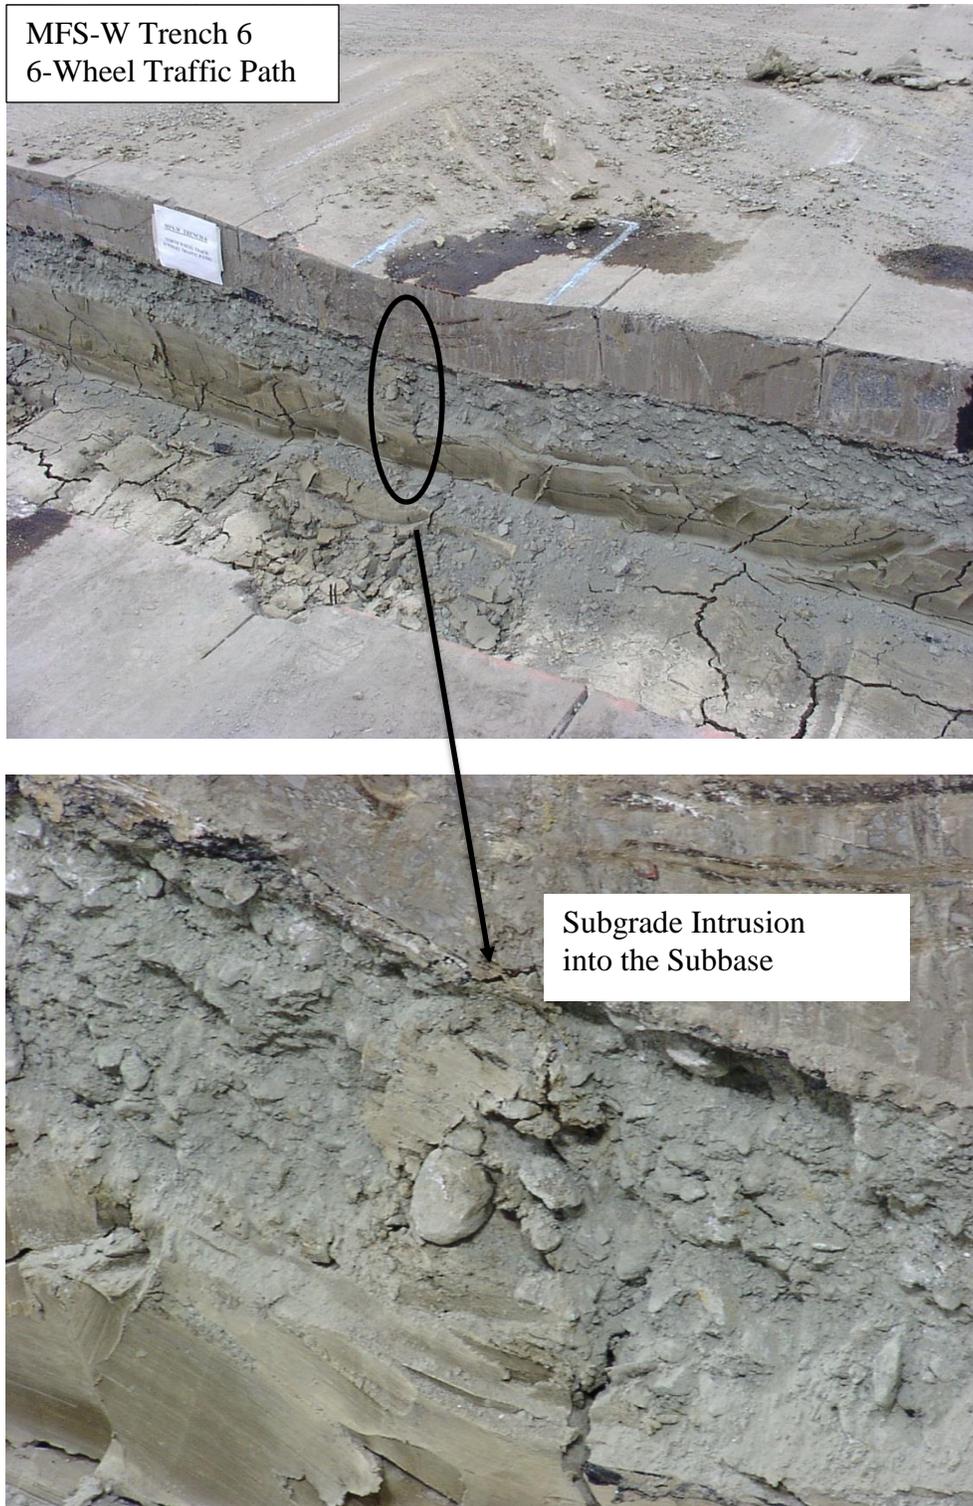
Figure 100. MFS West Trench Section in the 6-Wheel Traffic Path (Hayhoe and Garg 2004)

The P-401 surface and P-401 asphalt stabilized base were removed from the west trench to expose the P-209 subbase. Localized failure of the P-209 subbase was observed in the 6-wheel traffic path. A vertical crack was formed longitudinally in the P-209 subbase layer, which allowed subgrade material to intrude into the crack. The crack was approximately 2 inches (50 mm) wide at the bottom of the P-209 subbase and extended all the way up to the bottom of the asphalt base course. The longitudinal extent of the crack could not be determined, as it extended beyond the walls of the trench. Figure 100 shows the subgrade intrusion and shear failure in the subbase in the 6-Wheel traffic path. Similar behavior was observed in the 4-wheel traffic path but at a much lower severity (Figure 101).

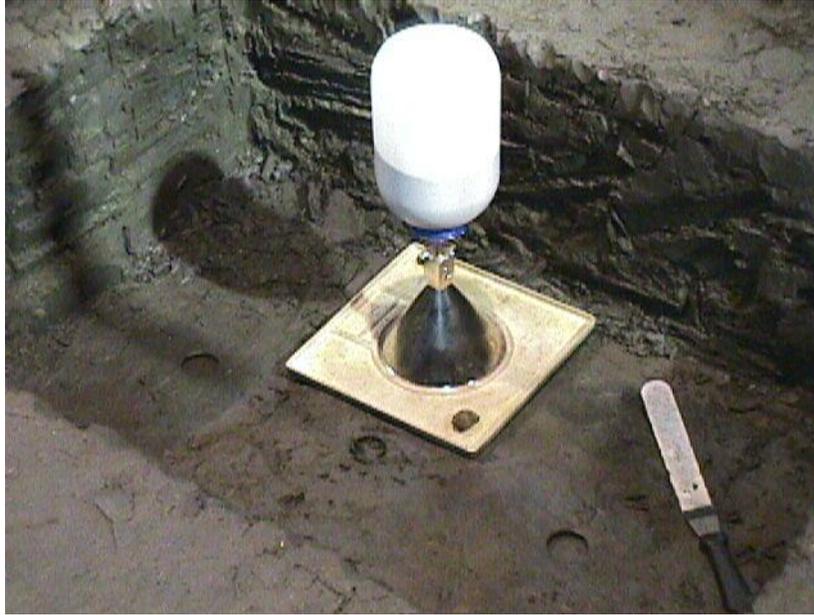
Figure 106. Sand Cone Test

Test pits were initially excavated from P-401 AC surface before the removal of layer for the trench, to expose the surface of P-209 base. In-situ density measurements were made using the sand replacement method (ASTM D4914-89) to characterize density changes from the location of maximum rutting (center of each wander path) to the location of maximum upheaval (outside the wander path) and were also compared to the density of the non-trafficked area (pavement centerline). Figure 105 and Figure 106 show the location of sand cone tests within a test pit and

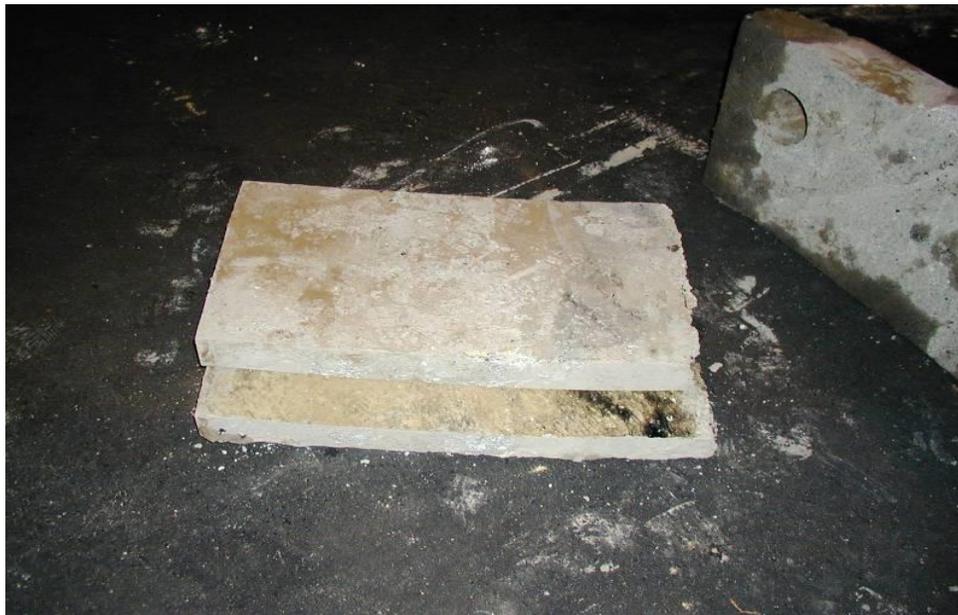
Figure 112. P-401 Surface Exhibiting Delamination

Figure 112 shows an example of delamination in the P-401 layer. A thin layer of dust between the two lifts could have caused the delamination (Garg 2001).

Before the excavation of test pits, 4-inch diameter cores were extracted from the north wheel track and the south wheel track for thickness measurements. The cores were inspected for delamination/separation at the interfaces between lifts and for the depth of cracks occurring in the pavement. Core locations were chosen so as to include the most severe cracks, hairline cracks, and medium-intensity cracks. In total, nineteen cores were extracted and four measurements were made on each core at opposite sides. Delamination between the two lifts of the P-401 layer was observed in the 4-wheel traffic path cores. Only two cores from the 6-wheel traffic path showed delamination.

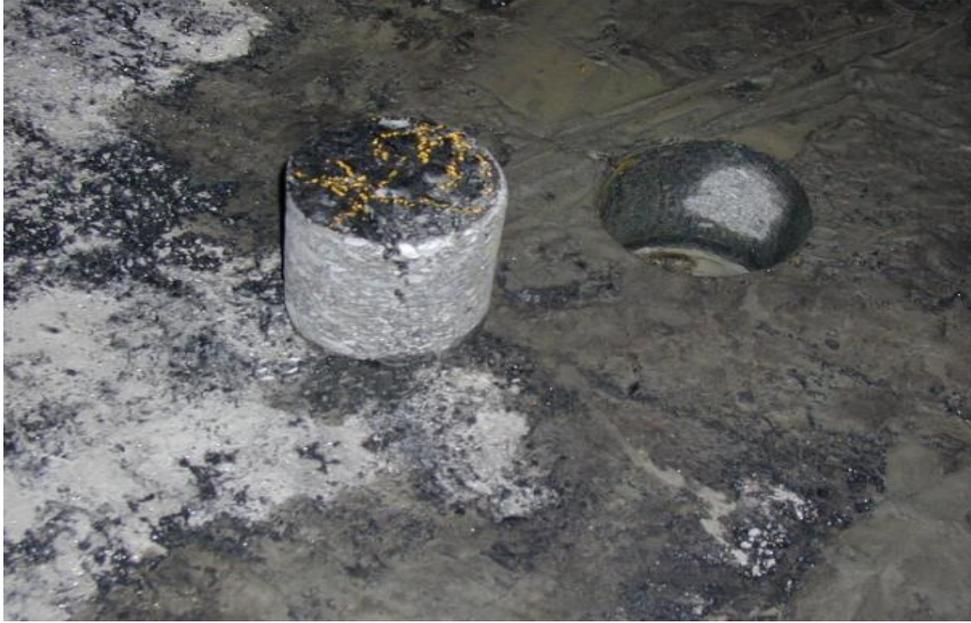
Figure 113. Core Showing Crack Location

Investigation of cores showed that nearly all the cracks initiated from the top with the exception of one core that was cracked from the bottom. Figure 113 shows an example of a P-401 core with crack starting from the top. The P-401 core details can be found in table D- 28 in Appendix D.

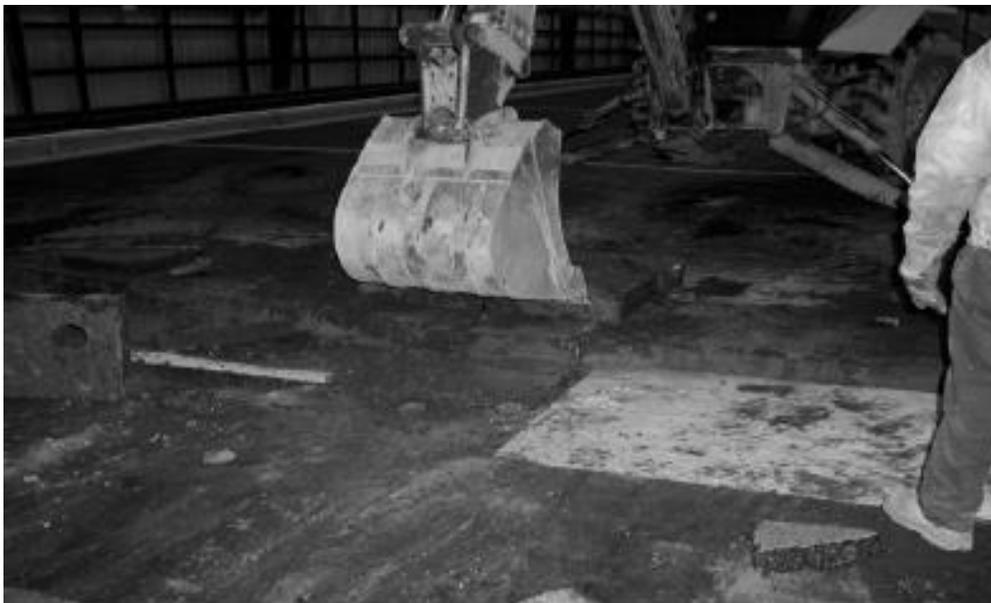
Figure 114. P-401 Removal

The P-401 layer was removed using a backhoe (Figure 114). During the removal, the two lifts of the P-401 layer in the four-wheel traffic path separated easily due to the delamination.

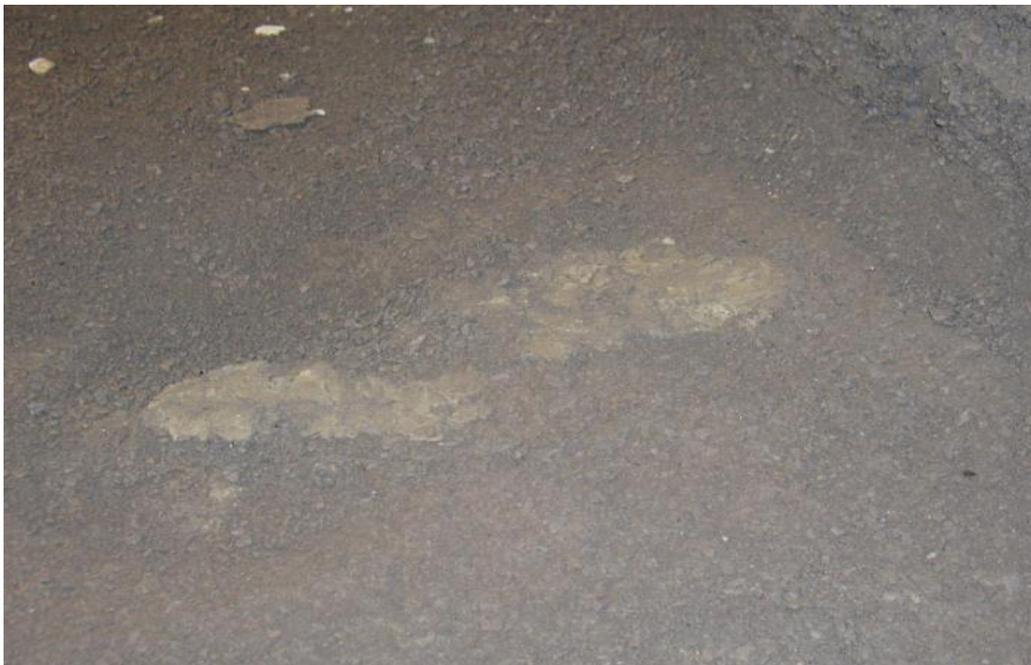
Figure 115. Subgrade Penetration into P-154 Subbase in 4-Wheel Traffic Path

After completing the tests in the P-154 test pits, the base and subbase were excavated using a backhoe. Figure 115 shows the penetration of clay subgrade into the P-154 subbase at the location of maximum rutting in the 4-wheel traffic path. For the subgrade, dry densities and moisture contents remained almost the same as pre-traffic values. In general, dry density and moisture content decreased with increasing depth. Figure 116 shows the variation of dry density and moisture content with subgrade depth.
