Contract No. DTFACT-15-D-00007
Task Order Number 005

Construction Cycle 7 Post-Traffic Report - Field Testing
DELIVERABLE 4.9.3.1

September 3, 2019

Composed by:
Gemini Technologies Inc., for General Dynamics Information Technology

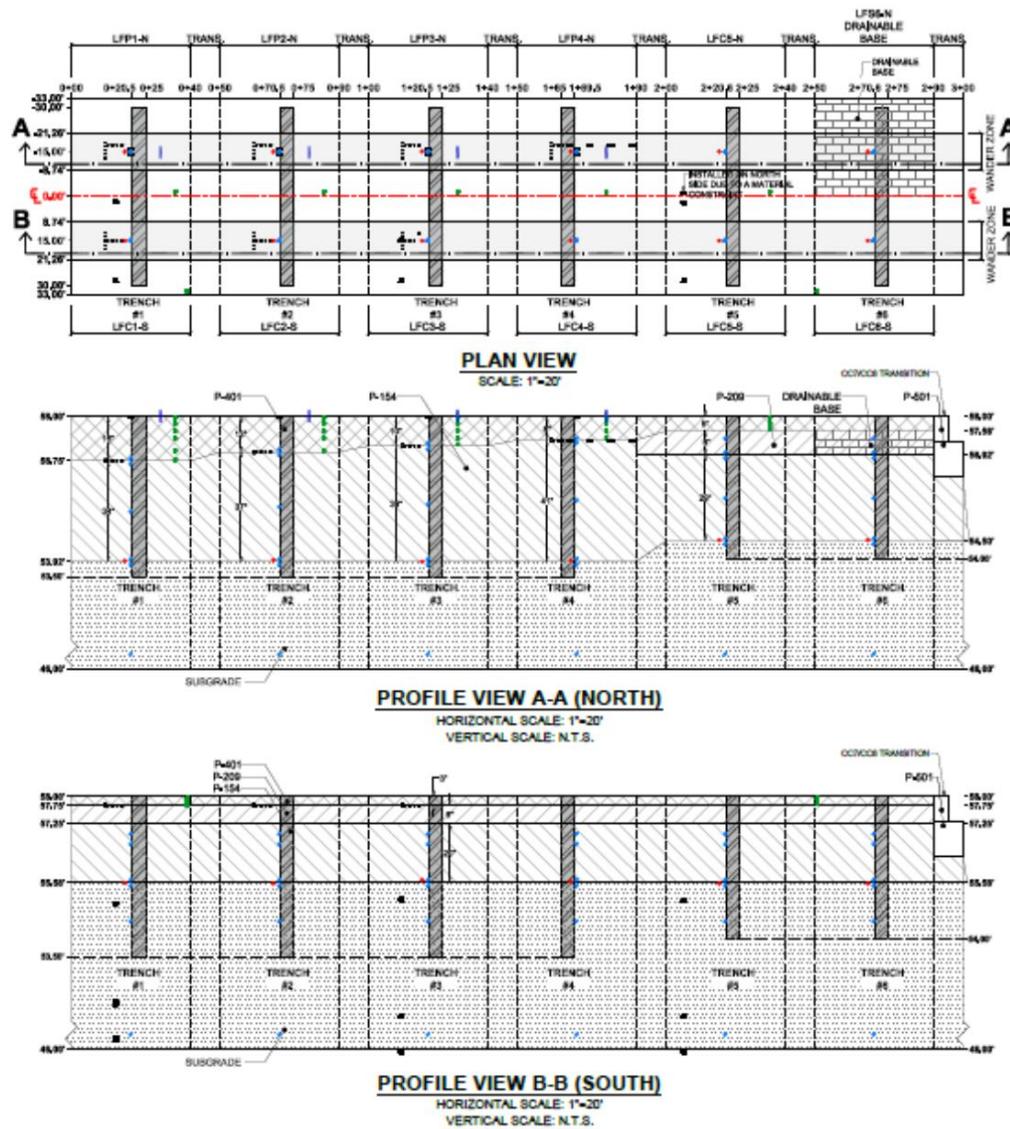
Figure 1. CC7 Post Traffic Trench Locations

One 60-ft long, 4-ft wide trench was excavated perpendicular to the centerline of NAPTF for each test item. Trenches in test items LFP1-N, LFP2-N, LFP3-N and LFP4-N were excavated to an approximate depth of 49 inches, including the removal of the P-154/P-152 interface. All remaining trenches in both north and south side were excavated to an approximate depth of 49 inches. Table 2 lists the start station and end station for each trench. As shown in figure 1, the proposed trenches are located between the MDD sensors and profile stations where the maximum rut depth was measured.

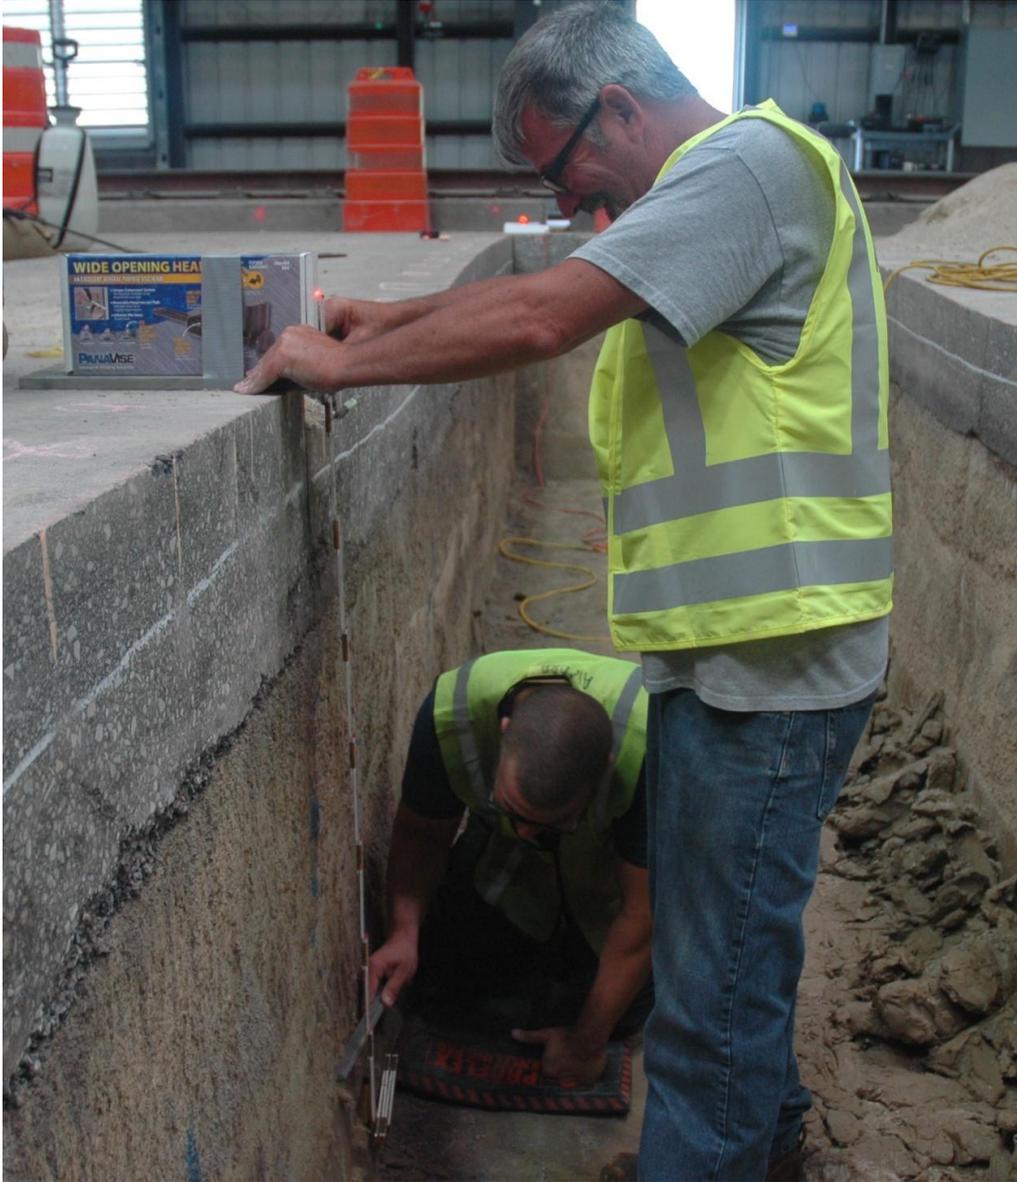
Figure 2. Layer Profile Measurement on Trench Wall

Upon the completion of all tests, transverse trench walls (at base, subbase and subgrade levels) were smoothed using shovels, chisels, and brooms. Once a clean trench wall was achieved, chalk and string lines were used to differentiate pavement layers. The profile of each layer was measured at regular intervals to determine its contribution to the total deformation and upheaval of the pavement structure (figure 2).

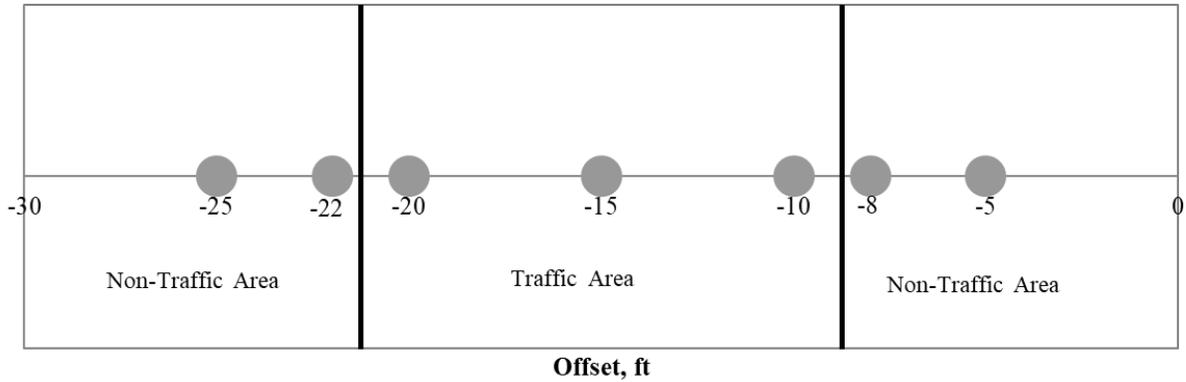
Figure 3. PSPA Test Locations

PSPA tests were performed on the surface of the P-401 as detailed in table 3. PSPA test was conducted at all the offsets in each station indicated in table 3. A typical layout of the test locations considered for trench surface testing is illustrated in figure 3.

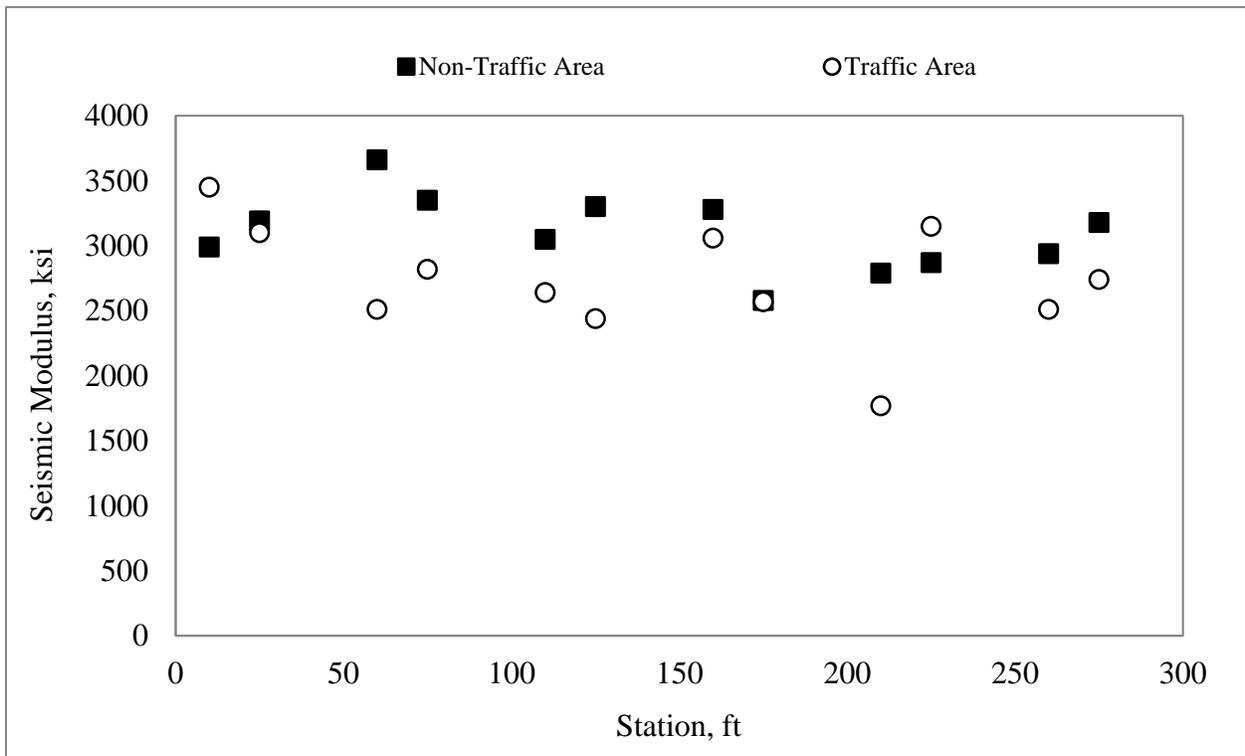
Figure 4. Comparison of Seismic Modulus Between Traffic And Non-Traffic Areas (CC7 North Side)

Figures 4 and 5 show the comparison of seismic modulus collected from traffic area and non-traffic area. The results appear to indicate that seismic moduli of P-401 in the non-traffic area is higher than traffic area in most test items. There was no significant difference in LFP1-N, because the P-401 layer was thicker than the other test items and the traffic did not produce much damage in the surface layer. Since the seismic wave cannot travel through macro cracks and there was a large amount of cracking in LFC6-S, the PSPA tests were performed on a traffic area without cracking. The seismic modulus in non-traffic area was close to the traffic area in test item LFC6-S. In summary, the modulus of P-401 materials reduced due to the traffic induced micro cracks.

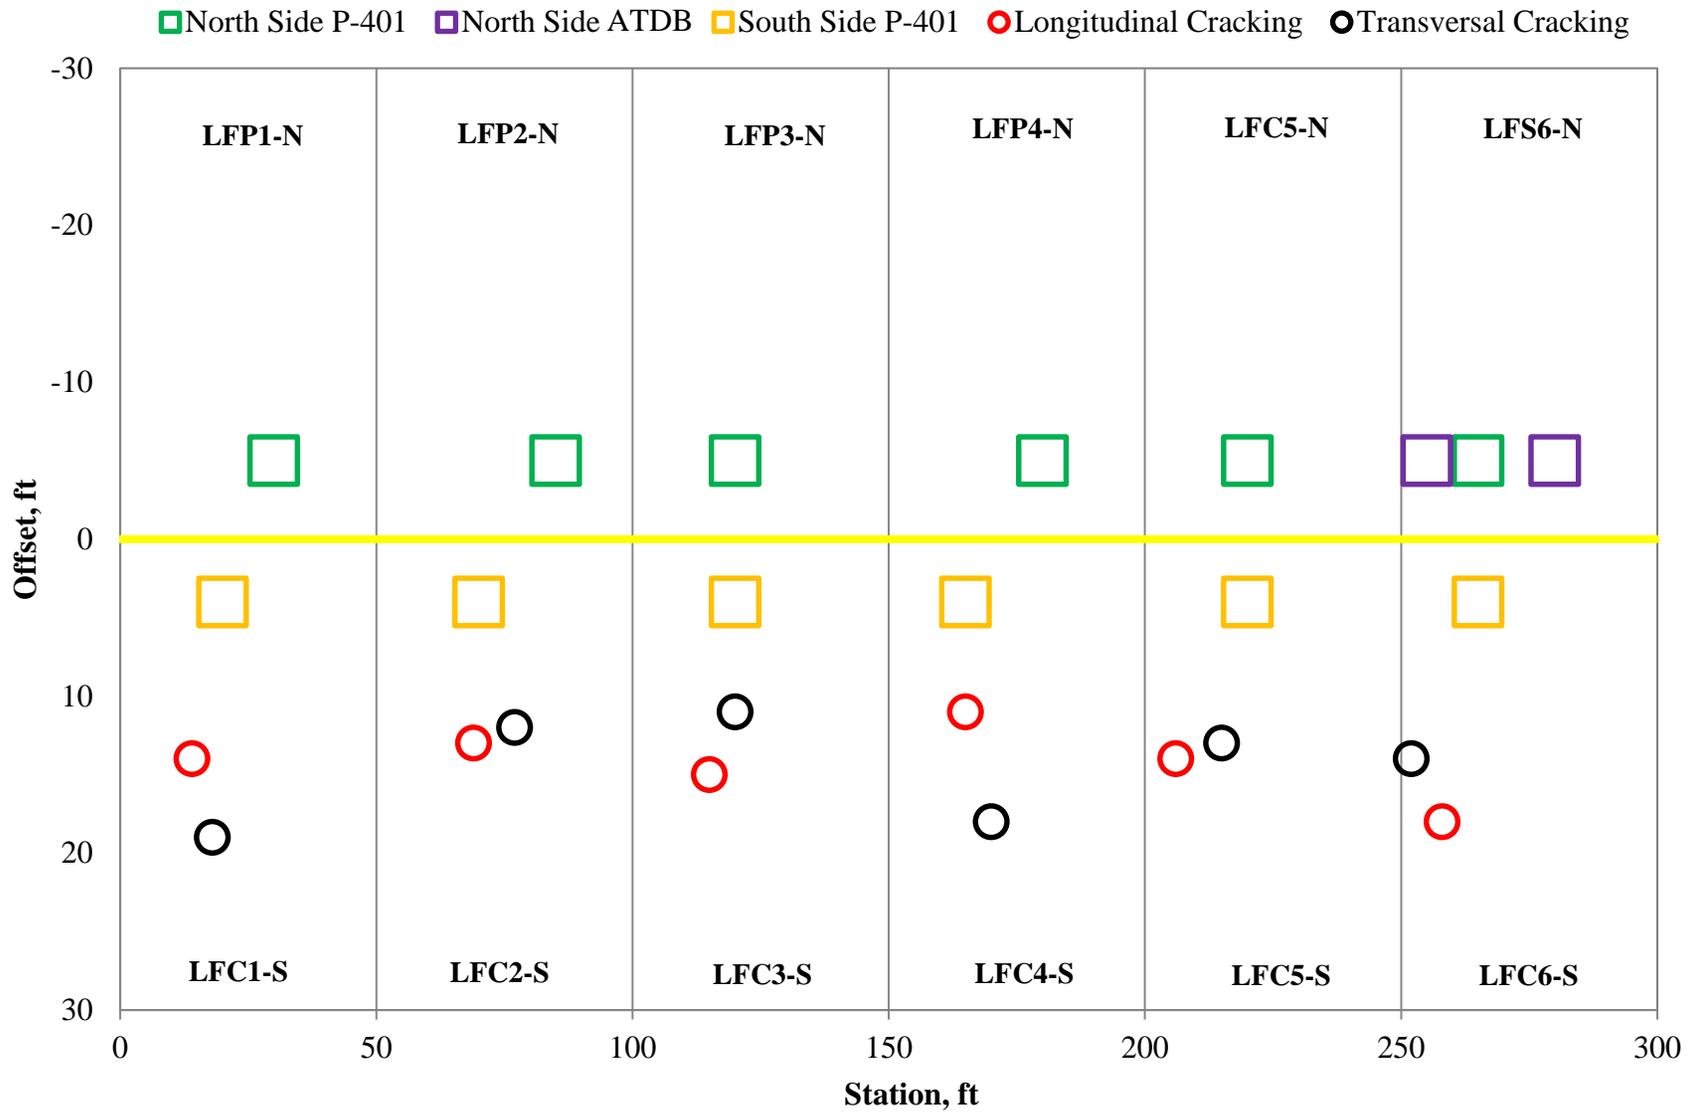
Figure 10. CC7 Post Traffic Coring Locations.

There were 6” Cores (Inner diameter of core bit=6”) collected from the non-traffic areas away from upheaval. Additional field cores were also extracted at crack locations in each south side test item. The detailed coring locations are shown in tables 4-6 and figure 10 (tables 7 and 8 show the laboratory test plans). Six and five cores were collected at each non-traffic location (figure 10) in the north and south side, respectively. Only one core per crack location was collected in the south side. The data analysis was provided in a separate CC7 Post-Traffic Report - Laboratory Testing (I).

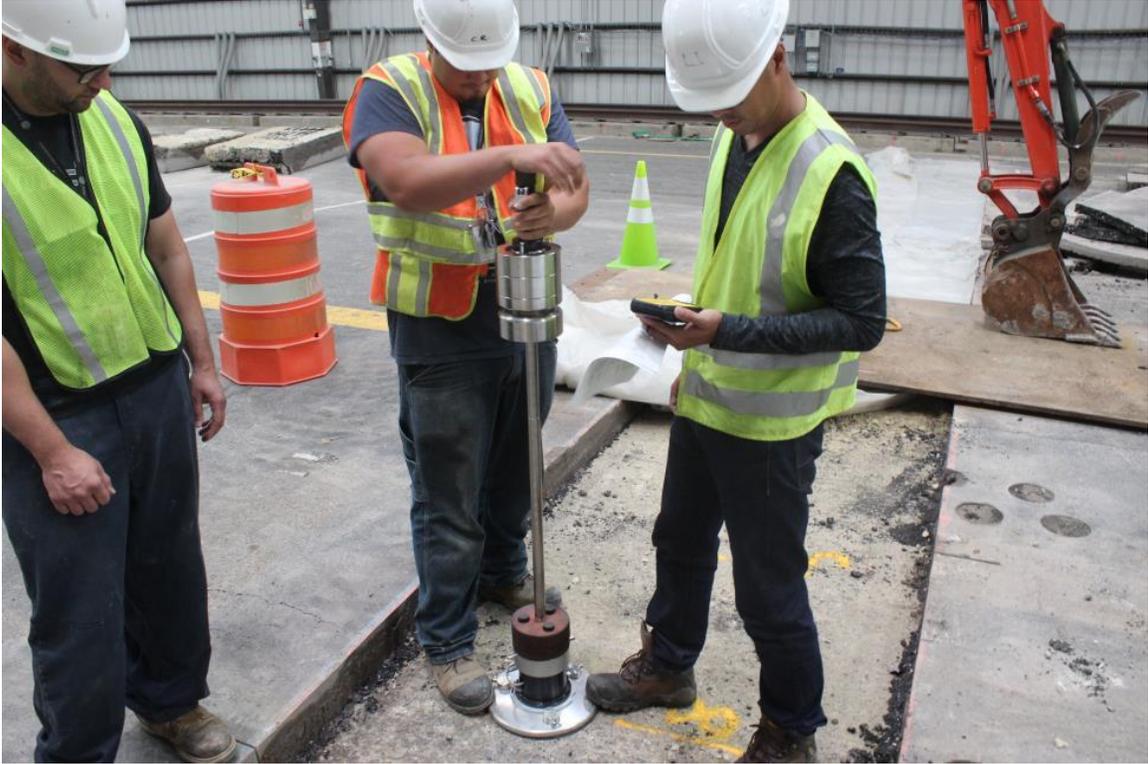
Figure 14. LWD Tests on P-209

Light Weight Deflectometer (LWD) is a portable version of the HWD. LWD measures the deflection from a falling weight and estimates the modulus. LWD (figure 14) tests were done at offsets -15ft, -10ft, -8ft, -5ft, +5ft, +8ft, +10ft, and +15ft atop of P-209 on both the north and south side. Figures 15 and 16 summarize the LWD results. The LWD results show a similar trend as PSPA results. On the CC7 south side, the LWD modulus in traffic areas was higher than non-traffic areas. Post-traffic LWD modulus were higher than pre-traffic LWD modulus. Additional post-construction compaction from full-scale traffic test increased the density of P-209 material in traffic areas.

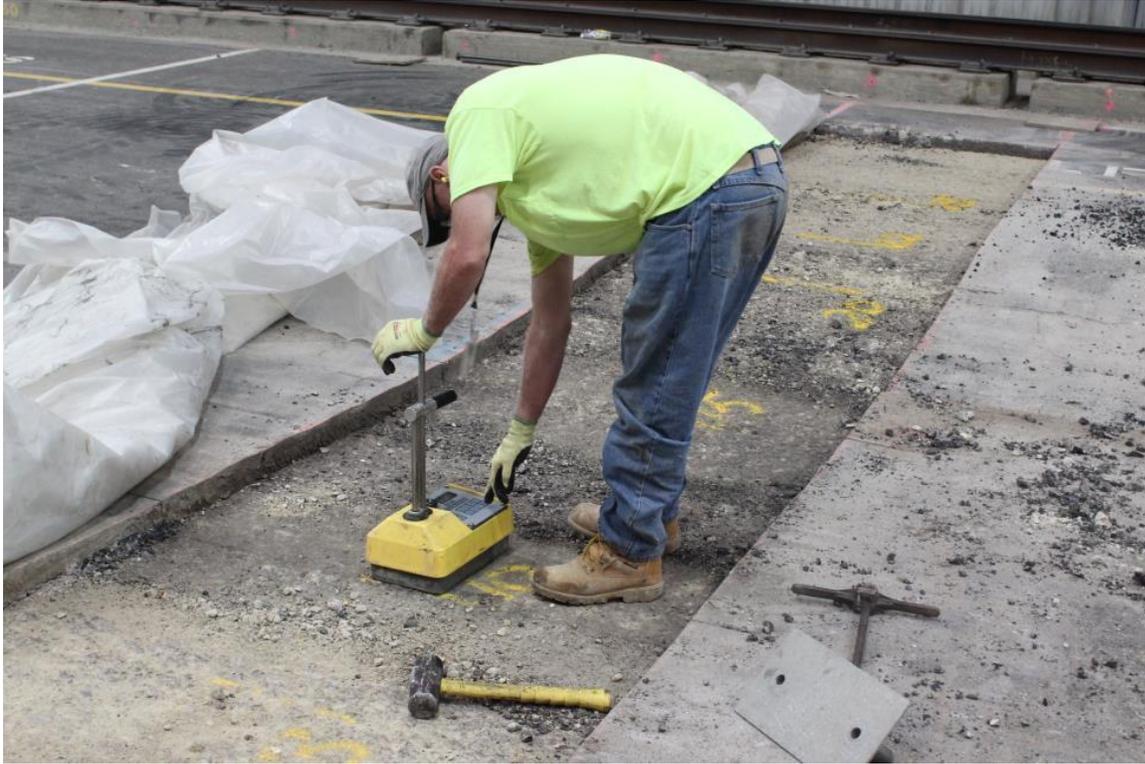
Figure 17. LWD Tests on P-209

Nuclear gauge density and 12-in sand cone tests were performed on the top of P-209 materials to determine the density and moisture content. Nuclear density tests (figure 17) were conducted at offsets -25ft, -22ft, -20ft, -15ft, -10ft, -8ft, -5ft, +5ft, +8ft, +10ft, +15ft, +20ft, +22ft, and +25ft on top of P-209 at each trench locations. The 12-in sand cone tests (figure 18) were also performed on P-209 at offsets -15ft, -10ft, -8ft, -5ft, +5ft, +8ft, +10ft, and +15ft at CC7 trench locations.

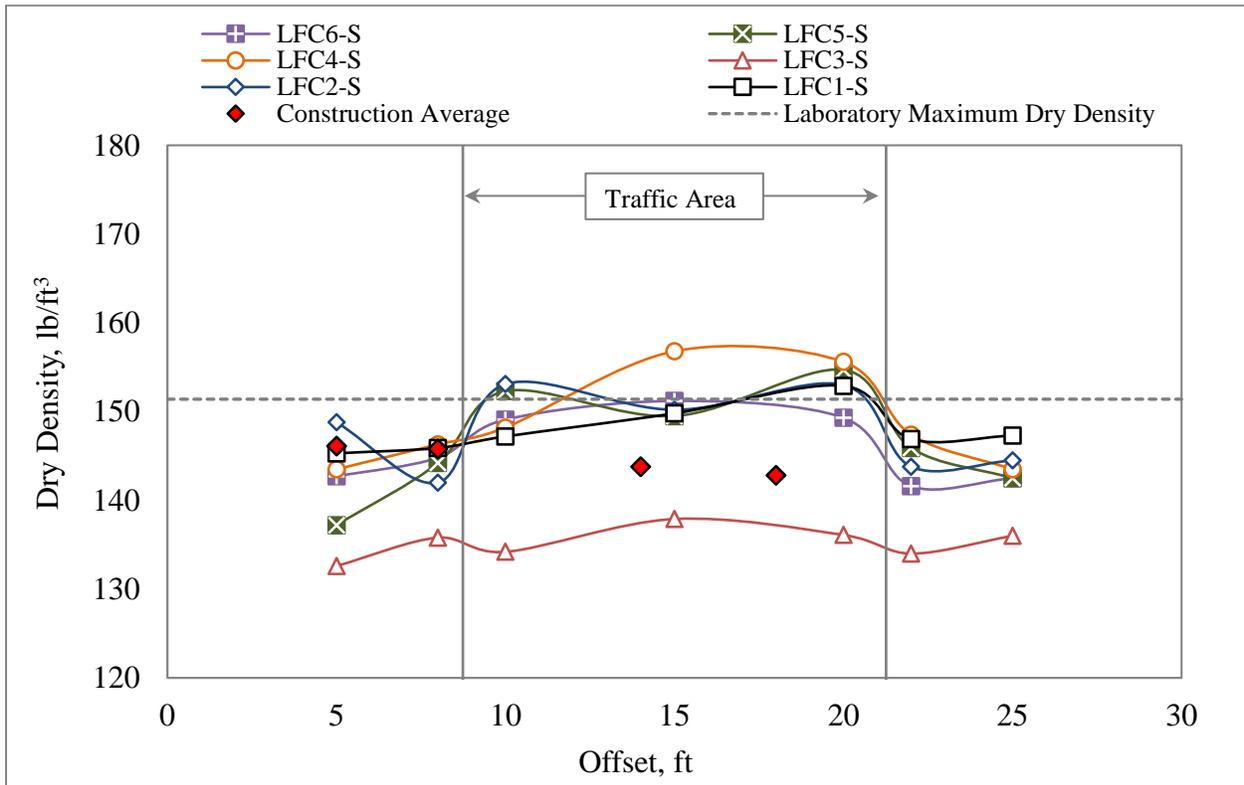
Figure 19. Nuclear Tests on P-209 (CC7 South Side)

Figures 19 and 20 summarize the nuclear density test results. The laboratory maximum dry density, $\gamma_{d\ max}$, and densities collected during construction are also plotted in those two figures. The results indicate that the traffic load densified the P-209 materials. The post-traffic density in traffic areas was higher than construction values. Furthermore, in some test items, the post-traffic density was even higher than $\gamma_{d\ max}$.

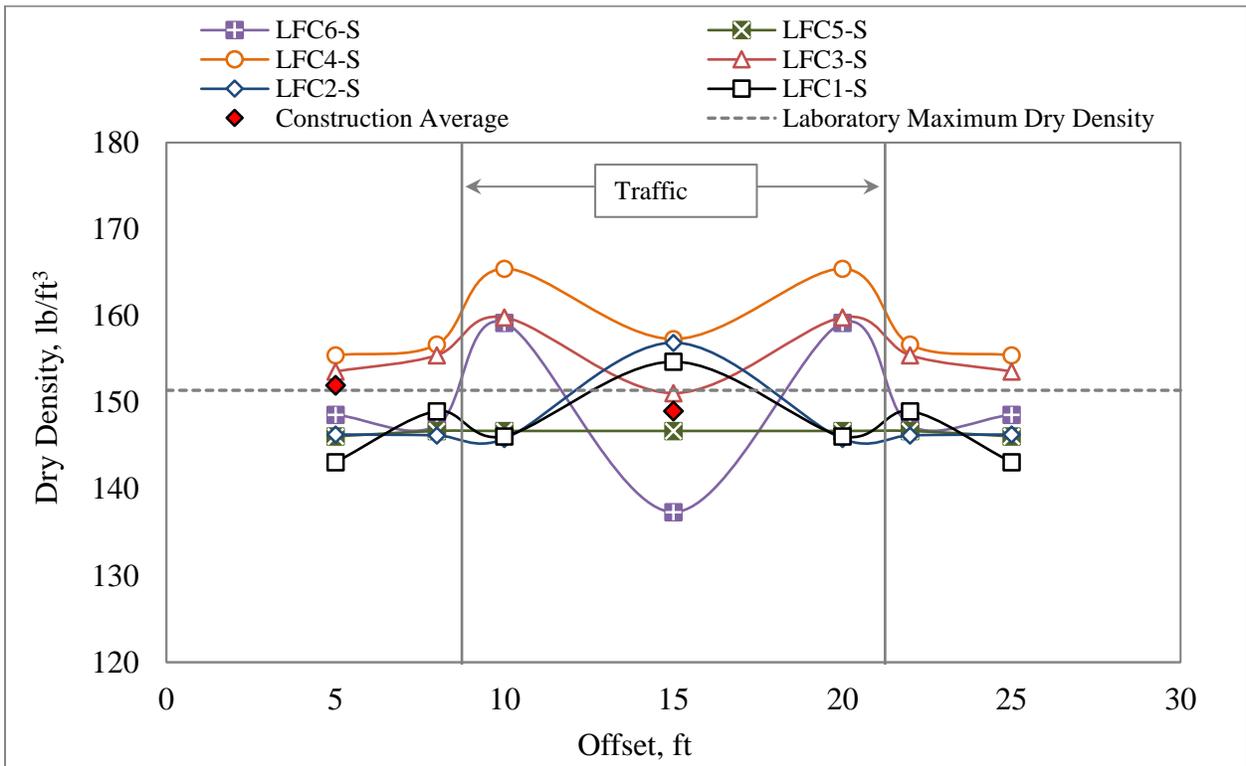
Figure 21. Sand Cone Tests on P-209 (CC7 South Side)

The sandcone results are shown in figures 21 and 22. The surface of P-209 was quite stiff and rough especially in the traffic area. Figure 23 shows the gradation of the P-209 in traffic area, non-traffic area and pre-traffic tests results. From the figure we can see that there was no significant changes on the gradation.
