Contract No. DTFACT-15-D-00007
Task Order Number 005

Construction Cycle 7 Post-Traffic Report - Field Testing
DELIVERABLE 4.9.3.1

September 3, 2019

Composed by:
Gemini Technologies Inc., for General Dynamics Information Technology

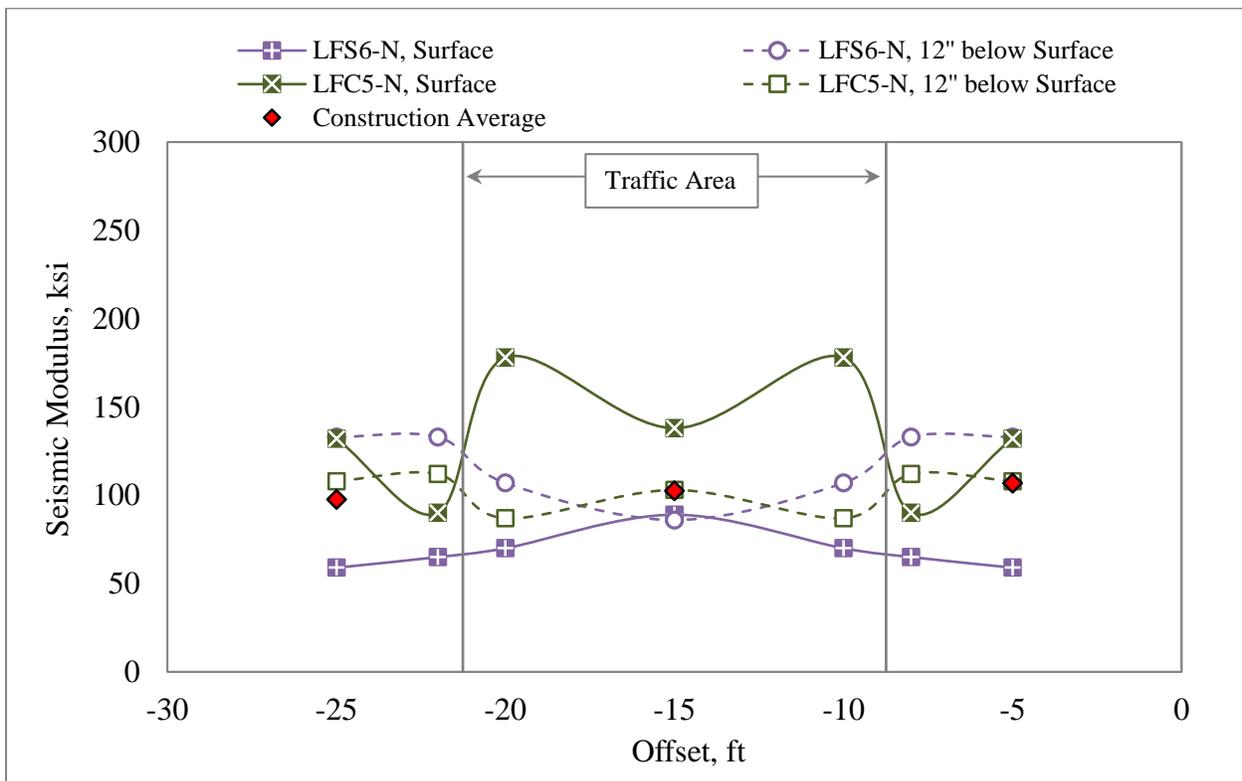
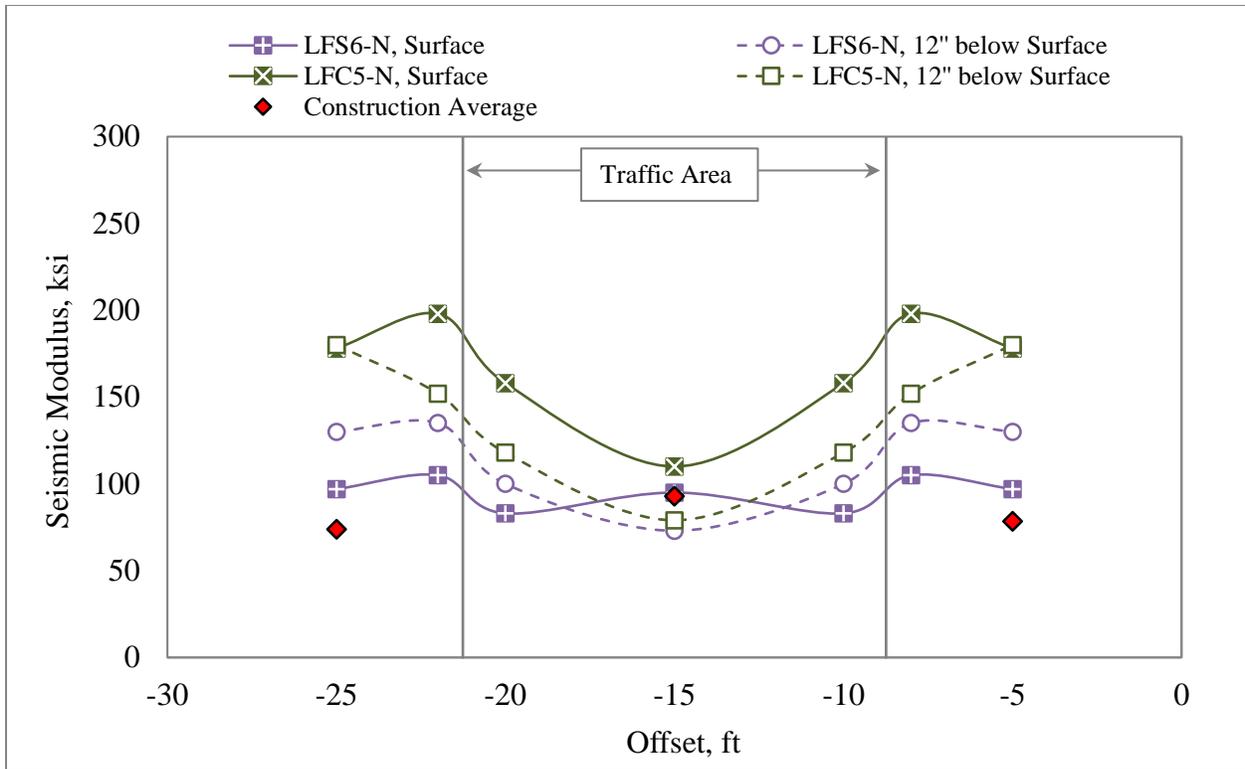
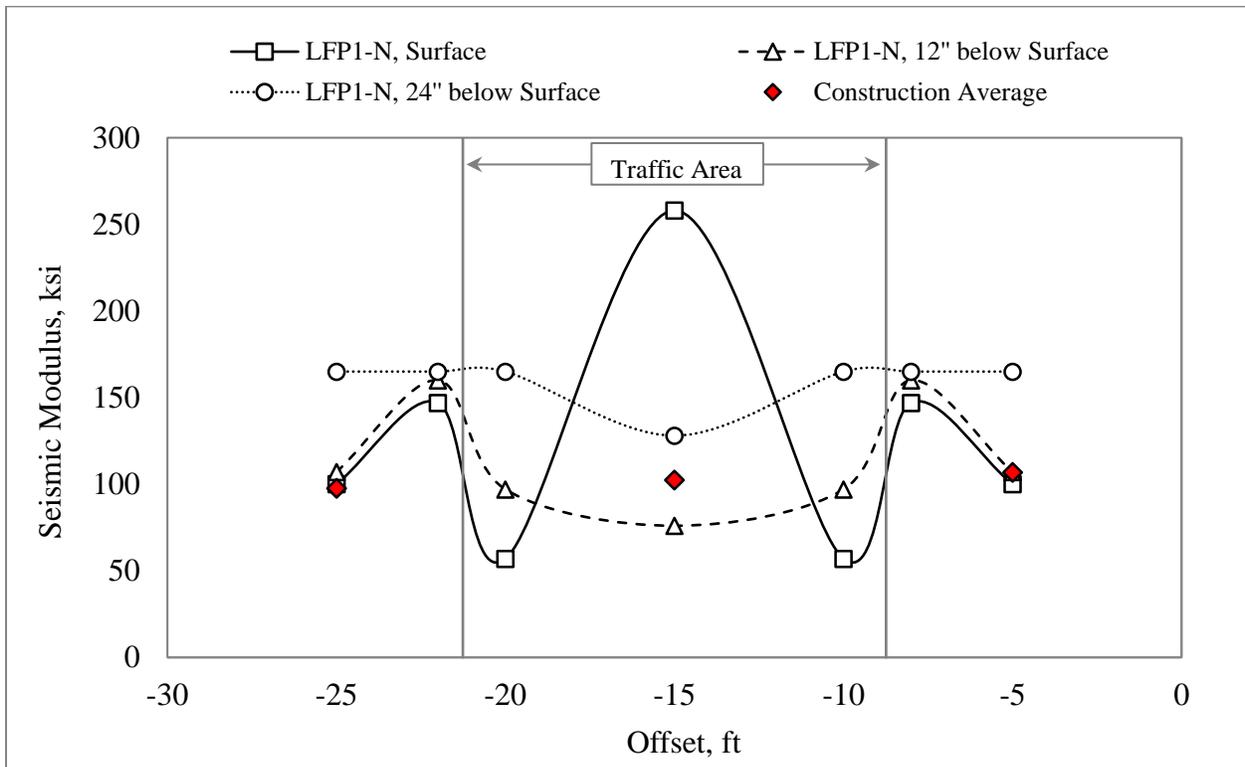
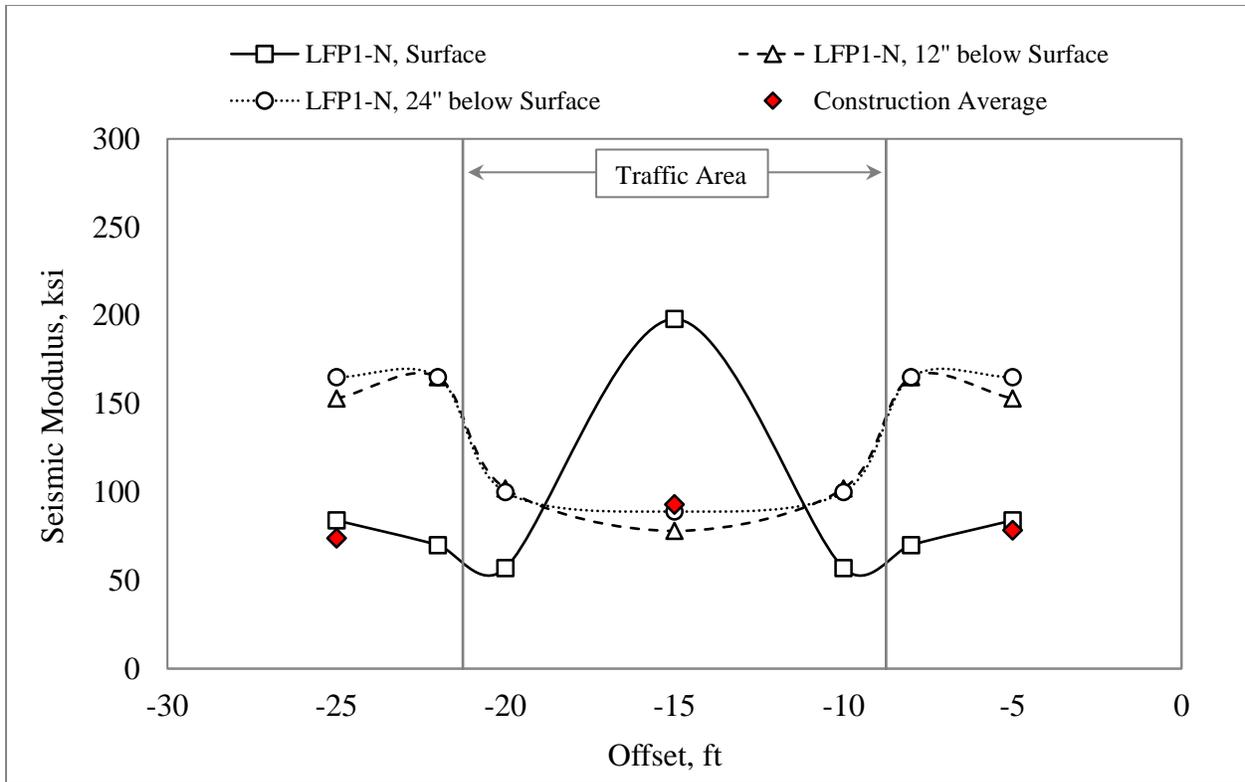
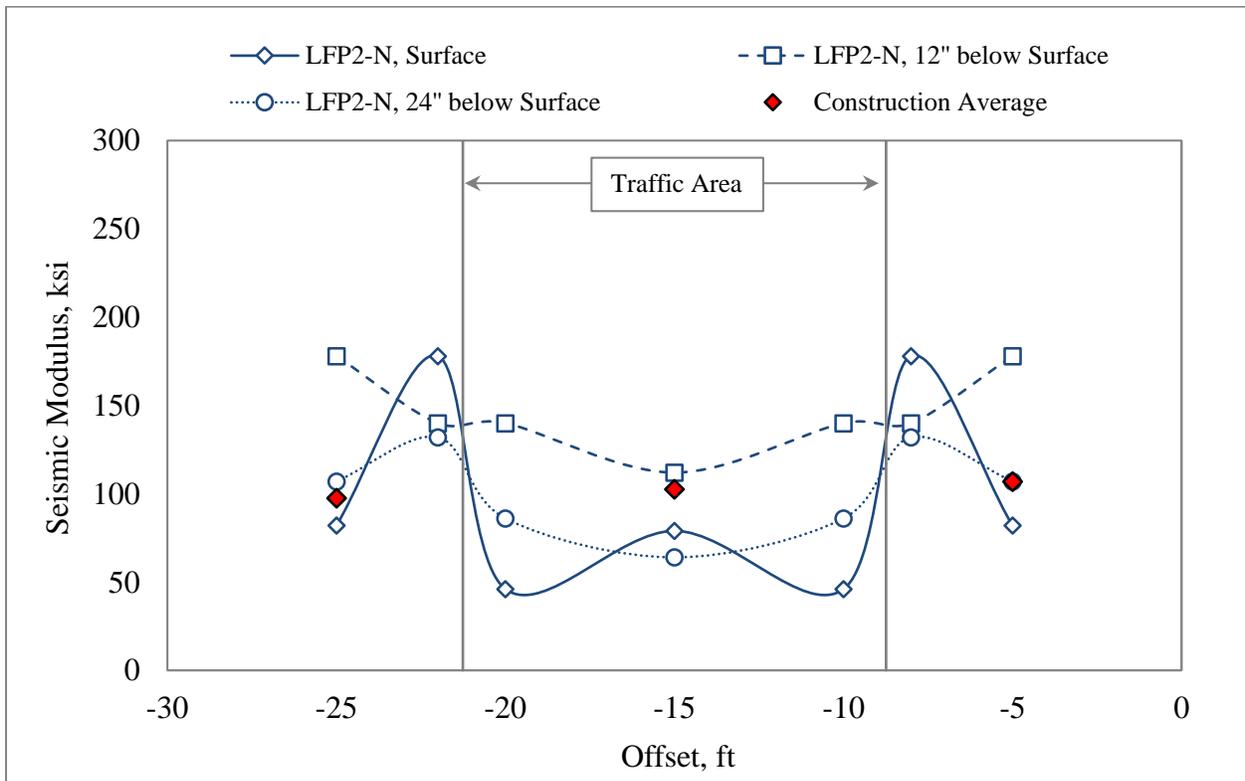
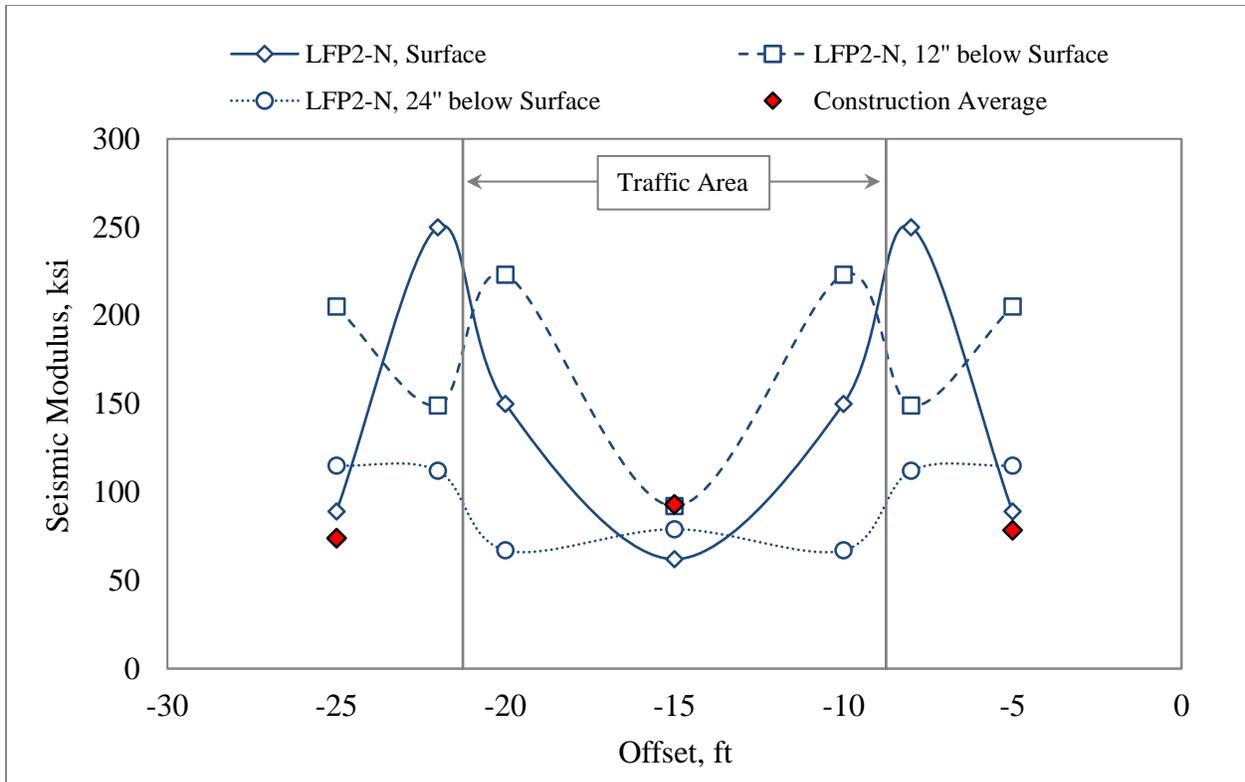
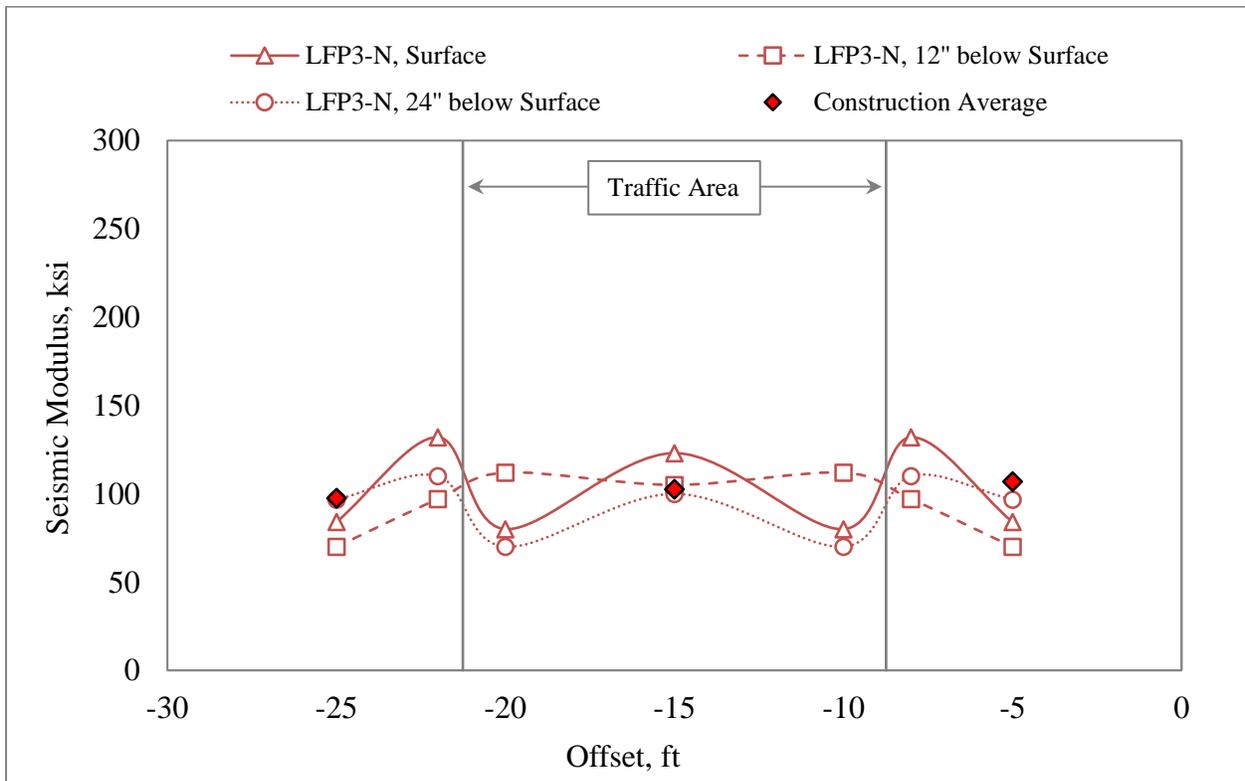
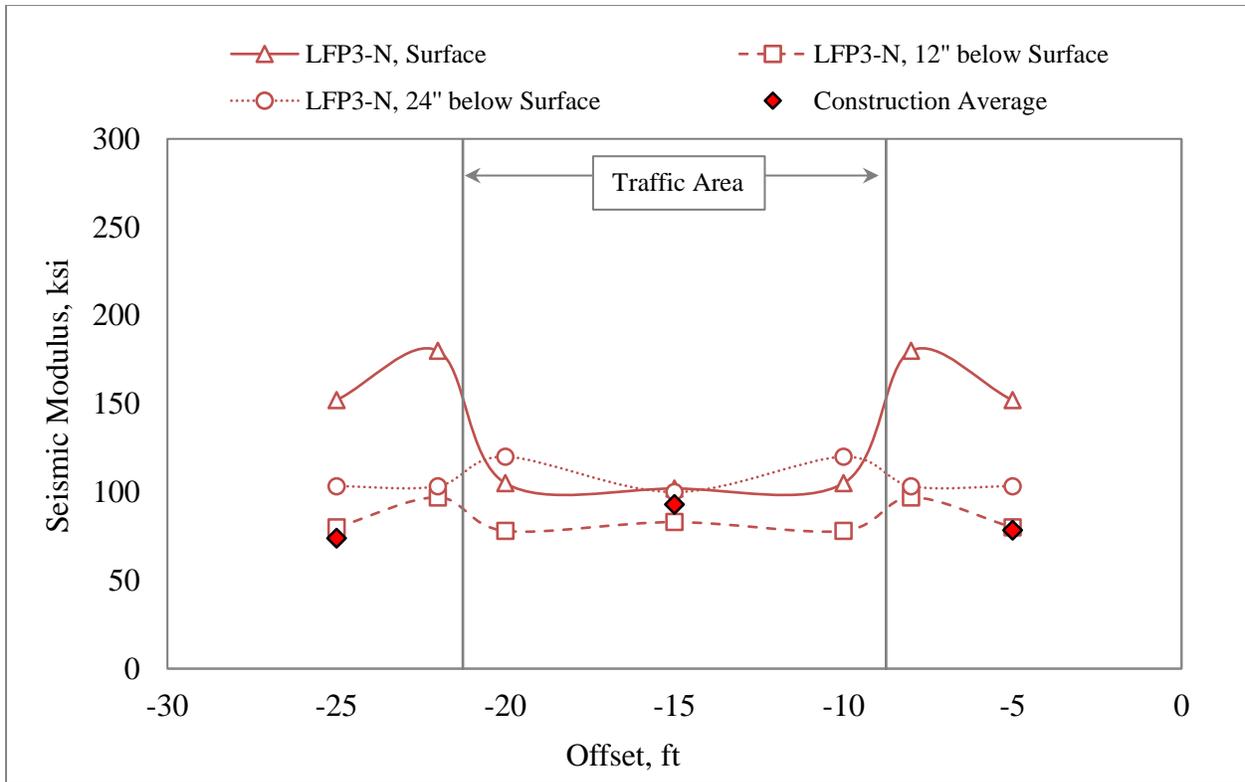
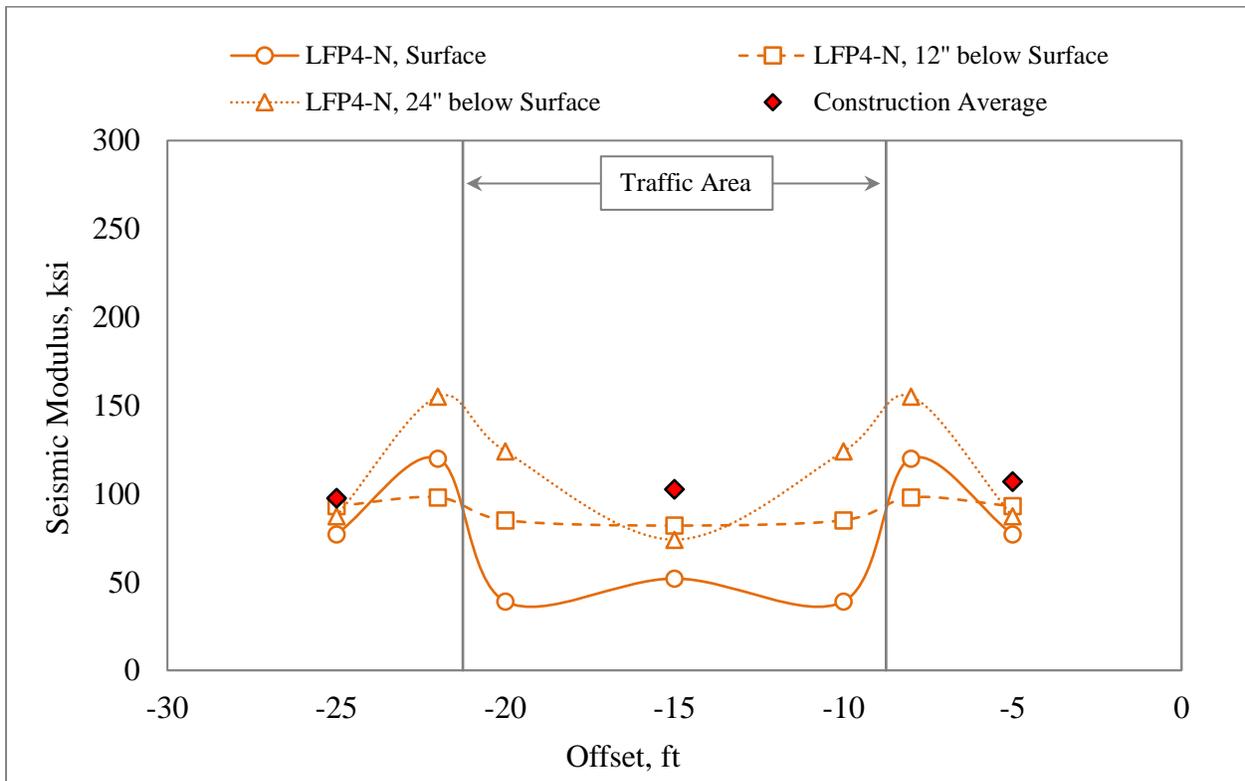
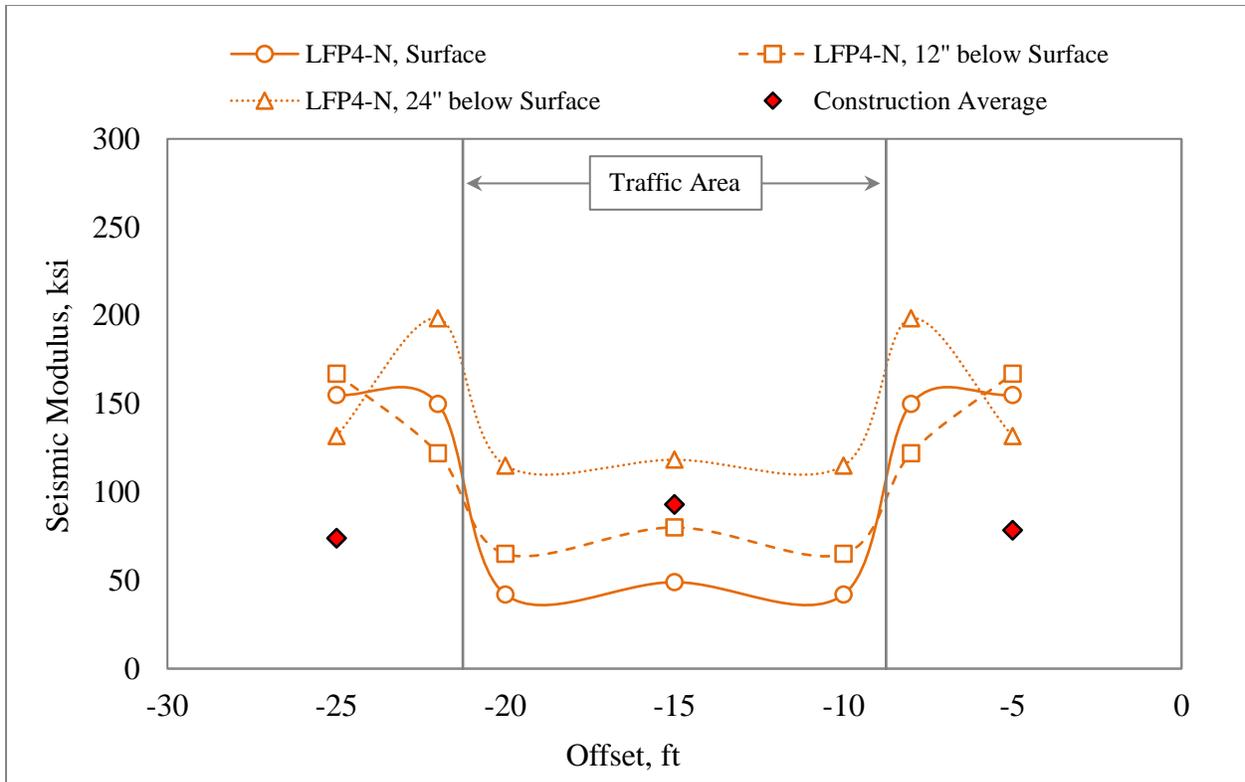
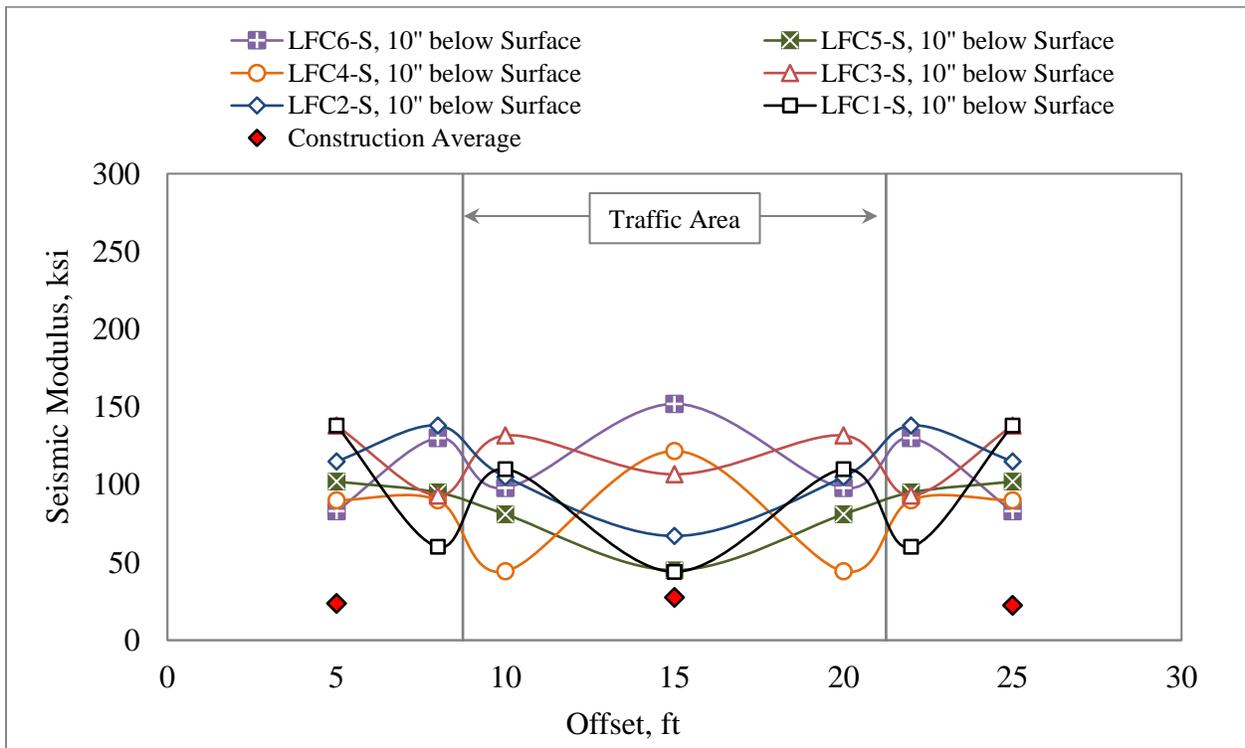
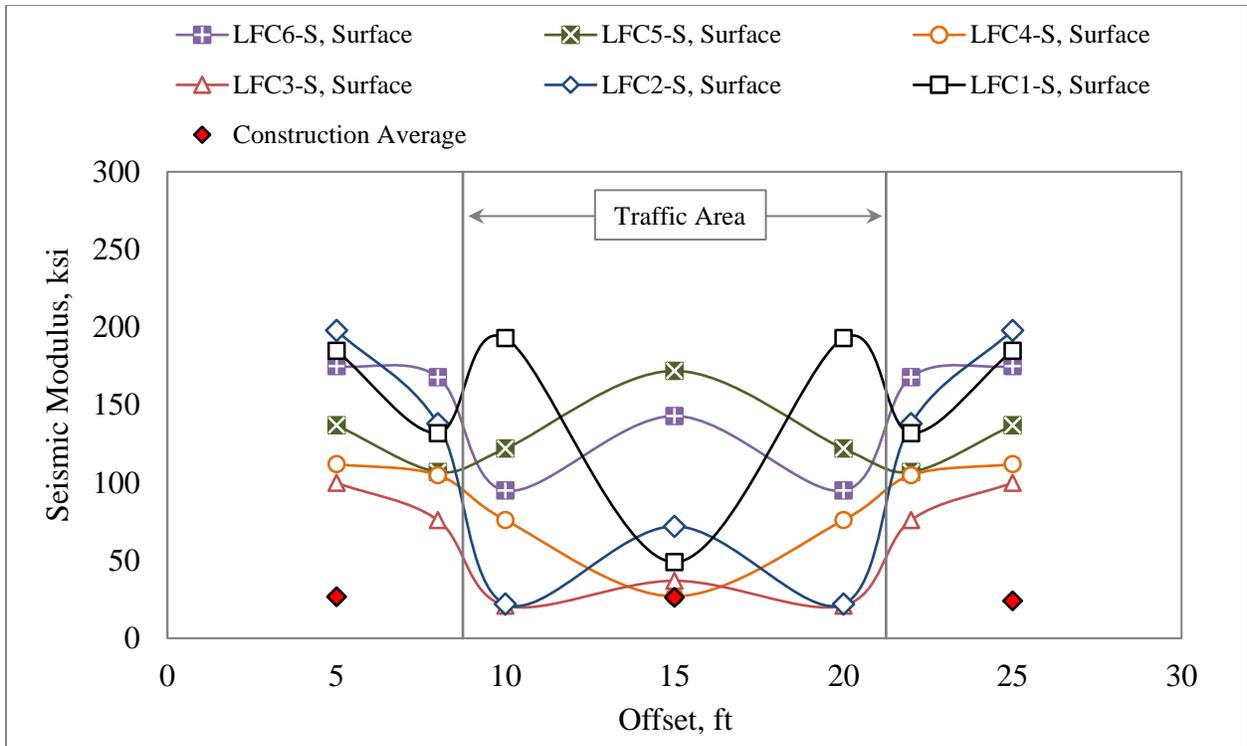
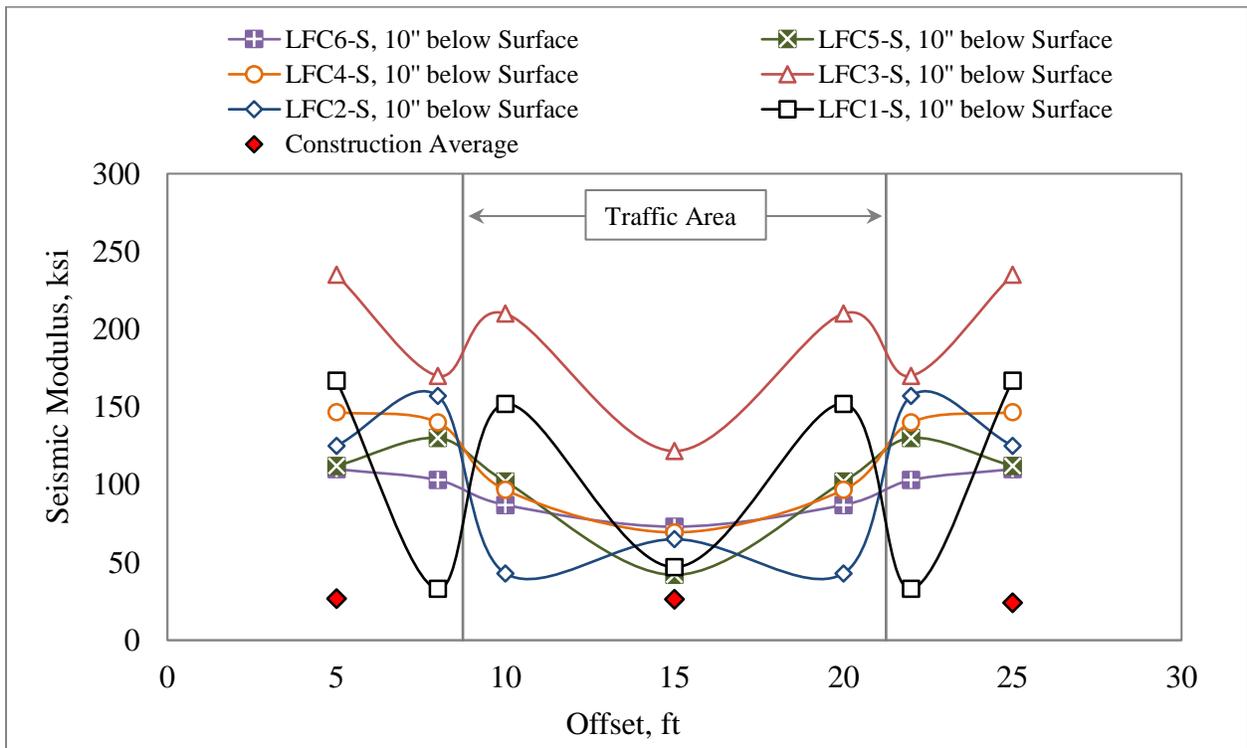
D-PSPA tests were done at offsets -15ft, -10ft, -8ft, -5ft, +5ft, +8ft, +10ft, and +15ft for on P-154 to determine seismic moduli of the subbase material. Figures 24-35 summarize the D-PSPA results.

In the figures, it can be observed that the PSPA data had a relatively high variation, which made it impossible to investigate the modulus differences between surface and deeper layers and the differences between traffic area and non-traffic area.

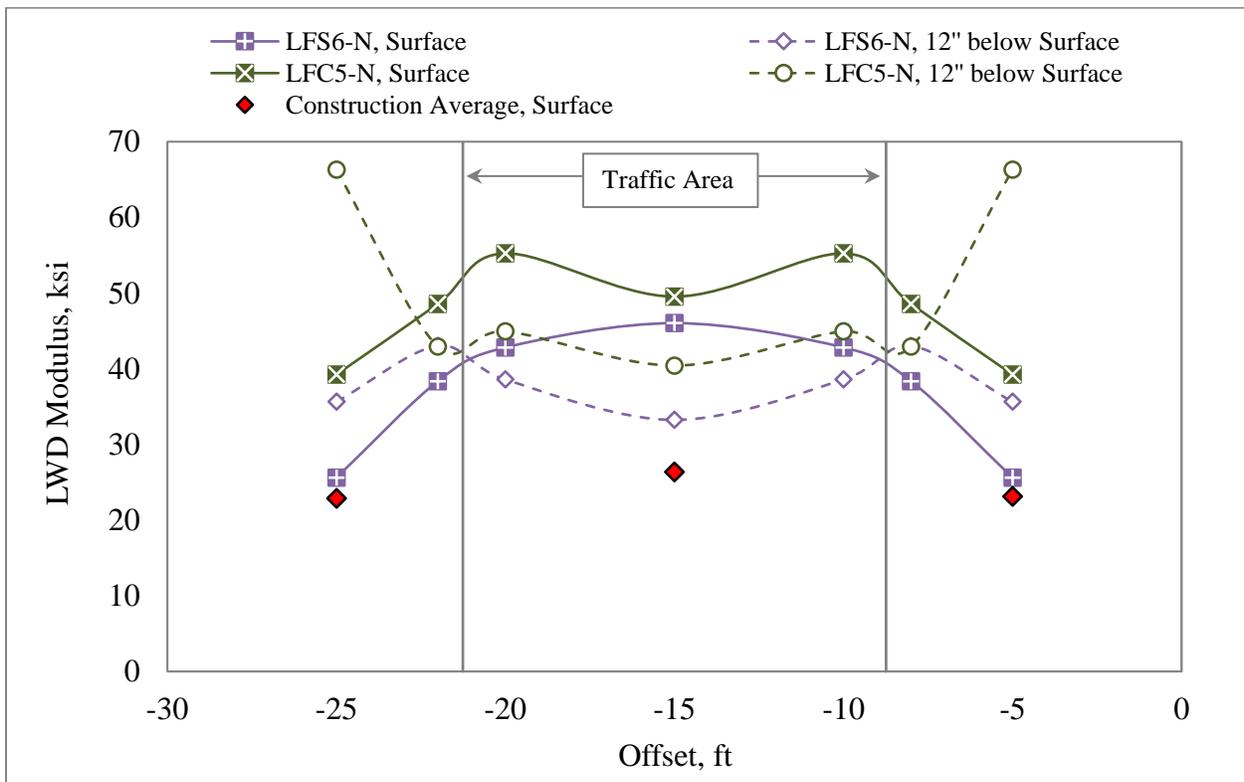
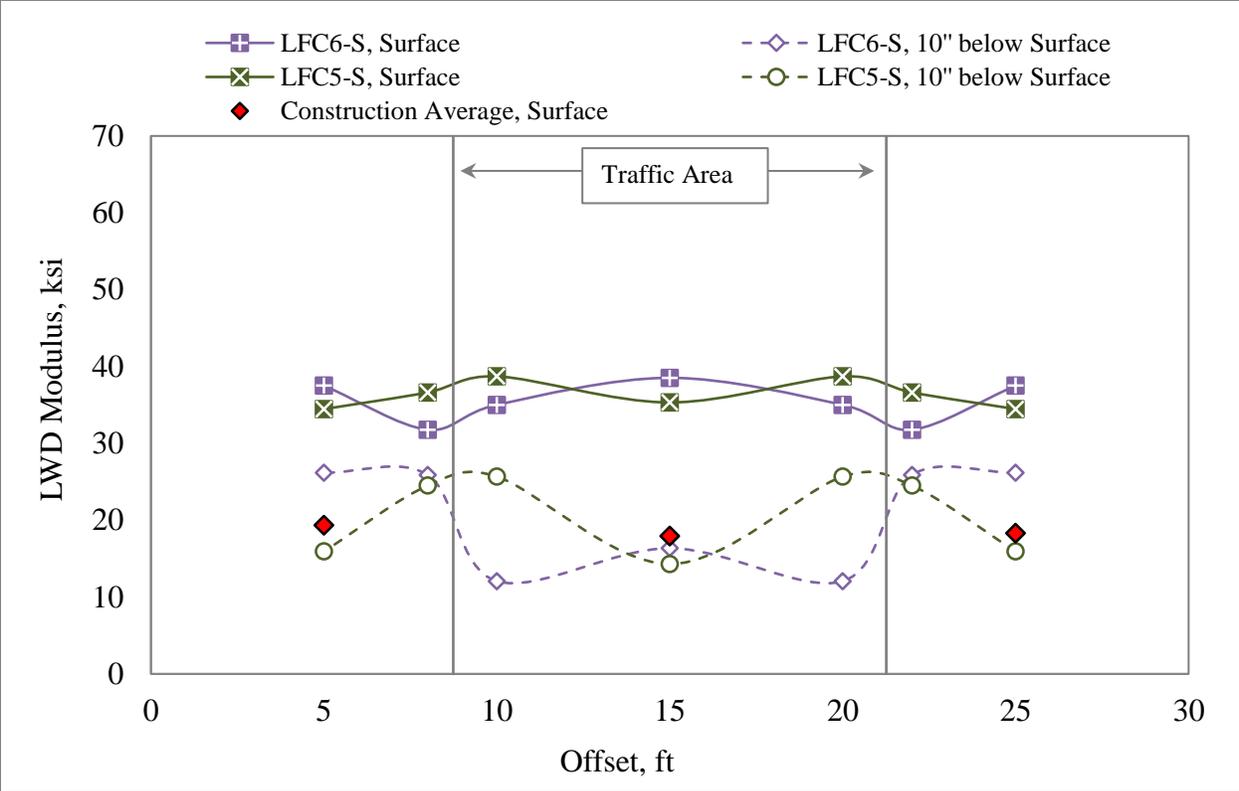
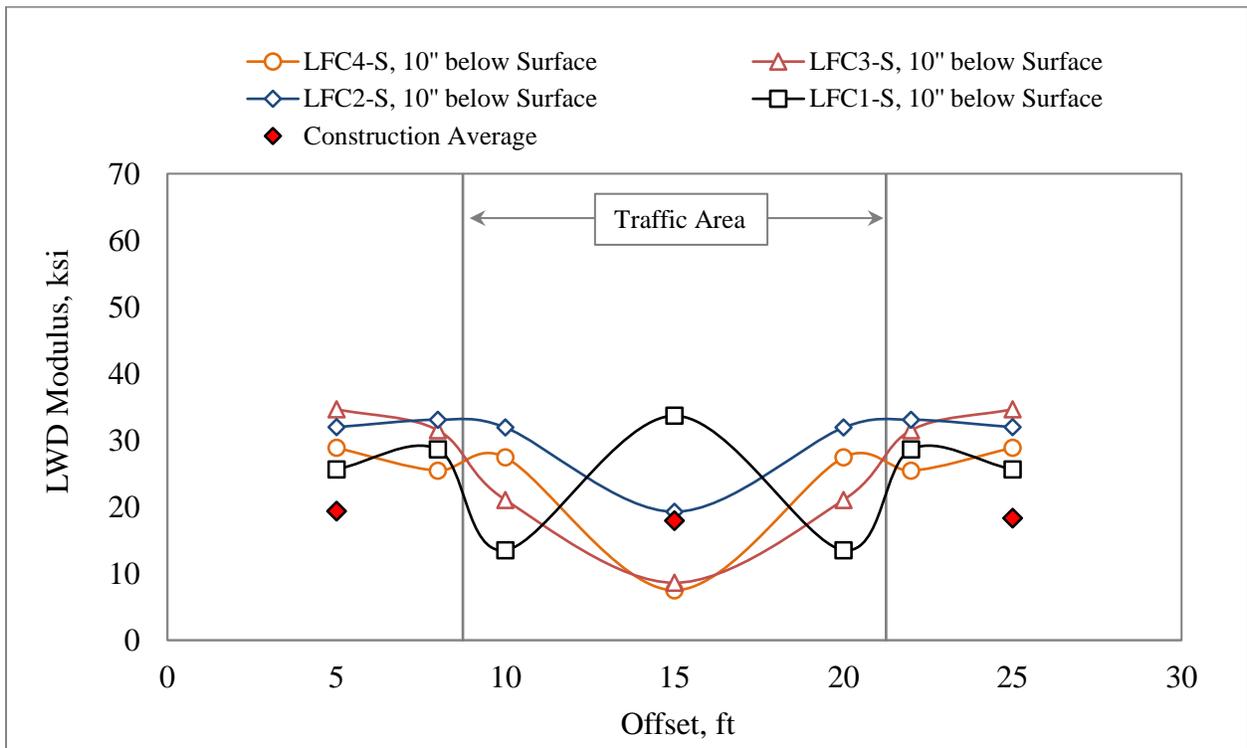
In figures 36 and 37, it can be observed that on the north side, there was no significant difference in LWD modulus between P-154 surface and 12 in. below the surface. In most of the test items, the LWD moduli in traffic areas were higher than non-traffic areas.

Figures 38 and 39 represent the LWD modulus of P-154 on the south side. The LWD modulus of P-154 surface was higher than 12 in. below the surface. The LWD moduli in traffic areas were also higher than non-traffic areas.

The P-401 layers on the north side was thicker than the south side. Therefore, the wheel load was distributed more efficiently on the north side, and traffic-induced stresses on top of the P-154 layer were smaller compared to those on the south side. The P-154 surface on the south side was exposed to higher vertical stresses.
