Contract No. DTFACT-15-D-00007
Task Order Number 005

Construction Cycle 7 Post-Traffic Report - Field Testing
DELIVERABLE 4.9.3.1

September 3, 2019

Composed by:
Gemini Technologies Inc., for General Dynamics Information Technology

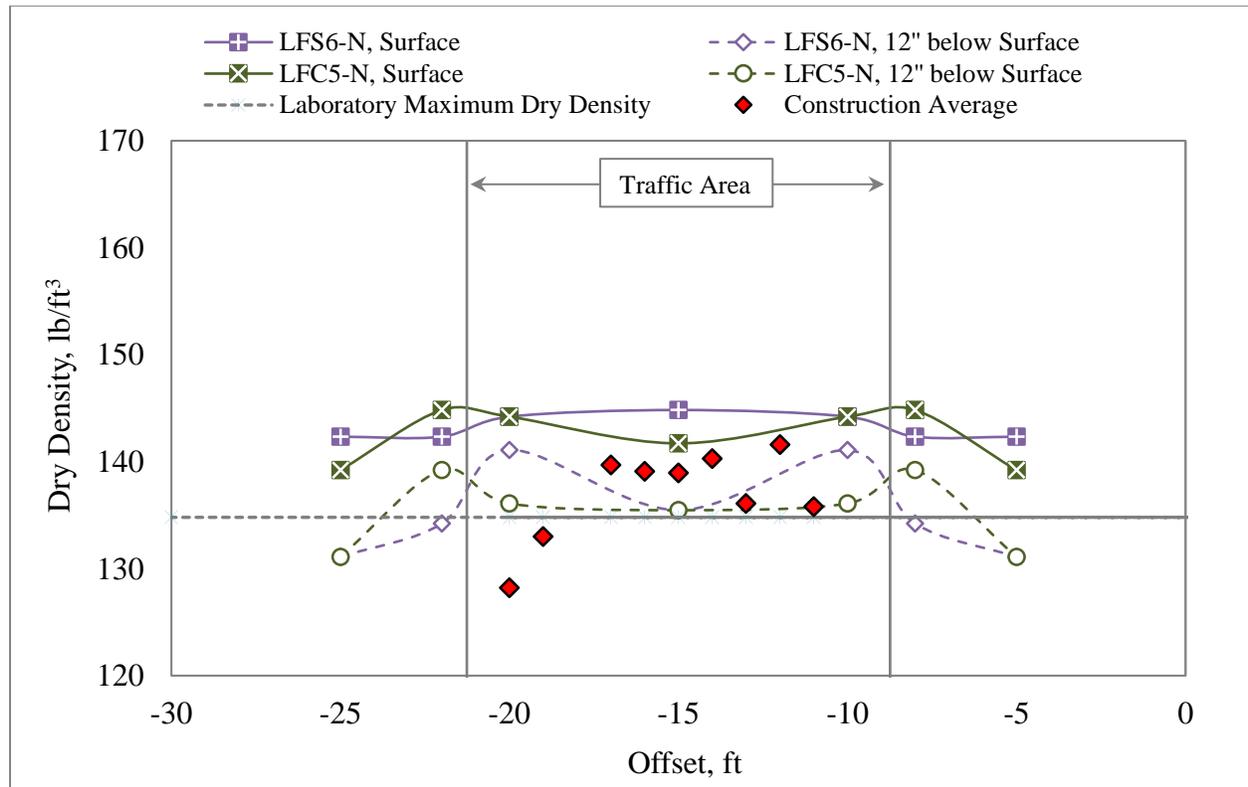
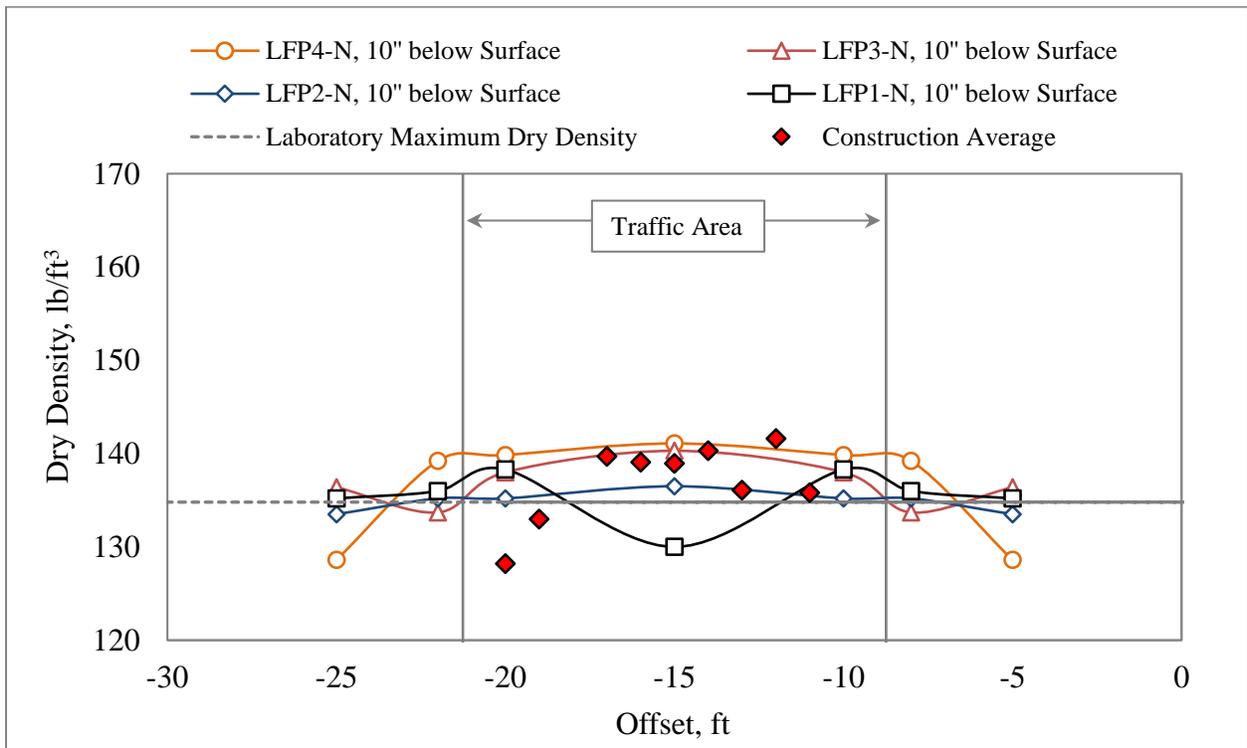
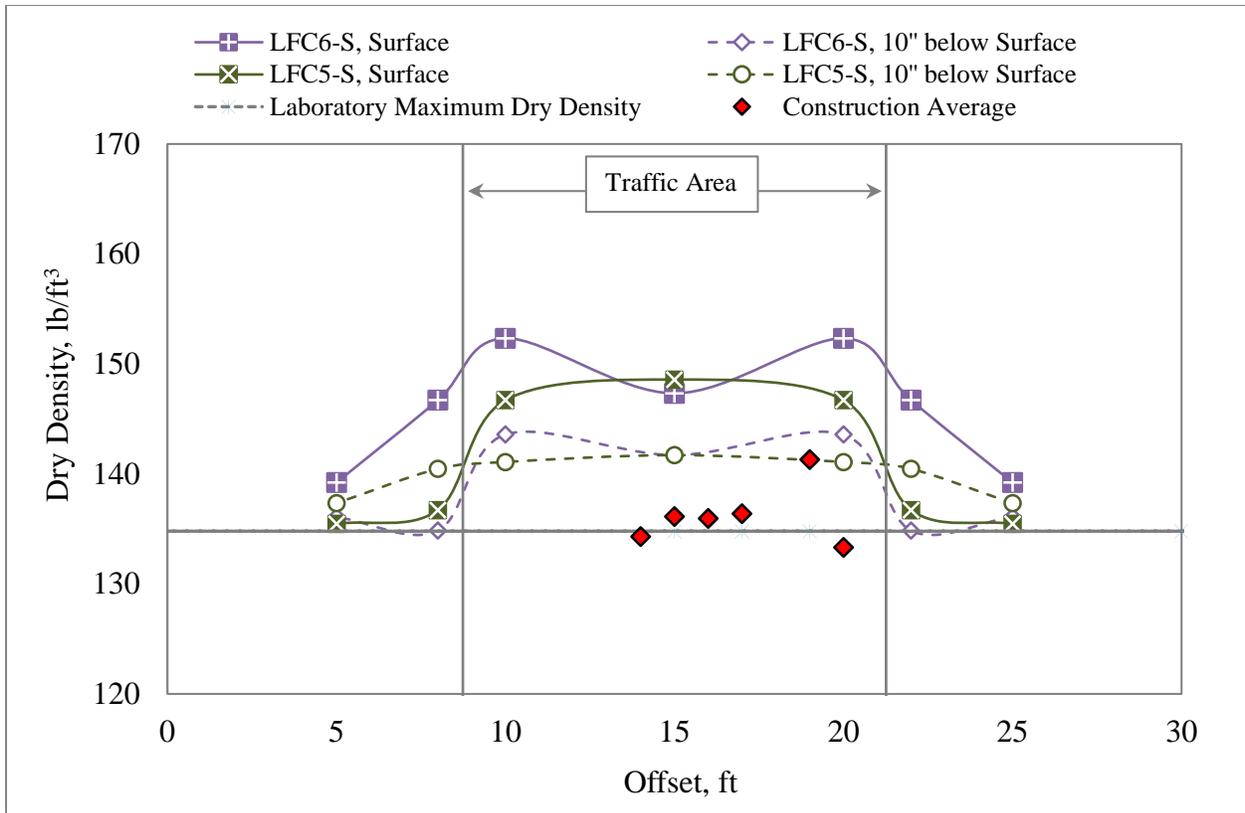
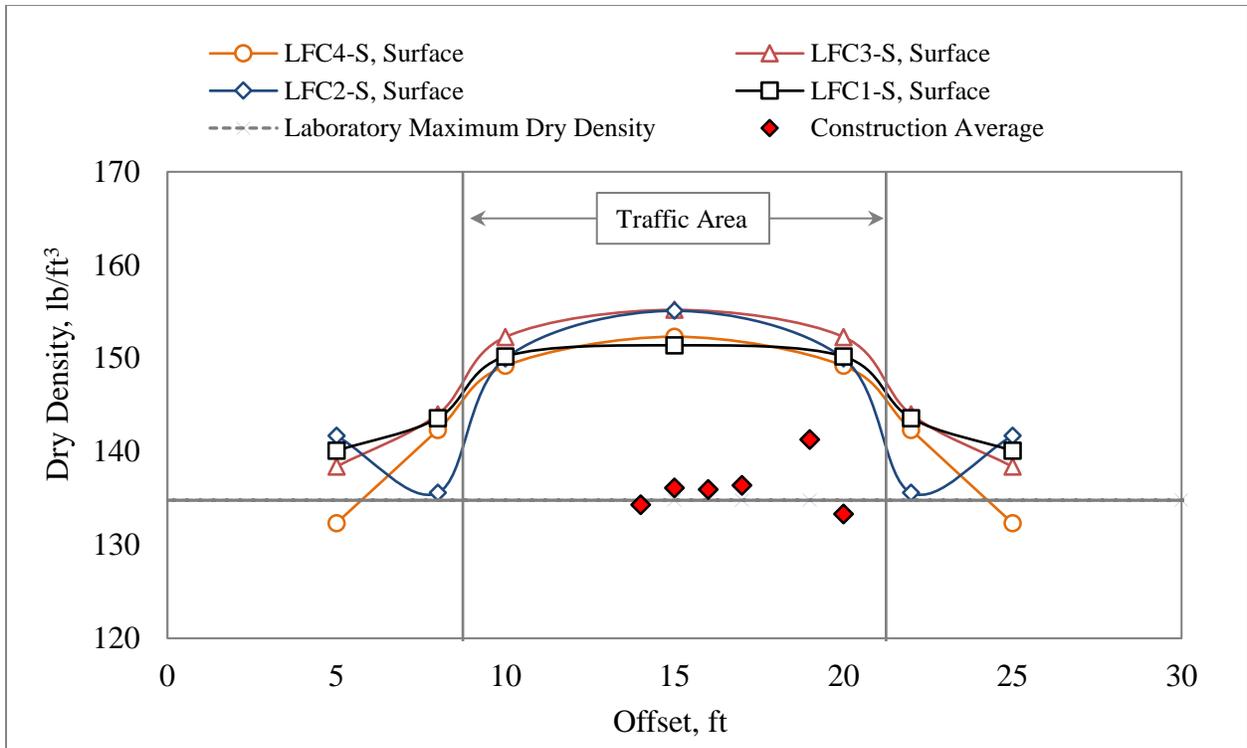
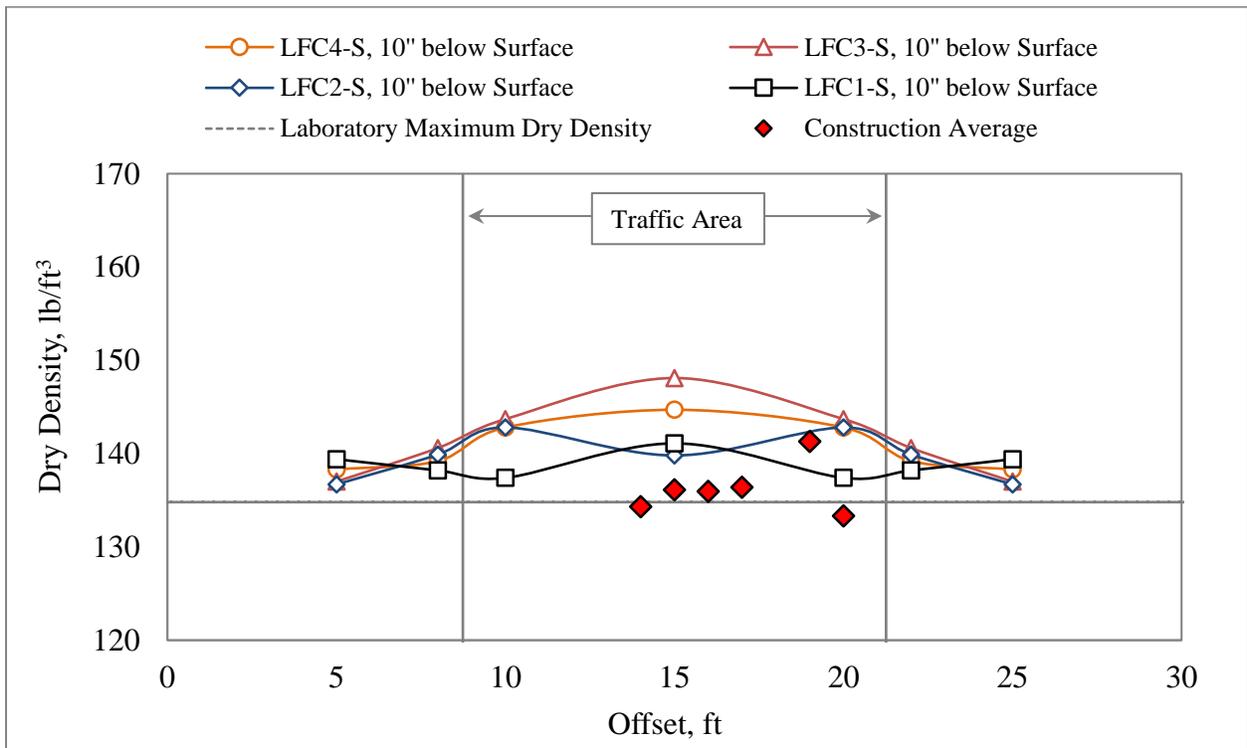
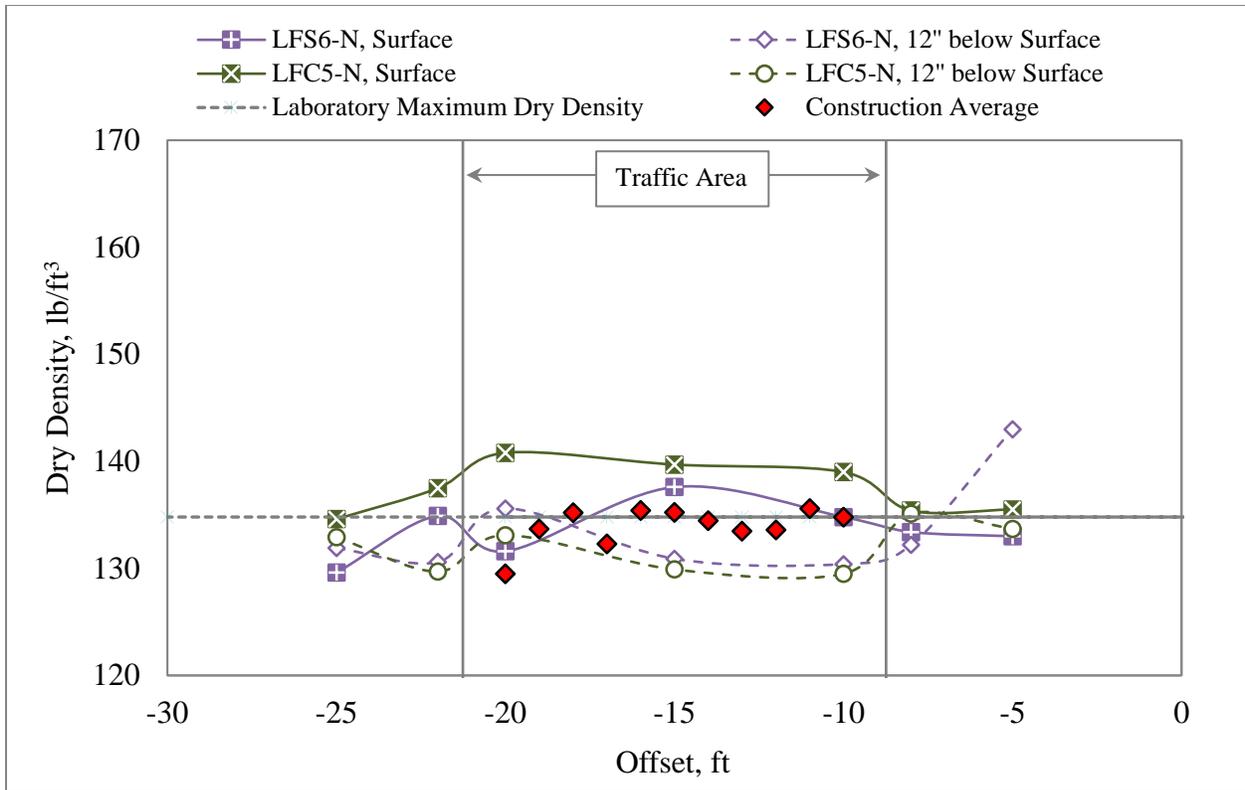
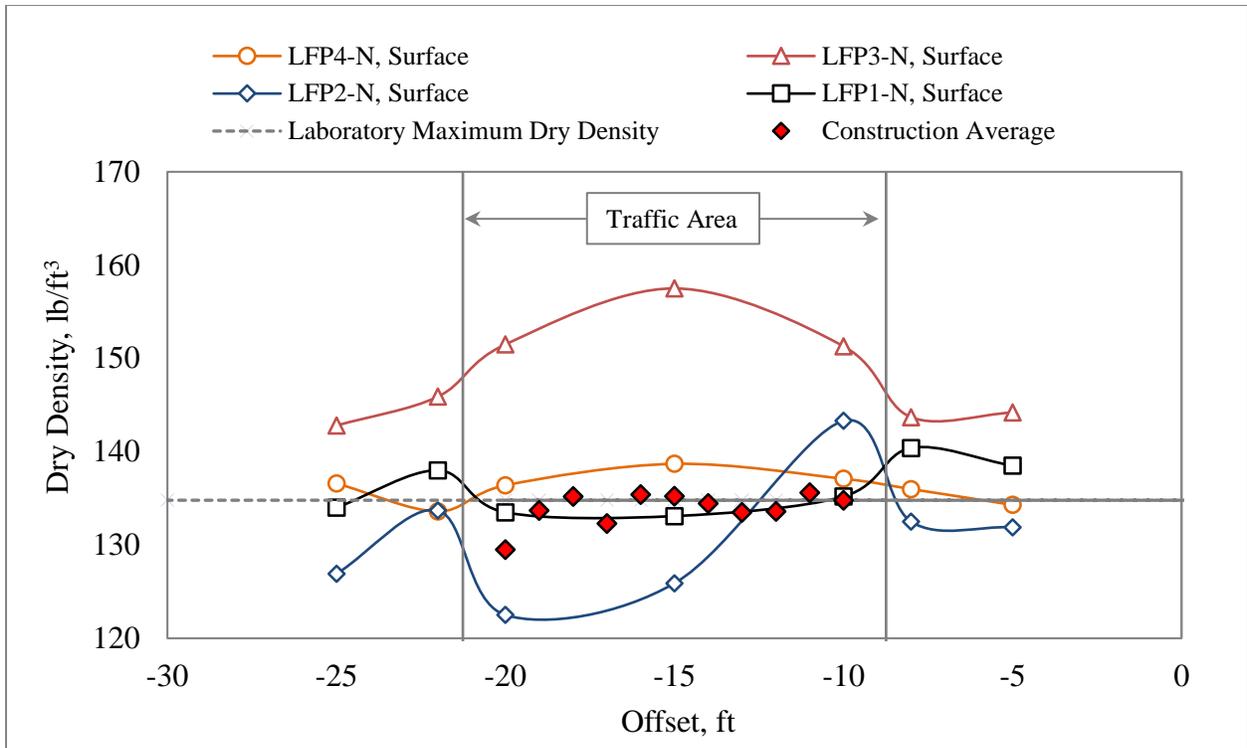
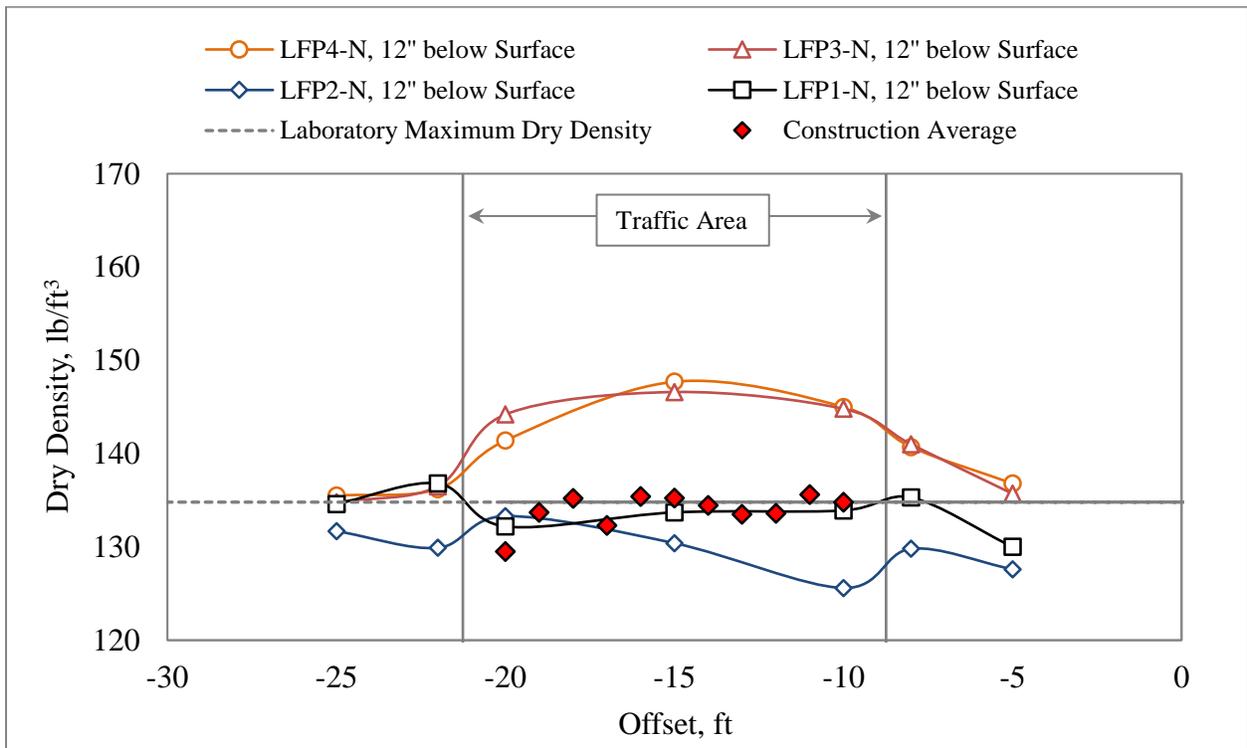
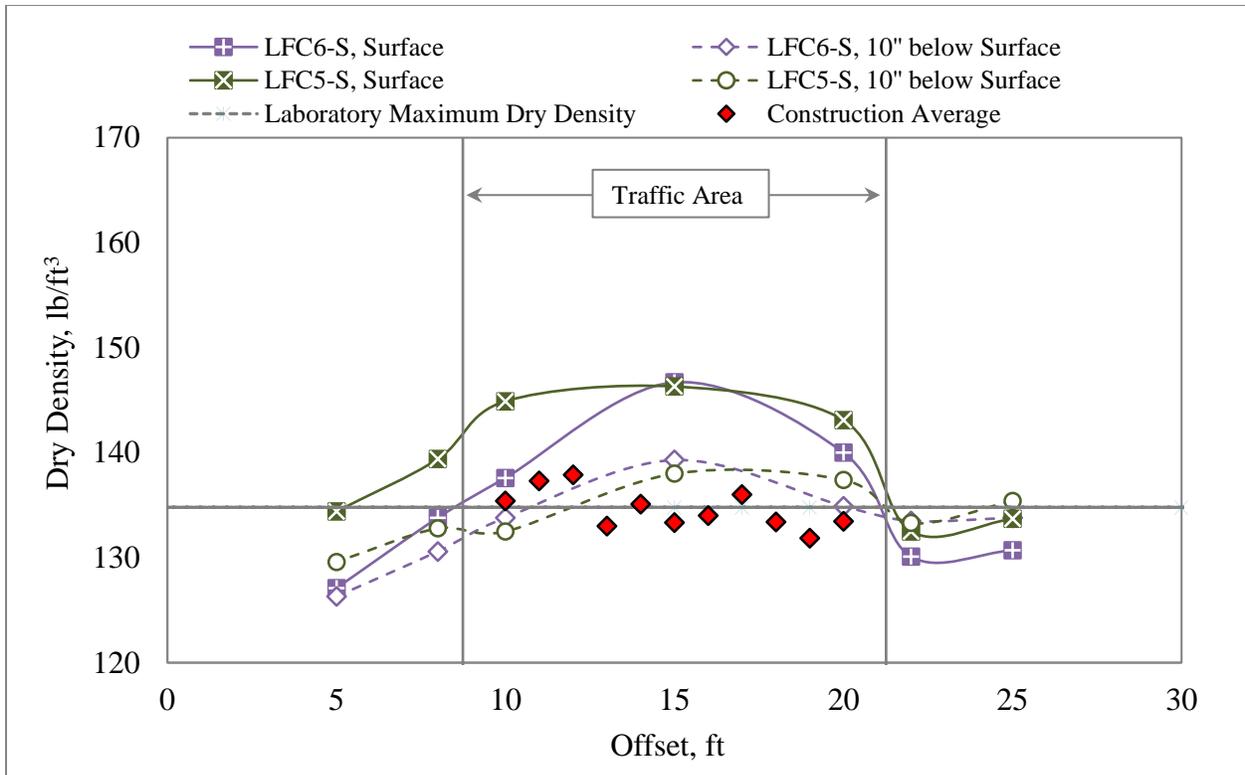
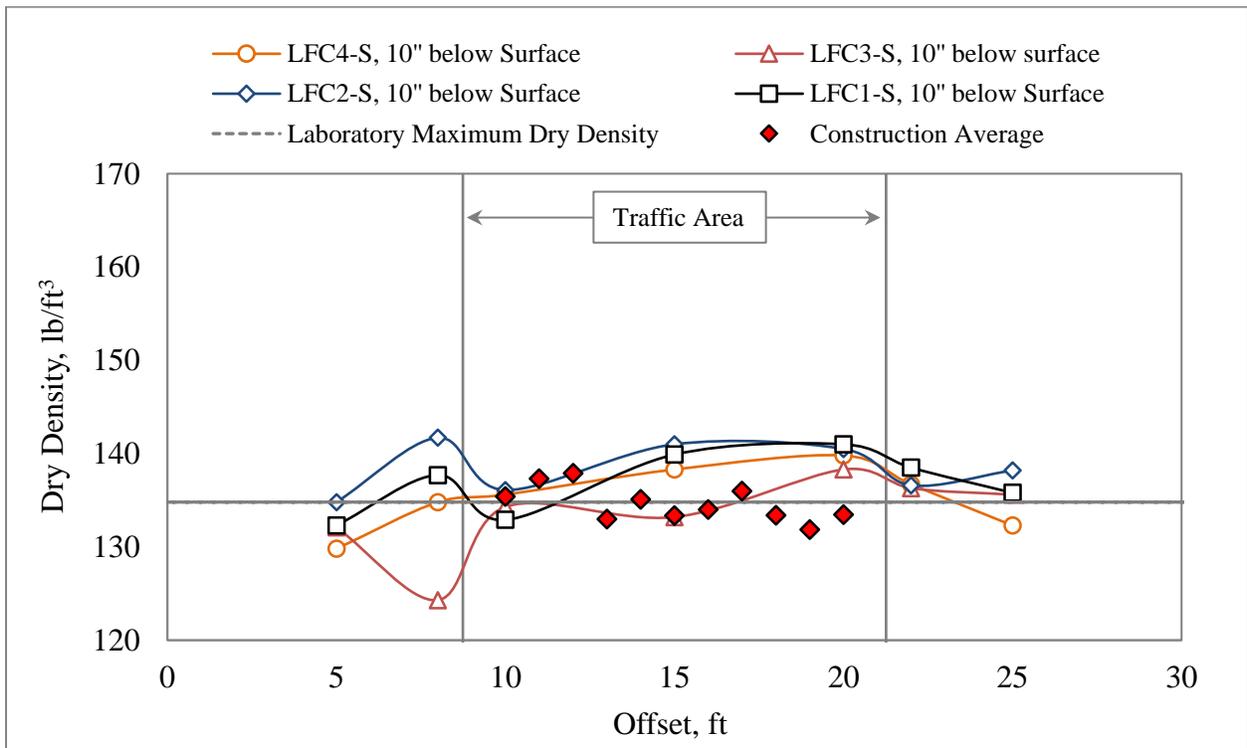
The sand cone results are summarized in figures 40-43. Figures 44-47 show the nuclear density results. Figures 40 and 44 indicate that in test items LFC5-N and LFS6-N, the density at the top of the P-154 layer was higher than 12 in. below the top. The density at the top of the P-154 layer in the south side was higher than 10 in below the top. On the south side, the density in the traffic areas was higher than non-traffic areas. Figures 48-50 show the P-154 gradations. Figures 49 and 50 show the gradation of the P-154 materials collected in traffic area, non-traffic area and pre-construction. The difference between gradations seemed insignificant.

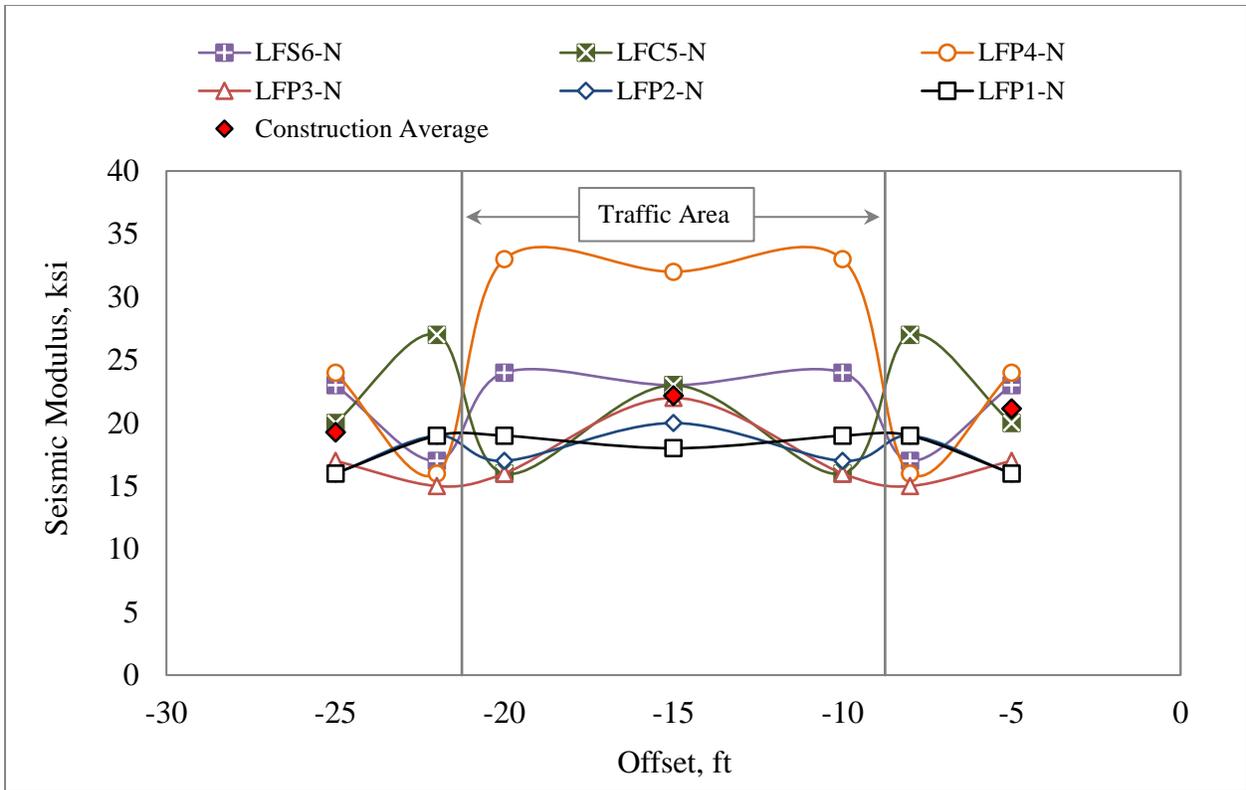
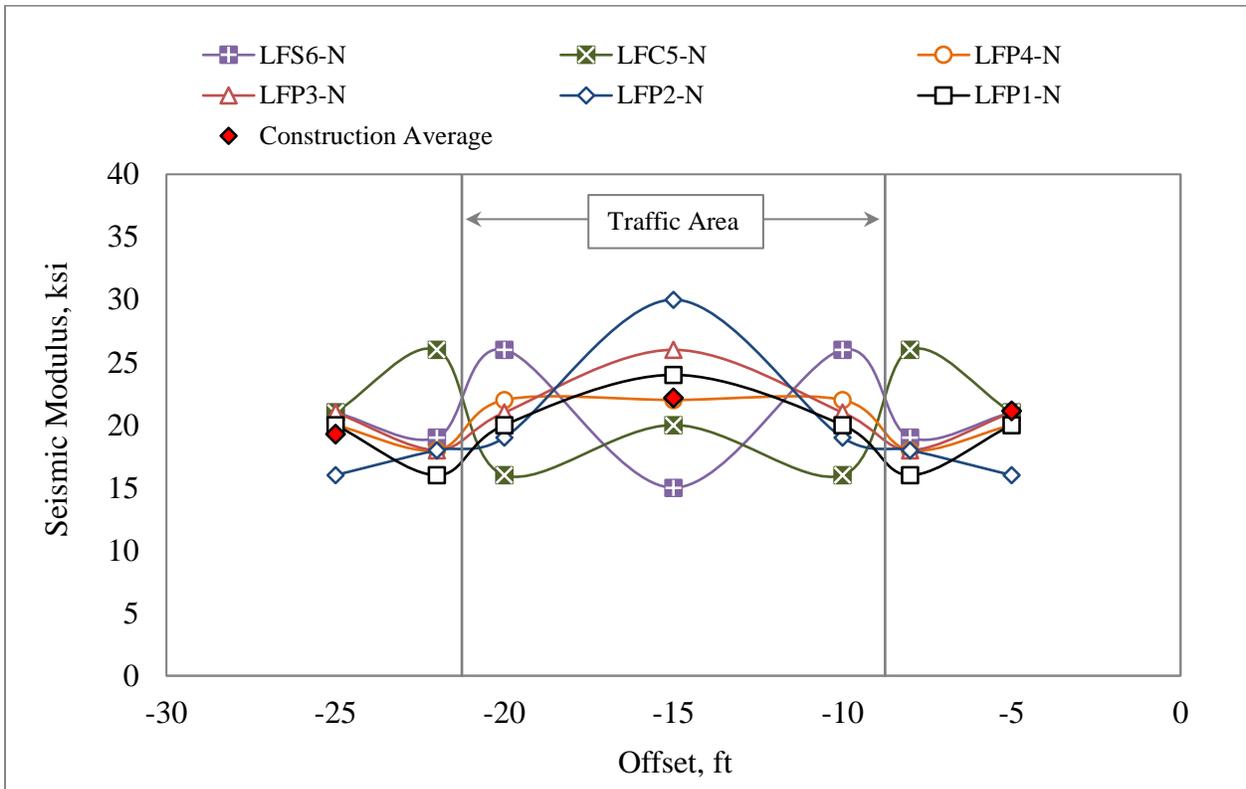
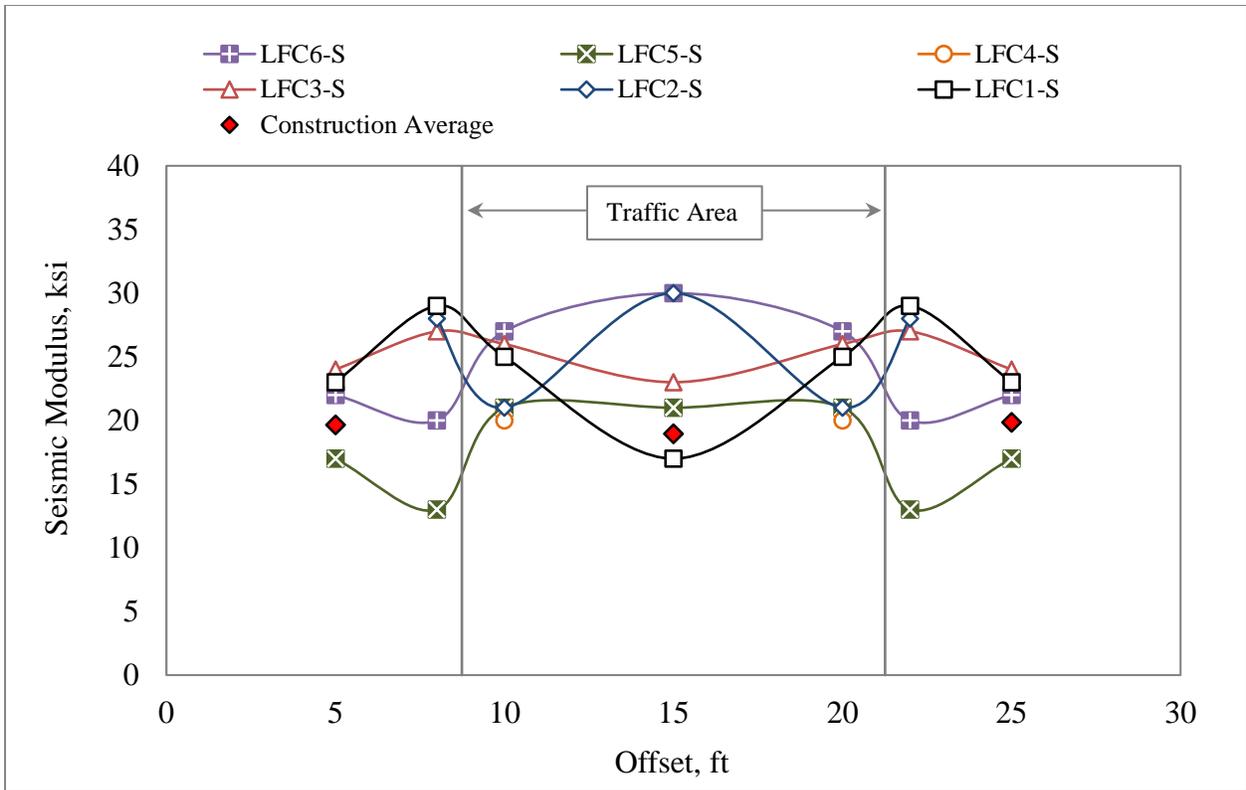
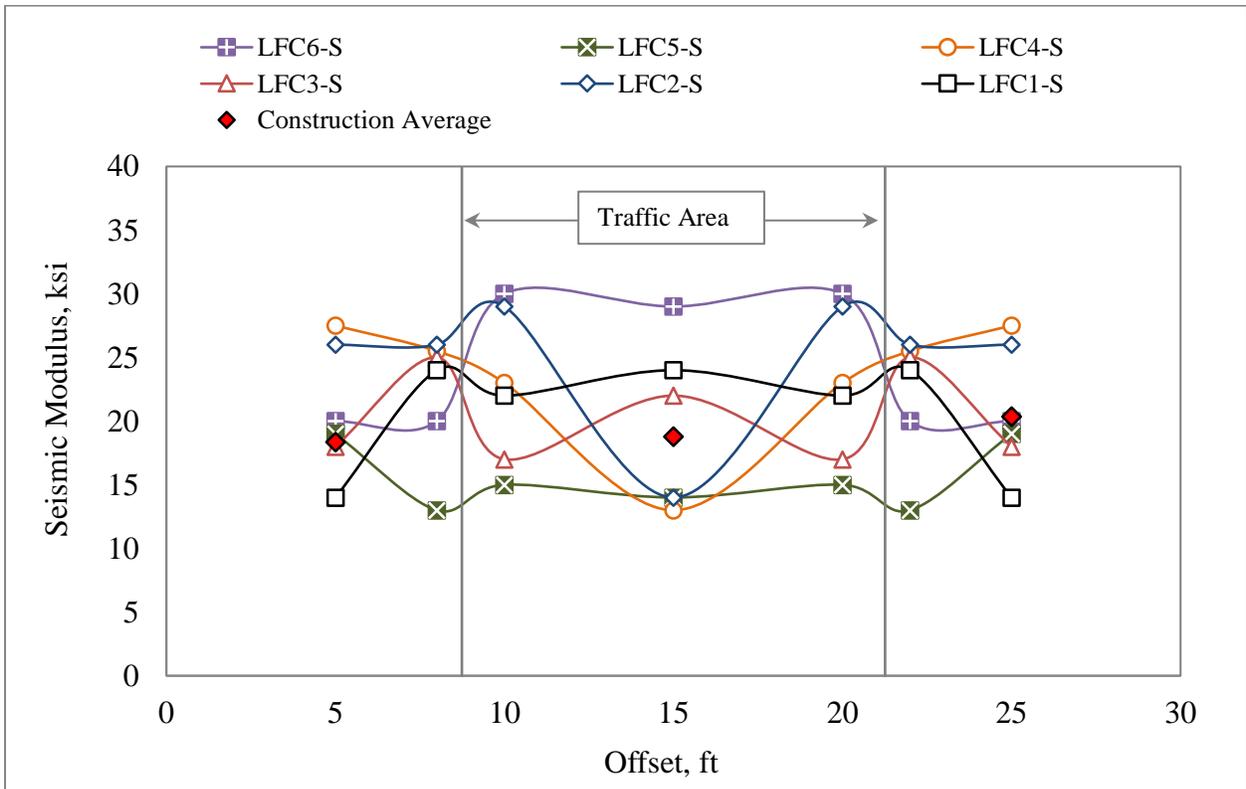
D-PSPA tests were done at offsets -15ft, -10ft, -8ft, -5ft, +5ft, +8ft, +10ft, and +15ft on P-152 to determine seismic moduli of the subbase material. Figures 51-54 summarize the D-PSPA results.

The figures show that there was no significant differences between traffic area and non-traffic area. The mean value of the post-traffic data was similar to the pre-traffic data.

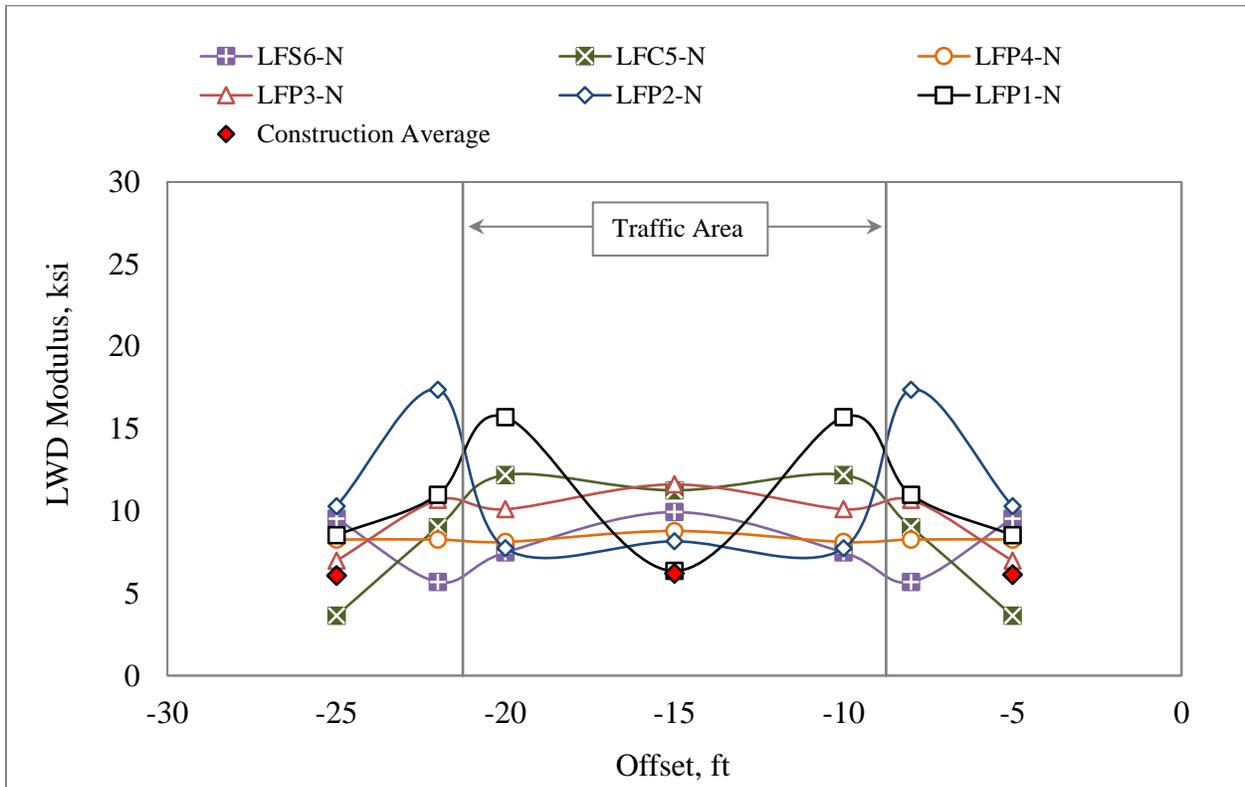
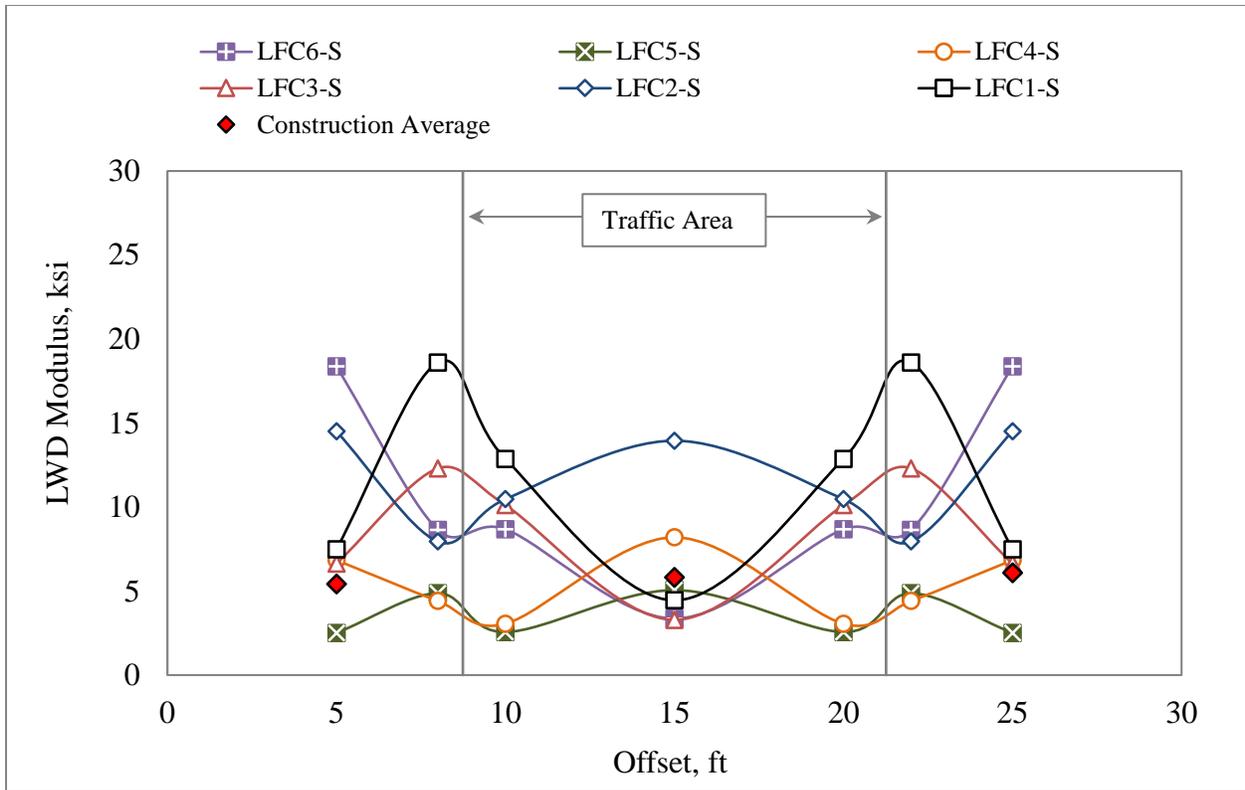
From figures 55 and 56, we can see that there was no significant difference between traffic area and non-traffic area. On the north side, the LWD moduli were higher than the pre-traffic average values. On the other hand, the LWD moduli on the south side were close to the pre-traffic values.

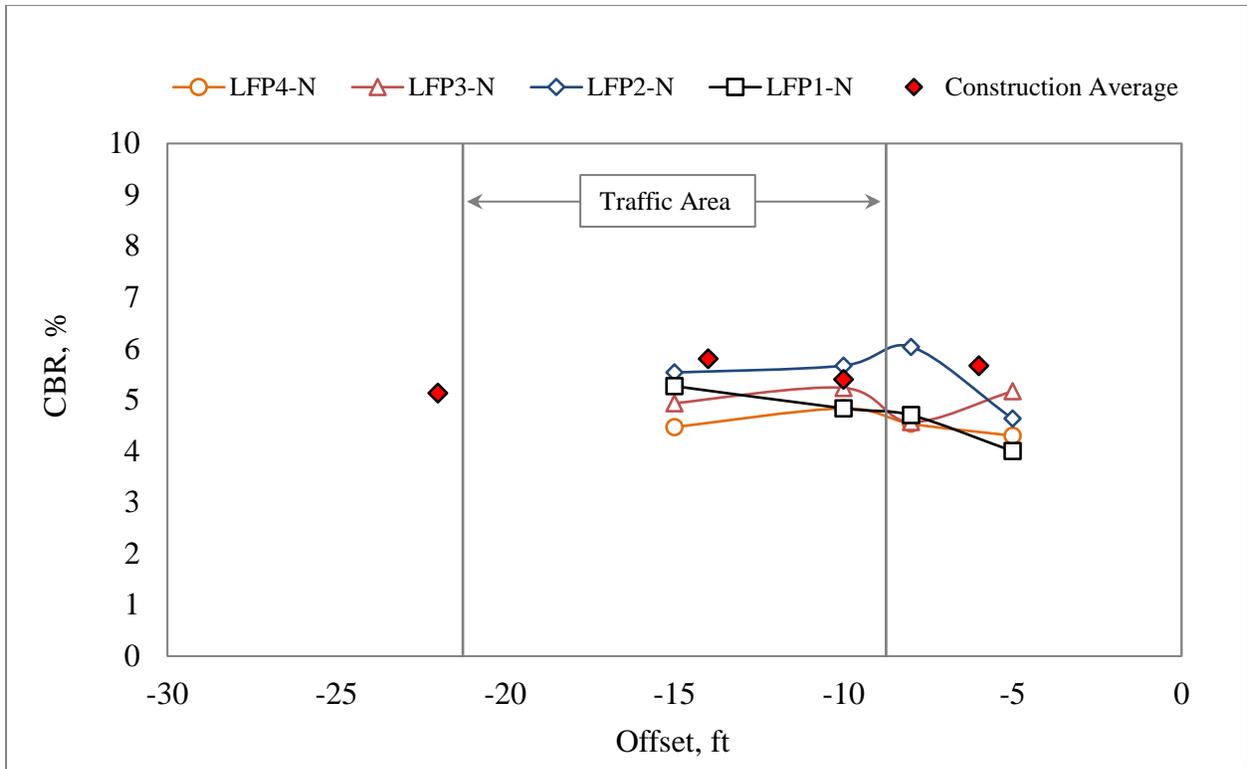
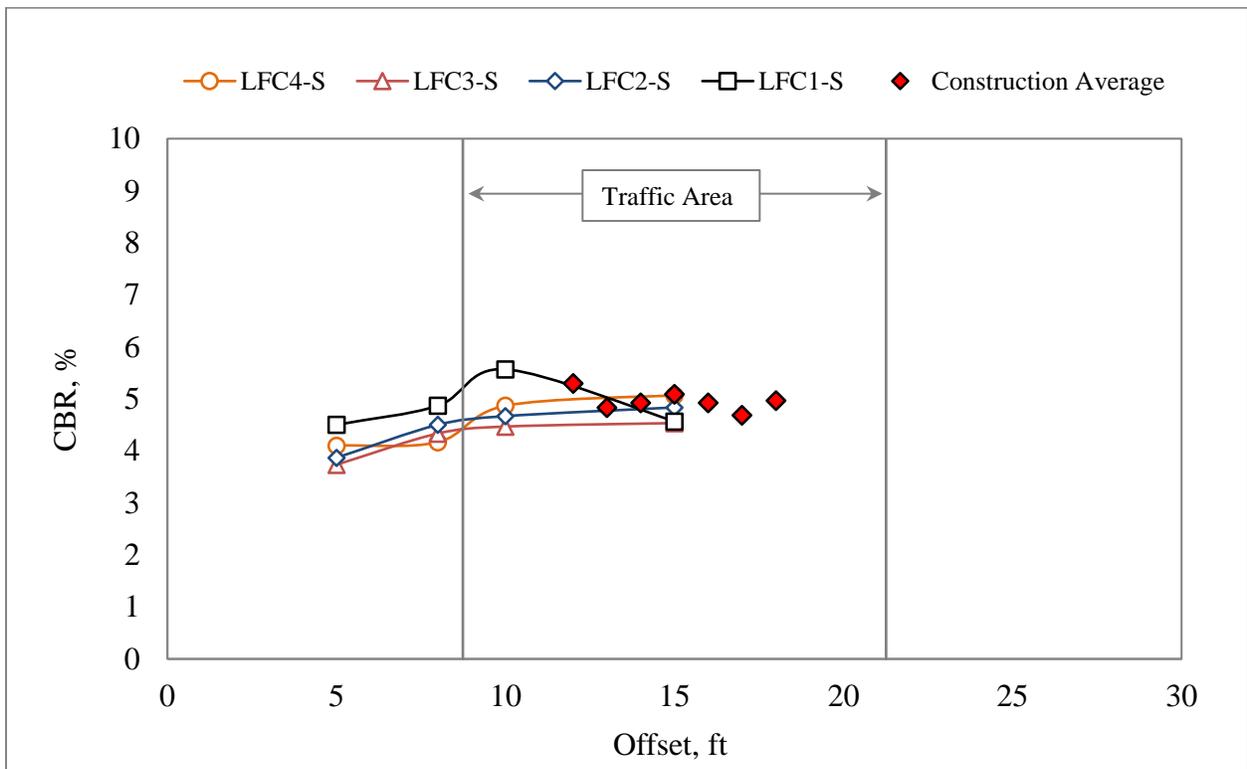
Figure 57. CBR Results on P-152: (a)North Side, (b)South Side

CBR tests were performed at the same locations as LWD tests. Three tests were done at each location. Three vane shear tests were conducted at each CBR location. The CBR and LWD results are summarized in figures 57 and 58. Since the vane shear test equipment was broken when performing tests on Trenches 5 and 6, figure 58 only represents data collected from Trenches 1-4.

In figure 57, it can be observed that most post-traffic CBR values were lower than the pre-traffic values. This is possibly a result of additional water that seeped by gravity during construction of P-154 and P-209 layers. The CBR and Vane Shear values in traffic area were slightly higher than non-traffic area.

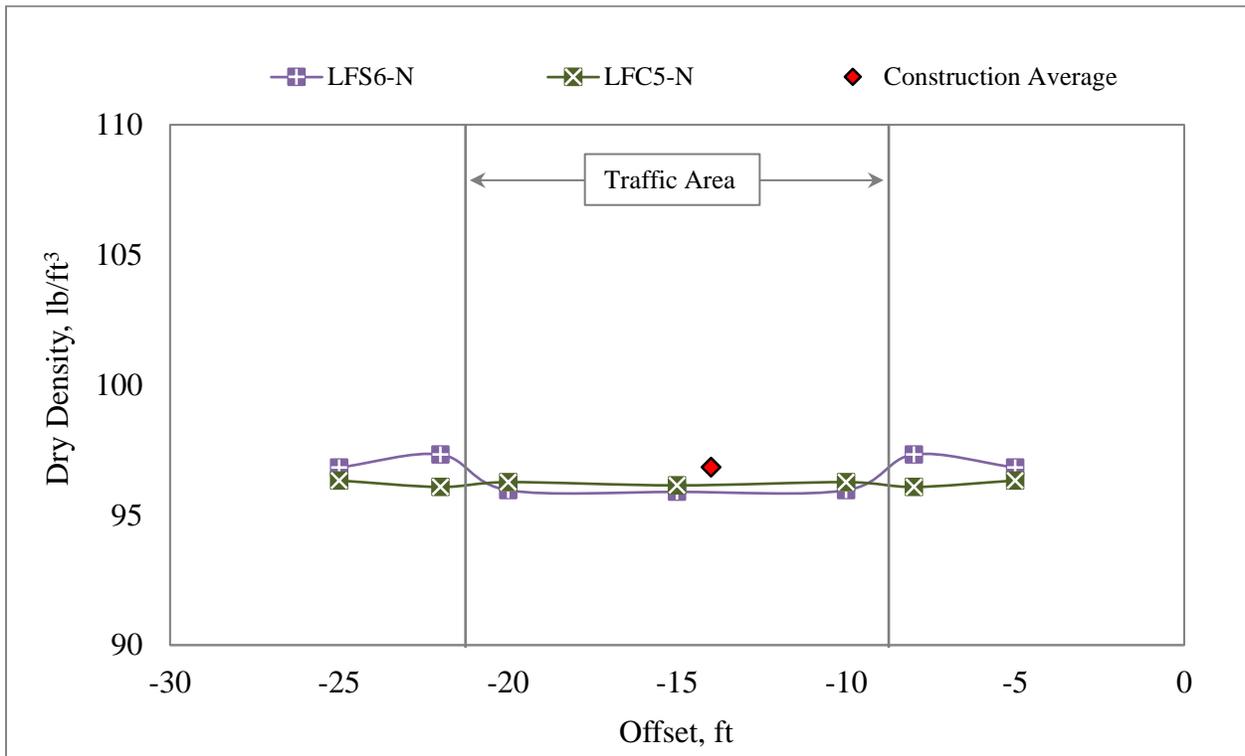
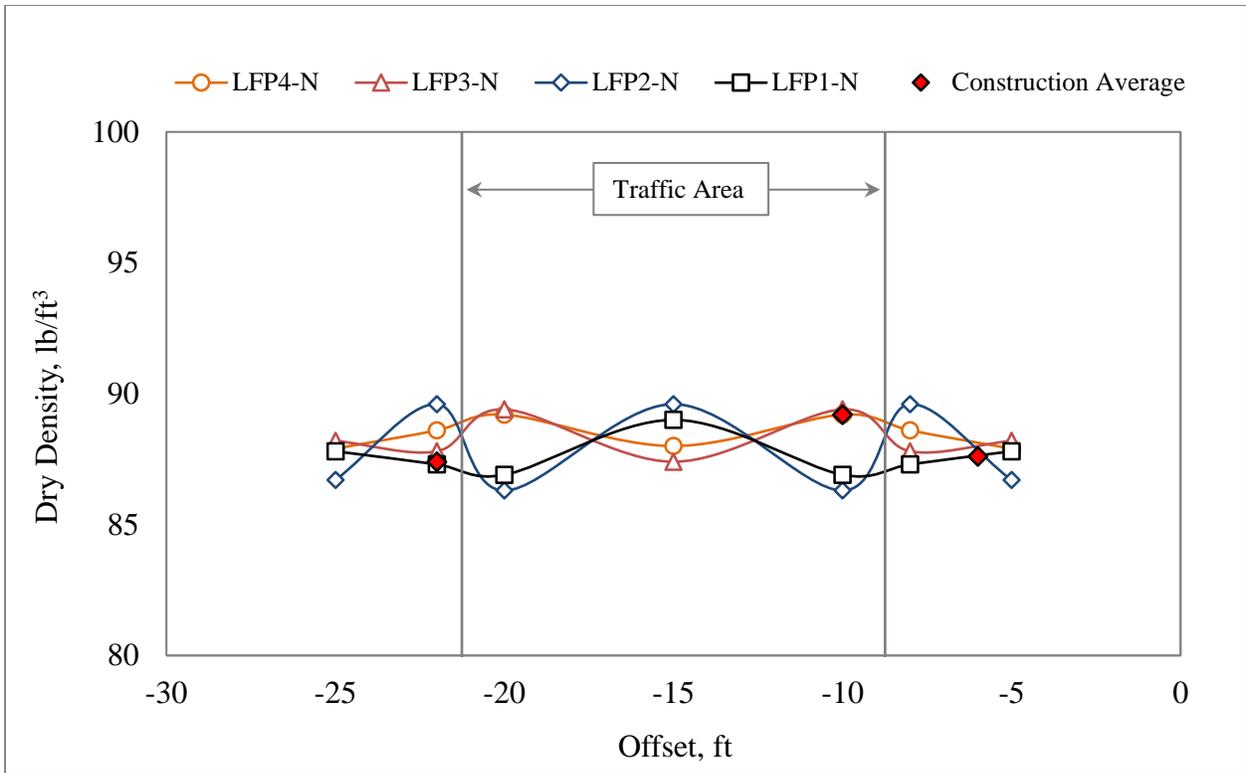
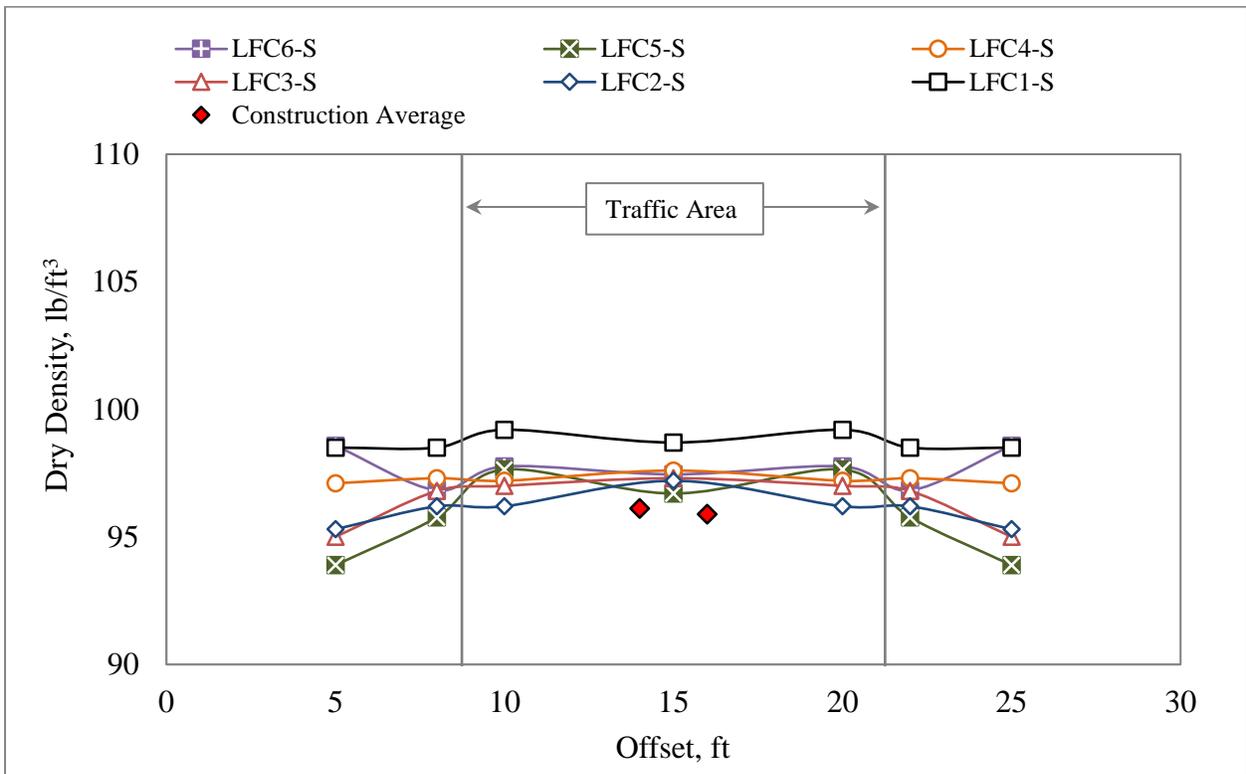
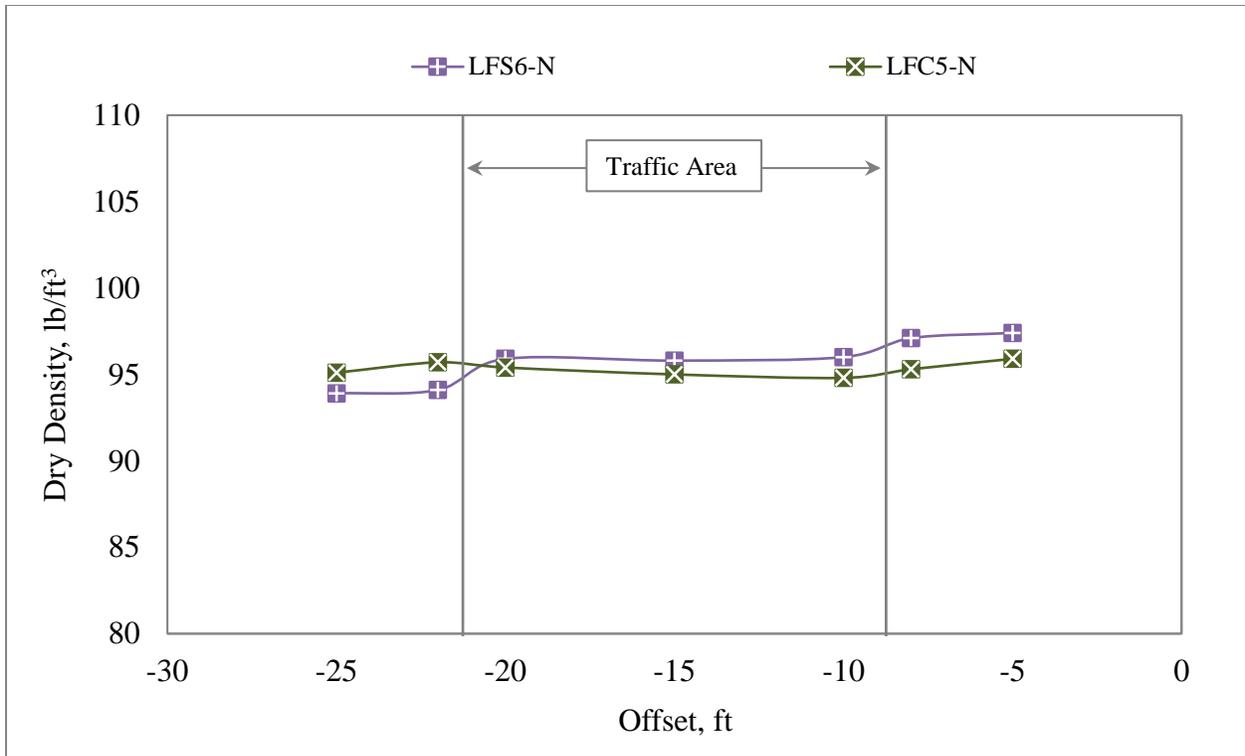
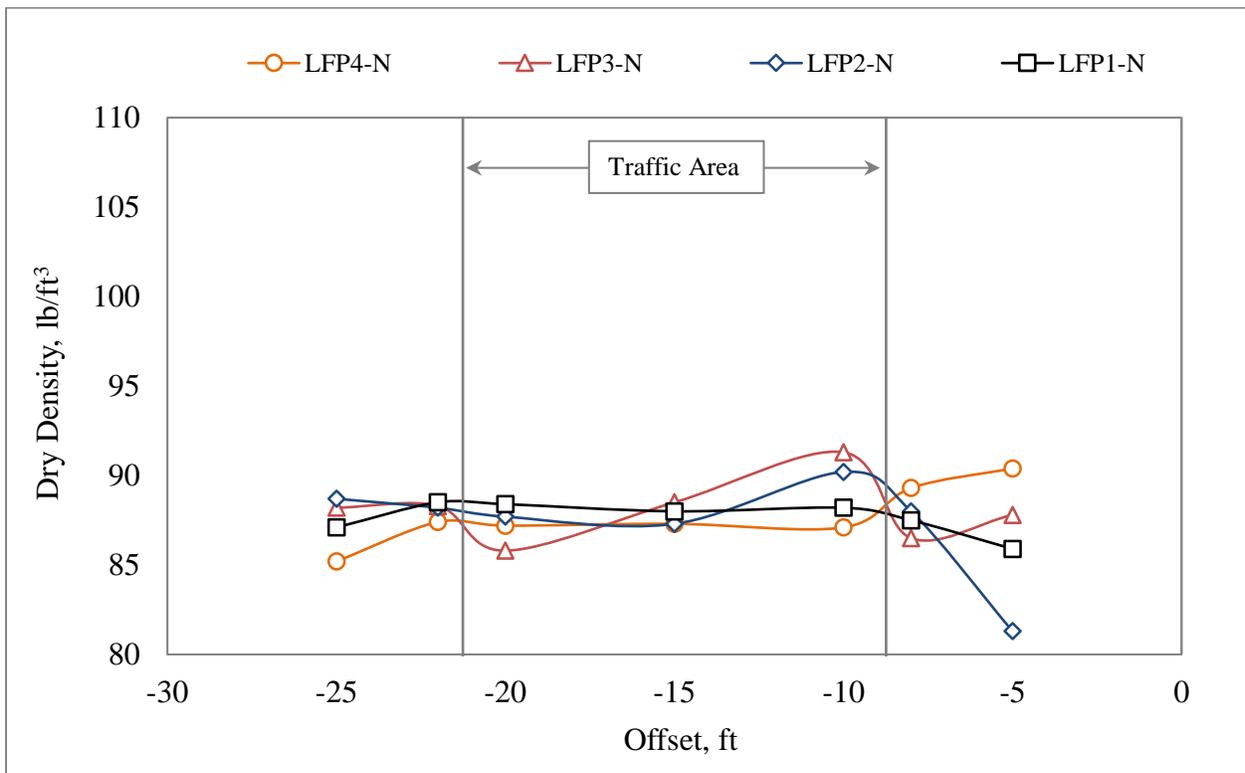
The dry densities determined by Drive Cylinder and Nuclear Density tests are summarized in figures 59-64. The results indicate that there was no significant difference in density between traffic and non-traffic areas. The difference between post-traffic and pre-traffic density values were also negligible.
