Contract No. DTFACT-15-D-00007
Task Order Number 005

Construction Cycle 7 Post-Traffic Report - Field Testing
DELIVERABLE 4.9.3.1

September 3, 2019

Composed by:
Gemini Technologies Inc., for General Dynamics Information Technology

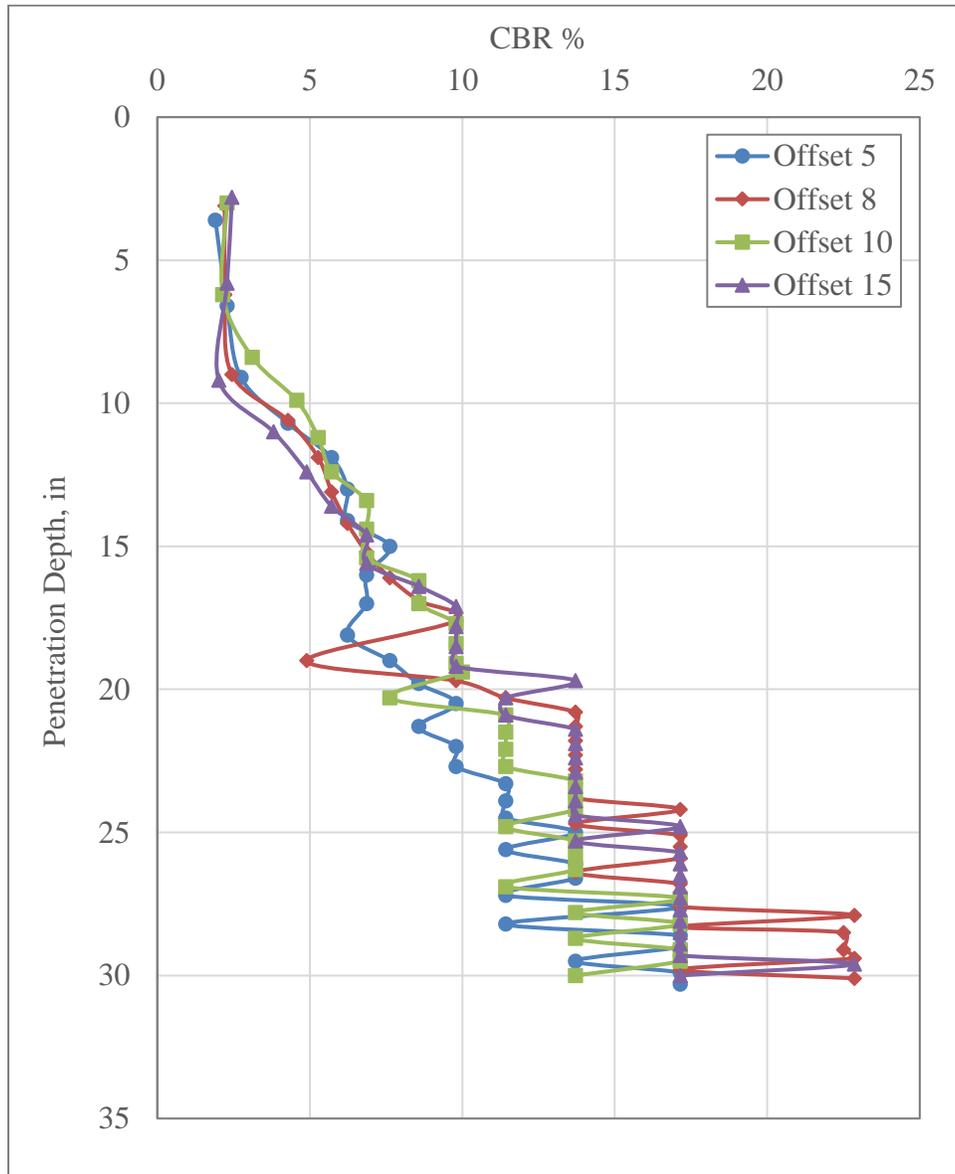
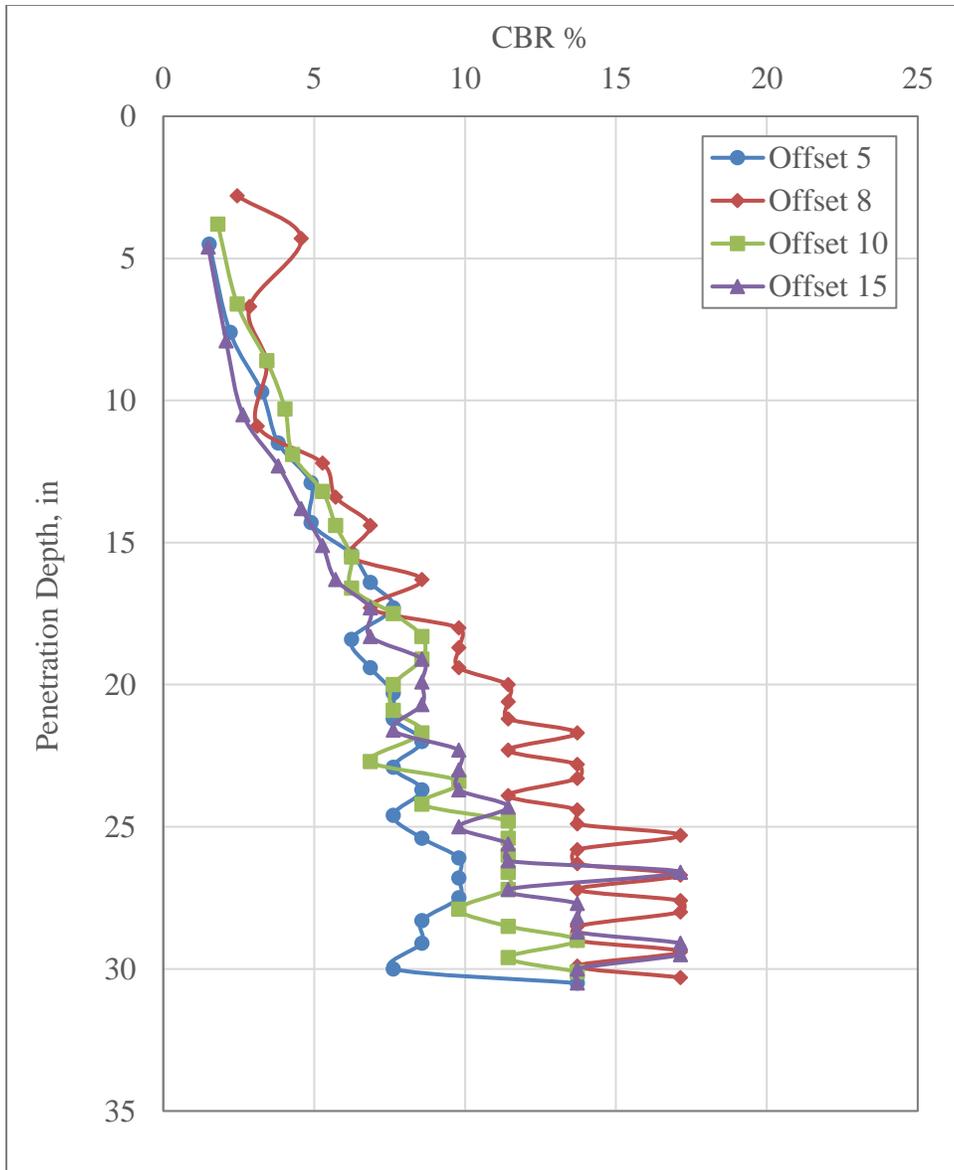
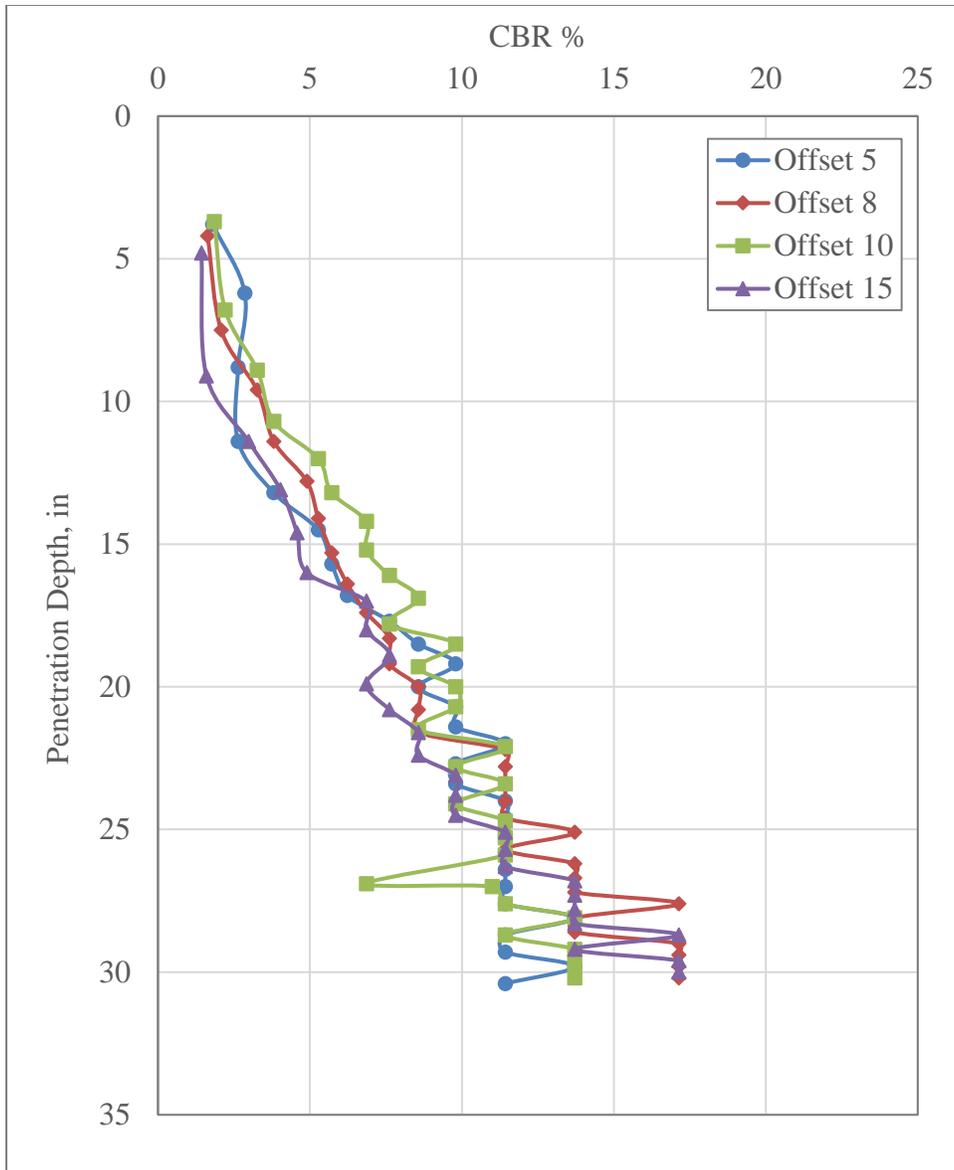
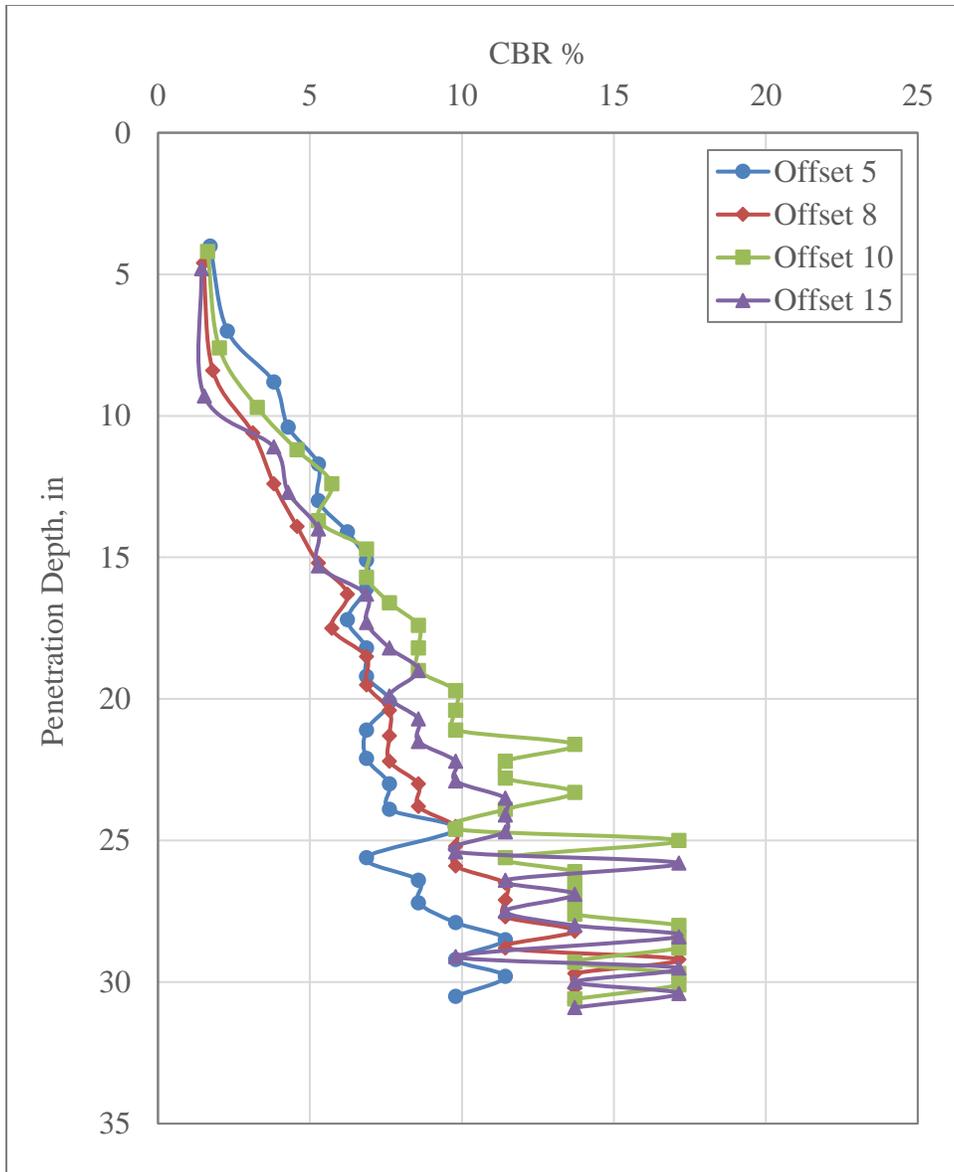
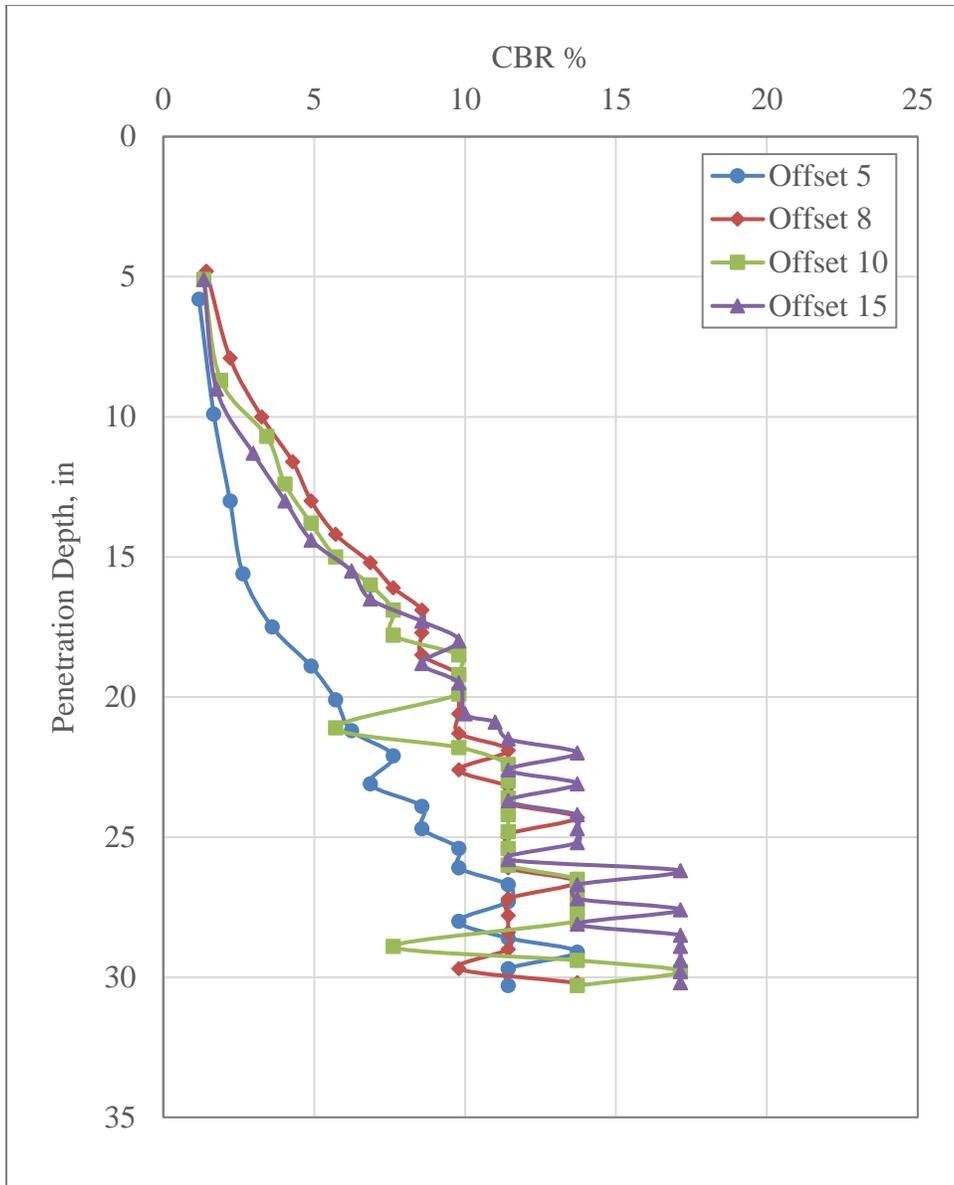
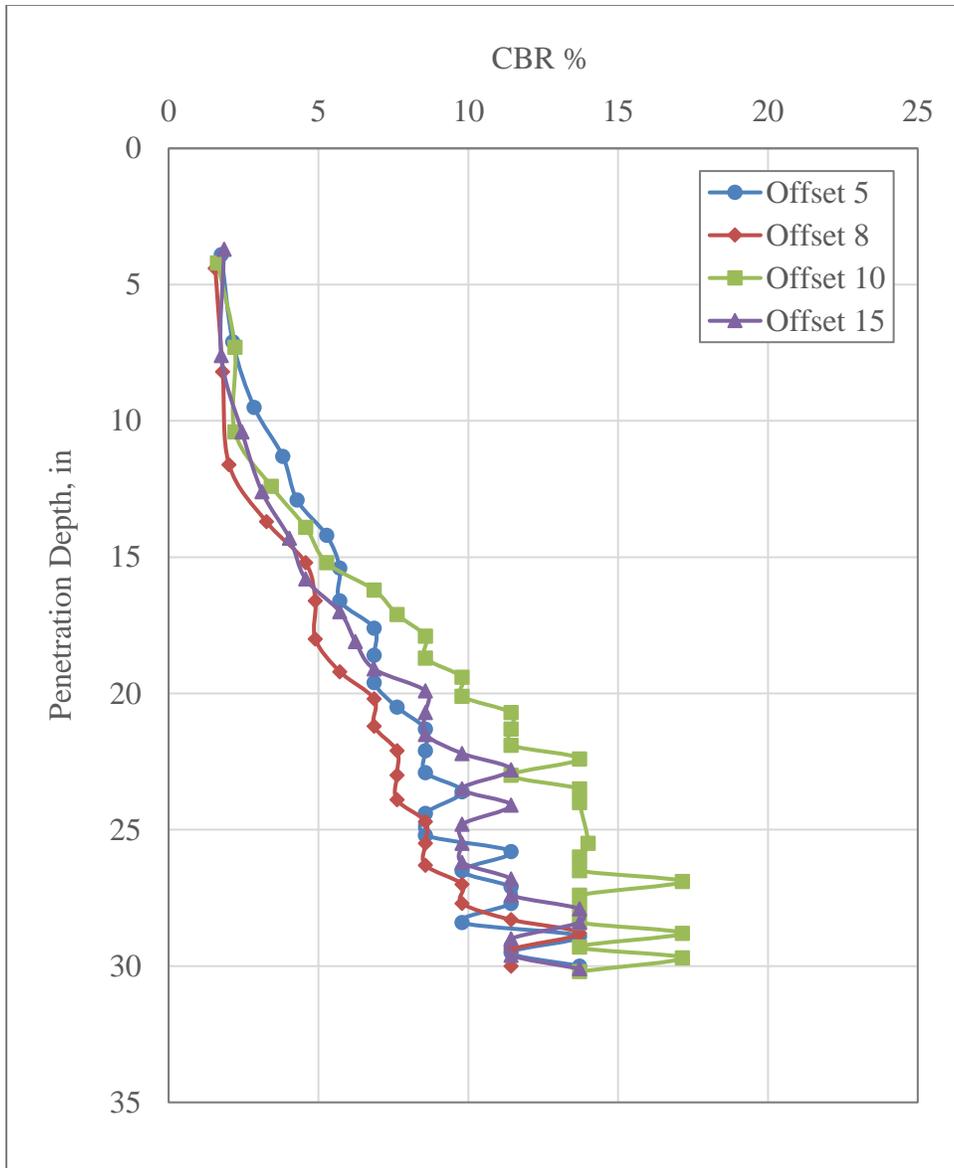
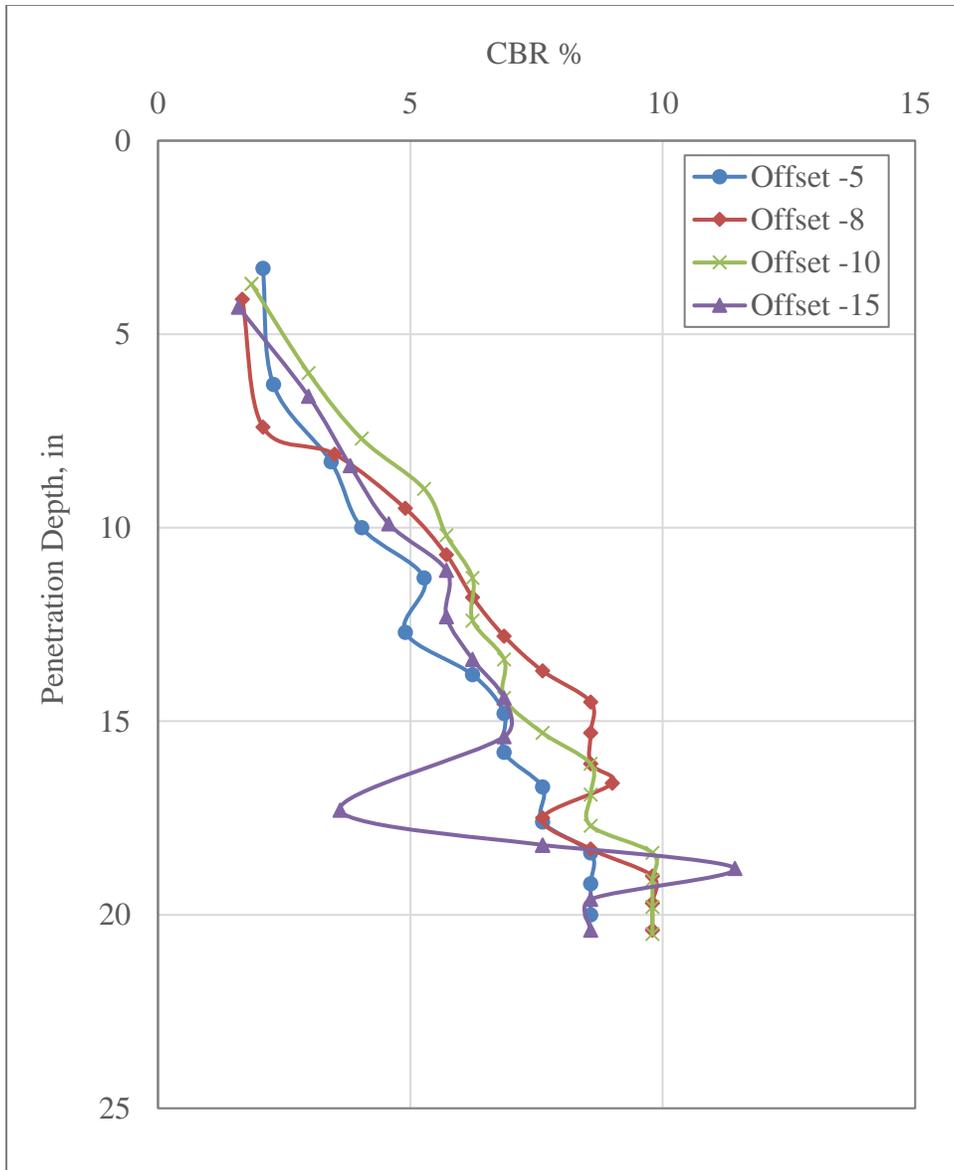
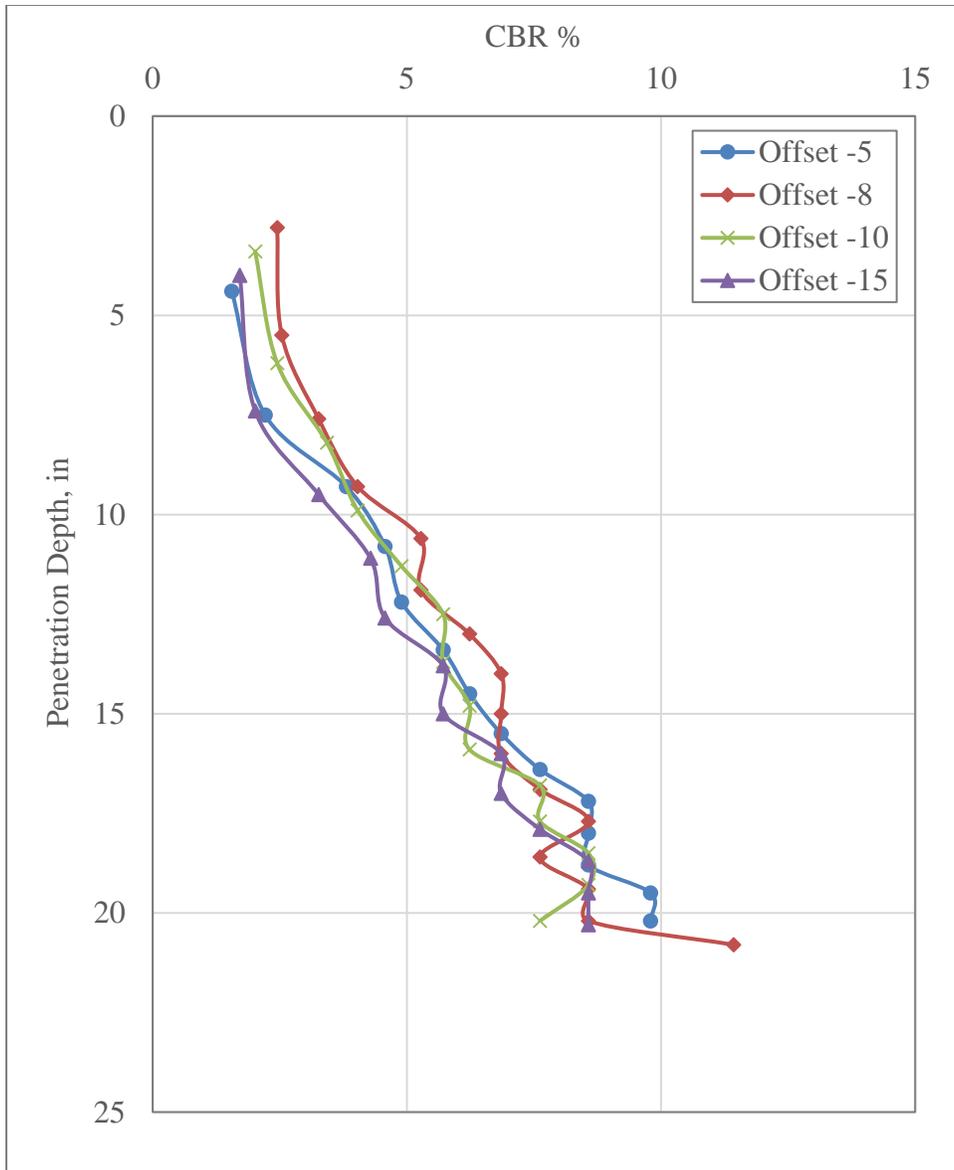
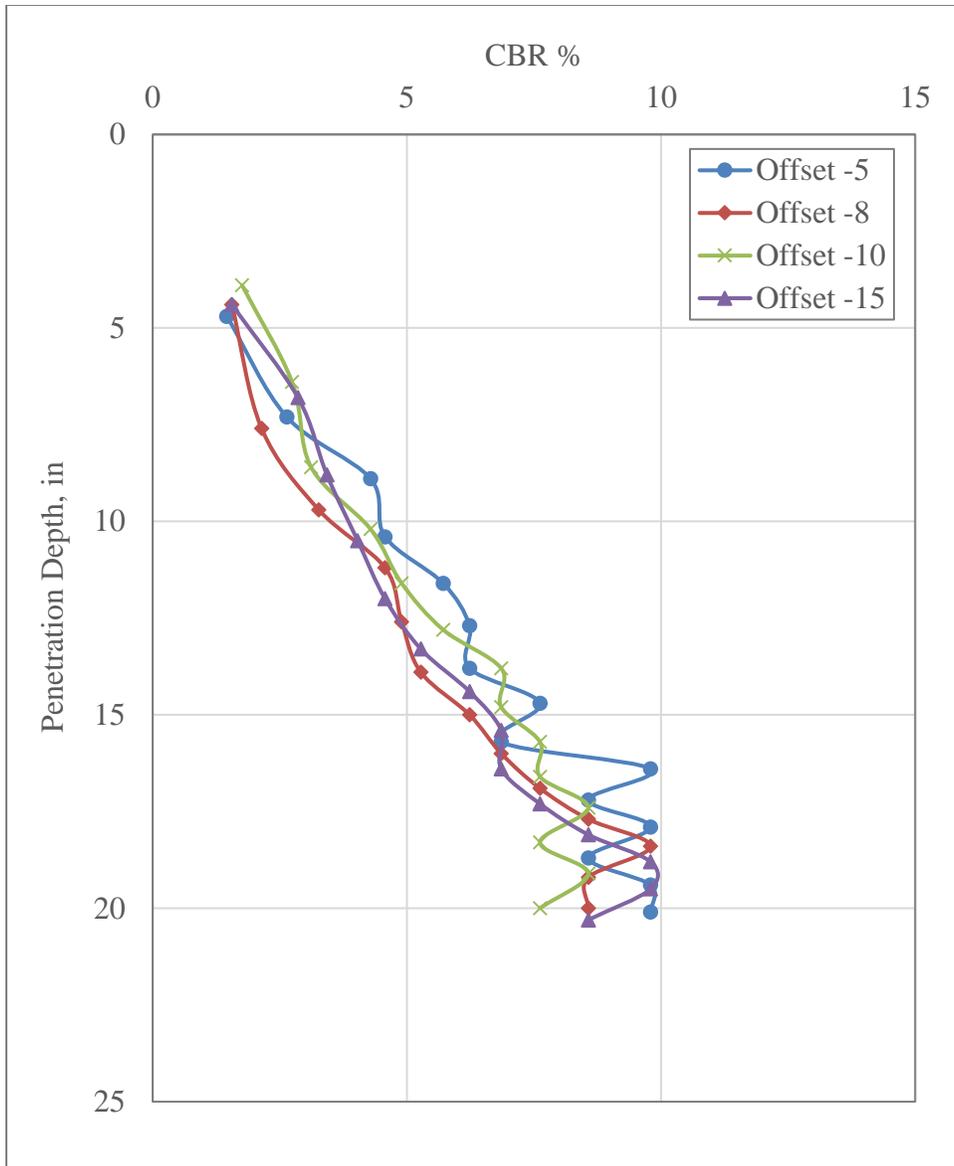
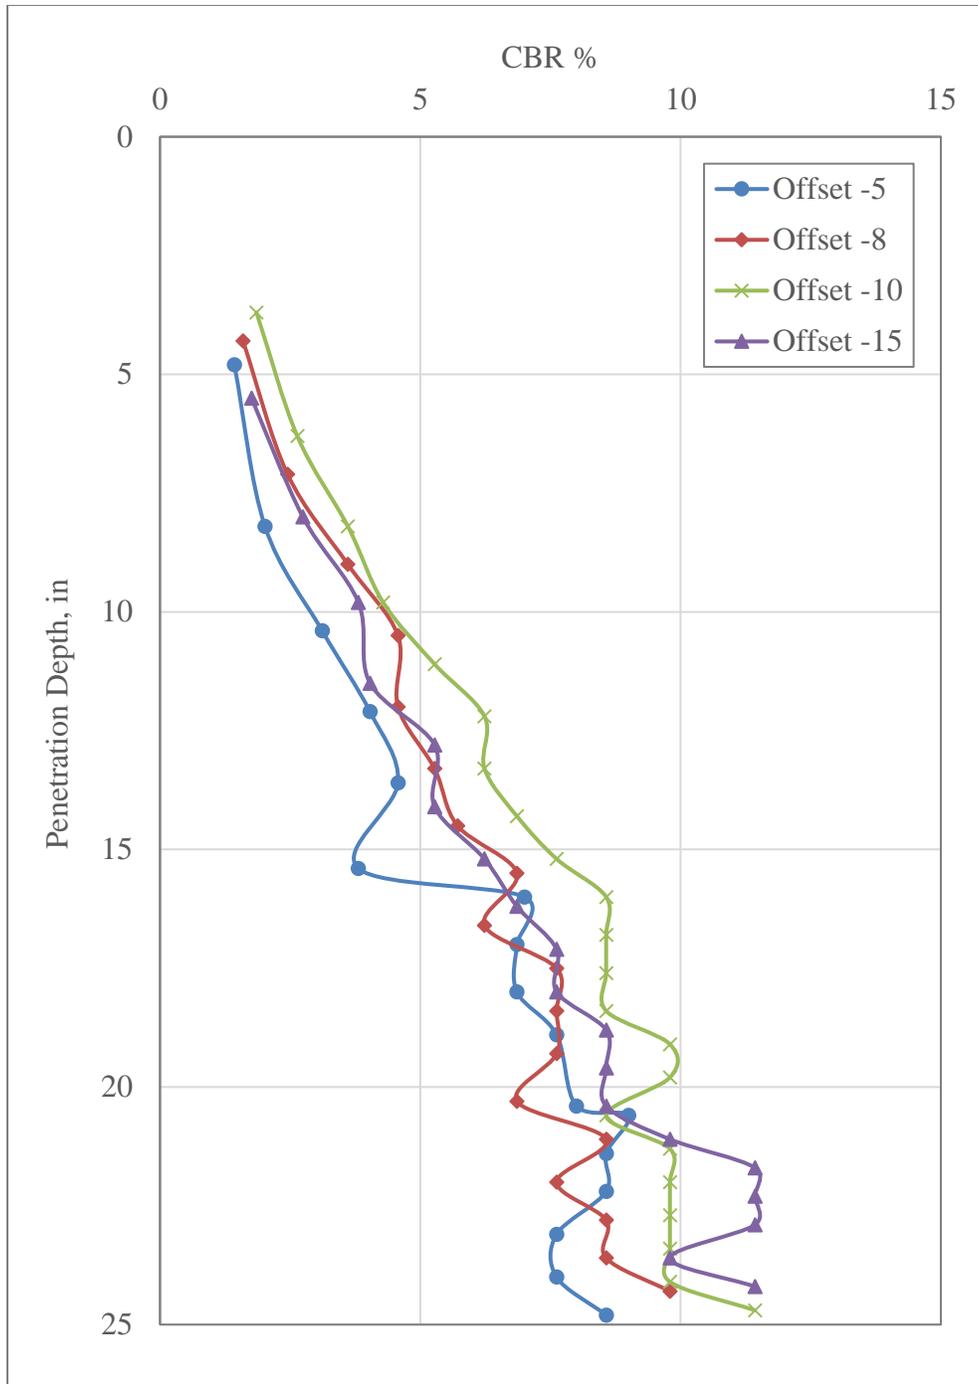
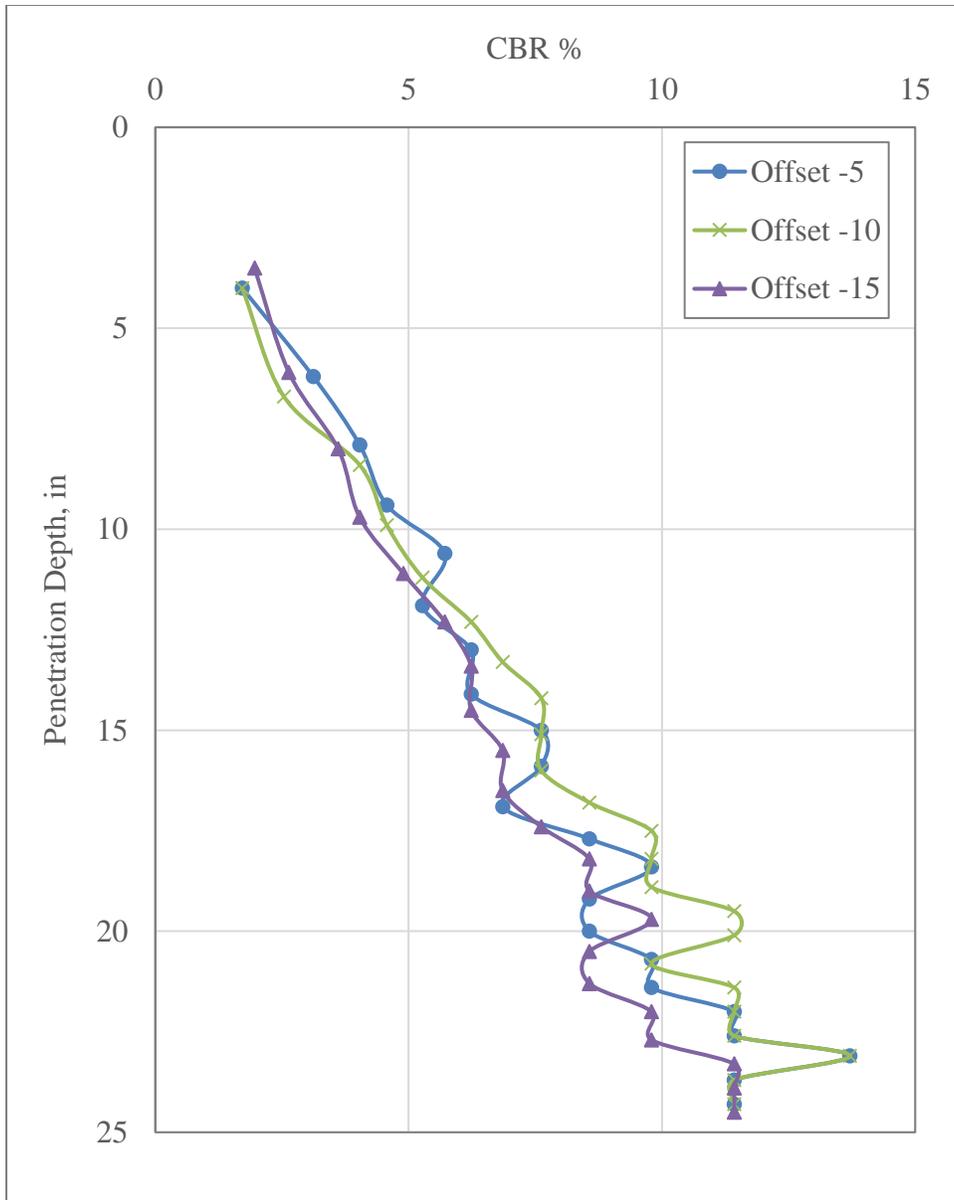
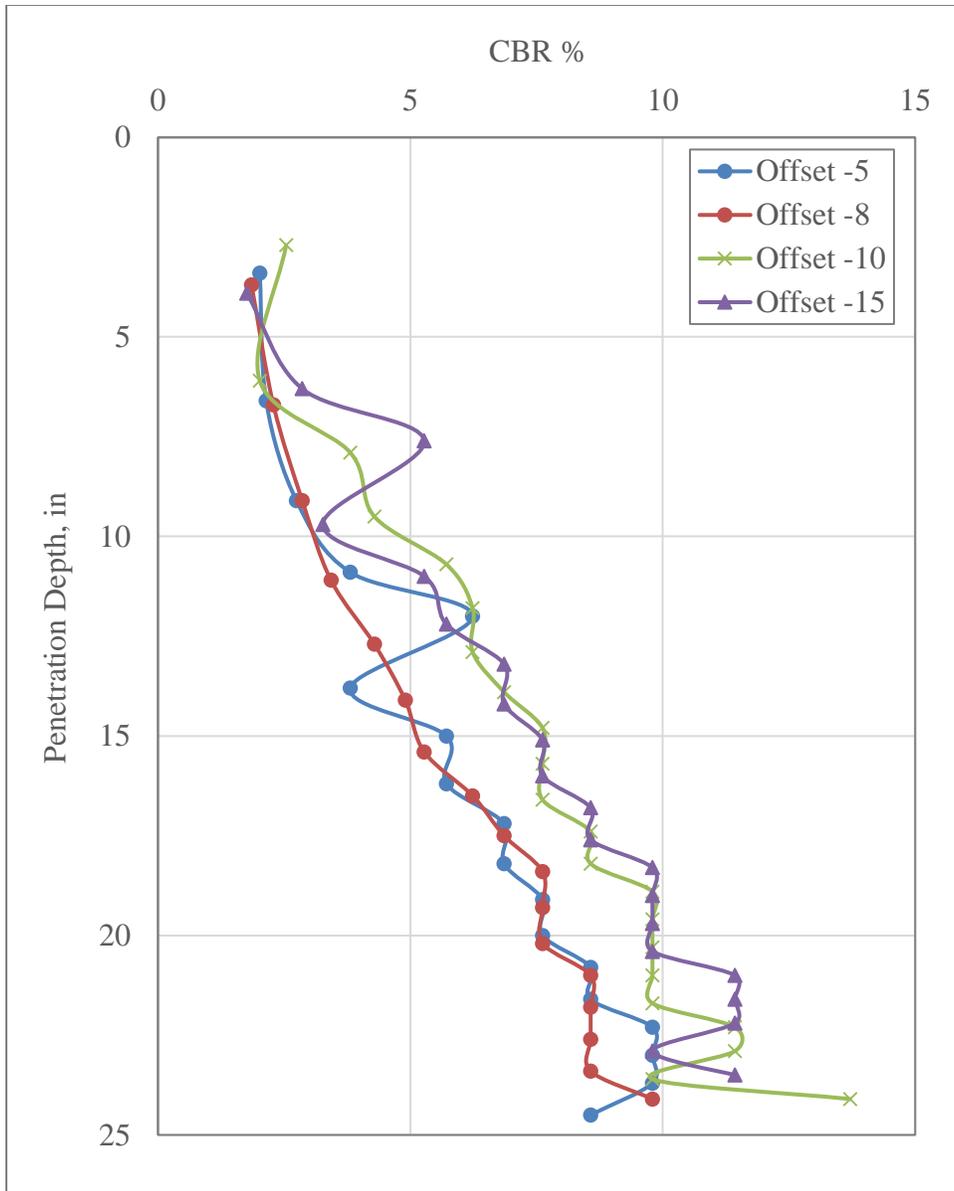
The CBR values were plotted versus penetration depth as shown in figures 65 to 76. The DCP results indicate that the CBR values are increasing with depth. On the south side, the CBR values range from 2% to 23%. On the north side, the CBR values vary from 2% to 14%.

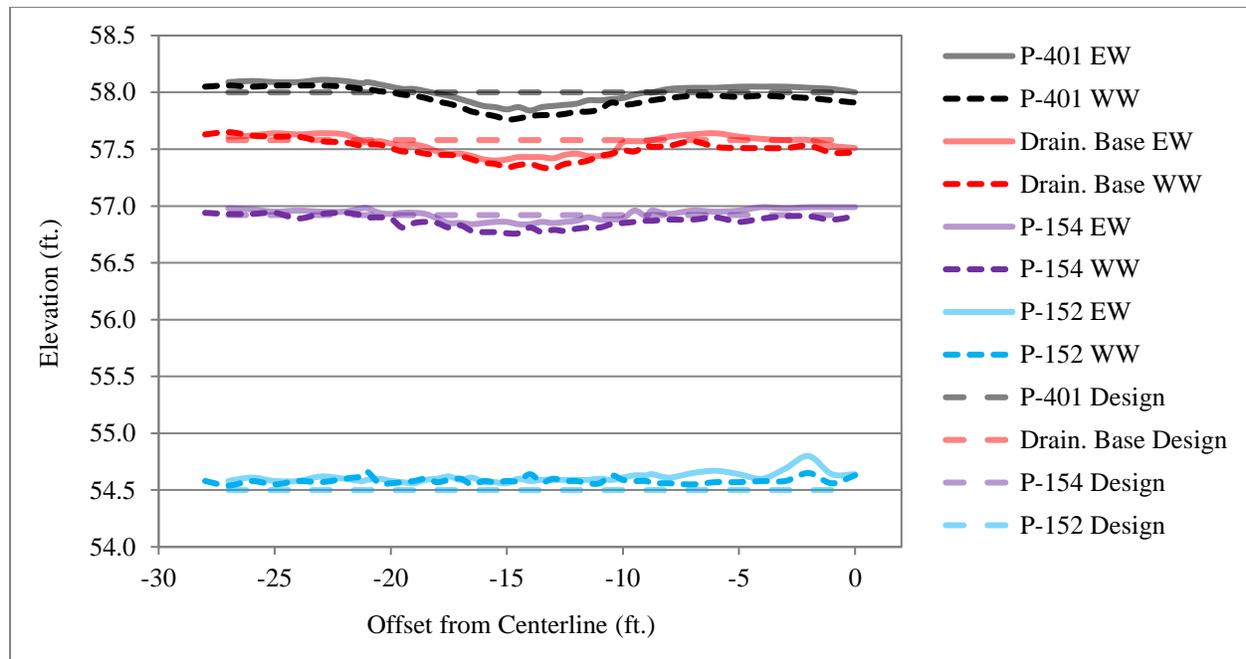
Figure 77. Pavement Layer Profiles, LFS6-N

Trench profiles show that for all the test items, the majority of the observed rutting was contributed by the subbase P-154 layer. The P-154 layer thickness reduction contributed 70% to 100% of the total rutting. The P-154 layer thickness reduction in LFC5-N was higher than LFS6-N. It is speculated that the ATDB material may distribute the traffic load more effectively than P-209 material. Consequently, under the same traffic load, the vertical stress on top of the P-154 surface in test item LFC5-N was higher than LFS6-N.
