Contract No. DTFACT-15-D-00007
Delivery Order 005 NAPTF Support
Deliverable 4.9.2.6.2: CC8 Phase 4 Strength/Fatigue
Traffic Test Report – Inner Lane

Submitted on February 12, 2021

Prepared by GDIT
with Horizon Engineering Consulting, LLC

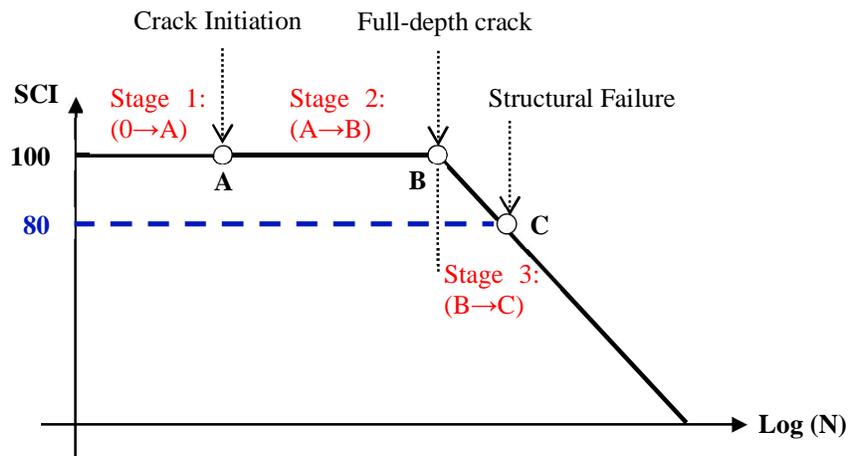
Figure 1. Rigid Pavement Failure Model in FAARFIELD (Reproduced from Guo et al. 2008)

As shown in figure 1, rigid pavement failure progresses through stages. Stage 1 is the initiation of a crack in a new or intact pavement. The CC8 S/F experiment started with stationary-load crack initiation tests to determine the cracking strength of selected slabs. For four slabs on the north inner lanes (SF1N, SF2N, SF5N and SF6N), the static load was initially conducted using a D module, with the tires spaced 34 inch apart (i.e., distance between inner tire edges). After reaching maximum load capacity with no indication of crack initiation from embedded strain gauge (EG) responses, the static load test on these four slabs had to be completed using an S module, which can attain wheel loads up to 150,000 lbs. The remaining slabs on the north (SF4N, SF4N, SF7N and SF8N) were not pre-cracked, so in those slabs the crack initiation (Stage 1) was intended to be achieved “naturally” by the moving gear load.

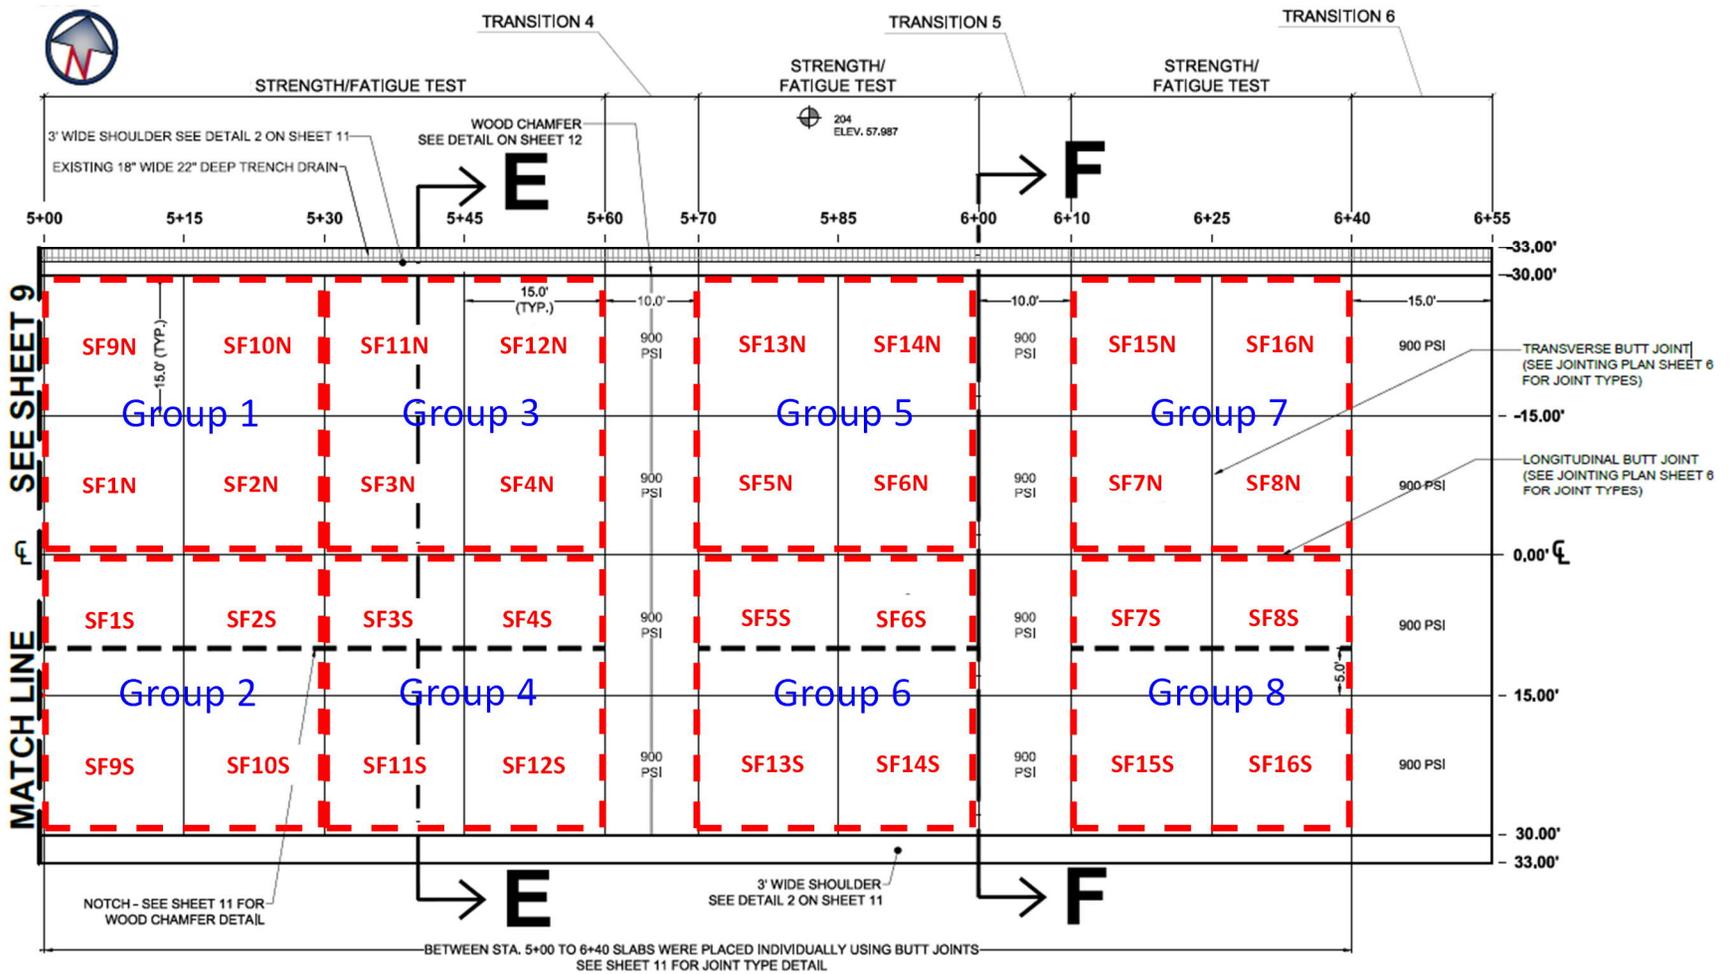
by the red dashed lines in the figure, based on combinations of (a) slab thickness, (b) design flexural strength R ; and (c) subgrade CBR. The black horizontal dashed line on the south side represents the notch location. The notch is intended to induce crack initiation at the bottom of slabs, directly under the traffic path. Neither longitudinal nor transverse joints were dowelled to prevent load transfer between slabs. Table 1 summarizes slab thickness, design flexural strength (R), and subgrade strength of each slab group.

Figure 2. Slab Groups in CC8 Phase 4 – S/F Test Area

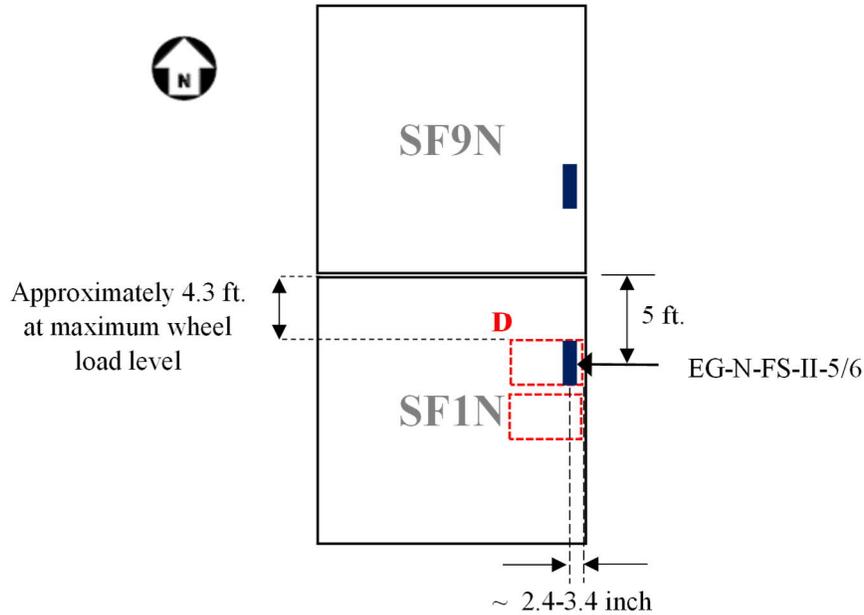
Figure 4. Position of D NAPTIV Module for Static Load Tests

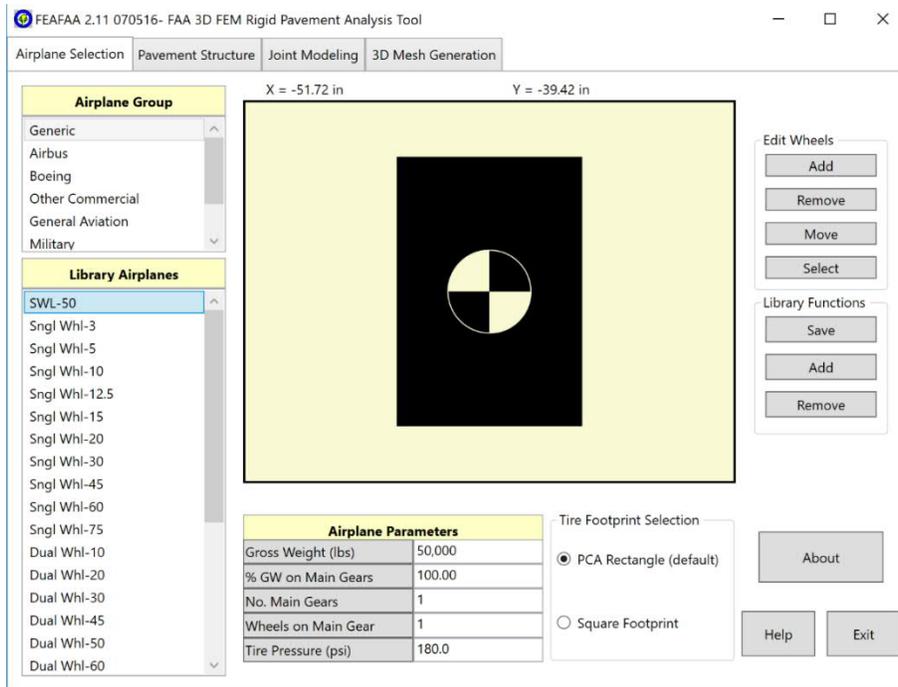
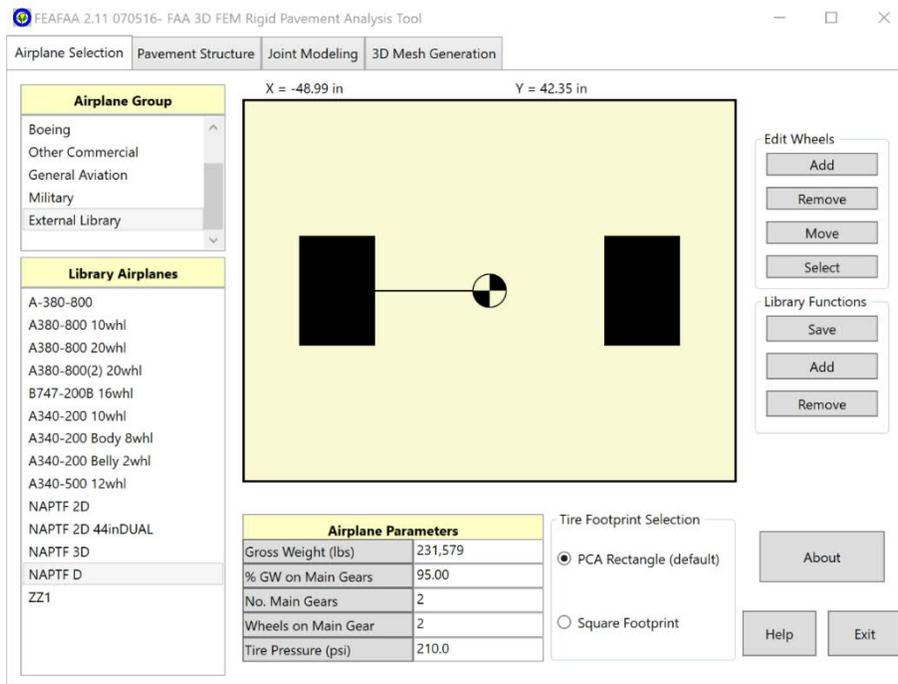
Figure 5. Aircraft Gear Configuration for FEAFAA Simulations: (a) S module, and (b) D module

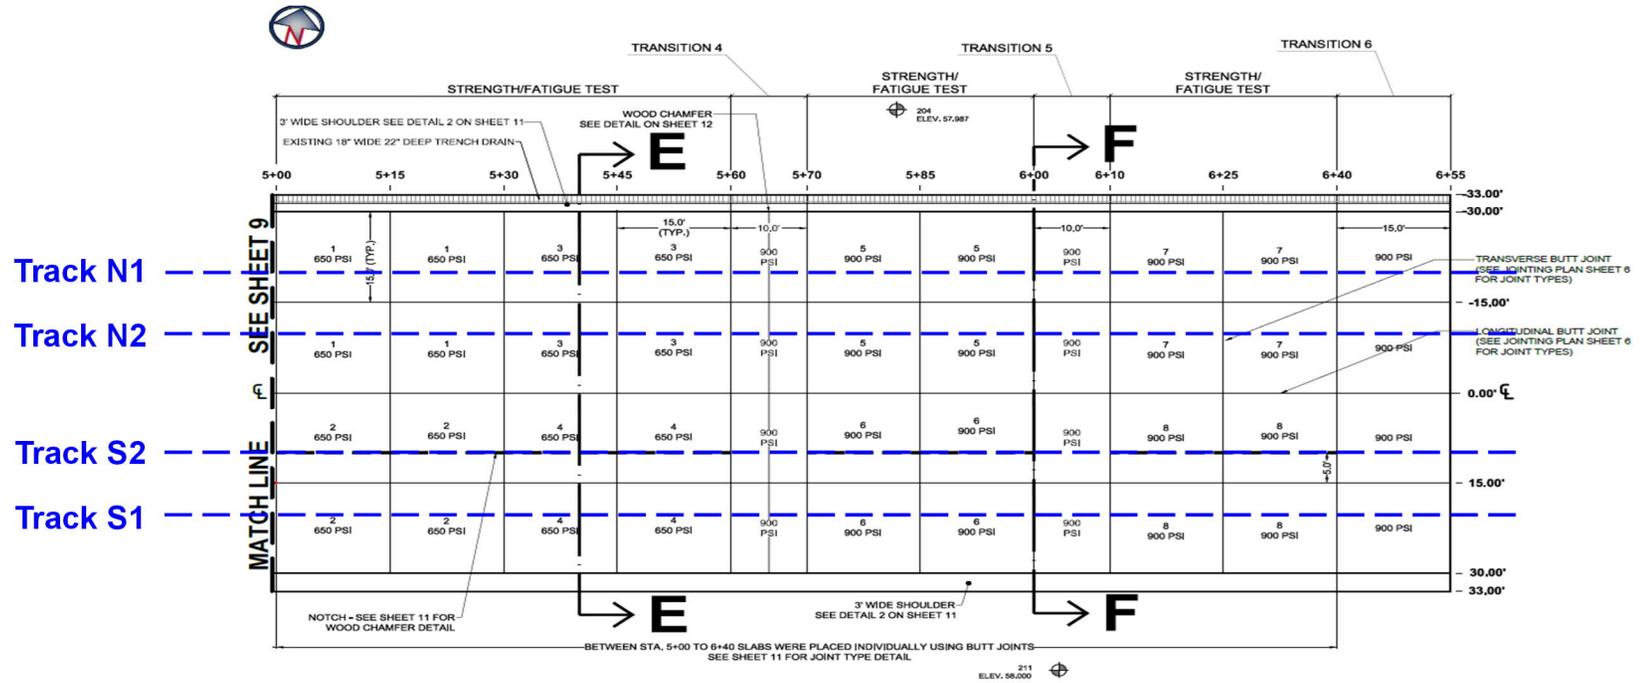
Once bottom-up cracks were initiated, additional trafficking was executed to complete Stage 2, characterized by the development of a full-length and full-depth crack. The Stage 2 failure mechanism was quantified by a rolling wheel test at 80% of the bottom-up cracking load. On both the north and south side, the D module was used to propagate cracks to the surface on inner lanes. The vehicle speed was 2.5 mph traveling in both West to East (W→E) and East to West (E→W) directions at the transverse gear positions, as shown in figure 6.

Figure 6. NAPTV Module Positions for Moving Load Test

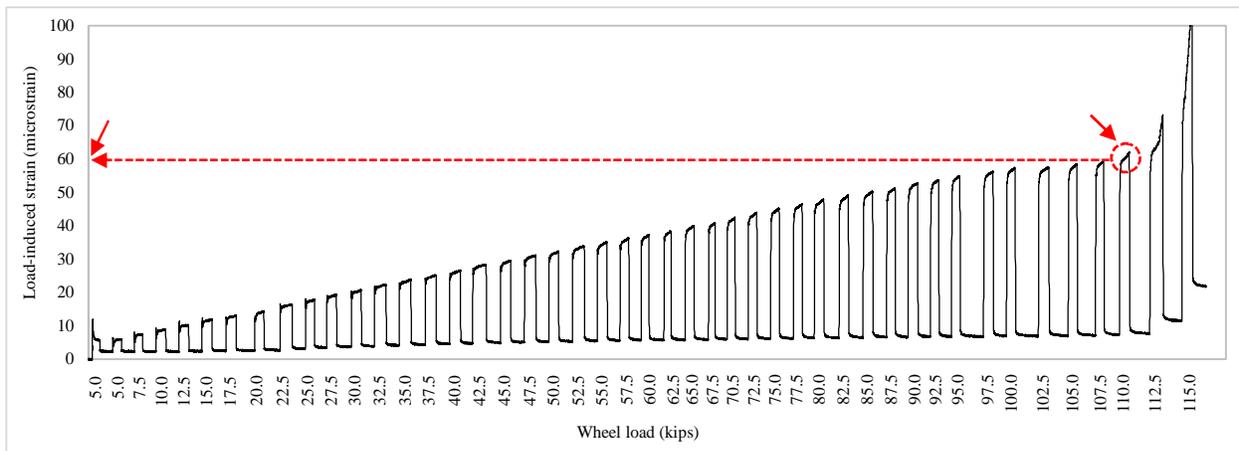
Figure 7 shows an example of a static load test to initiate a bottom-up crack in slab SF2N. For this test, the NAPT V S module was positioned as described in section 3.2.1.1 and illustrated in figure 4. The initial wheel load of 5,000 lbs was applied, held for approximately 10s, and then released. The wheel load was then increased in 2,500 lbs increments and the procedure repeated until the response of transverse gauge EG-N-SF-II-8 indicated a rupture at the slab bottom. The relationship observed between the recorded strain and applied load in figure 7 was approximately linear at low load levels. The relationship flattens at approximately 90,000 lbs before turning highly nonlinear at an inflection point corresponding to 110,000 lbs, which indicates the crack formation.

Figure 7. Static Load Test on the North Inner Lane, Slab SF2N - Strain vs. Load

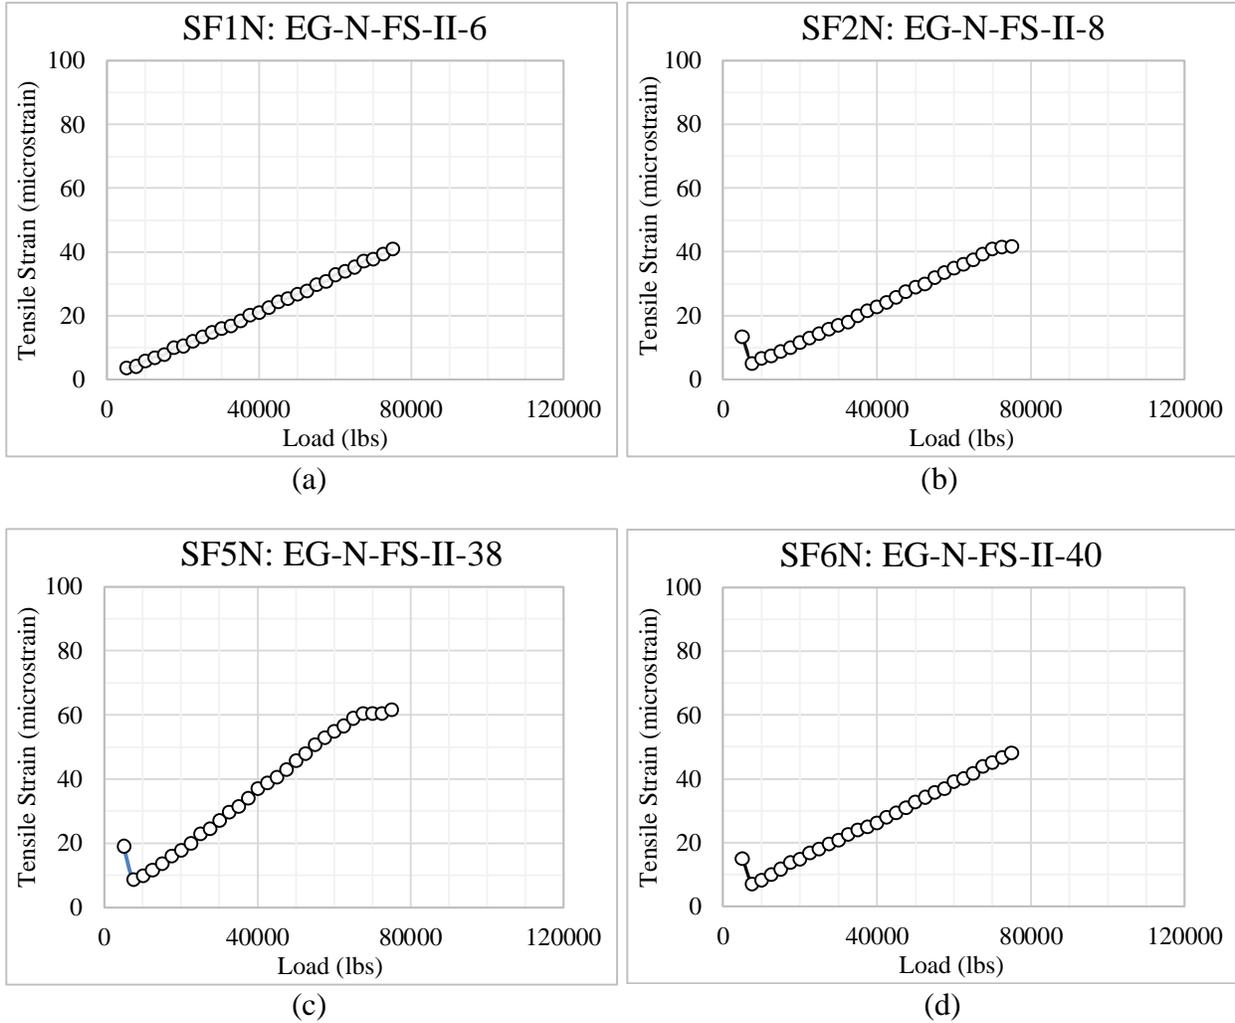
Figure 8 shows the relation between tensile strain and wheel load for 12 inch and 9 inch-thick slabs in the north inner lane, respectively. Up to the maximum load capacity with D module (i.e., 75,000 lbs), no indication of bottom-up cracking was observed from transverse EG responses. Figure 9 shows the relation between tensile strain and S module wheel load for the same slabs. Table 4 summarizes both cracking loads and strains from static load tests using the S module.

Figure 8. Tensile Strain vs. Load using D Module, North Inner Lane: (a) SF1N (12 inch), (b) SF2N (12 inch), (c) SF5N (9 inch), (d) SF6N (9 inch)

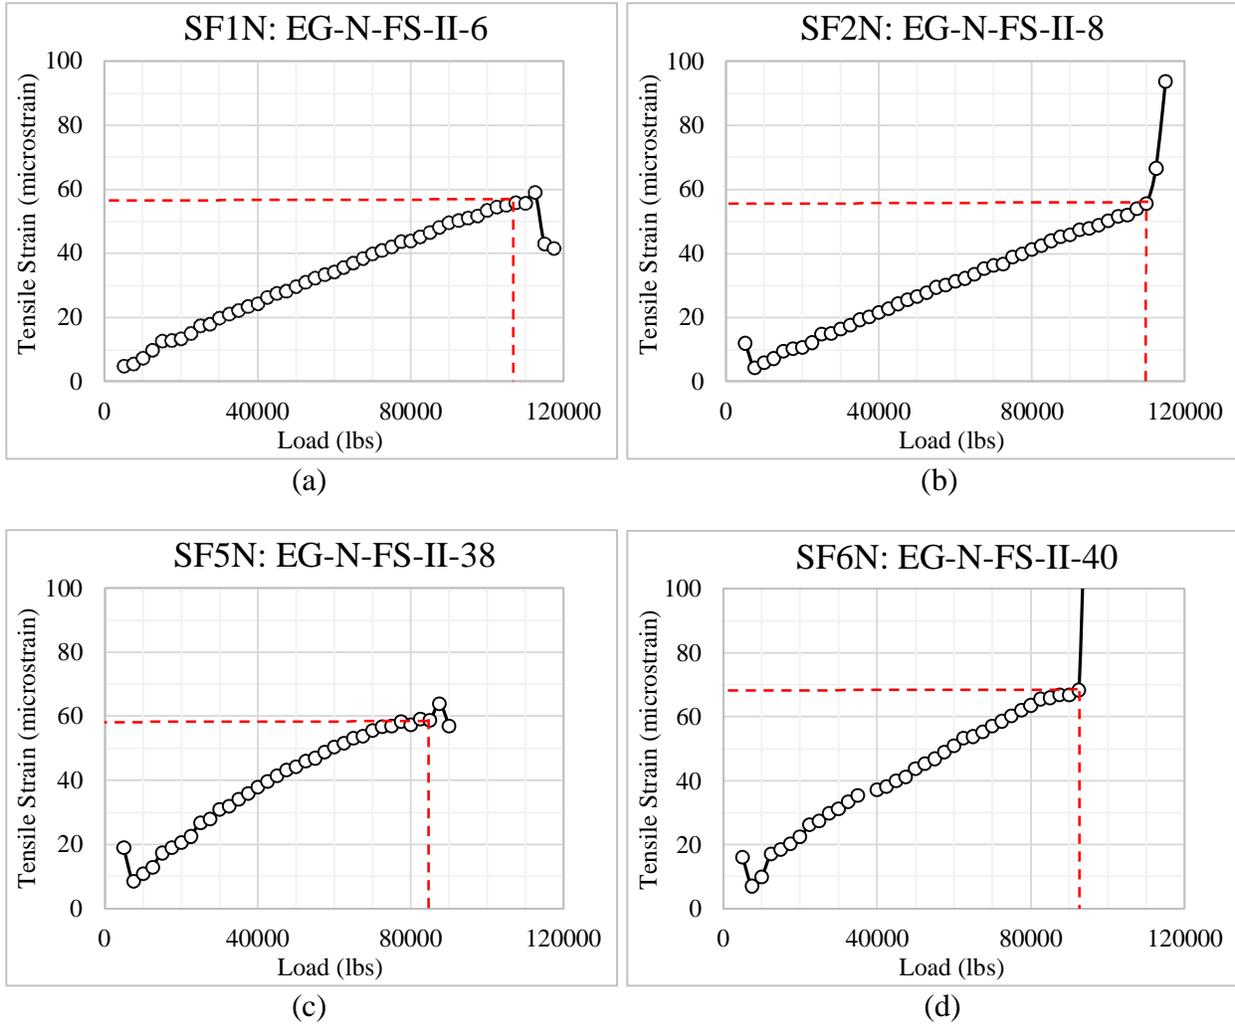
Figure 9. Tensile Strain vs. Load using S Module, North Inner Lane: (a) SF1N (12 inch), (b) SF2N (12 inch), (c) SF5N (9 inch), (d) SF6N (9 inch)

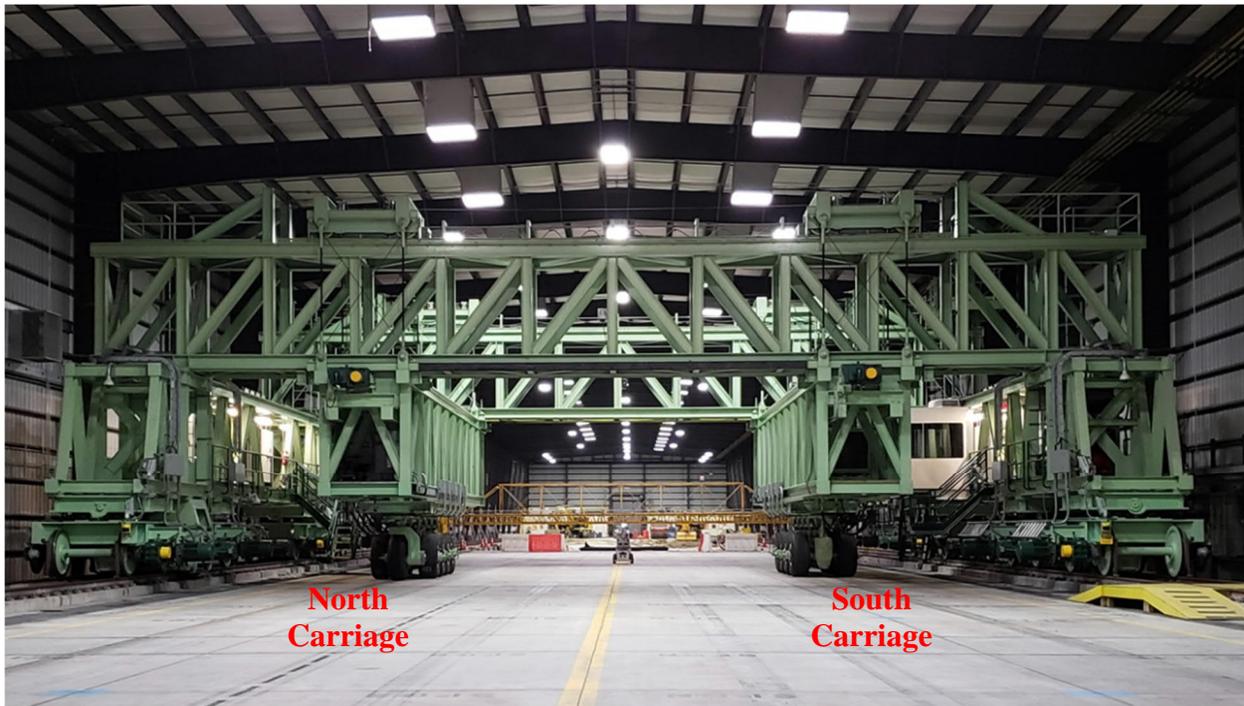
Figure 10. Moving Load Test

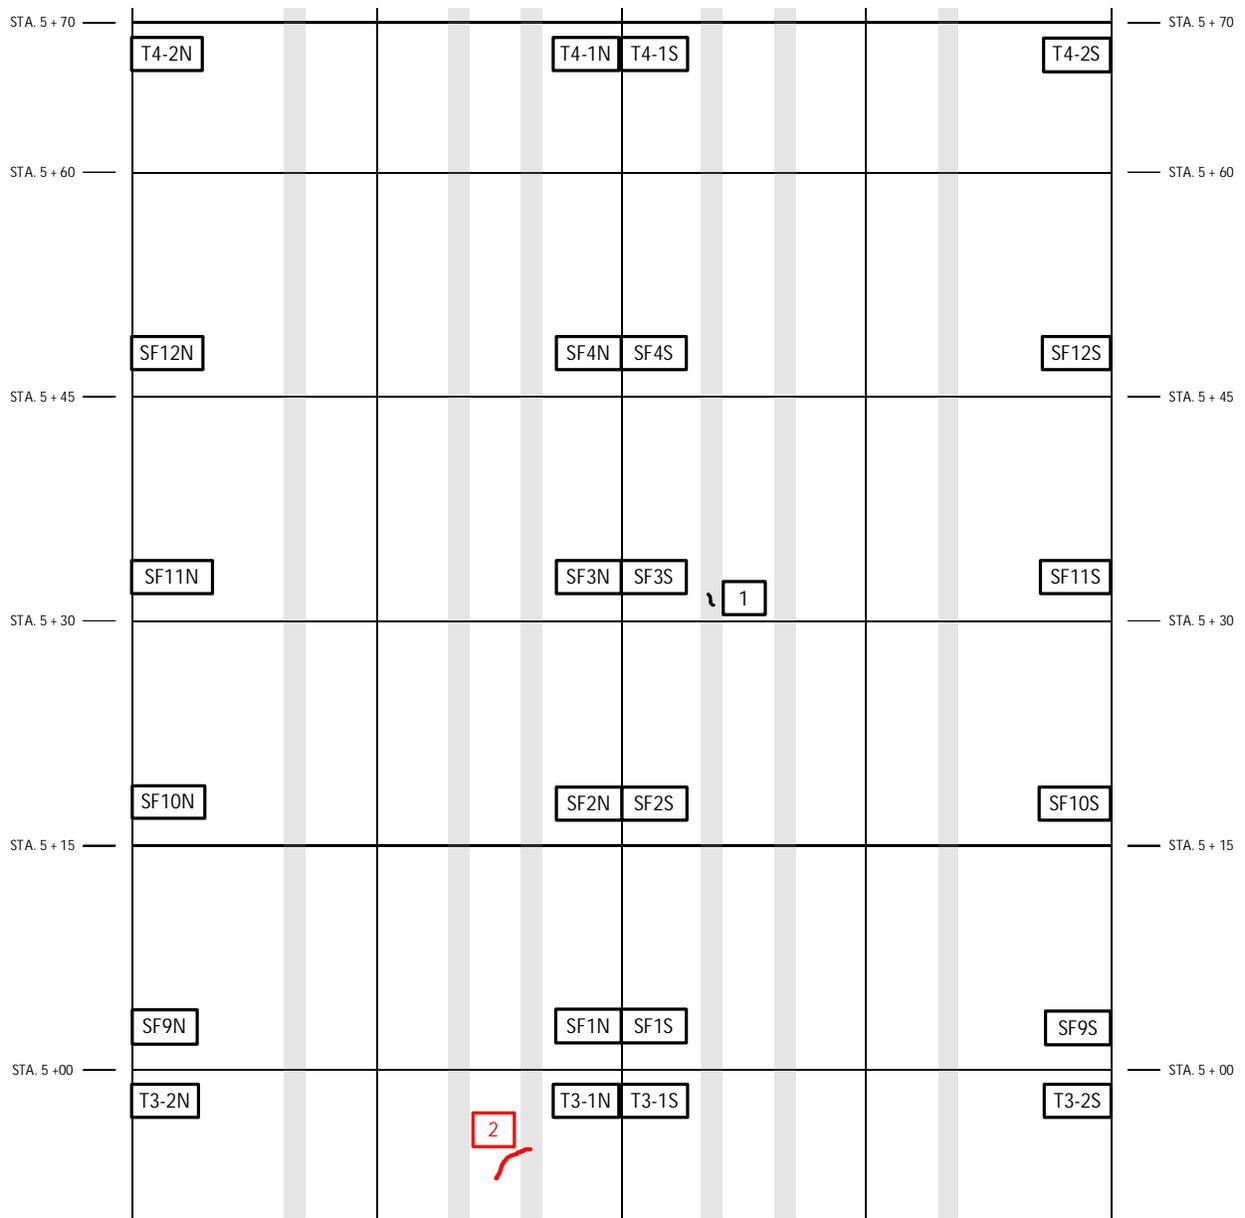
Figure 11. Current Distress Map for Inner Lanes (Groups 1-4, Last Updated: March 19, 2020)

The cumulative passes applied with D module on both north and south inner lanes are 25,000 as of March 6, 2020. Prior to the moving load tests, 50 passes were applied on July 15, 2019 to both north and south inner lanes as a separate effort in preparation for CC9 data collection. This resulted in an unintended crack on SF3S (12-inch thick, $R=650$ psi and CBR 7-8) along the inner wheel path. After the traffic test commenced on October 16, 2019, only one diagonal crack was recorded on T3-1N (i.e., transition slab at west end of CC8 S/F test area). This distress was observed on October 18, 2019 after 838 cumulative passes. Neither north nor south inner lane slabs (i.e., on the actual CC8 S/F test area) has shown any additional surface distress. To date, isolating the three phases of fatigue failure (i.e., crack initiation, full-depth and full-length crack propagation) is not possible due to the lack of performance data. Figures 11 and 12 show current distress maps for slab groups 1-4 and 5-8, respectively.

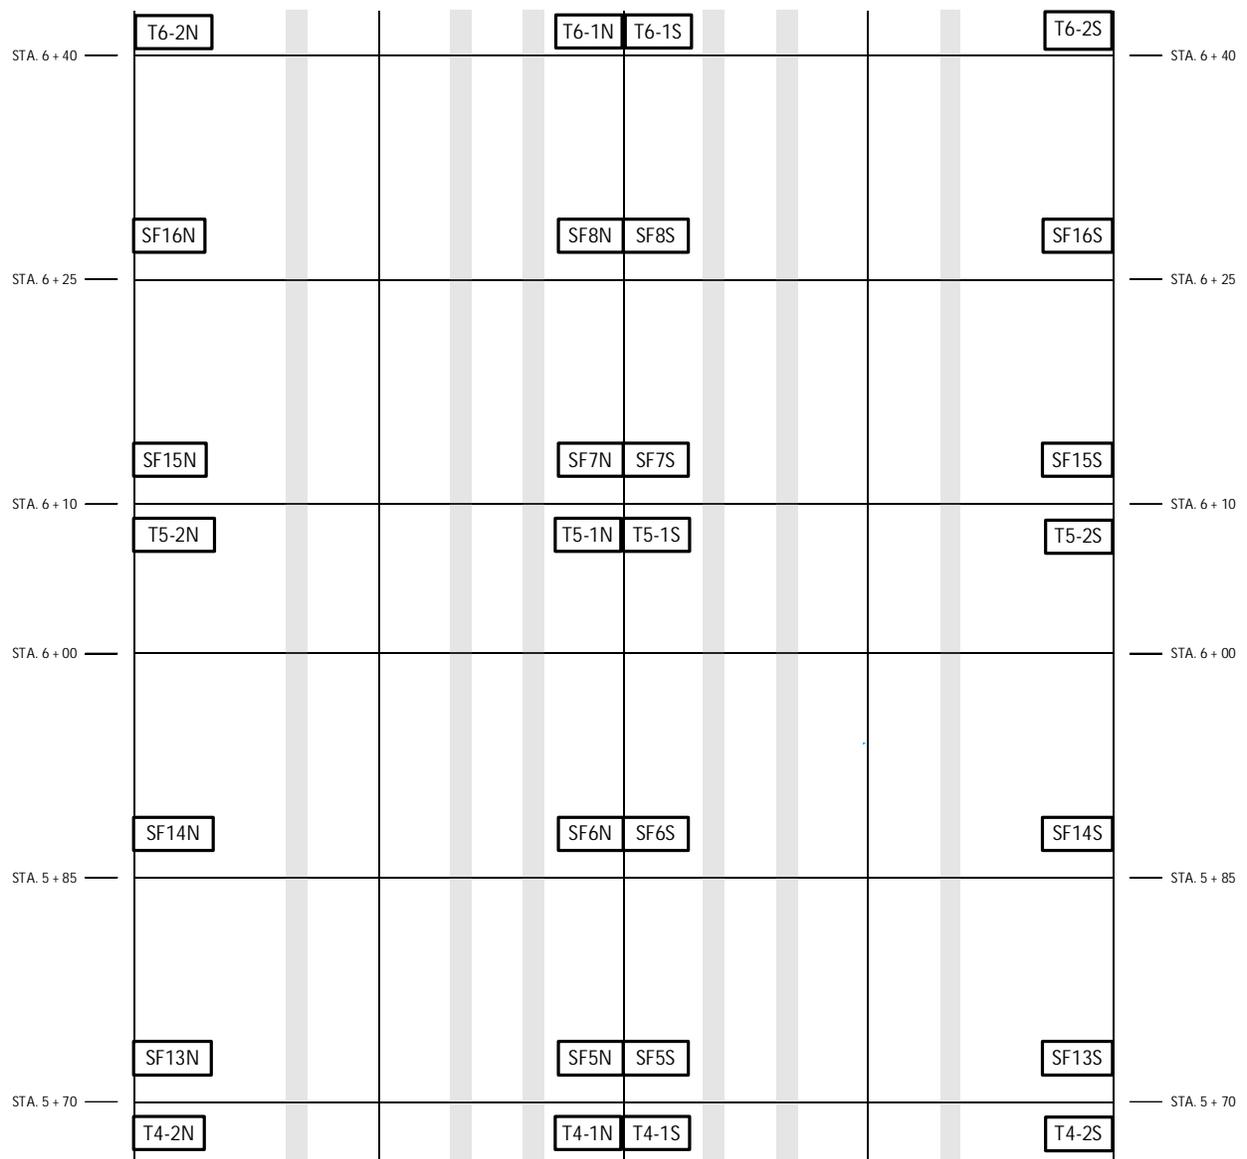
Figure 12. Current Distress Map for Inner Lanes (Groups 5-8, Last Updated: March 19, 2020)

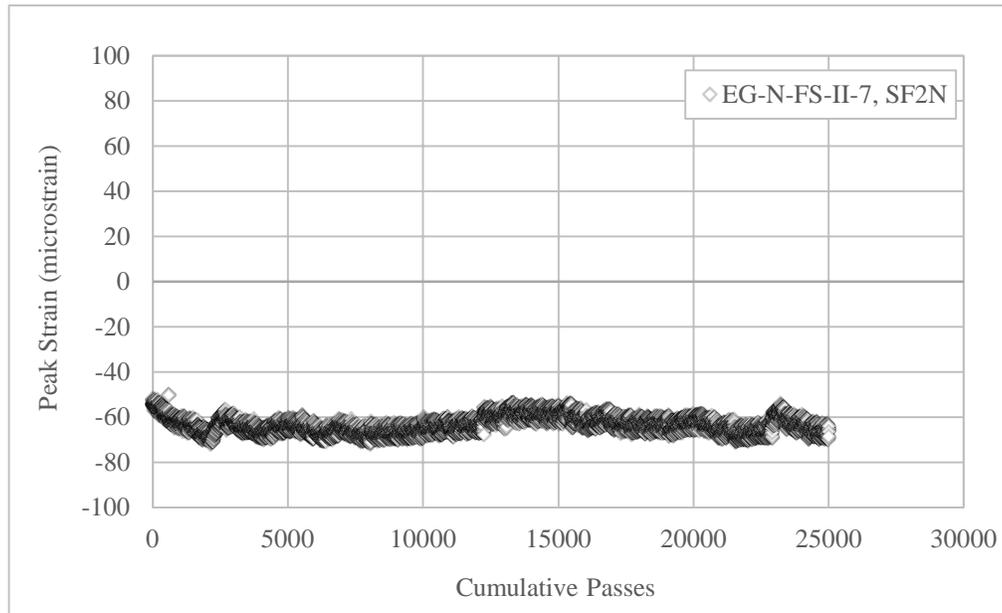
Figure 13 shows as example the top EG response from slab SF2N (i.e., 12-inch thick slab). A gradual increase in negative strain possibly due to initial stabilization of the pavement was observed at the beginning of trafficking. Following the initial increase, the strain response was fairly stable except for an observable fluctuation around cumulative pass 23,000. This fluctuation could be indication of full-depth propagation. Figure 14(a) and (b) show the top EG response of 9-inch thick slabs SF5N and SF6N, respectively. Compared to slab SF2N, the peak negative strains in slabs SF5N and SF6N were more consistent.

Figure 13. Response of Top EG in SF2N (12-inch PCC Slab)

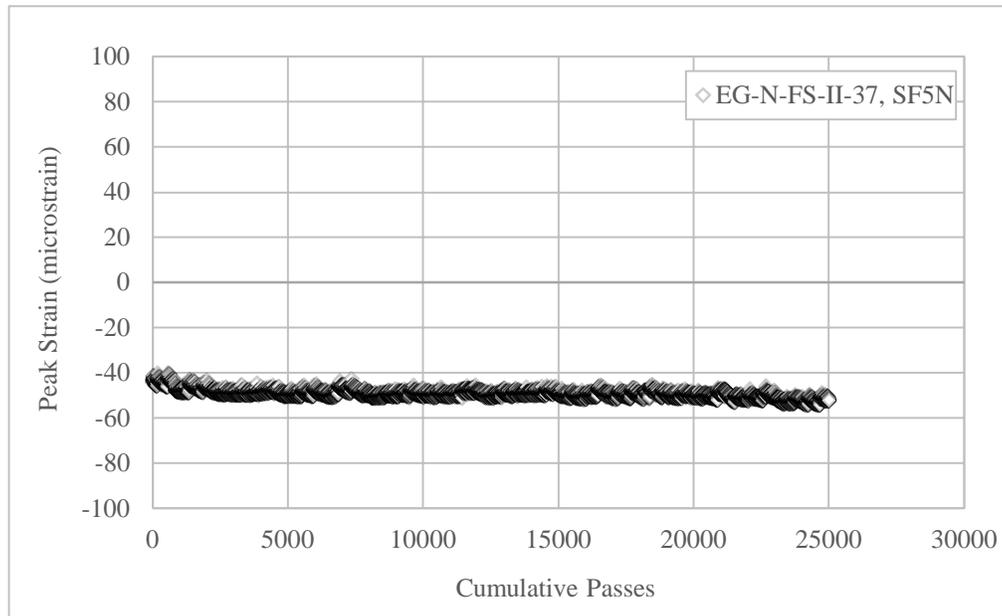
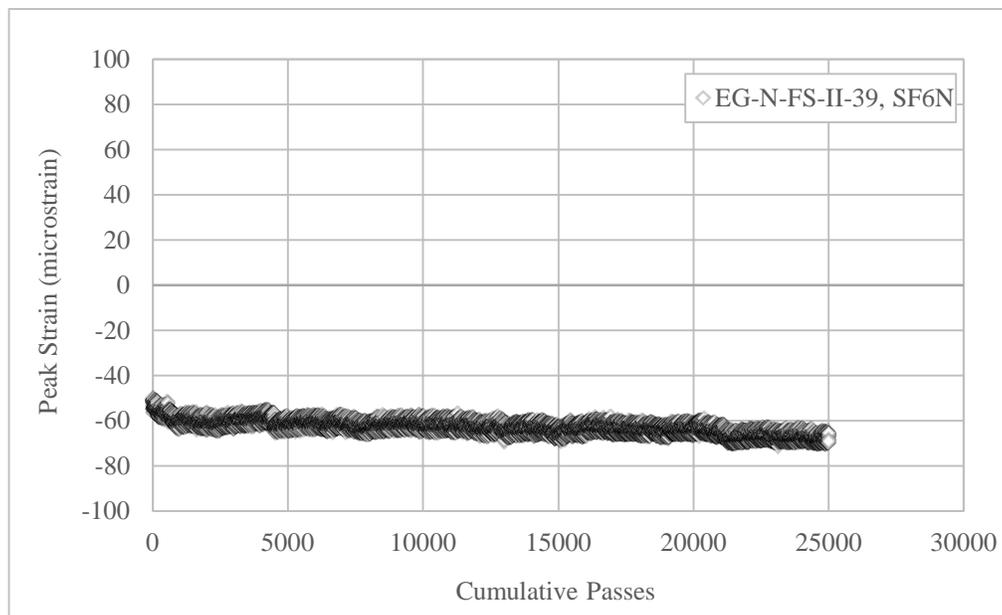
Figure 14. Response of Top EG in 9-inch PCC Slabs: (a) SF5N, (b) SF6N

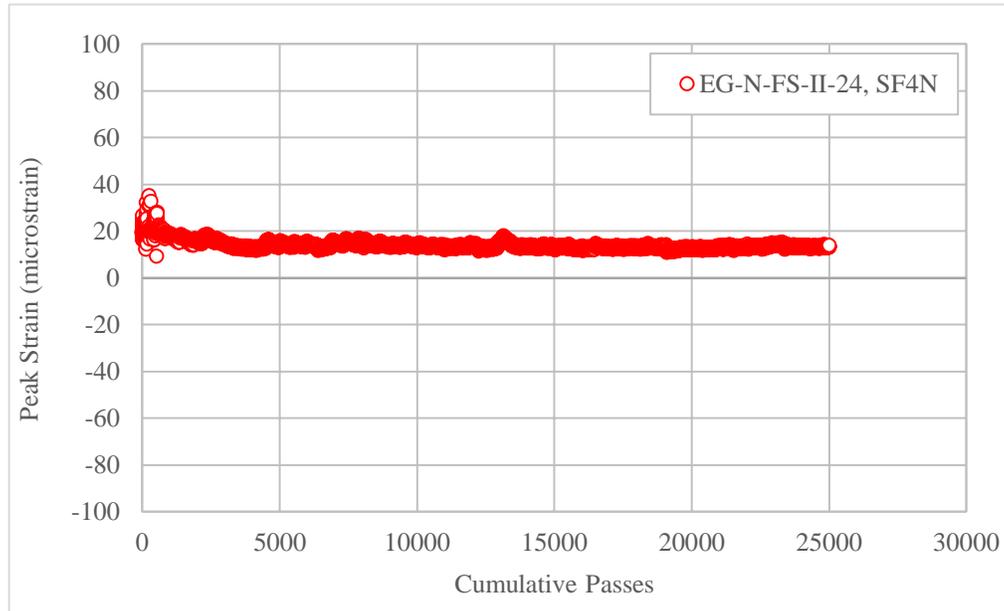
Figure 15 shows as example the bottom EG response from slab SF4N that had a thickness of 12 inches. The peak positive strain was initially inconsistent but became fairly stable later on. No signs of bottom-up crack initiation were observed over the 25,000 cumulative passes applied with D module.

Figure 15. Response of Bottom EG in SF4N (9-inch PCC Slab)

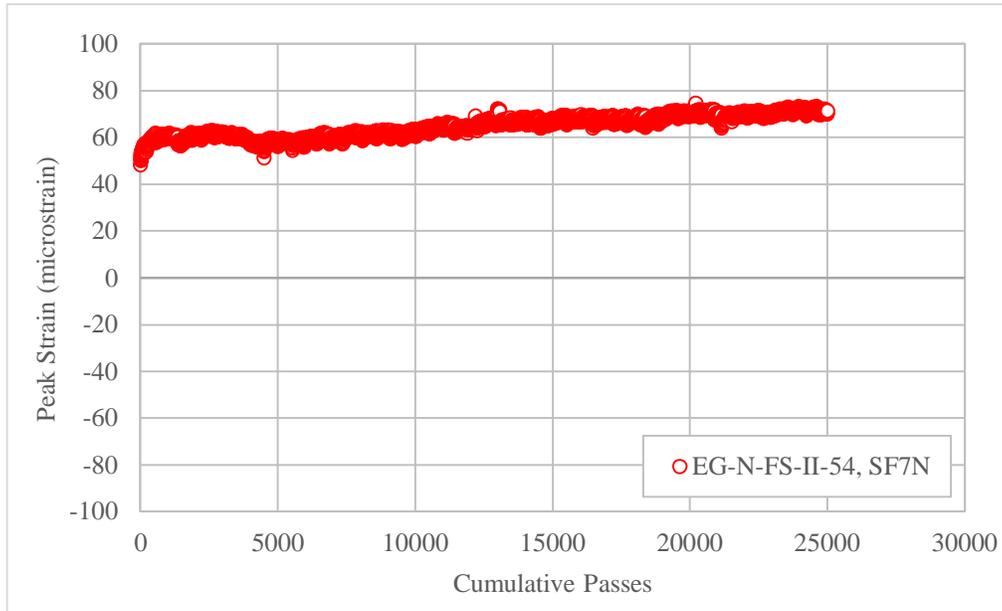
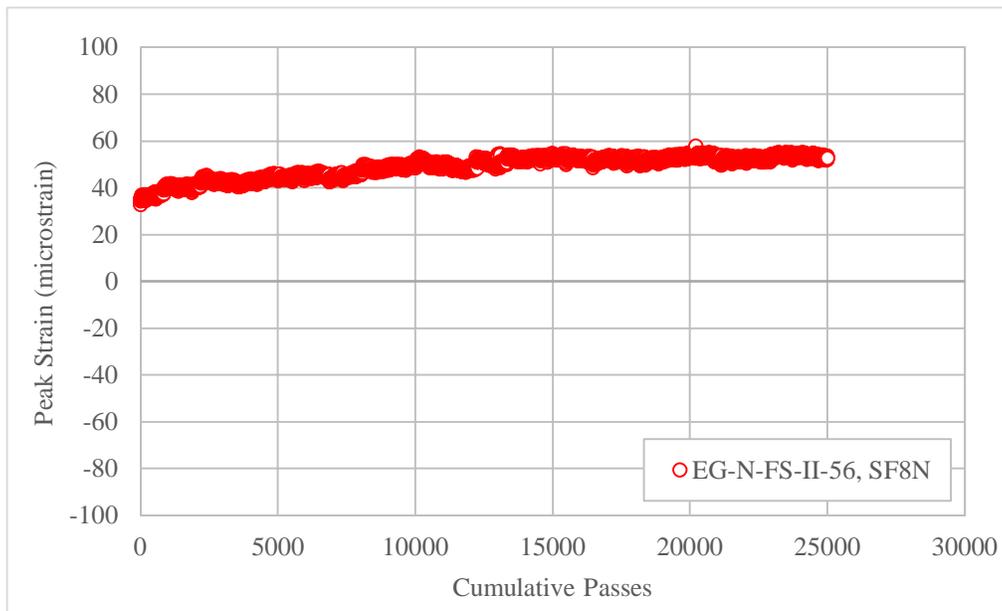
Figure 16(a) and (b) show the bottom EG responses of 9-inch thick slabs SF7N and SF8N, respectively. Slab SF7N shows a rapid increase in peak positive strain at the beginning of trafficking possibly due to initial stabilization of the pavement. Later, a slight drop in peak positive strain observed after approximately 4,000 cumulative passes was followed by a gradual increasing trend. Unlike 12-inch slab SF4N, both slab SF7N and SF8N generally exhibit a gradual increase in peak positive strain over the course of trafficking. Note that the peak positive strain in SF7N is higher compared to SF8N. This suggests that with additional traffic, SF7N may show surface distress earlier than SF8N.

Figure 16. Response of Bottom EGs in 9-inch PCC slabs: (a) SF7N, (b) SF8N

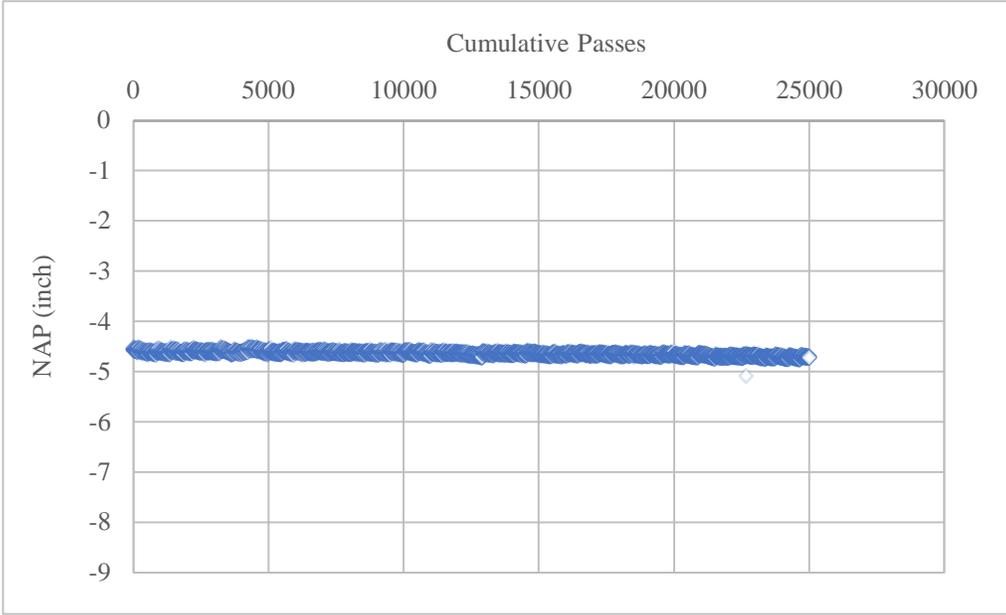
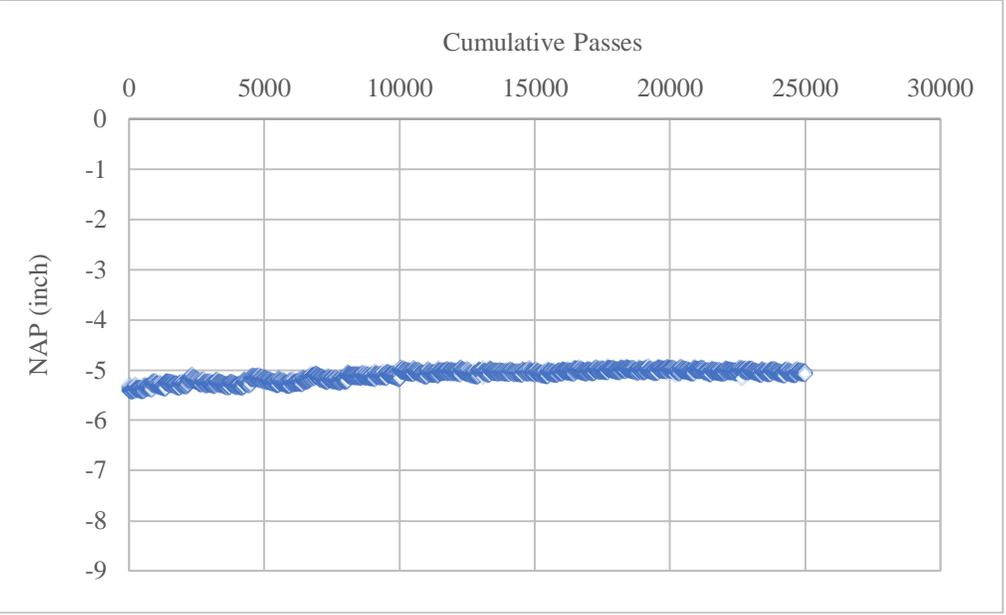
The neutral axis position (NAP) is defined as the location within the slab where the strains induced by moving load change from compression to tension. The NAP was calculated for SF7N and SF8N (i.e., using top and bottom EG responses) to perform in-depth characterization of bottom-up crack initiation. It is expected that changes in NAP observed over the course of trafficking will provide indication of crack initiation and propagation. Note that the NAP is measured relative to the pavement surface. Figure 17(a) and (b) show the change in NAP over the course of trafficking for SF7N and SF8N, respectively. The NAP for SF7N remained relatively constant throughout trafficking. For SF8N, an increasing trend at a generally slow rate can be observed. In both cases, the NAP gives no sign of crack initiation.

Figure 17. NAP Trends in 9-inch PCC Slabs: (a) SF7N, (b) SF8N

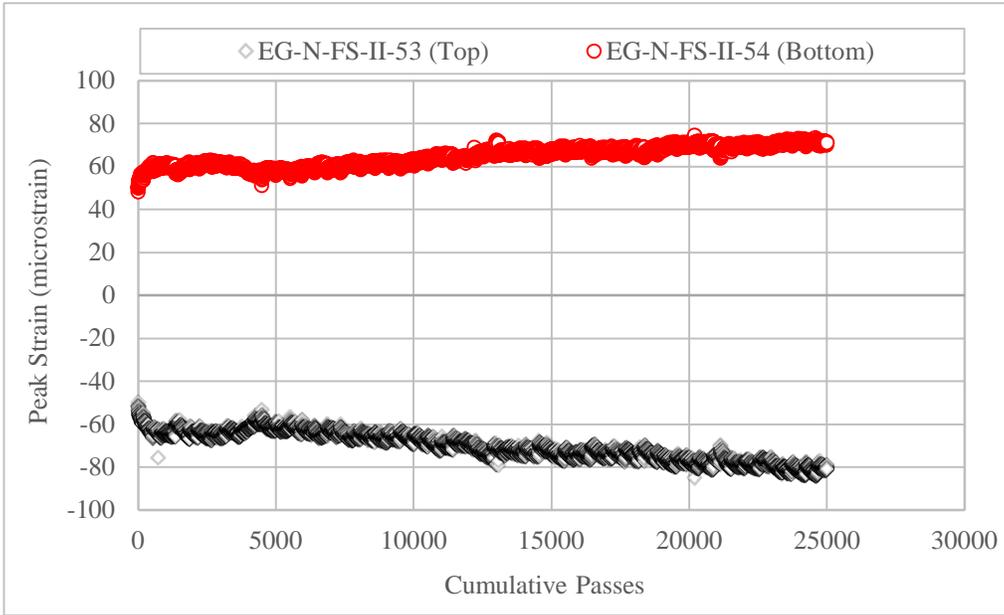
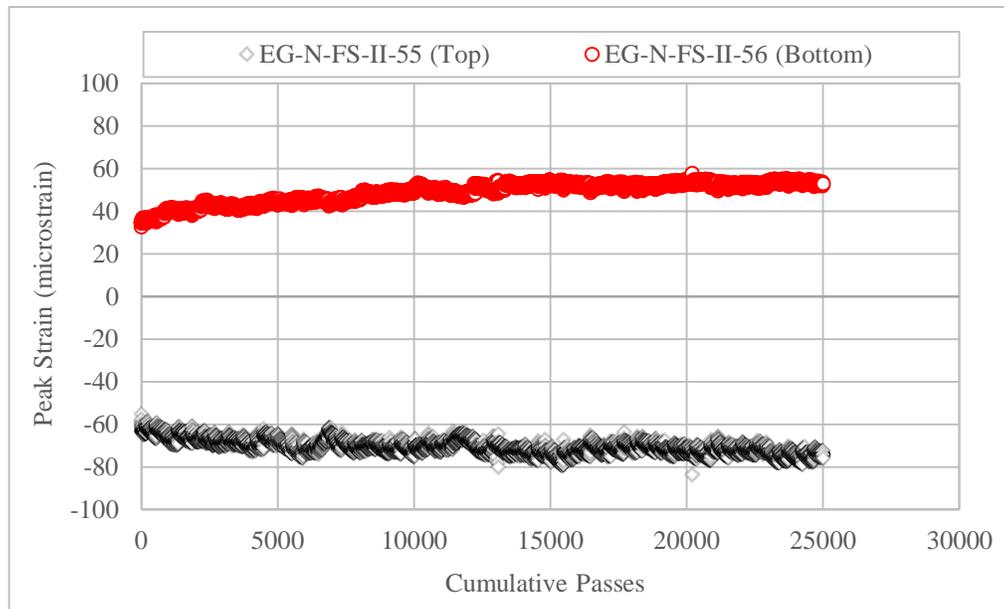
than the bottom which is consistent with the NAP in this slab being generally higher than that of SF7N. The bottom EG peak response in none of these two slabs indicates crack initiation.

Figure 18. Response of Top and Bottom EGs in 9-inch PCC slabs: (a) SF7N, (b) SF8N

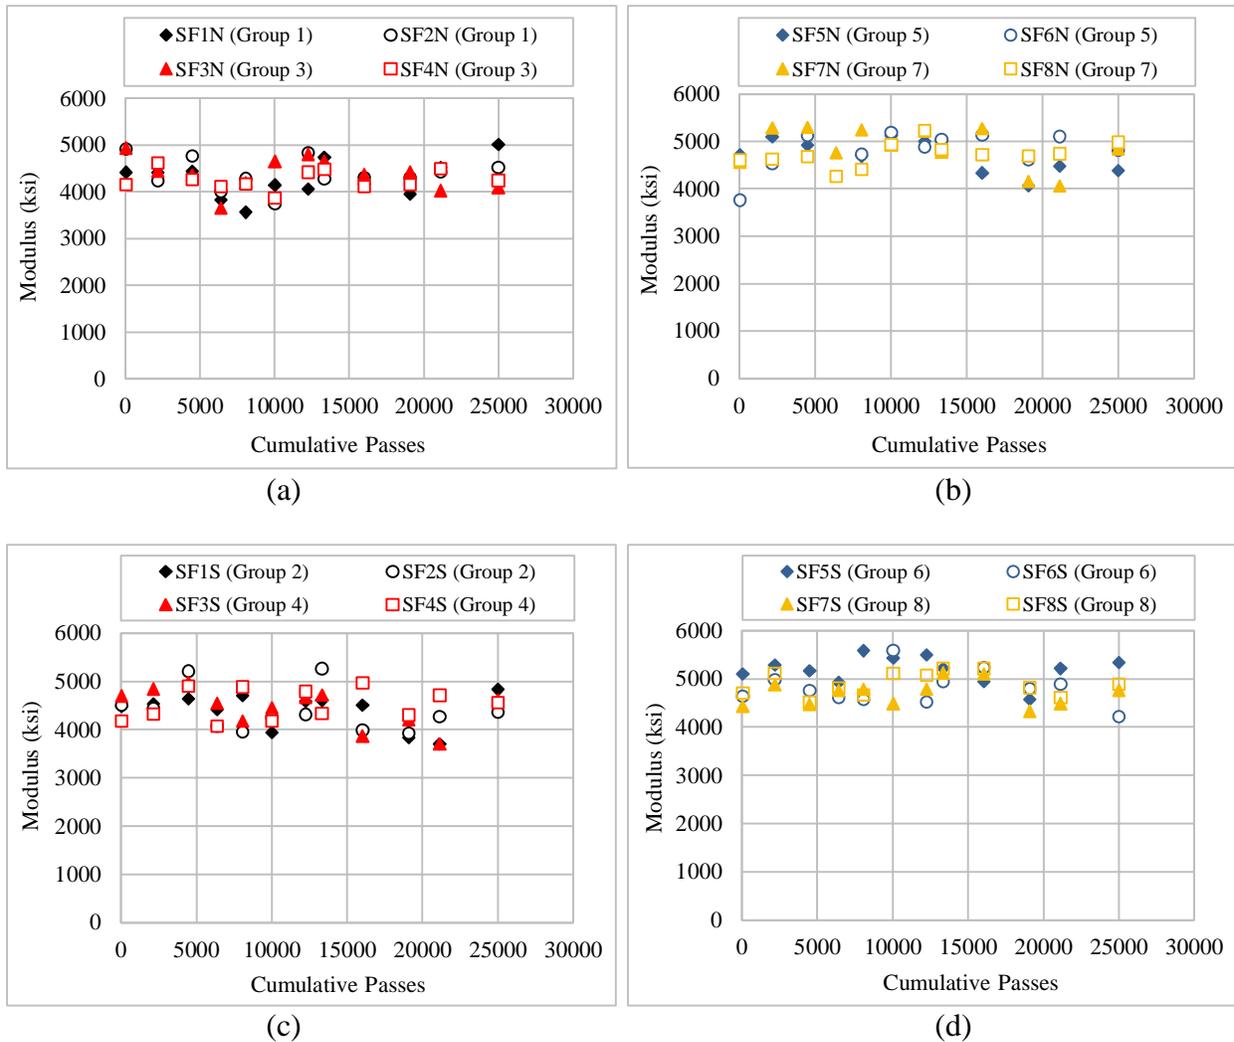
PSPA tests were performed on inner lanes to assess the change in slab modulus over the course of trafficking. Figure 19(a)-(d) show the change in slab modulus with cumulative passes. Neither the north nor south inner lane slabs show signs of modulus degradation indicating that slabs integrity remained unchanged. In the figures, 9-inch thick slabs exhibit slightly higher slab modulus compared to 12-inch thick slabs on both the north and south inner lane, possibly due to the difference in flexural strength.

Figure 19. PSPA Slab Modulus: (a) North Inner Lanes (Group 1 & 3: 12 inch), (b) North Inner Lanes (Group 5 & 7: 9 inch), (c) South Inner Lanes (Group 2 & 4: 12 inch), (d) South Inner Lanes (Group 6 & 8: 9 inch)
