Contract No. DTFACT-15-D-00007
Delivery Order 005 NAPTF Support
Deliverable 4.9.2.6.2: CC8 Phase 4 Strength/Fatigue
Traffic Test Report – Inner Lane

Submitted on February 12, 2021

Prepared by GDIT
with Horizon Engineering Consulting, LLC

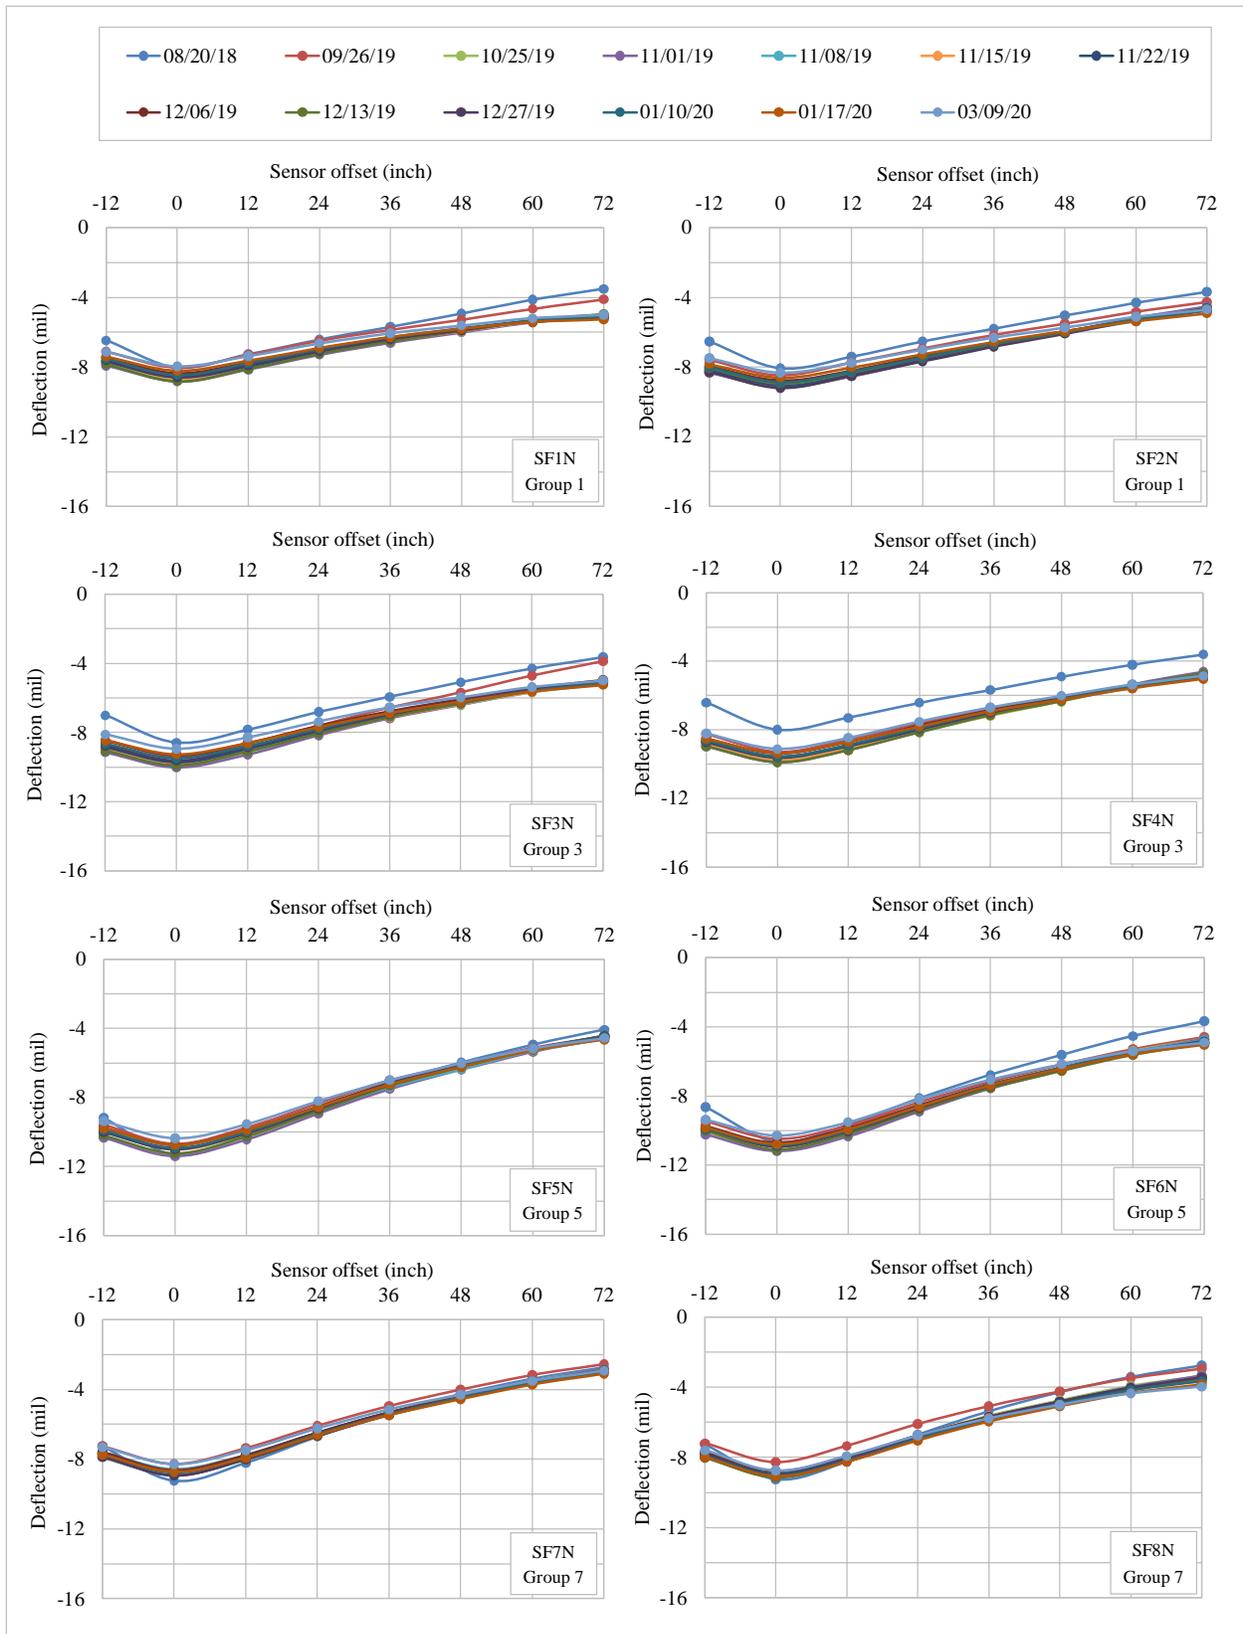
HWD tests were performed on a weekly basis at the center of all 16 S/F inner lane slabs and slab corners. Figures 20 and 21 show deflection basins normalized to 36,000-lbs HWD drops at slab centers for both north and south inner lanes, respectively. In general, the deflection basins of slabs on the south inner lanes showed more consistency over the course of trafficking compared to slabs on the north. Based on the magnitude of deflection, SF5S and SF6S were the weakest of the south inner lane. On the north inner lane, the deflection basin of slabs SF3N and SF4N exhibited a downward shift over the course of trafficking, indicating decrease in structural integrity. Slabs SF5N and SF6N showed the highest deflection values, which suggests these two were the weakest of the entire CC8 S/F test area.

Figure 20. Slab Center Deflection Basins, North Inner Lanes

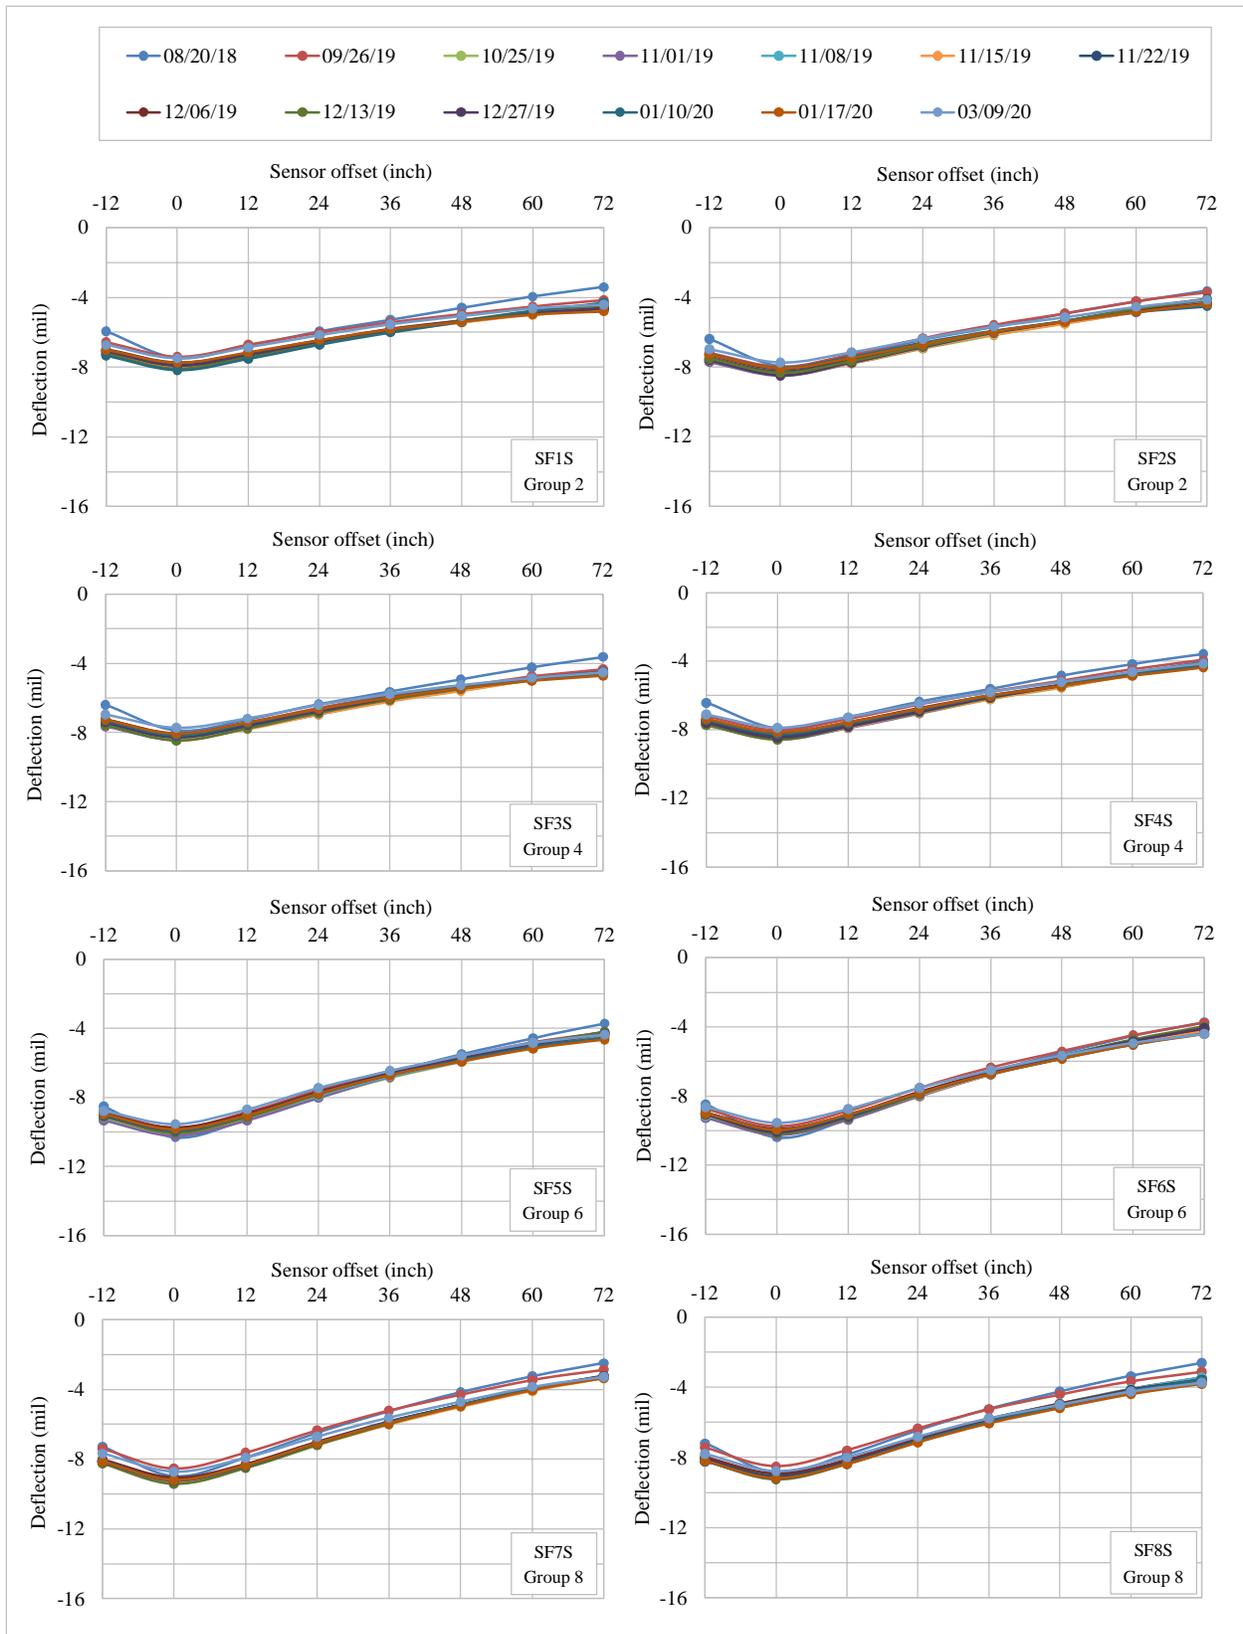
Figure 21. Slab Center Deflection Basins, South Inner Lanes

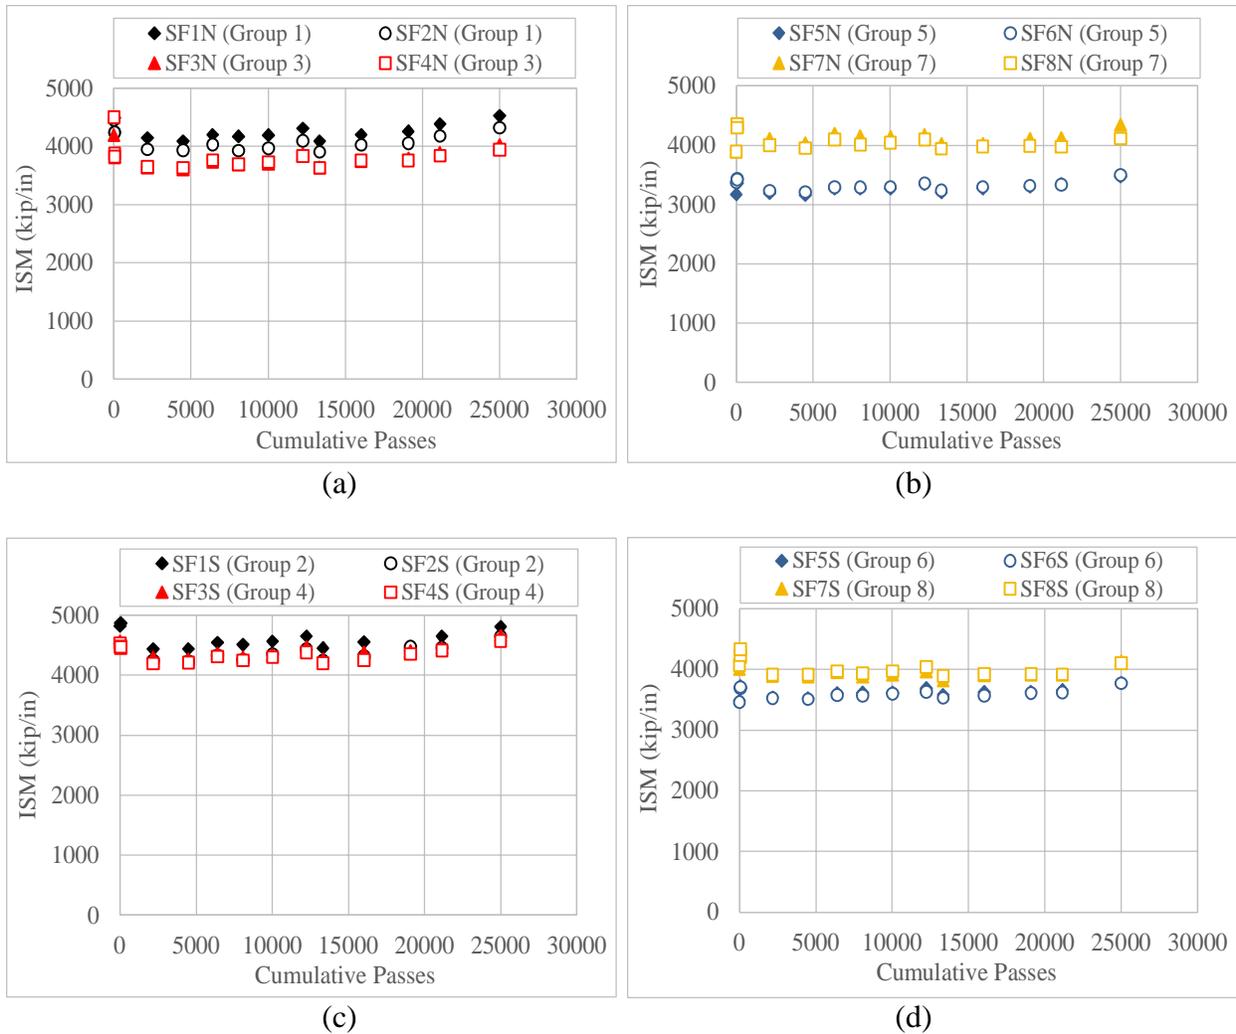
Figures 22(a) and (b) illustrate the changes in ISM as a function of cumulative passes for 12- and 9-inch thick slabs on the north inner lane, respectively. In general, the ISM trends show no sign of degradation in slab integrity. The ISM of slabs in groups 5 and 7 (i.e., 9-inch thick slabs) showed more consistency over the course of trafficking compared to groups 1 and 3 (i.e., 12-inch thick slabs). Test area built over subgrade with CBR 3-4 (group 7) were expected to show lower ISM than the area built over subgrade with CBR 7-8 (groups 1, 3 and 5). However, in figure 22(b), slabs SF7N and SF8N (group 7) showed higher ISM than slabs SF5N and SF6N (group 5). This observation suggests that the effect of subgrade strength was possibly offset by strength variability in shallower layers (e.g., higher compressive strength of P-306MR observed for slab groups on subgrade with CBR 3-4 compared to groups on subgrade with CBR 7-8).

Figure 22. ISM vs. Cumulative Passes for Inner Lanes: (a) North (Group 1 & 3), (b) North (Group 5 & 7), (c) South (Group 2 & 4), (d) South (Group 6 & 8)

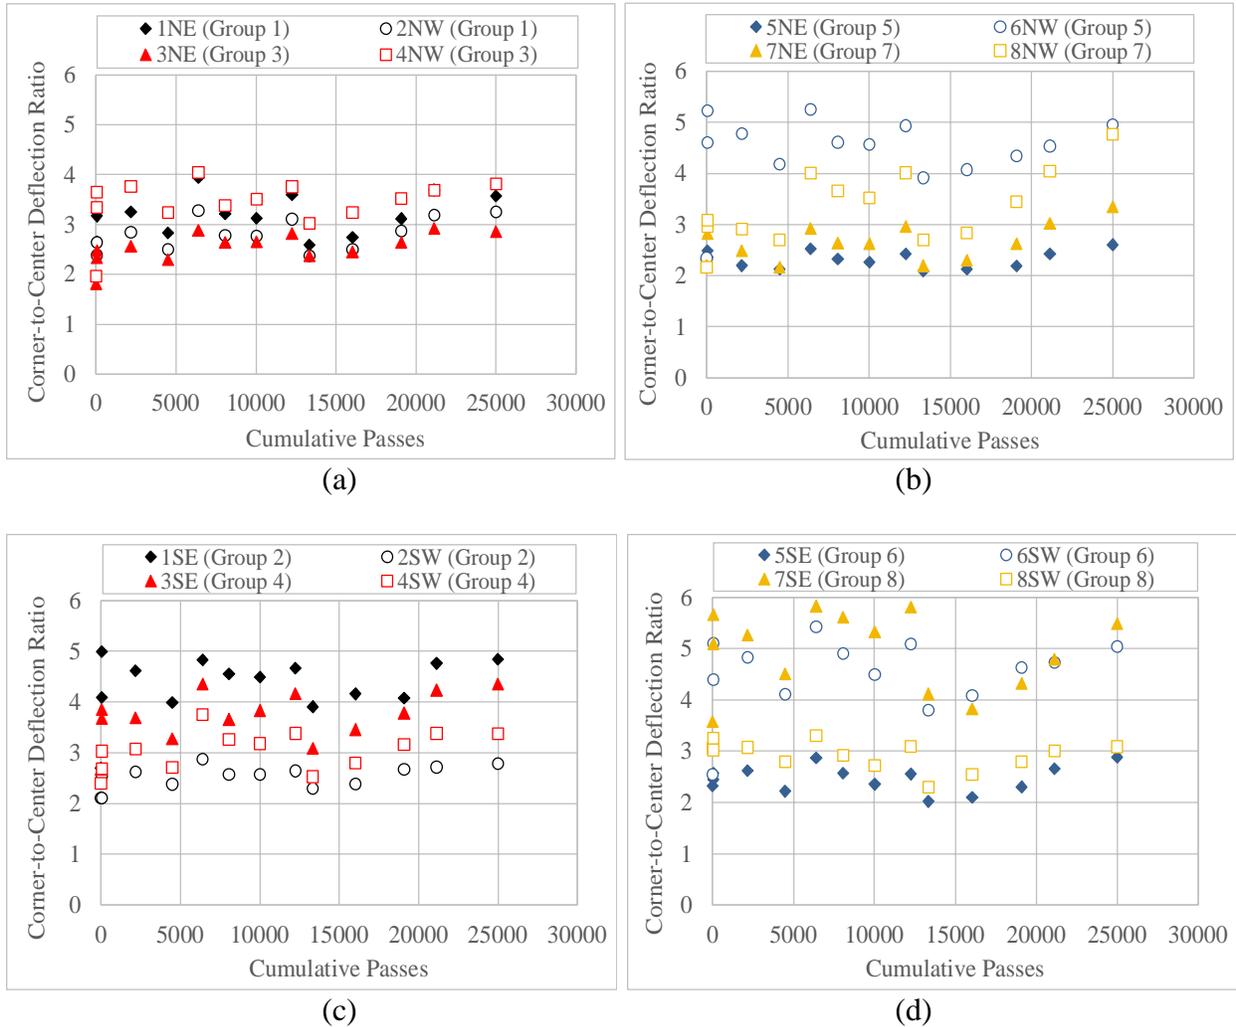
Notable changes in corner-to-center deflection ratio over the course of trafficking that are not associated to changes in slab temperature may provide indication of crack initiation/propagation. Figures 23(a)-(d) illustrate the change in corner-to-center deflection ratio over the course of trafficking. The trends of corner-to-center deflection ratio for 12-inch thick slabs (groups 1-4) were more uniform than those for 9-inch thick slabs (groups 5-8). The corner-to-center deflection ratios of slabs SF6N, SF1S, SF6S, and SF7S were relatively high compared to the rest of the slabs. It is speculated that localized deficiency of slab corner support resulting from construction variability can be a possible source for the observed high corner-to-center deflection ratios.

Figure 23. Corner-to-Center Deflection Ratio vs. Cumulative Passes for Inner Lanes: (a) North (Group 1 & 3), (b) North (Group 5 & 7), (c) South (Group 2 & 4), (d) South (Group 6 & 8)

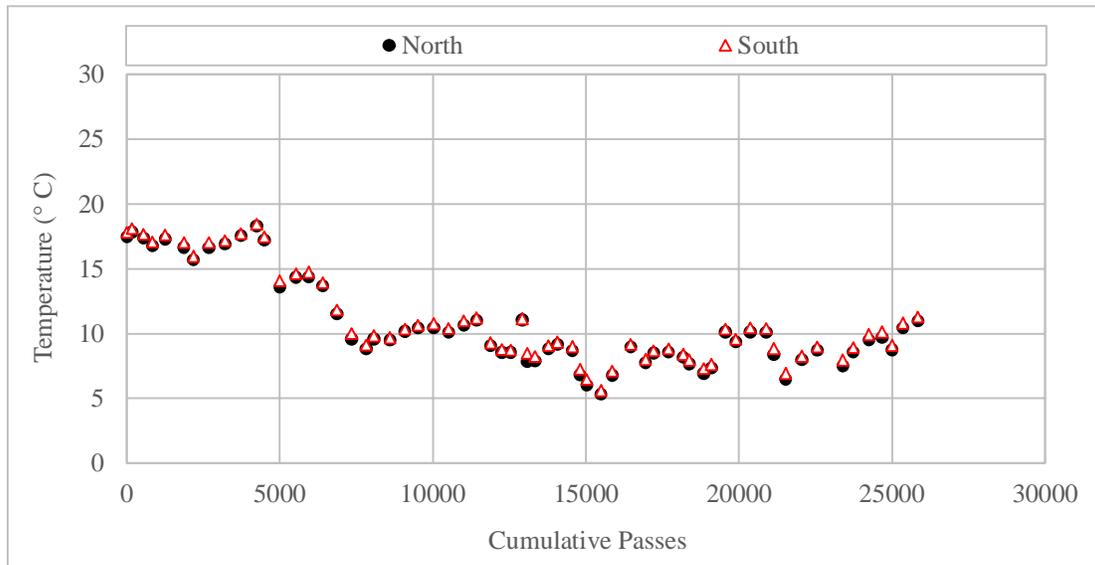
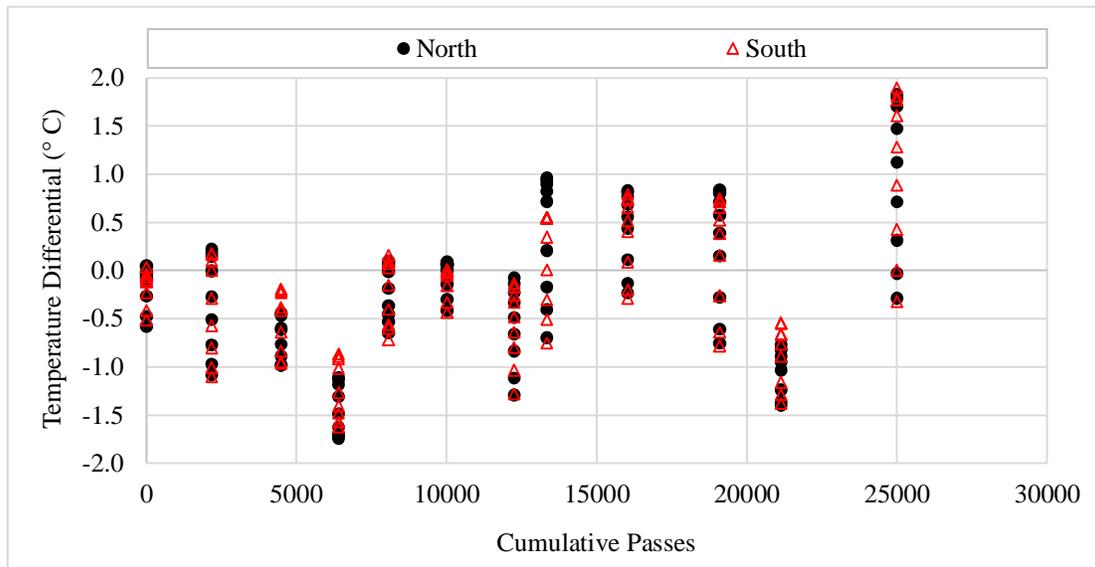
approximately 15,000 cumulative passes and remained low thereafter. In figure 24(b), the slab temperature differential (i.e., top-bottom) generally fluctuates between positive and negative values up to about cumulative pass 15,000 and showed a decreasing trend thereafter up to about 21,000 passes, which is consistent with the increasing trend of corner-to-center deflection ratio. Since no thermocouple data are available for 9-inch slabs, the final change in temperature differential at 25,000 passes is only reflected in 12-inch slabs (i.e., groups 1-4). Changes in slab temperature trigger curling and warping cycles, which explains the observed variation in corner-to-center deflection ratio.

Figure 24. Change in Slab Temperature over the Course of Trafficking: (a) Average Slab Temperature, (b) Temperature Differential (Top-Bottom)

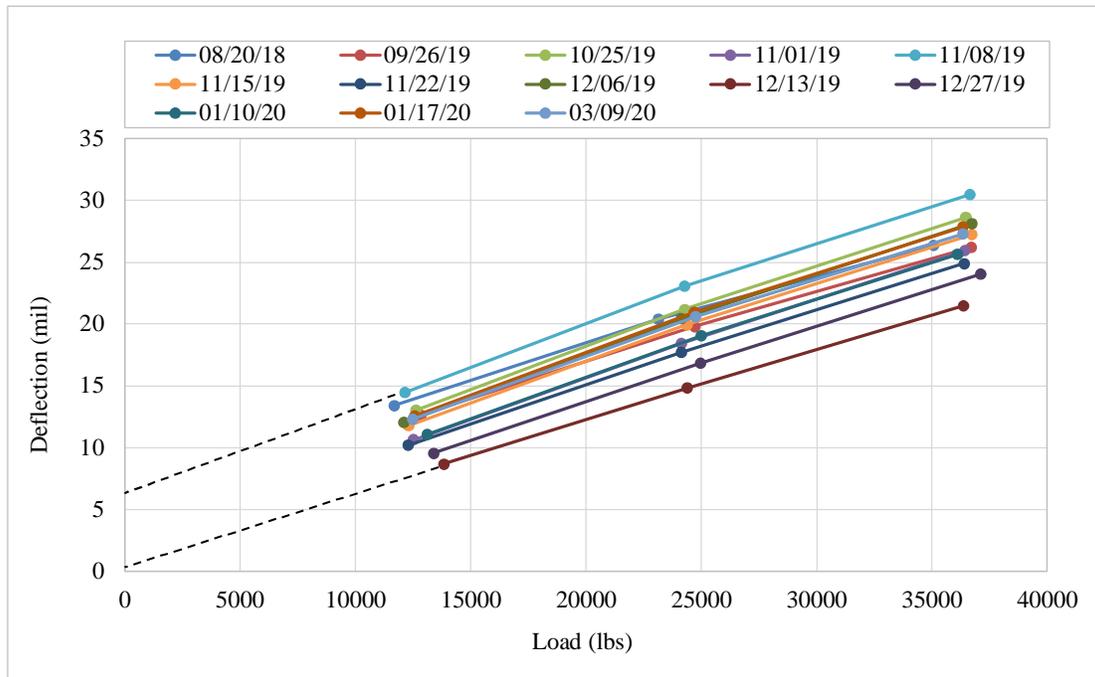
Figure 25. Example of Void Detection in Corner 8SW of Slab SF8S

Slab support conditions are key element of the performance of rigid pavements. The occurrence of surface distresses such as corner breaks, joint faulting, and slab cracking can all result from loss of support. Figure 25 presents an example of maximum deflection at slab corner (D_0) versus HWD loads, from corner 8SW of slab SF8S. Intercept values greater than zero along the vertical axis, indicate the possible presence of voids (or gaps between the slab bottom and top of the base course).

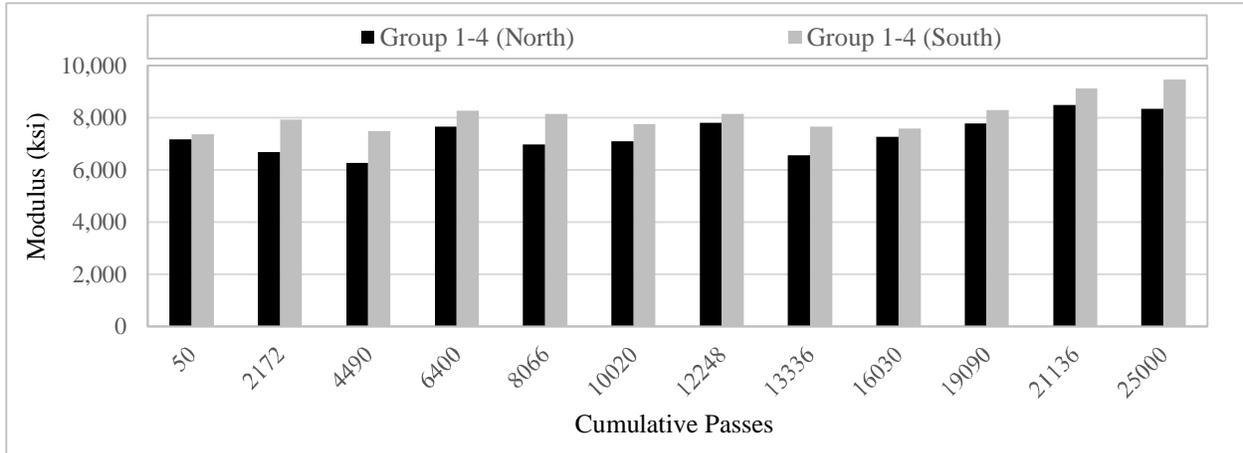
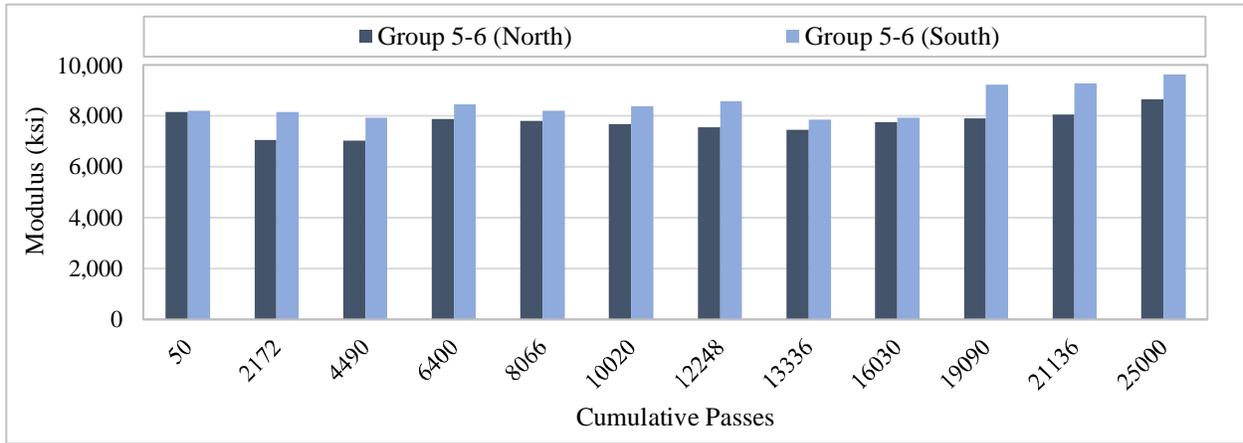
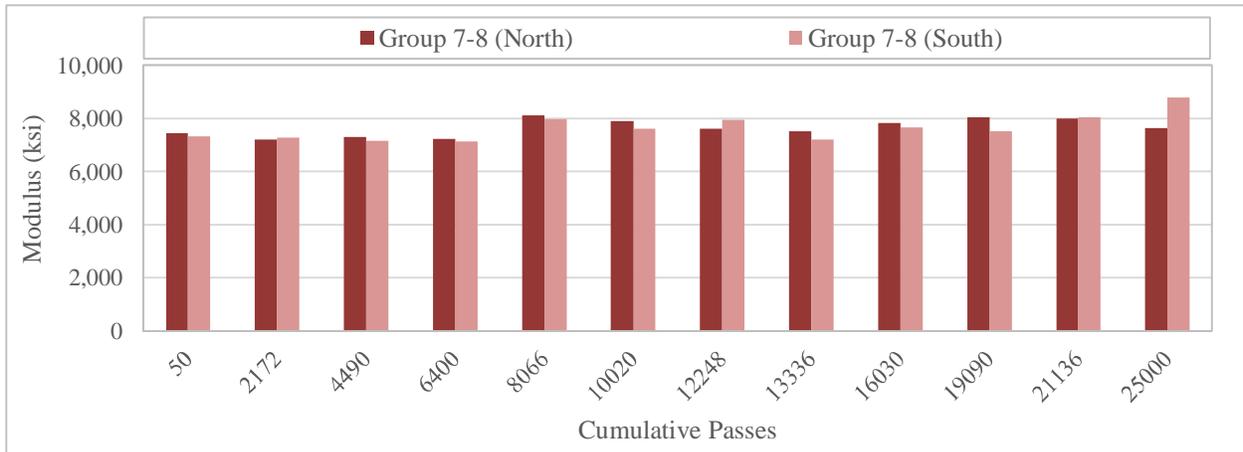
Figure 27. Backcalculated Moduli of P-501MR vs. Cumulative Passes for Inner Lanes:
 (a) Groups 1-4, (b) Groups 5 & 6, (c) Groups 7 & 8

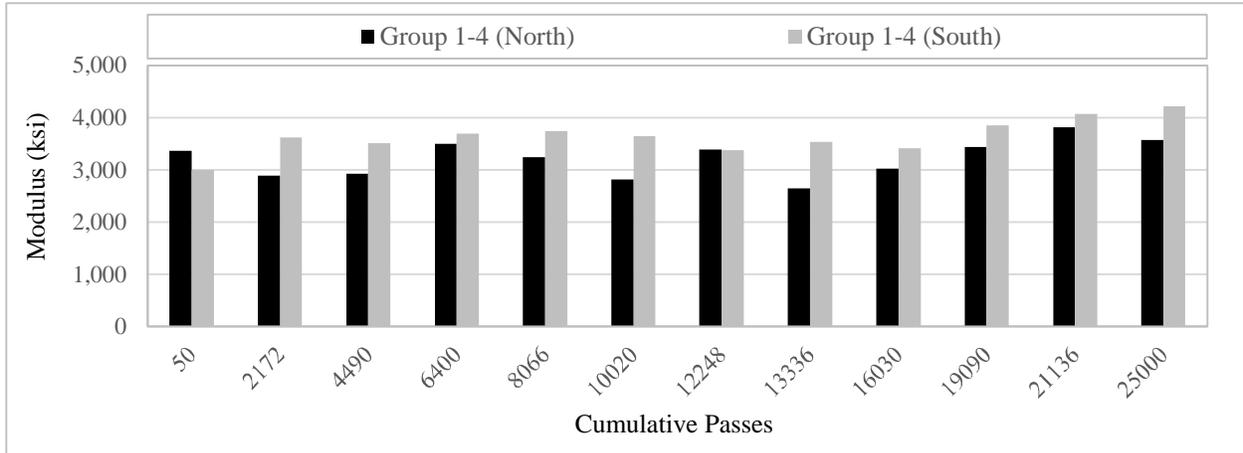
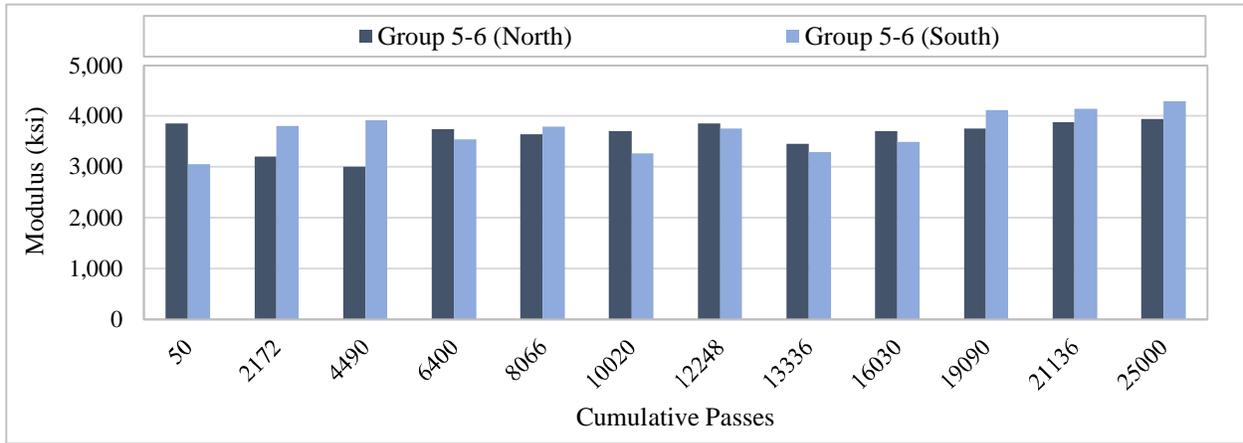
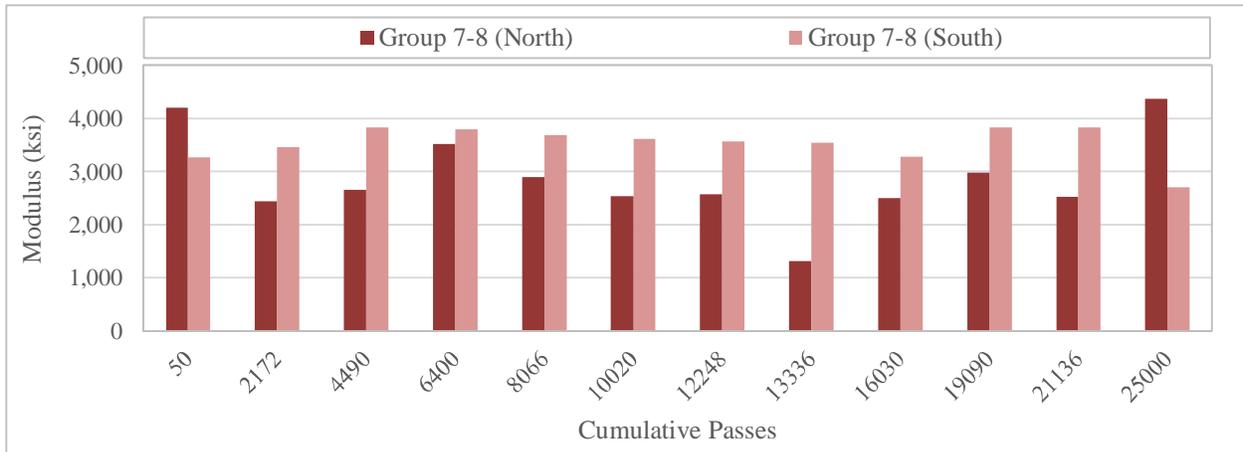
Figure 28. Backcalculated Moduli of P-306MR vs. Cumulative Passes for Inner Lanes:
 (a) Groups 1-4, (b) Groups 5 & 6, (c) Groups 7 & 8

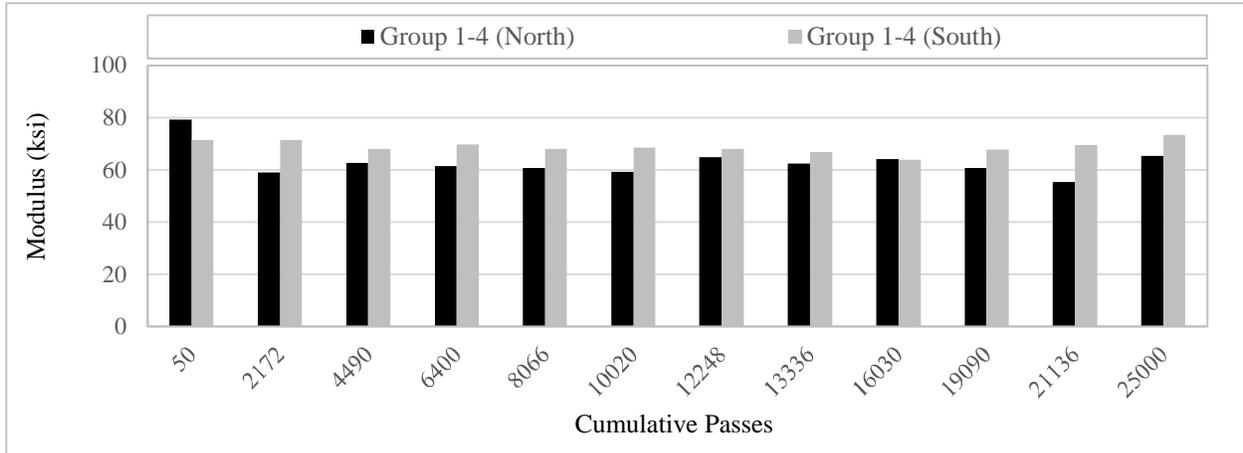
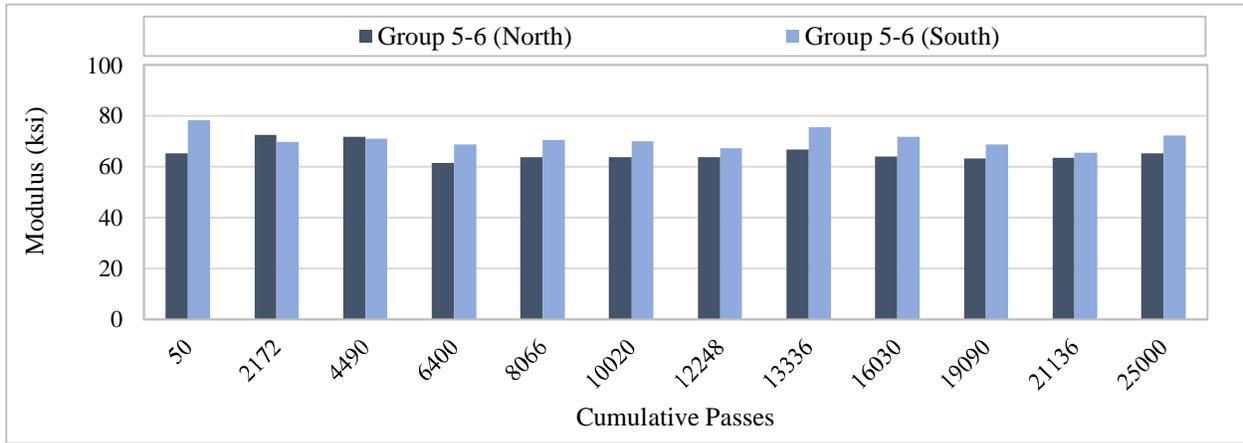
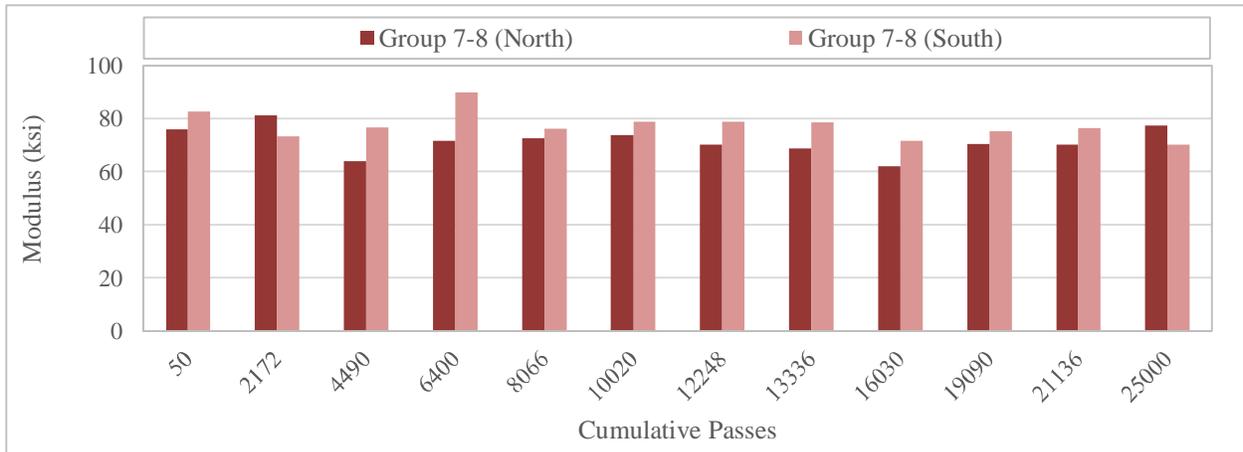
Figure 29. Backcalculated Moduli of P-154M vs. Cumulative Passes for Inner Lanes:
 (a) Groups 1-4, (b) Groups 5 & 6, (c) Groups 7 & 8

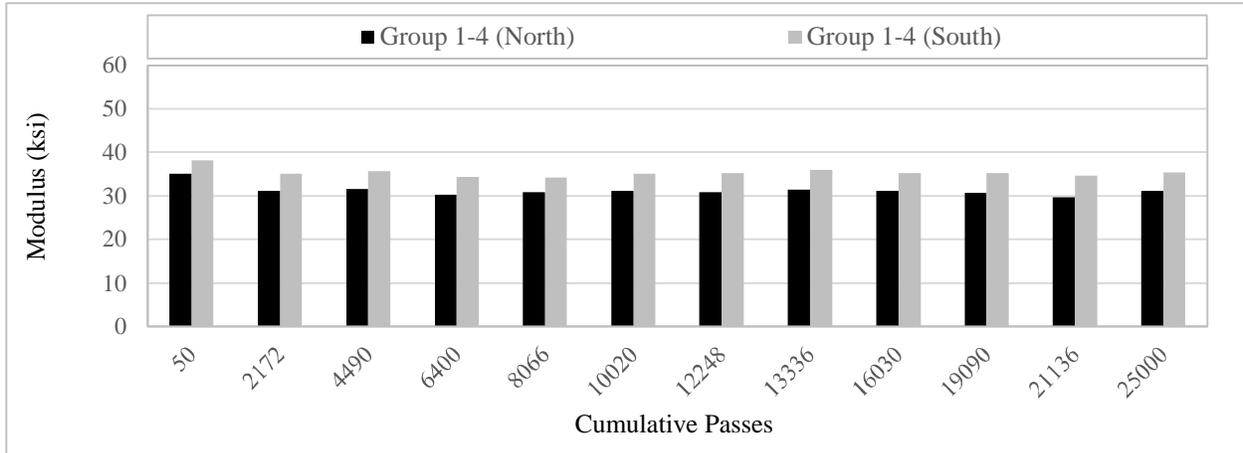
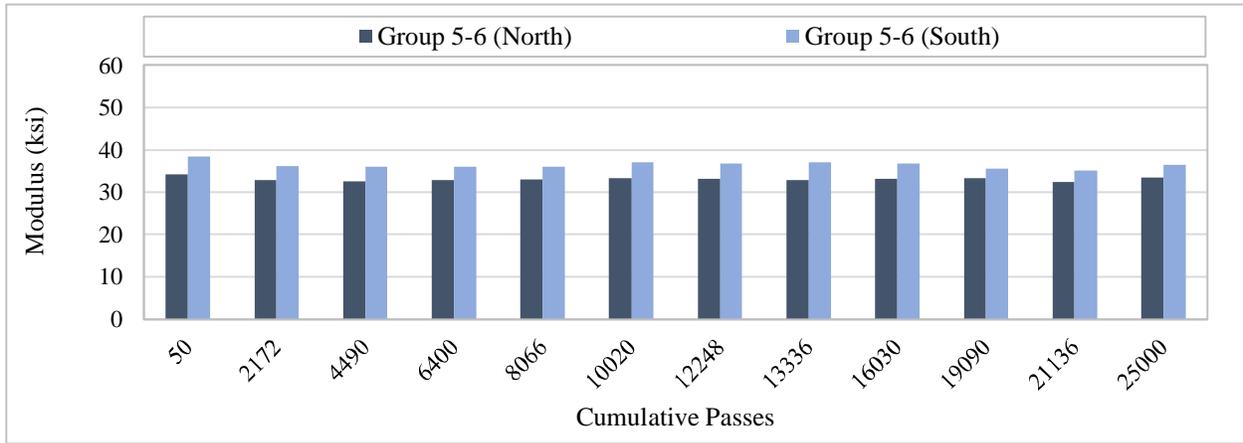
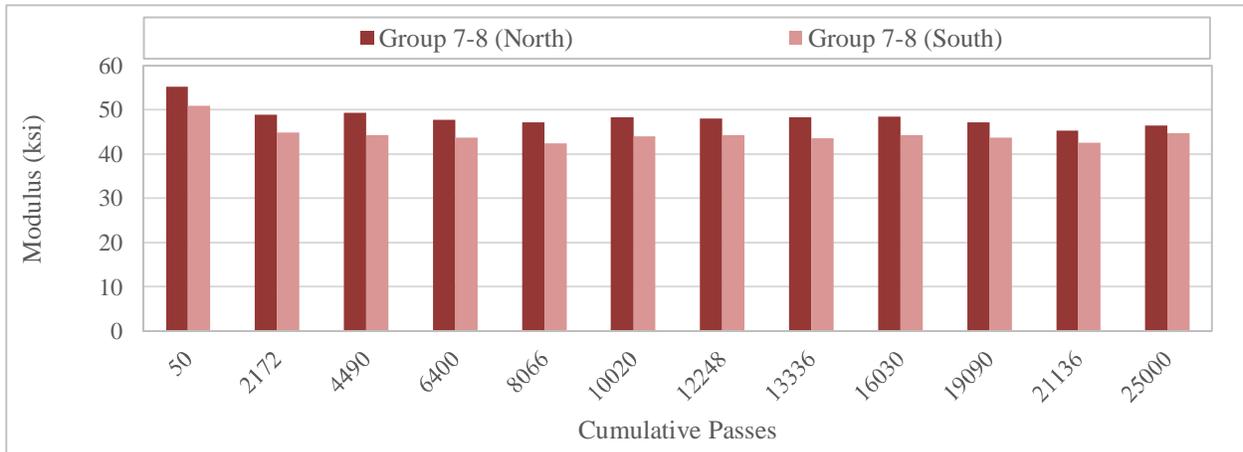
Figure 30. Backcalculated Moduli of P-152M vs. Cumulative Passes for Inner Lanes:
 (a) Groups 1-4, (b) Groups 5 & 6, (c) Groups 7 & 8

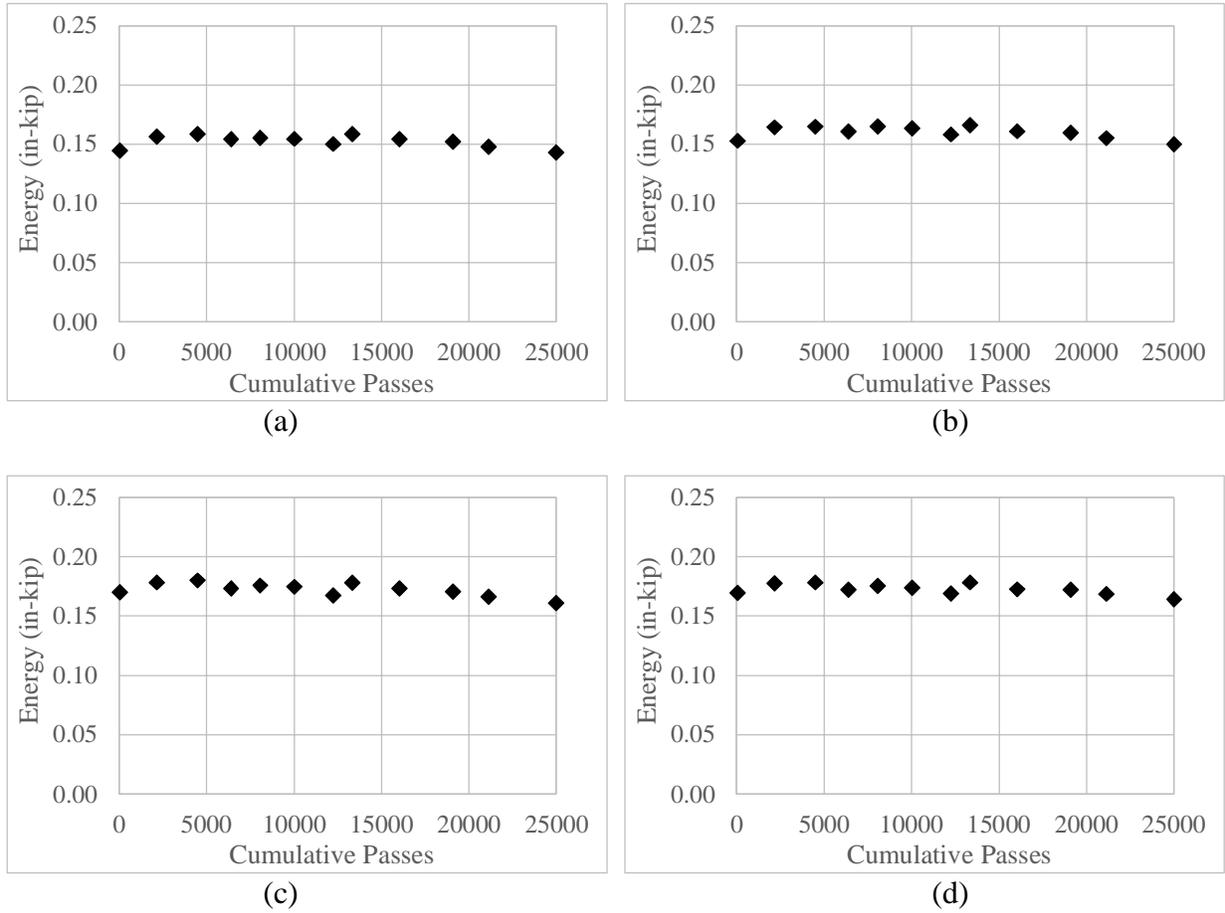
Figure 33. Pavement Deformation Energy on 12-inch Thick Slabs in North Inner Lanes: (a) SF1N, (b) SF2N, (c) SF3N, (d) SF4N

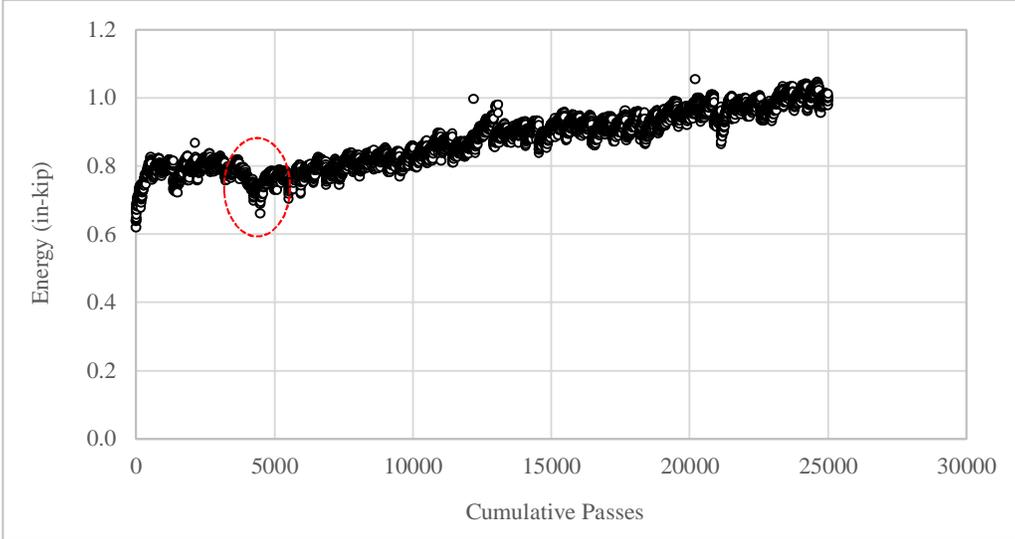
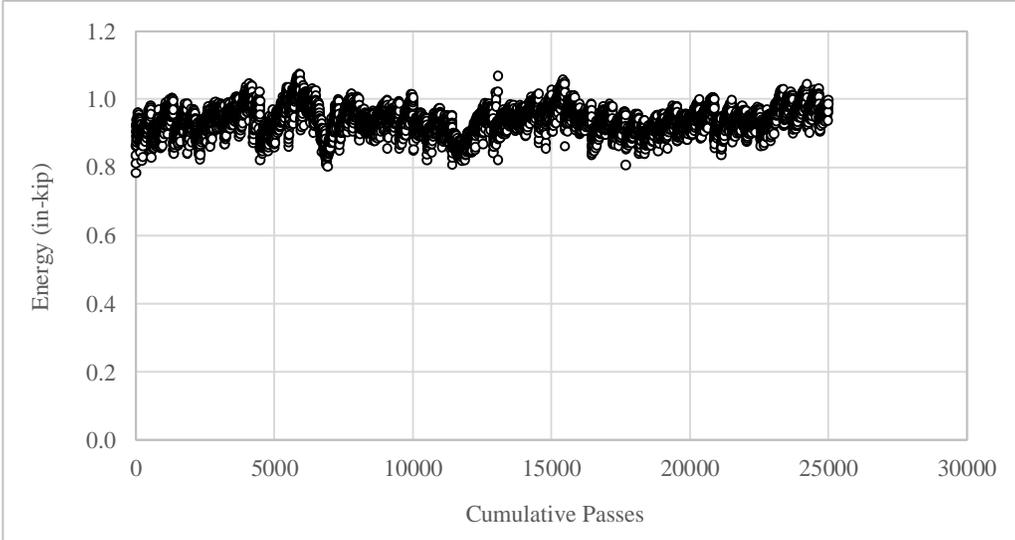
Figure 38(a) and (b) show the changes in internal strain energy over the course of trafficking for slab SF7N and SF8N, respectively. In figure 38(a), the strain energy trend for SF7N shows a clear inflection point after approximately 5,000 cumulative passes. The increasing trend observed after this inflection point may indicate the initiation of bottom-up cracks. The crack (if initiated) has not completed full-depth propagation since no sign of surface distress has been reported as of March 19, 2020. In figure 38(b), the strain energy for slab SF8N shows a relatively constant trend. No evident change of trajectory that can be associated to crack initiation is observed in the data.

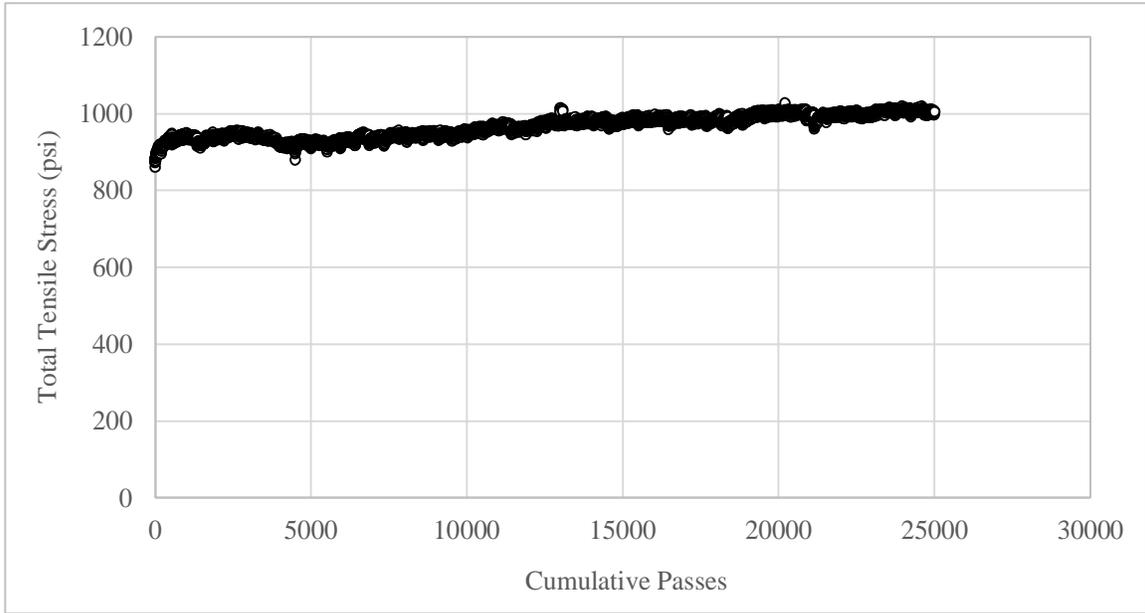
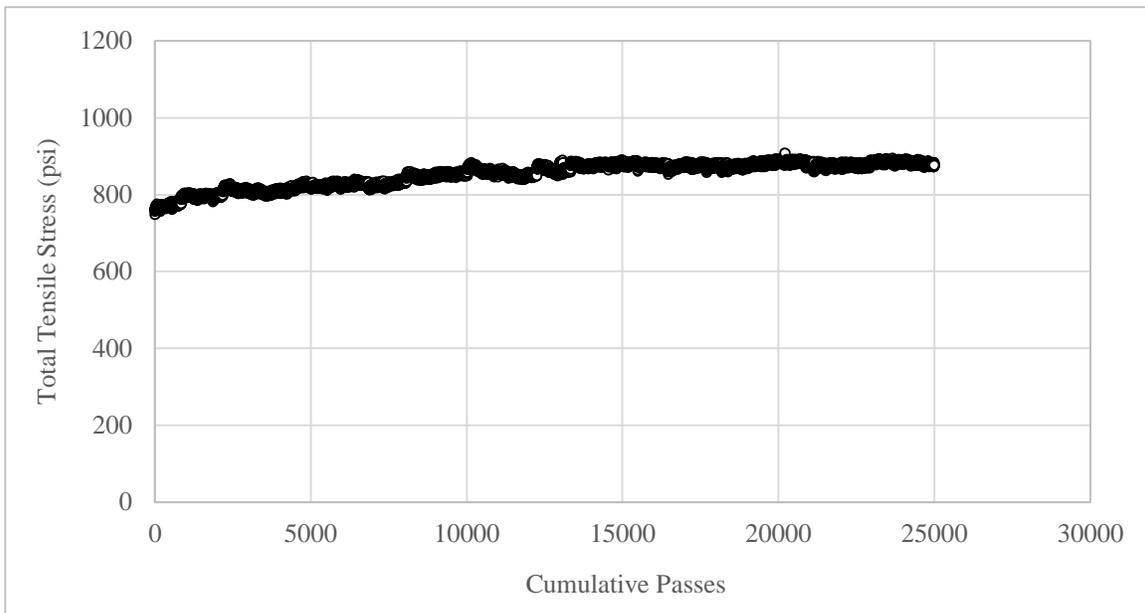
Figure 39. Change in Total Tensile Stress Over the Course of Trafficking: (a) SF7N, (b) SF8N

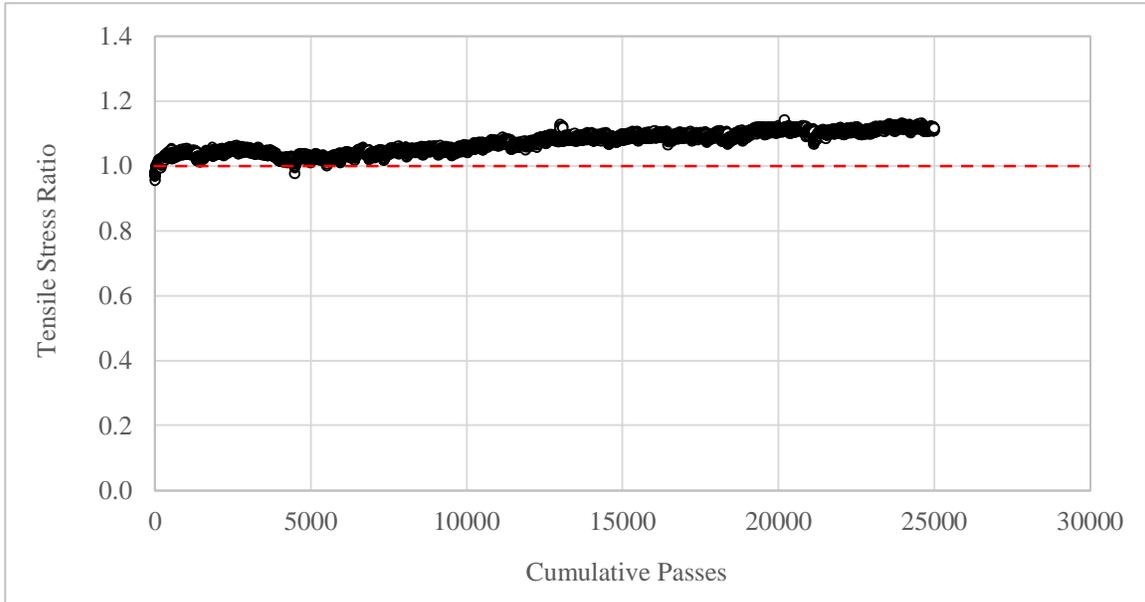
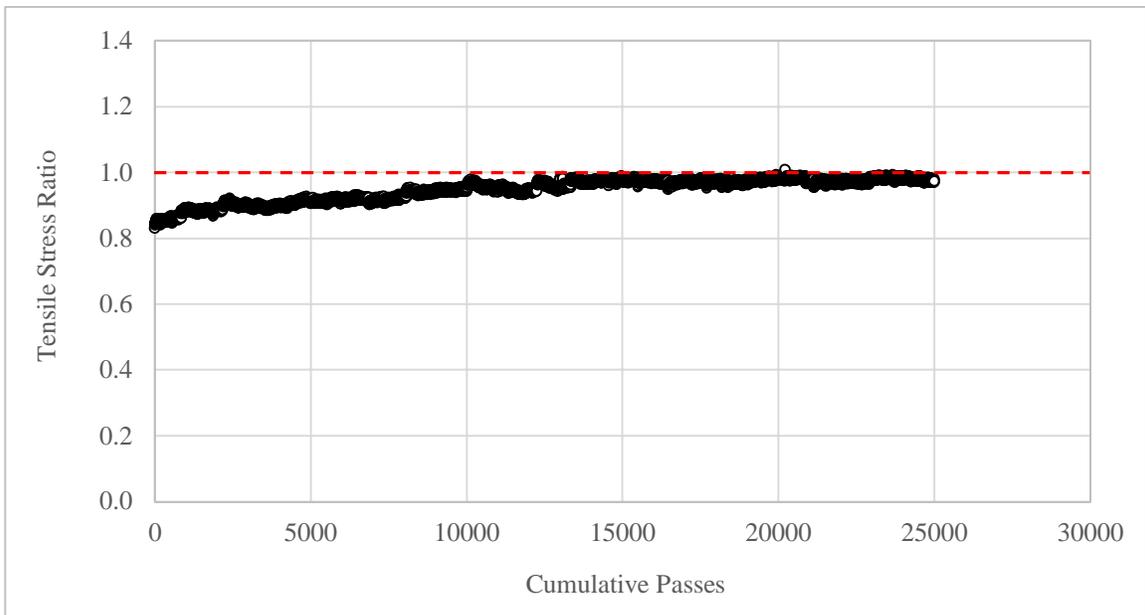
The ratio of total tensile stress to flexural strength (tensile stress ratio) was calculated. Figure 40 (a) and (b) show the change in tensile stress ratio over the course of trafficking for SF7N and SF8N, respectively. In the figures, the red line corresponds to the threshold tensile stress ratio of 1 (i.e., the total tensile stress equals the flexural strength of 950 psi for SF7N and SF8N). As illustrated in the figures, the total tensile stress already exceeds the flexural strength for SF7N, while the ratio remains below the threshold for SF8N. This is an indication that in both slabs a bottom-up crack may be about to initiate (if not initiated already).
