Contract No. DTFACT-15-D-00007
Delivery Order 005 NAPTF Support
Deliverable 4.9.2.6.2: CC8 Phase 4 Strength/Fatigue
Traffic Test Report – Inner Lane

Submitted on February 12, 2021

Prepared by GDIT
with Horizon Engineering Consulting, LLC

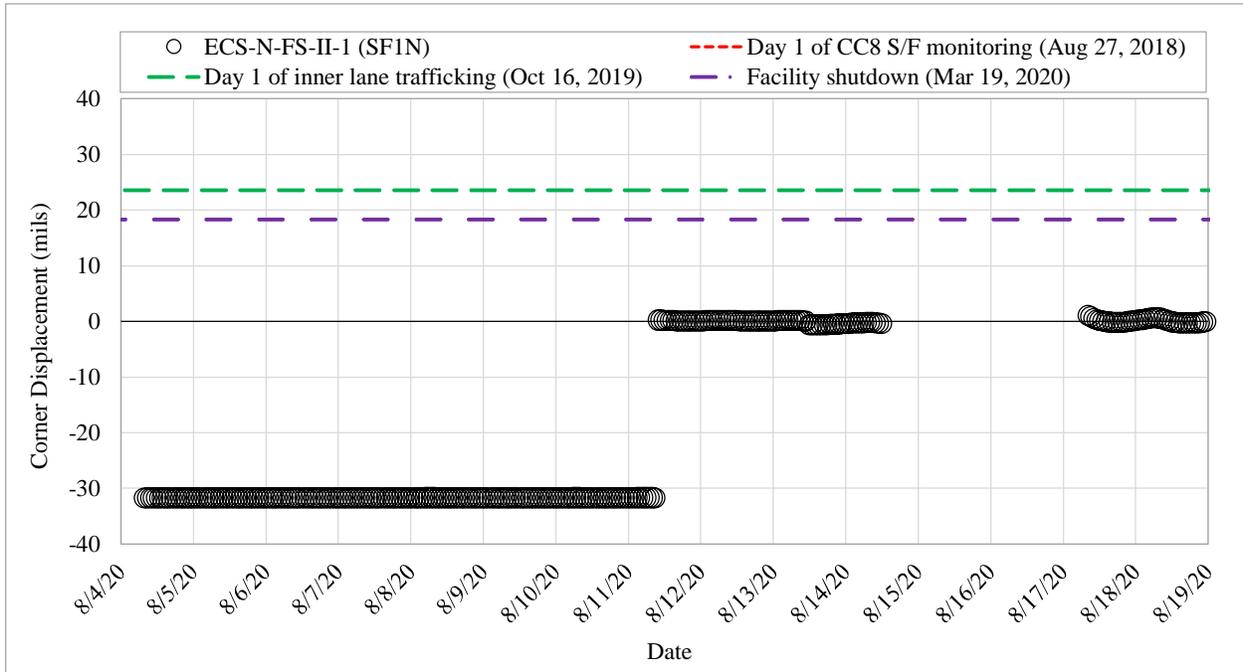
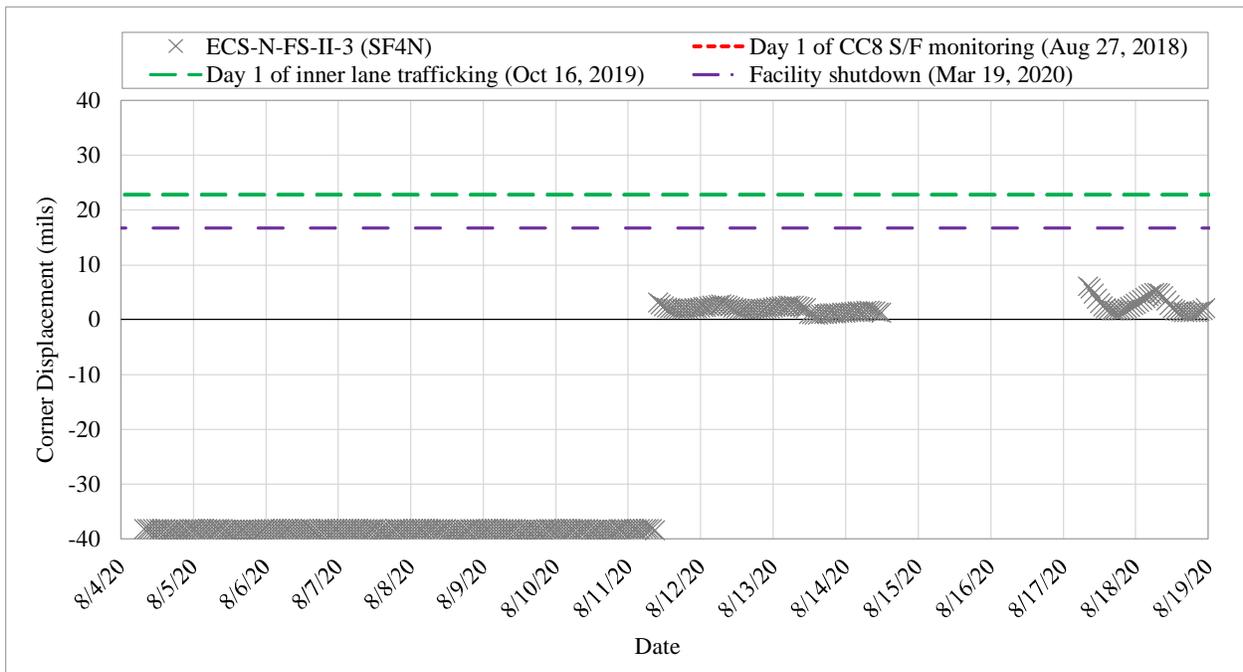
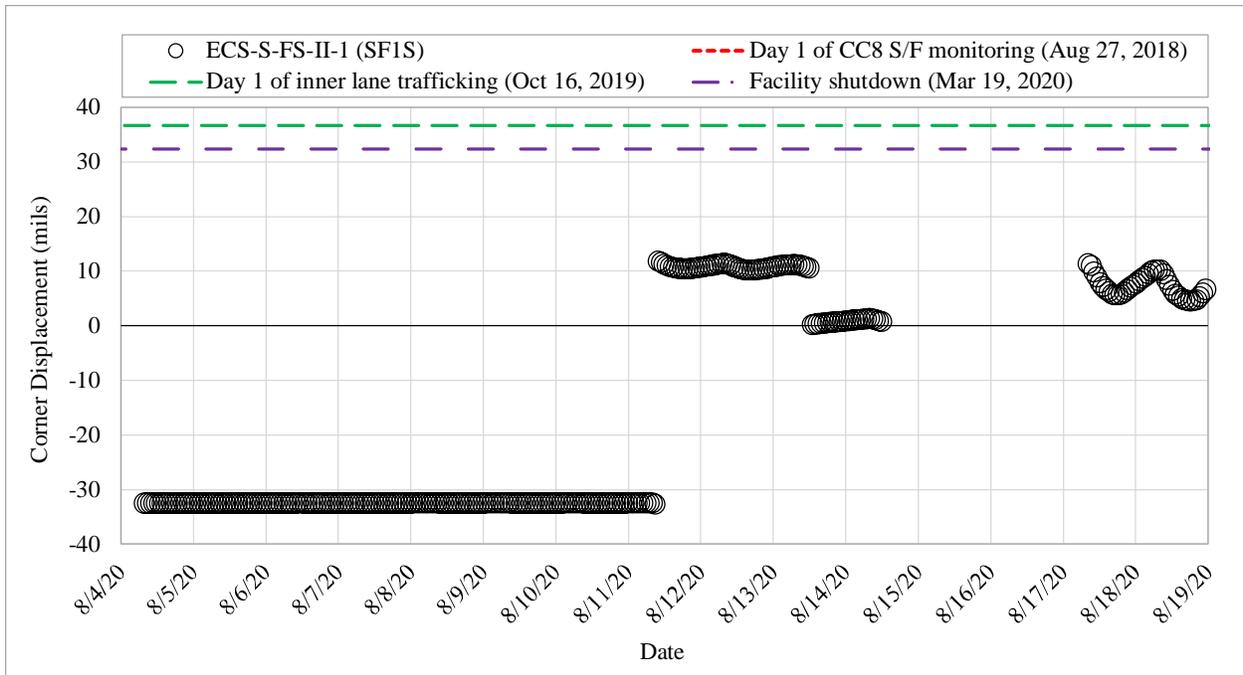
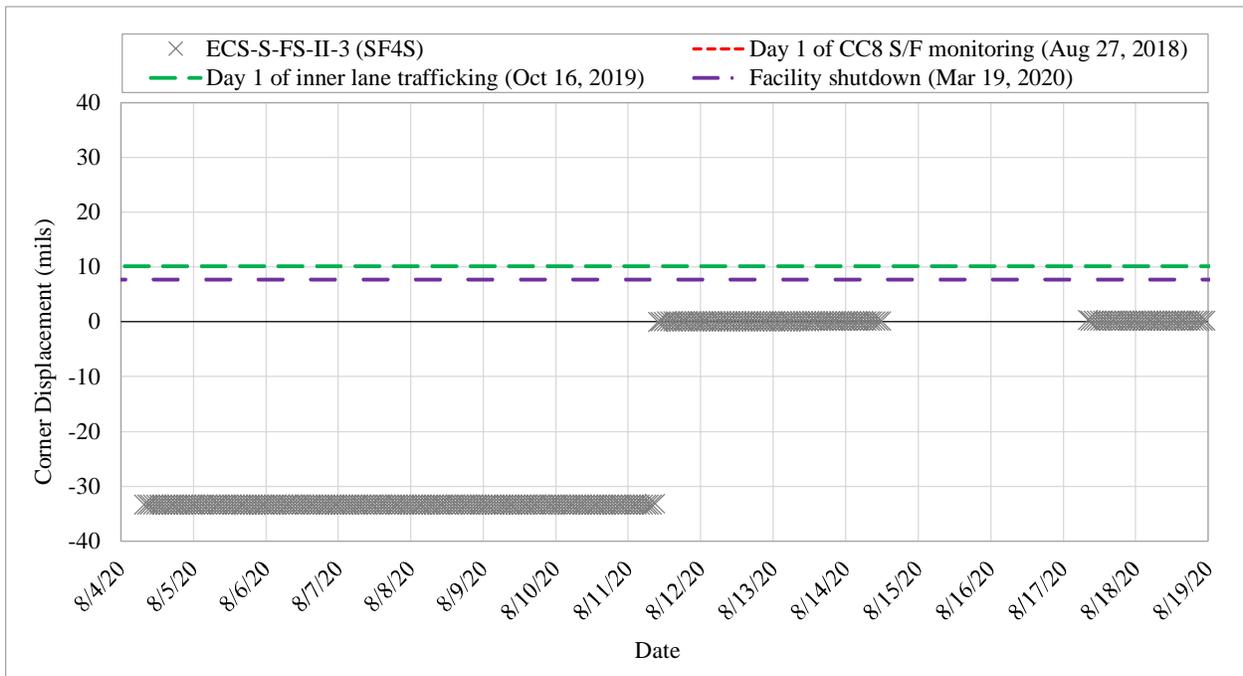
displacement for 12-inch thick slabs generally remained flat, while corners of 9-inch thick slabs show noticeable movement. During an instrumentation inspection conducted on August 11, a burnt terminal and tripped breaker in SPU 4 were reported. After SPU 4 was repaired, the high corner displacement recorded by ECS in 12-inch slabs returned to anticipated normal (lower) levels.

Figure 41. Corner Displacement in 12-inch Thick Slabs: (a) SF1N, (b) SF4N, (c) SF1S, (d) SF4S

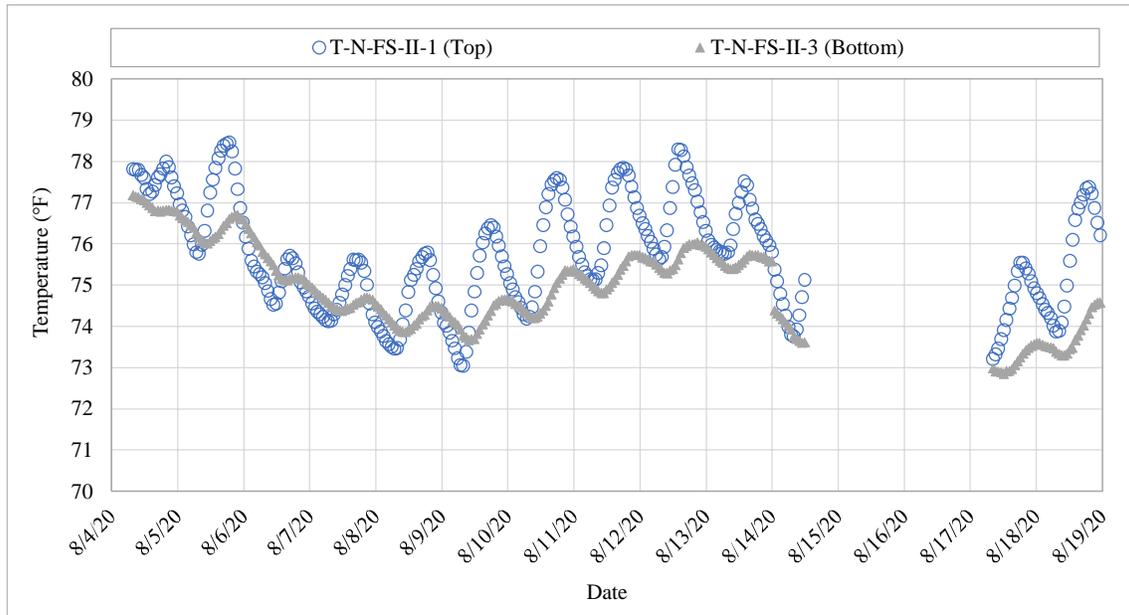
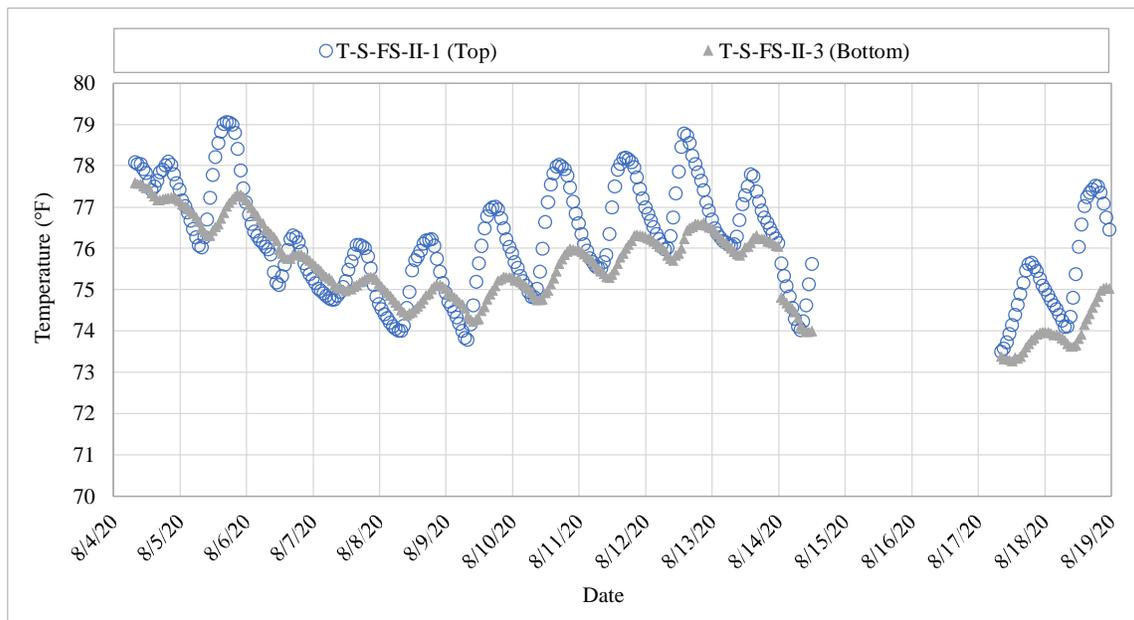
Figure 43 shows that the fluctuation in temperature differential between the slab top and bottom agreed with the change in corner displacement of 9-inch thick slabs over time. Slab watering for corner displacement control started on August 4. In figure 42, the gradual attenuation of corner displacement fluctuation indicates the effectiveness of watering in controlling slab curling. Note that due to a pre-scheduled power outage in the facility, data collection was discontinued from August 14 to August 17.

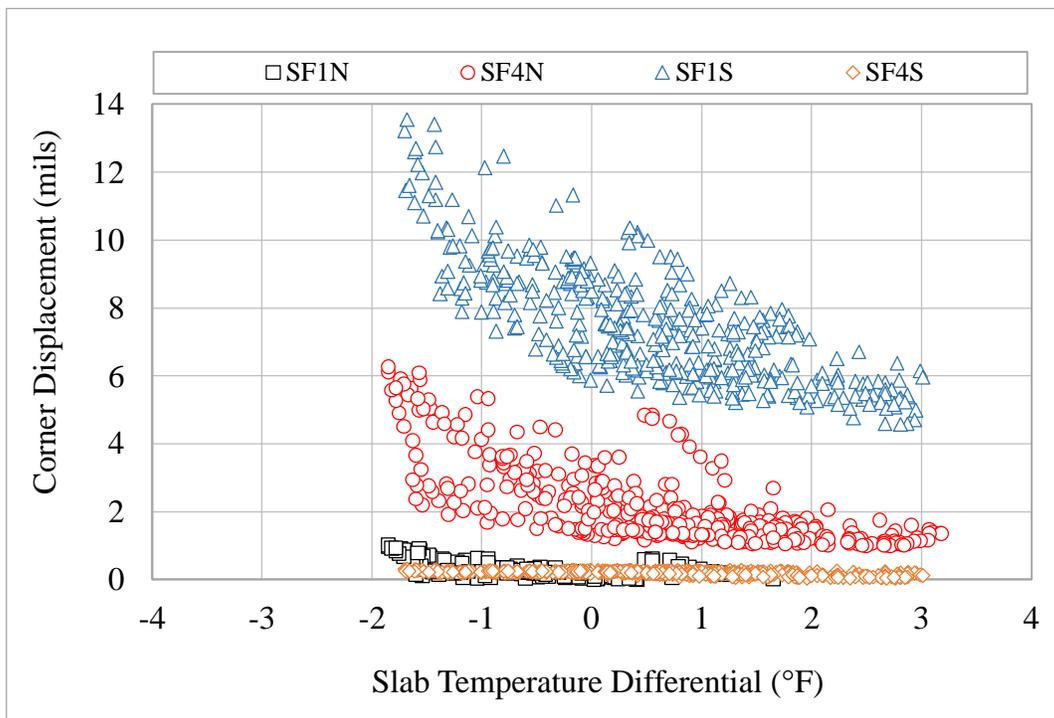
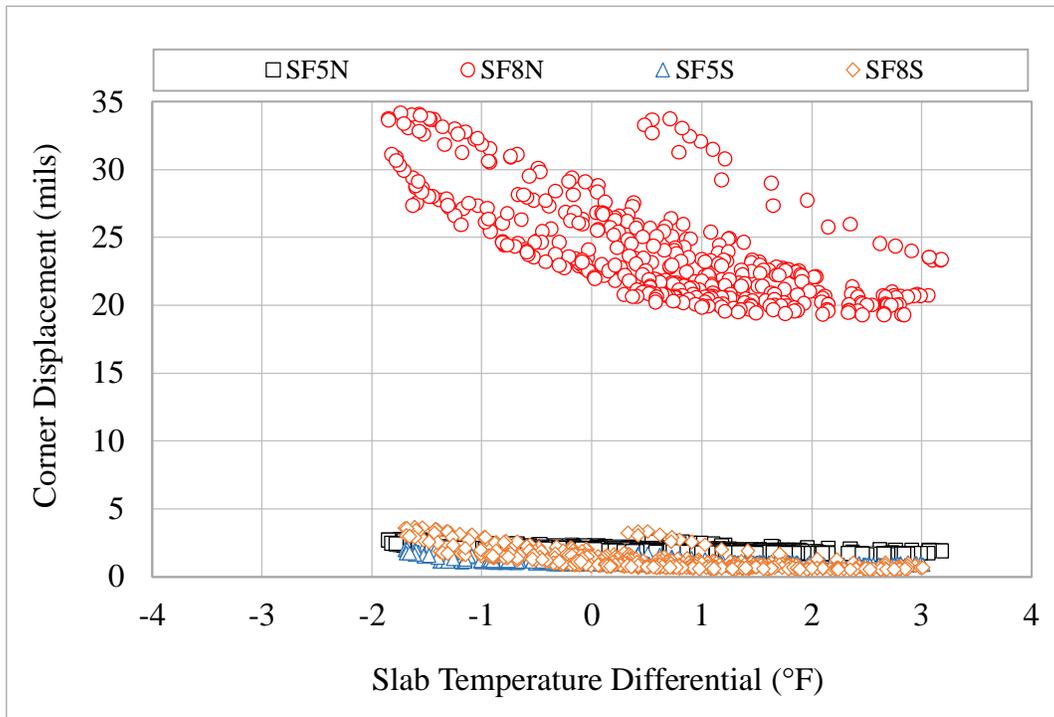
Figure 44(a) and (b) show the slab corner displacement measured by ECS as a function of temperature differential (i.e., difference between top and bottom slab temperature) for 12- and 9-inch thick slabs, respectively. The figures plot data collected from August 18 to September 03, 2020. Negative temperature differentials indicate that the temperature at the slab top is lower than at the slab bottom, whereas the opposite applies for positive differentials. Contraction at the top of the slab resulted in the upward displacement of the corners (i.e., slab curling). Expansion of the slab top produced downward corner displacement. In both figure 44 (a) and (b), the range of corner displacement varies among the slabs. For instance, in figure 44 (a) the corner displacement for slab SF1N varies over a 10-mil range while the displacement for slab SF1S is only recorded over a 1-mil range. The upward corner displacement observed in all slabs decreases at varying rates as the negative temperature differential approaches to zero. In general, a non-uniform correlation between corner displacement and slab temperature differential was observed.

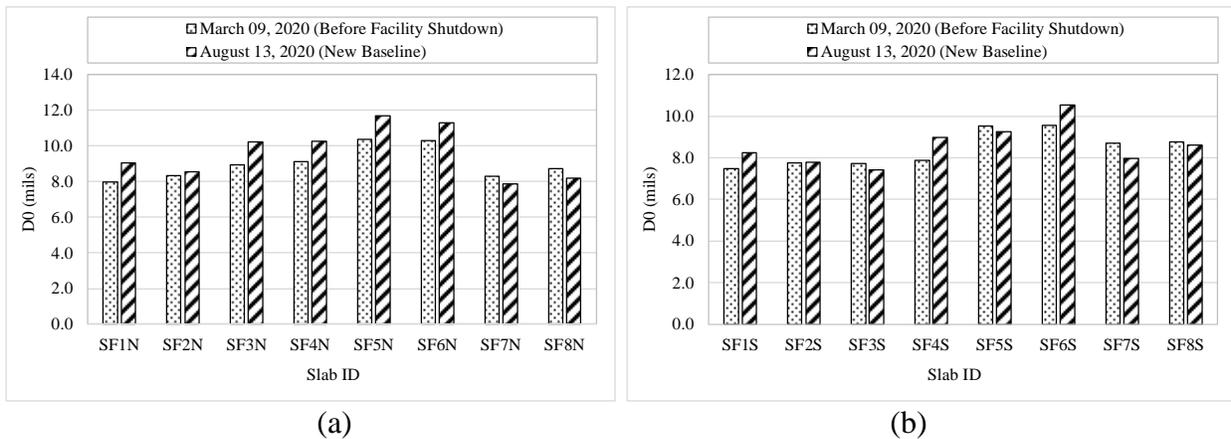
New baseline HWD and PSPA tests were conducted on August 13-14, 2020 to evaluate the pavement condition after the temporary facility shutdown. The tests were performed at the locations indicated in the CC8 S/F test procedure, on both north and south inner lane slabs. HWD testing was conducted following the loading sequence also described in the CC8 S/F test procedure. Figure 45 compares maximum HWD deflections (D0) measured before the facility shutdown on March 09 with values measured on August 13. Deflections from both data sets are comparable. The same applies for the comparison between PSPA modulus data sets in figure 46.

Figure 45. Maximum HWD Deflection at Center of Slabs: (a) North, and (b) South

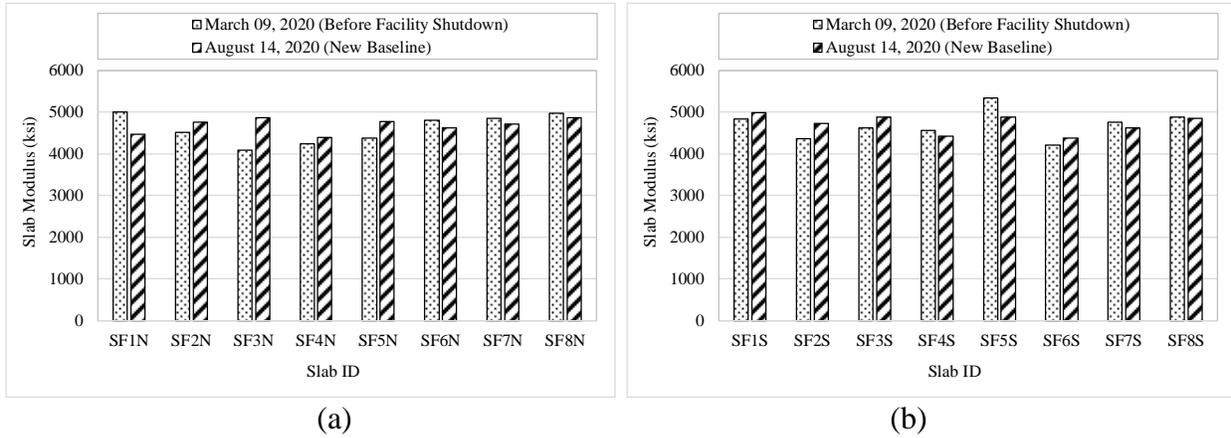
Figure 46. Slab Modulus from PSPA Testing at the Center of Slabs: (a) North, and (b) South

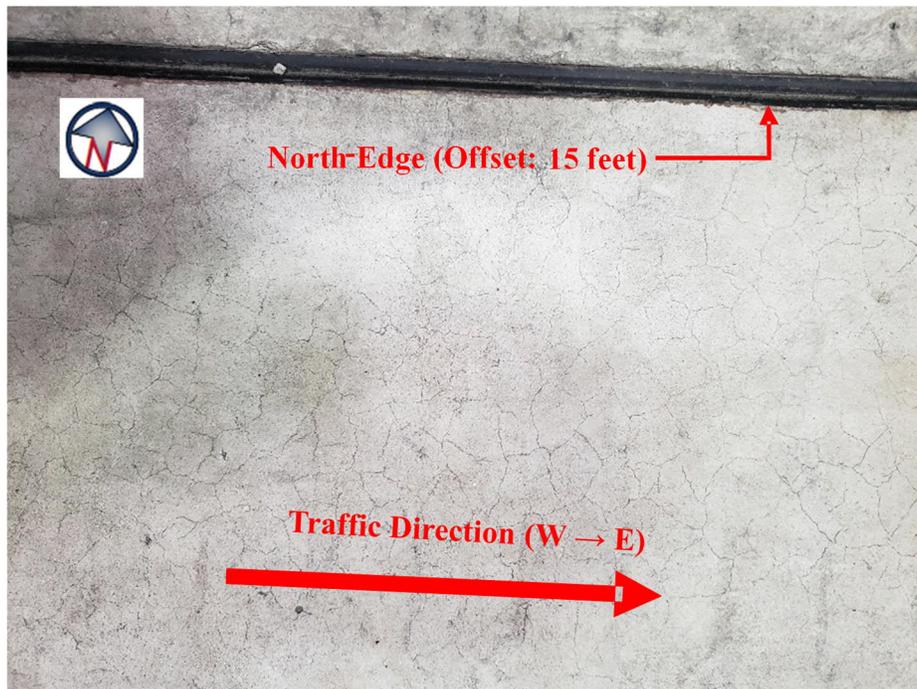
The initial slab visual inspection conducted after reopening the facility reported: hairline cracks, joint faulting, corner displacement, and undulated slab surface. Slabs SF3N, SF4N, SF5S, and SF6S were further evaluated on August 17, 2020. Non-load related shrinkage cracks were observed on the surface of slab SF4N, close to the north edge as shown in figure 47.

Figure 47. Shrinkage Cracks on Slab SF4N

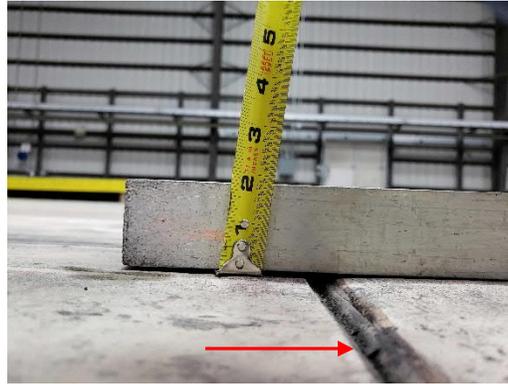
During inspection of transverse joints, differences in the surface elevation of slabs SF4N and SF6S relative to SF3N and SF5S, respectively, were reported. As illustrated in figure 48(a) and (b), joint

faulting is obtained by measuring the vertical difference (δ) between the bottom of a straight edge placed on top of the elevated slab and the top of the adjacent slab. Figure 48 (c) indicates the measurement locations along transverse joints. Table 16 summarizes the faulting measurements. Note that faulting of 0.0625 inch is reported at a +/-12 ft. offset from the centerline. This measurement location is the nearest to the wheel track (i.e., +/-10 ft. offset)

Figure 48. Joint Faulting Measurement: (a) Field Measurement, (b) Faulting Interpretation, (c) Measurement Locations

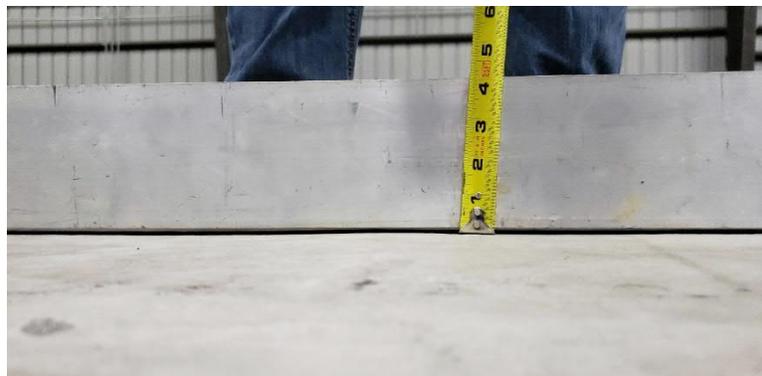
The slab surface elevation was mapped using the straight edge as shown in figure 49. Figure 49(a) illustrates the straight edge placed transversely across the middle of slab SF4N, aligned with the slab north edge at one of its ends (i.e., offset -15 ft.). The surface depression (i.e., vertical difference between the straight edge bottom and the slab surface) was measured at different locations, as shown in figure 49 (b). Contours of the surface elevation were generated for slabs SF3N, SF4N, SF5S, and SF6S as shown in figure 50 (a) and (b). The interior of the slabs exhibited higher depression.

Figure 49. Surface Elevation Mapping: (a) Placement of Straight Edge, (b) Surface Measurement
